LIFT REPORT

Raine & Horne

Macquarie Gardens 1 Fontenoy Road Macquarie Park

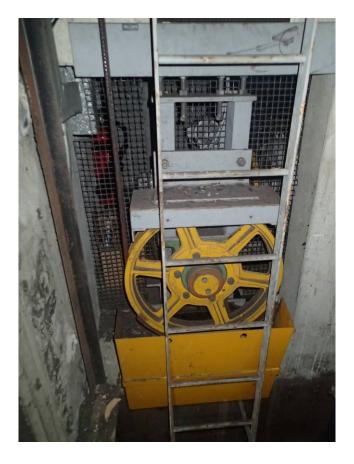
Hoisting machine oil leaks must be repaired and oily rags removed
