04 November 2014

Our ref: 2140438-REP

**RE: SP52948 - 1-15 FONTENOY STREET, NORTH RYDE NSW 2113
WATER INGRESS IN NOMINATED UNITS**

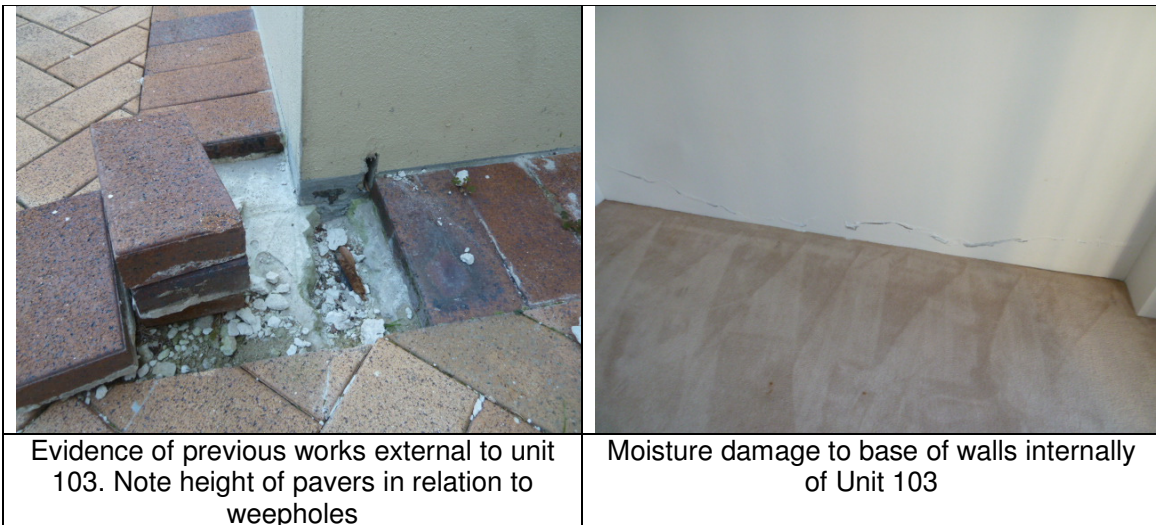
The building is of a full masonry construction with rendered and painted external walls. Weep holes at the base of the walls have generally been put in position to all the nominated units (other than 49) however the weep holes have been partially covered over by the pavers used to the external patio areas.

The positioning of the pavers will greatly reduce the ability of the cavities to self drain any water which may enter the cavity via cracks within the external render and or gaps at window and door reveals.

It is considered that moisture entering the cavity (by the aforementioned means) is being trapped within the base of the cavity by the pavers and lack of weepholes for Unit 49. This saturation of water will then allow for it to migrate through to the internal masonry walls via capillary action through laps and other possible failures (holes) within the cavity flashing or via mortar bridges formed on the cavity flashing from mortar droppings that were not fully cleaned out during the original construction.

<p>Area of sunken enclosed patio wall within unit 146 that requires the installation of an air brick</p>	<p>Note height of pavers in relation to weep holes for unit 151</p>

- Supply and install 455mm x 75mm brass wire air bricks within the wall areas to each unit. Unit 49, 7 bricks. Unit 103, 7 bricks, Unit 146, 5 bricks including 1 brick to the wall within the sunken enclosed tiled patio, Unit 150, 7 bricks and Unit 151, 5 bricks.

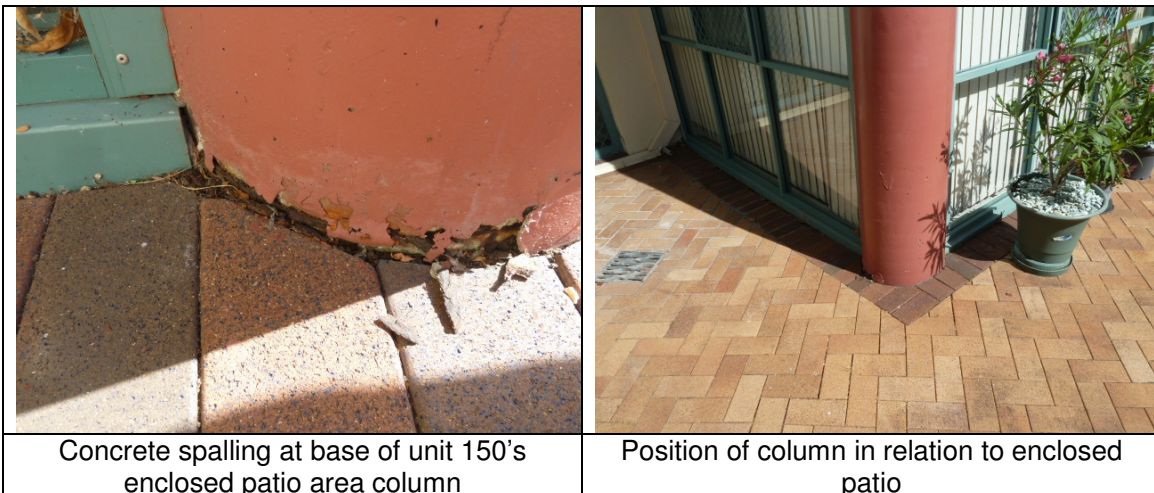
While carrying out the inspection from the paved patio area of Unit 150, it was noticed that the round concrete column forming one corner of the sunken enclosed patio was suffering from concrete spalling (concrete cancer) at the base.

Close inspection of the damage area showed a circular perimeter bar was exposed along with what appeared to be lots of small pieces of tie wire and other metallic pieces such as nails etc.

Unless remedial actions are taken the corrosion will continue to the point where the repairs are costly and may require the input of a Structural Engineer if some of the more structural steel bars start to corrode.

- Grind back the exposed sections of steel to a minimum of 15mm below the surface level of the concrete.
- Remove and replace those sections of steel that have had their overall cross sectional size reduced by more than 20%.
- Treat the top of the steel with a zinc rich primer.
- Fill the hole with a polymer modified render mix similar in qualities to "BASF MASTER EMACO S5400 CI",
- Make good all surface finishes affected by the original defect, any exploratory and or remedial works.
- Clean up on completion.
