Major upgrades on 26 townhouses in amount of \$92,950.00 in 2017 without evidence of work done

1 SP52948 – Solicitor Adrian Mueller, on behalf of owners corporation, confirming that maintenance of common property is compulsory and that some strata files are missing on 14th of November 2019

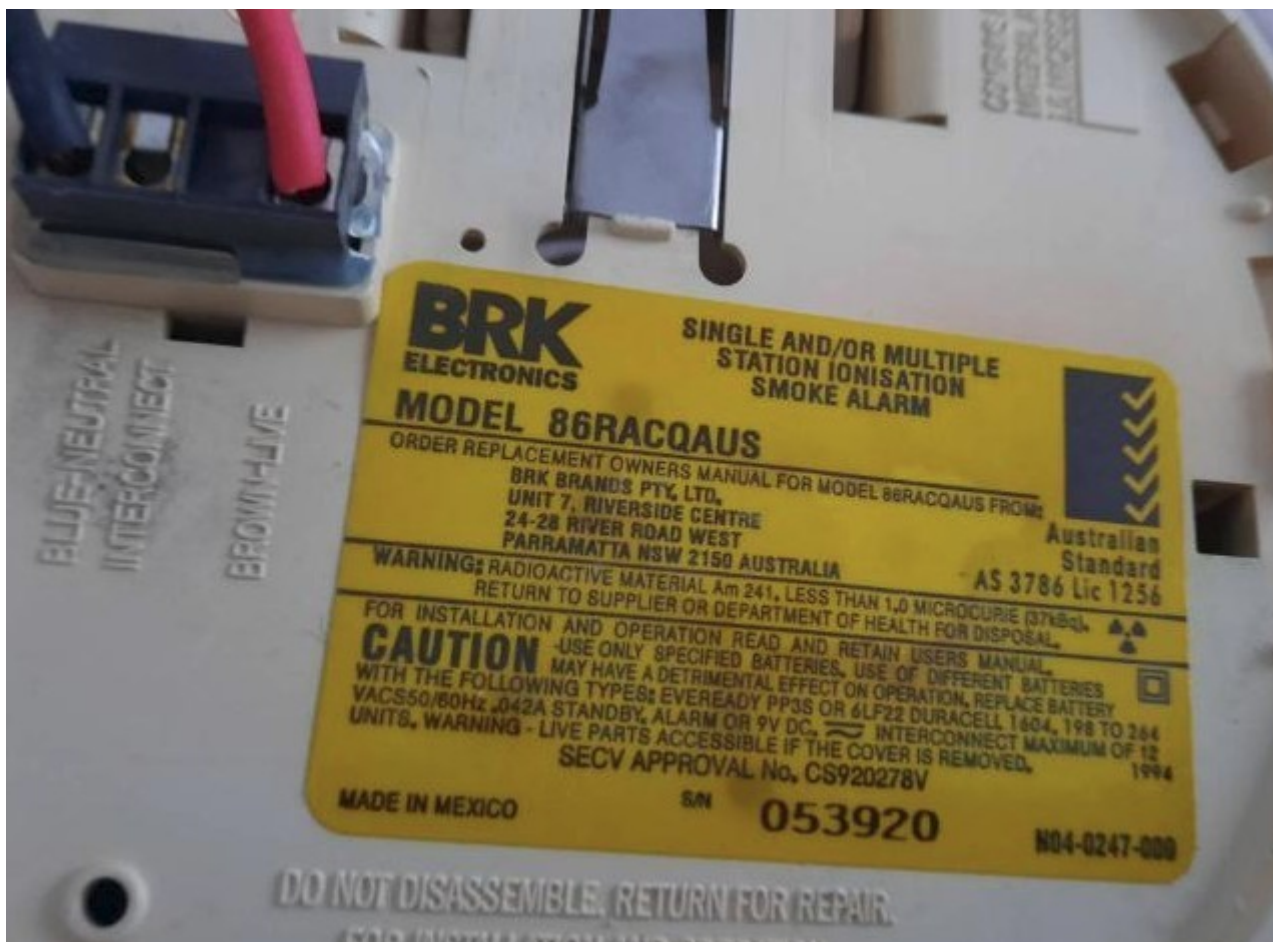
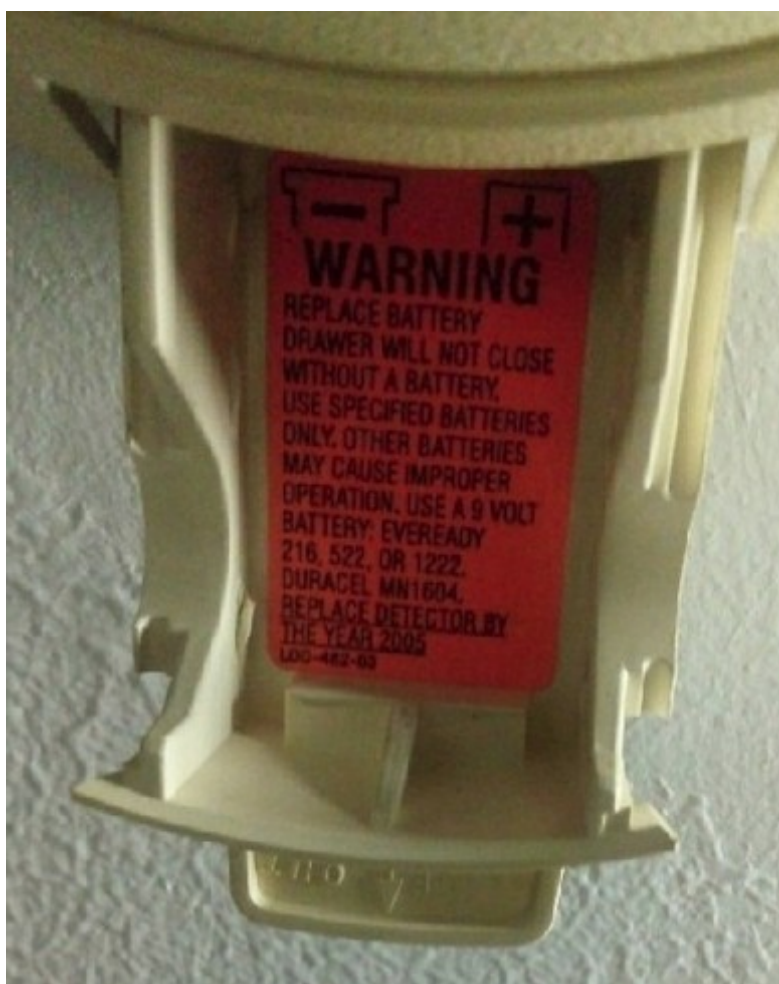
10 One smoke alarm in Lot 158 expired in 2005 and other in 2019, both declared faulty in 2019 and 2020 in fire inspections, and not replaced as of 1st of October 2021

As of 1st of October 2021, both smoke alarms in Lot 158 (and possibly many other units) have not been replaced yet.

En-suite bedroom (manufacture date 1994, expired in 2005):

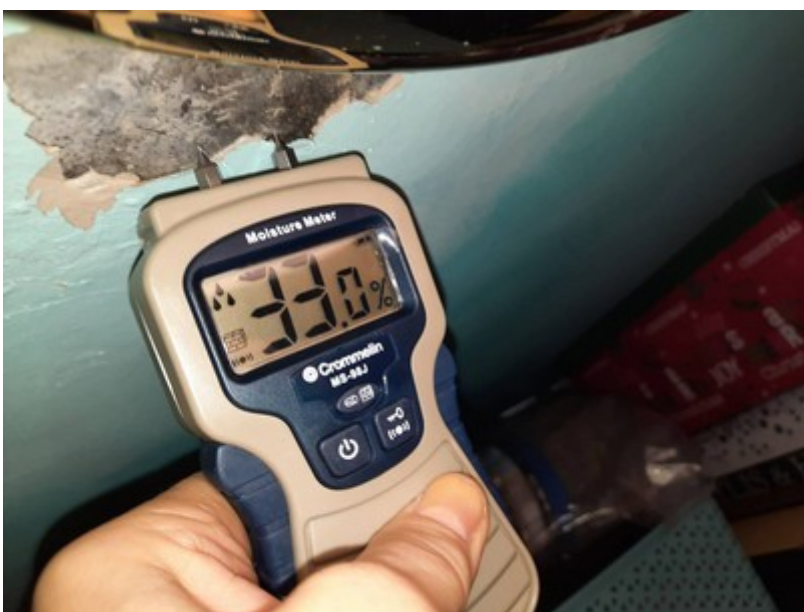
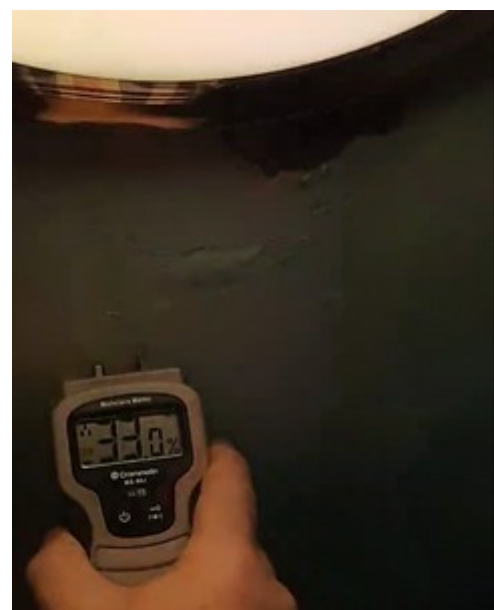
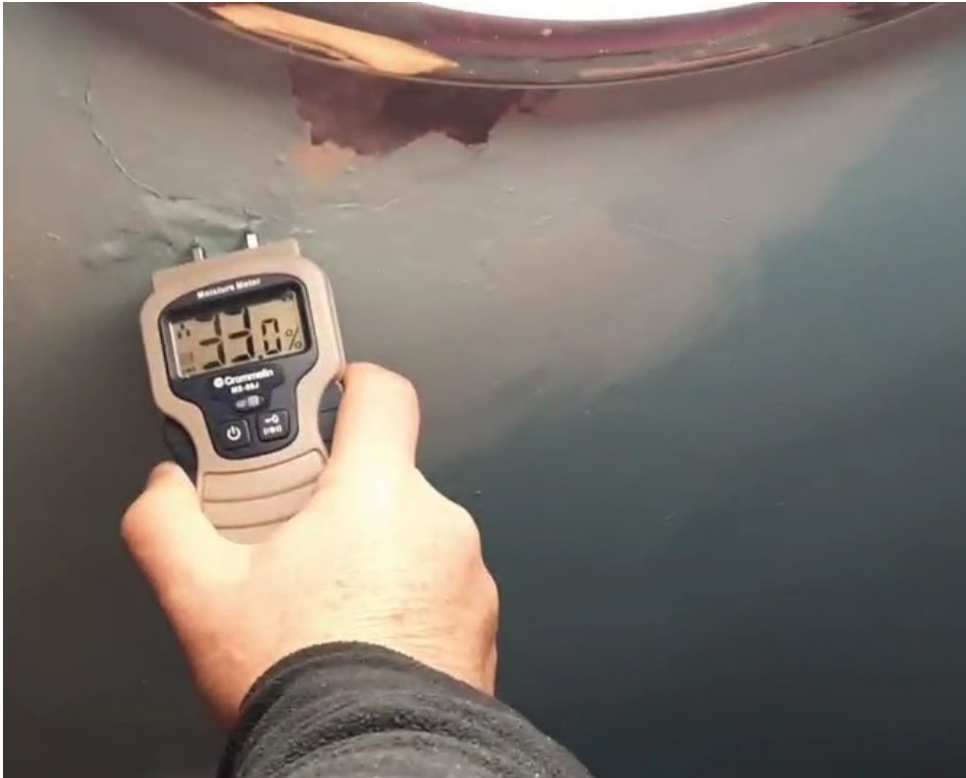
Photos take in sunroom of Lot 158 on 11th of May 2021:

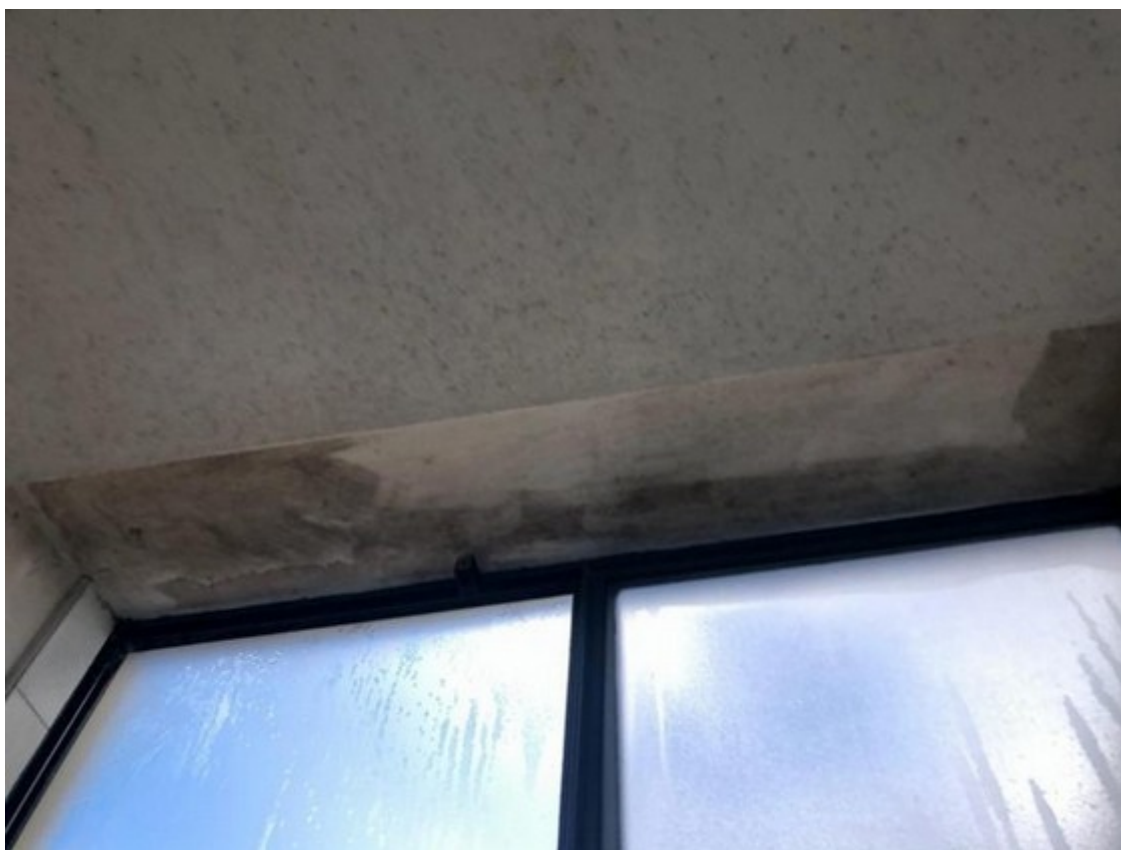
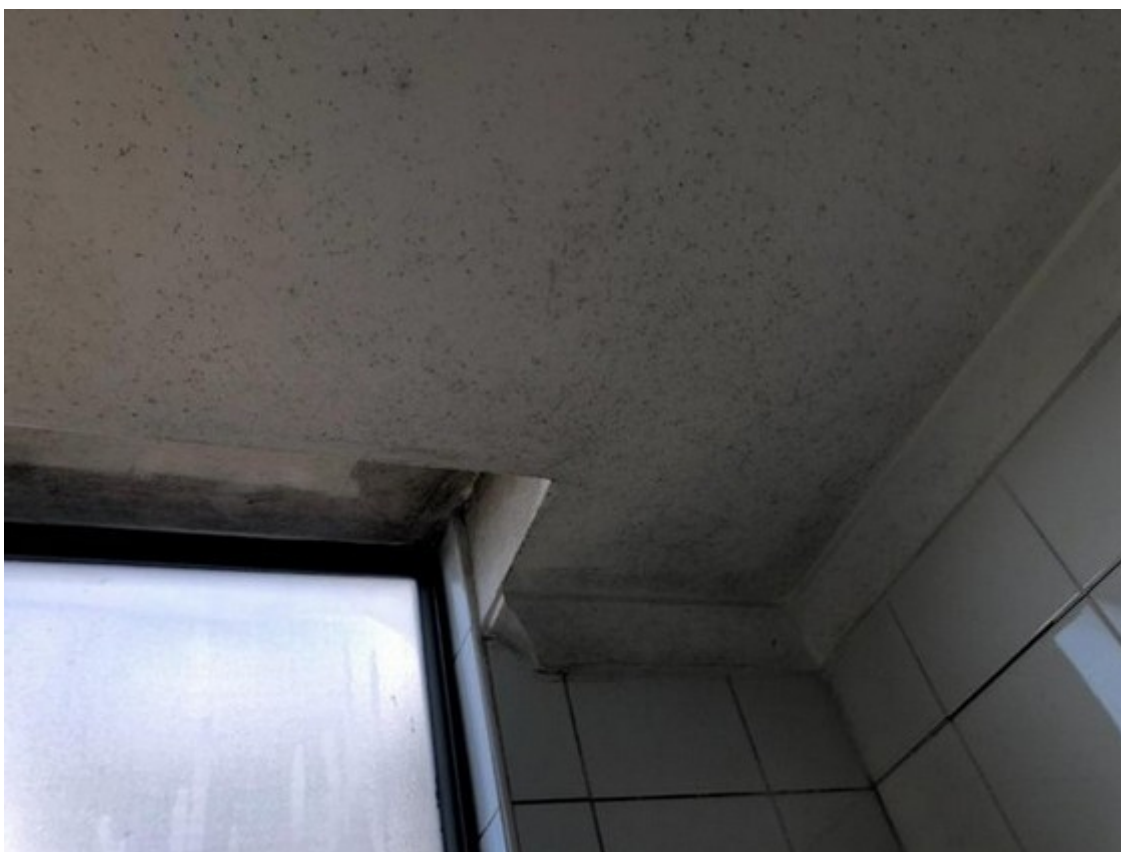
14 Lot 43 poor ventilation in bathrooms and increased health and safety risks, as reported in June 2020

On 13th of June 2020, Lot 158 documented problems with water leaks and dampness in bathrooms of Lot 43 (top floor in Block B), which created not only serious health risks, but also dangers of water entering electrical installations.

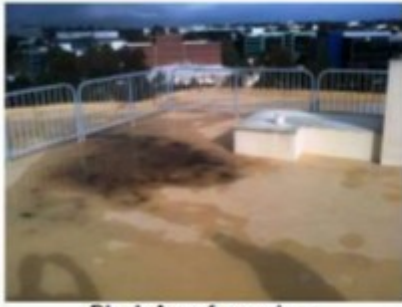
From Napier & Blakely report in July 2012:

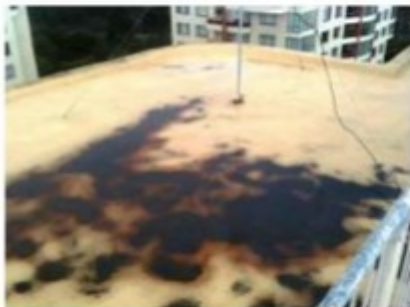
The falls to the drainage are insufficient and improving the existing falls should also be considered. The internal units were not inspected for any water penetration via the roof slab.

Standing water to flat roof deck, Block A

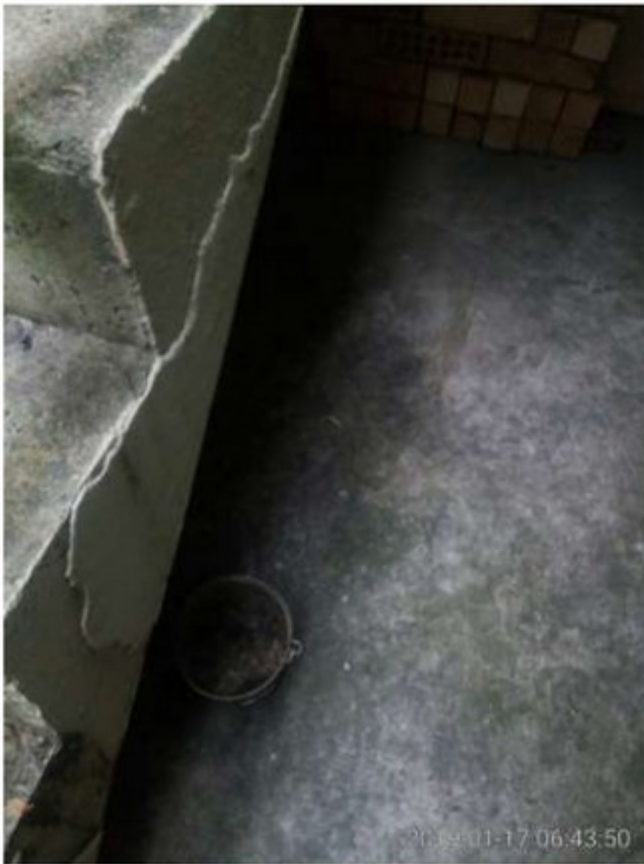
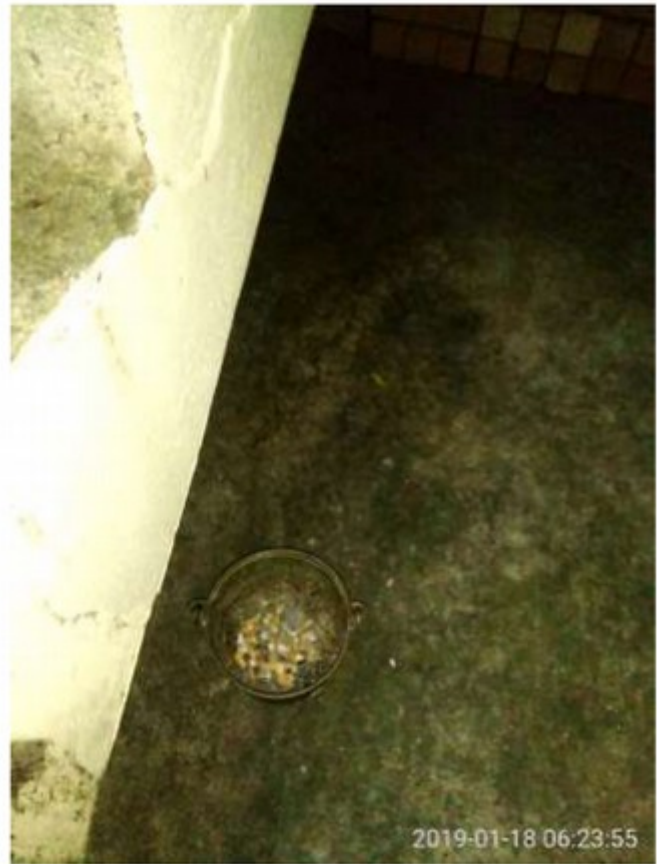
Fire door 2 below Block A was kept open in non-compliance with fire safety regulations almost every day for many months in 2018/2019 and smoking allowed. Example of what one day of smoking created between dates of 17th and 18th of January 2019:

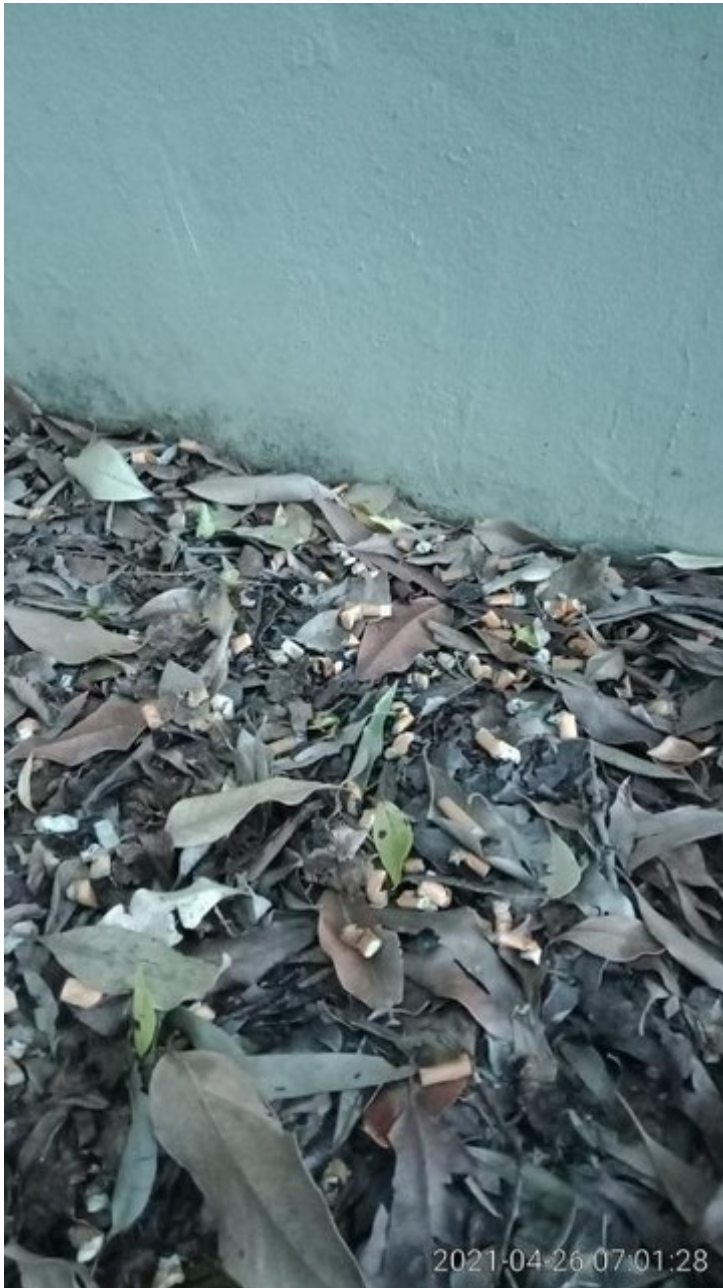
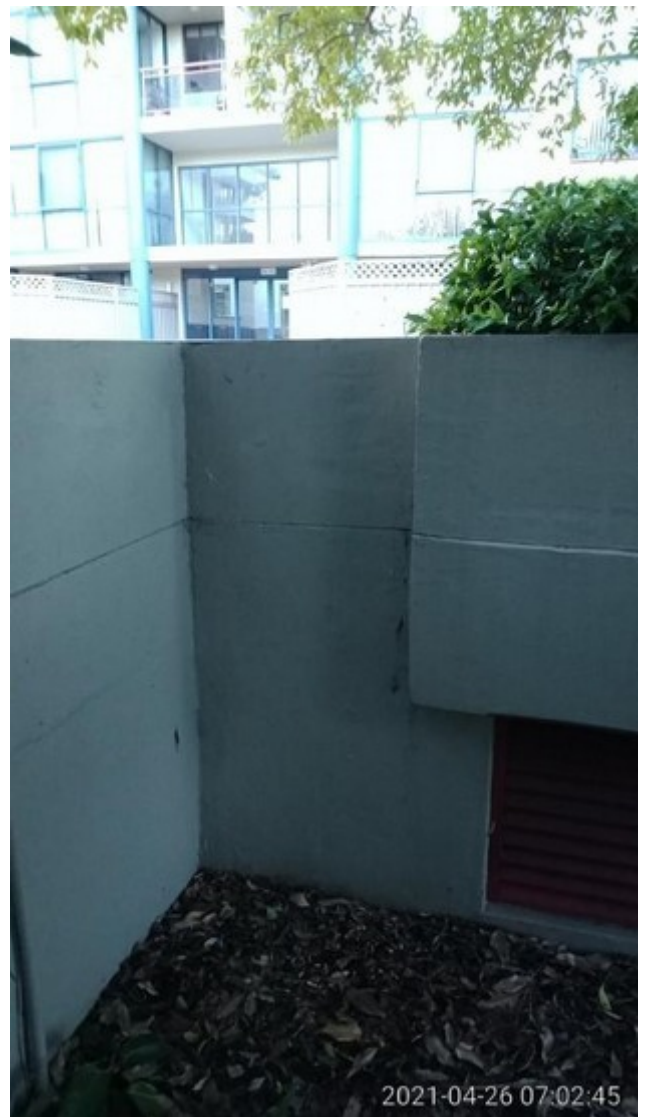
Garden area near Block D, flooded with cigarette butts and not cleaned. Apart from obvious pollution to the nature, dry leaves and branches can easily start the unintentional fire as well.

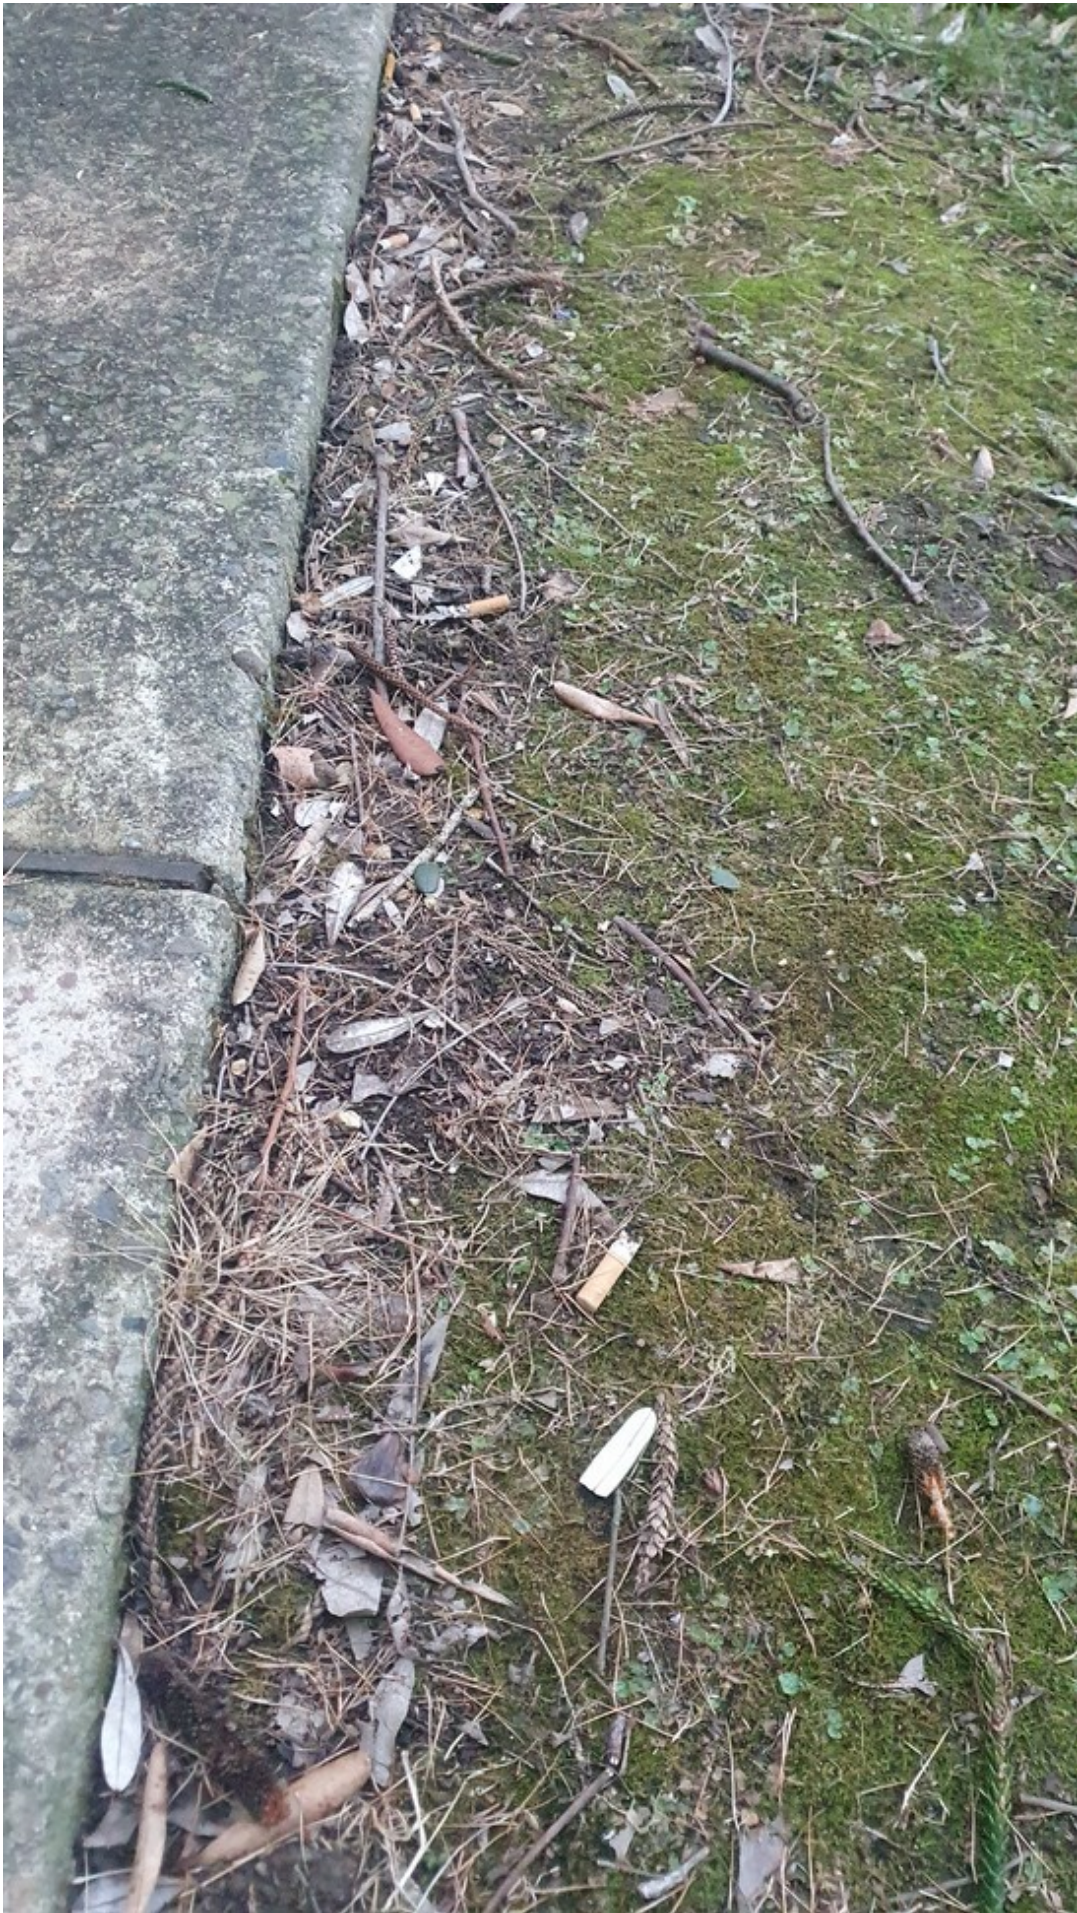
17 Smoking in the complex continue to be a serious fire safety risk – Block D garden pathway where lot of dry barks and leaves cover the grounds

Photo taken on 16th of July 2021 prove the same problem is still in existence:

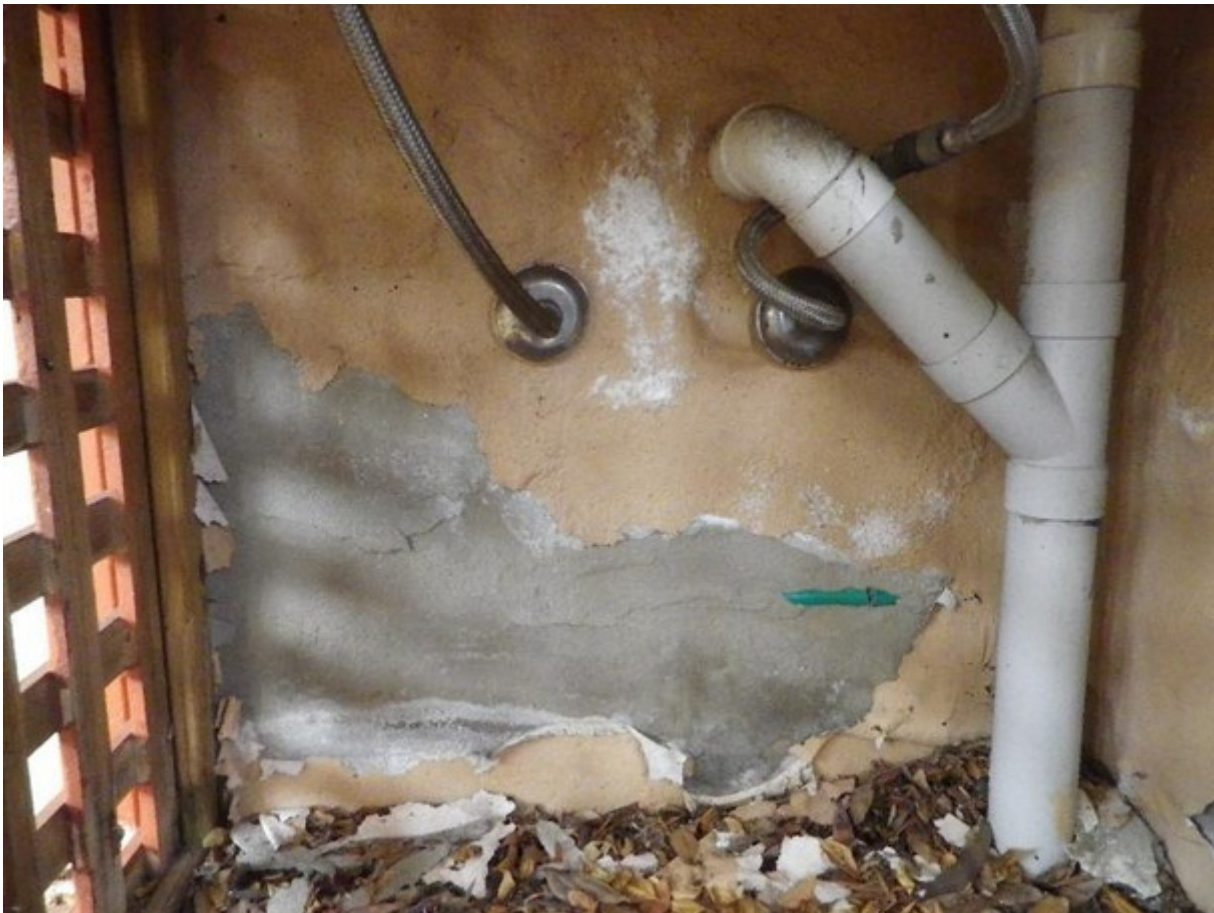
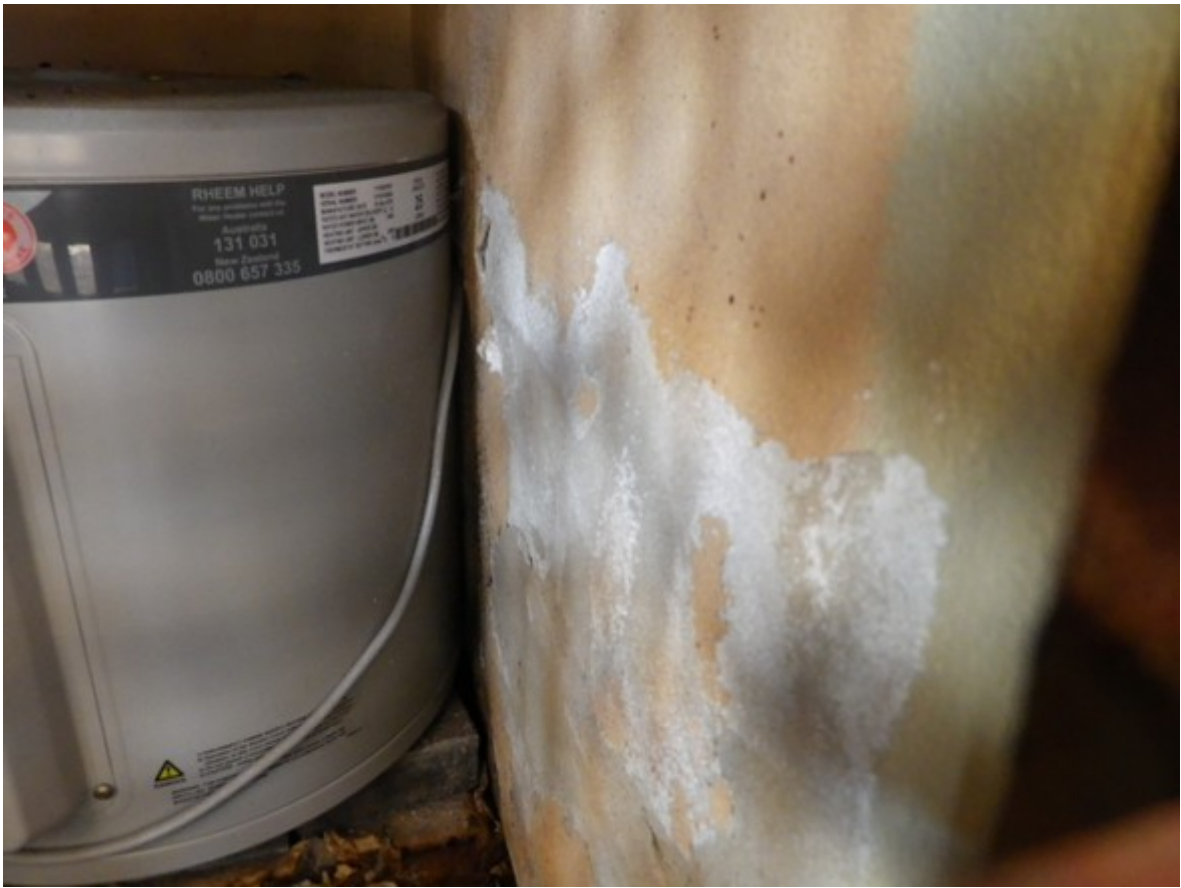
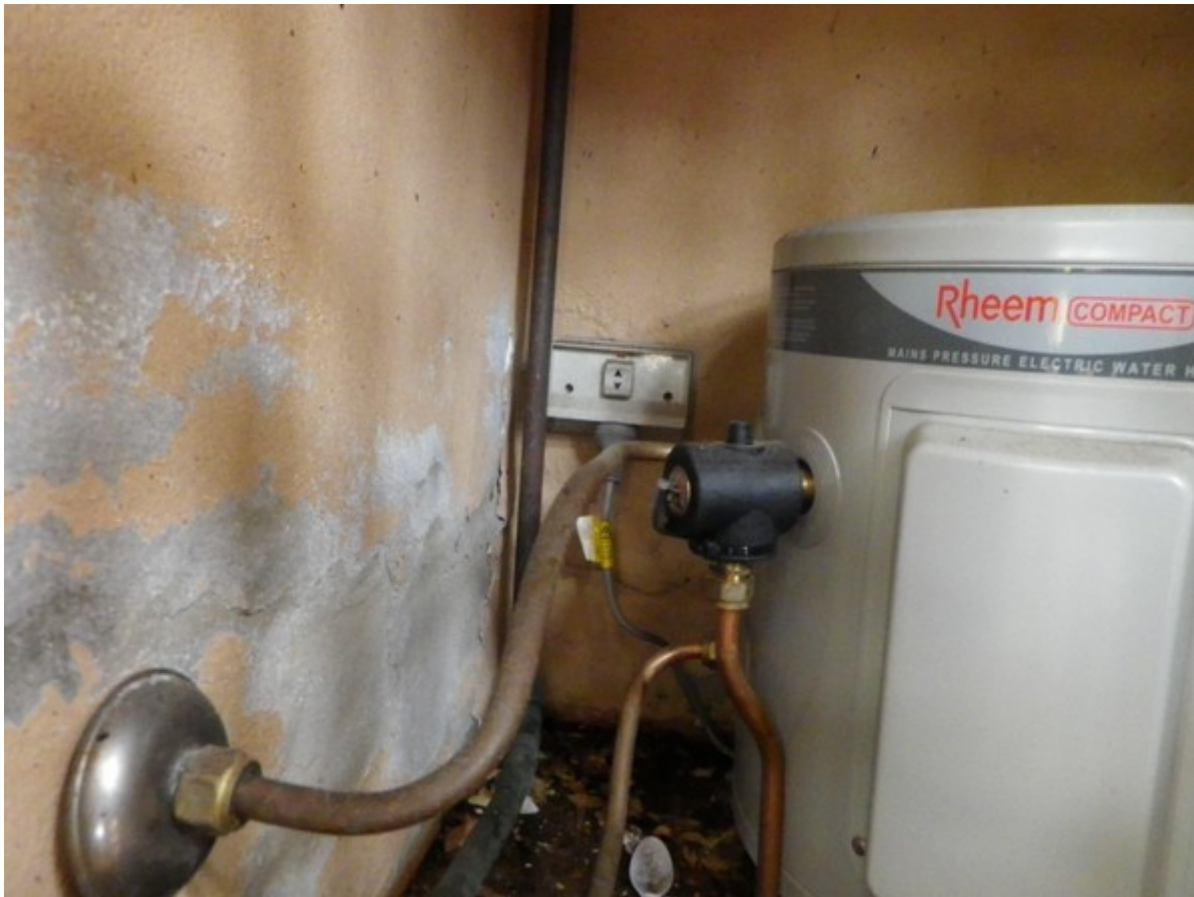
18 BBQ area below sink high fire safety risks for four years

- a) Walls damaged by long-term water penetration and leaks,
- b) Piece of PVC pipe protruding through the wall,
- c) Rusted hoses,
- d) Rusted pipes,
- e) Potential for electrical hazards because water leakages and wall damages appear to be close to wall socket,
- f) Dry leaves could create fire hazard,
- g) Water wastage?

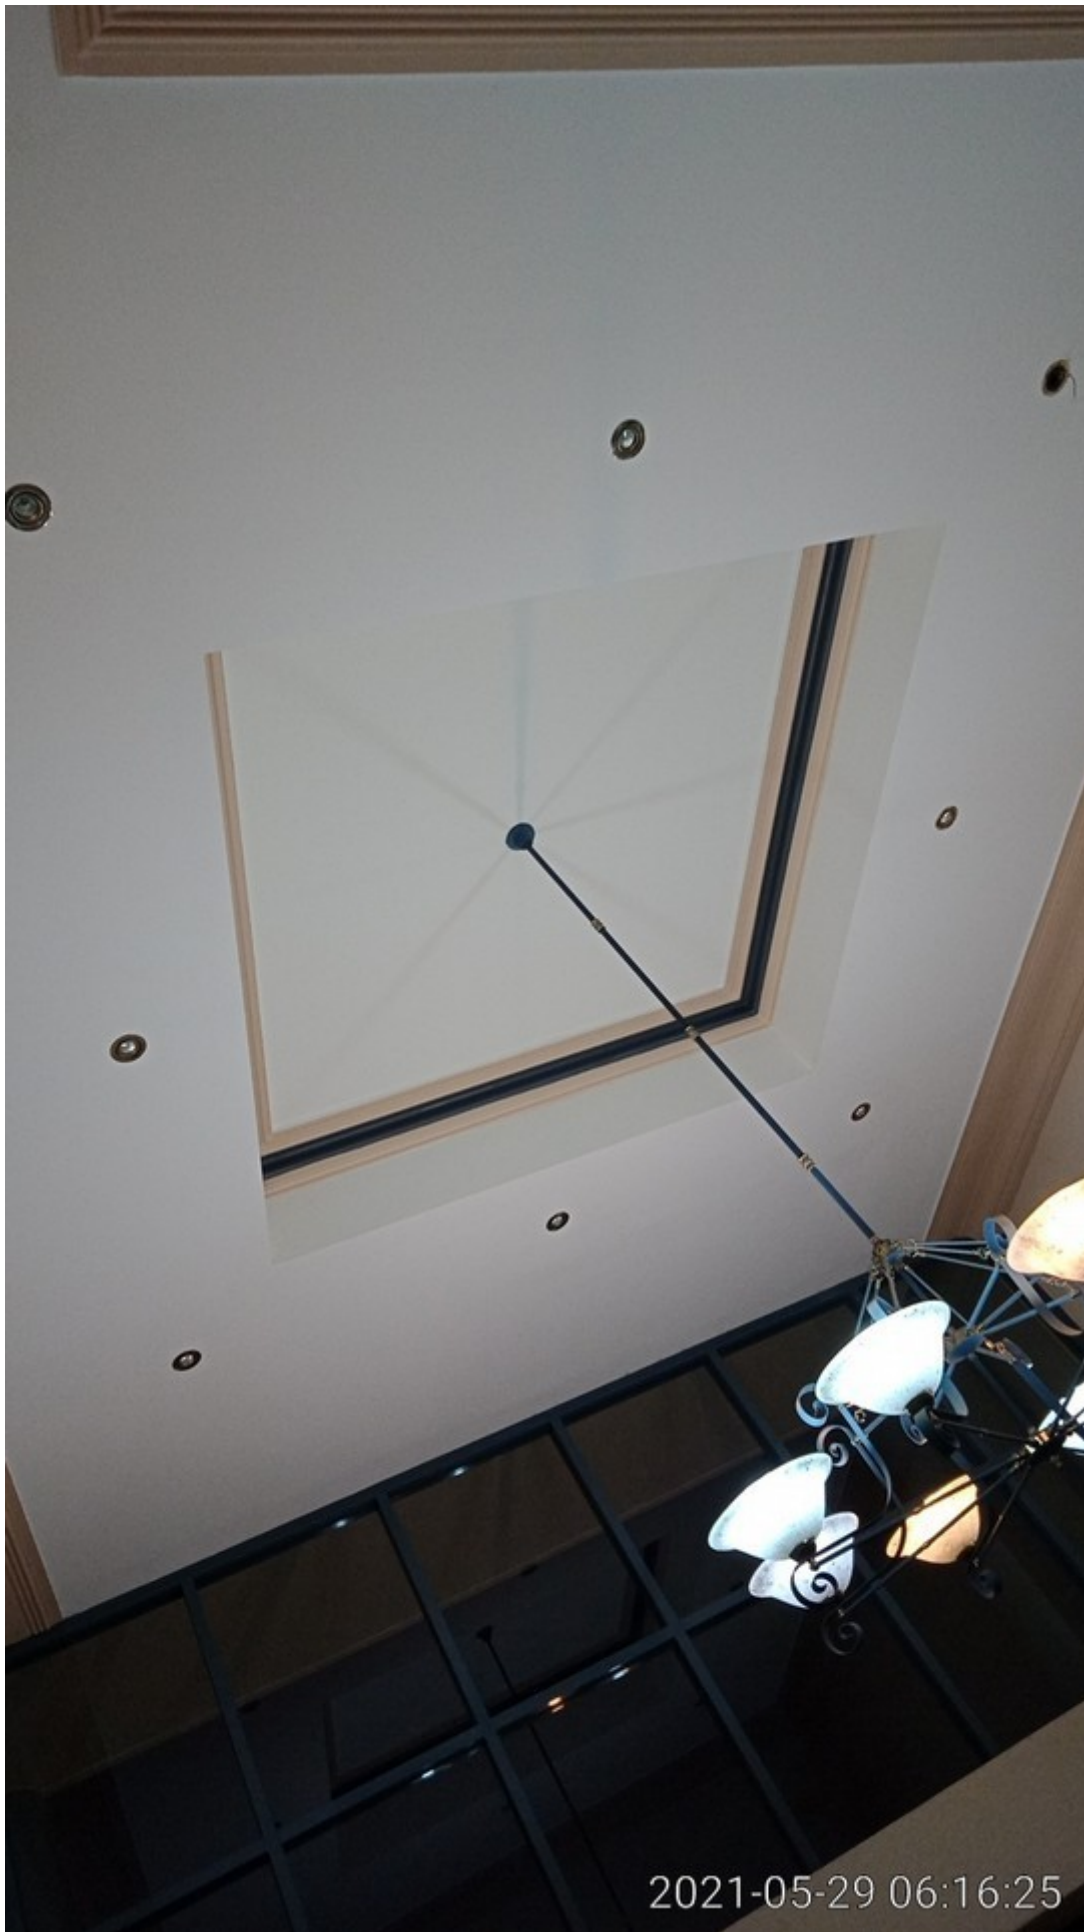
d) Block D, none of eight down-lights operational

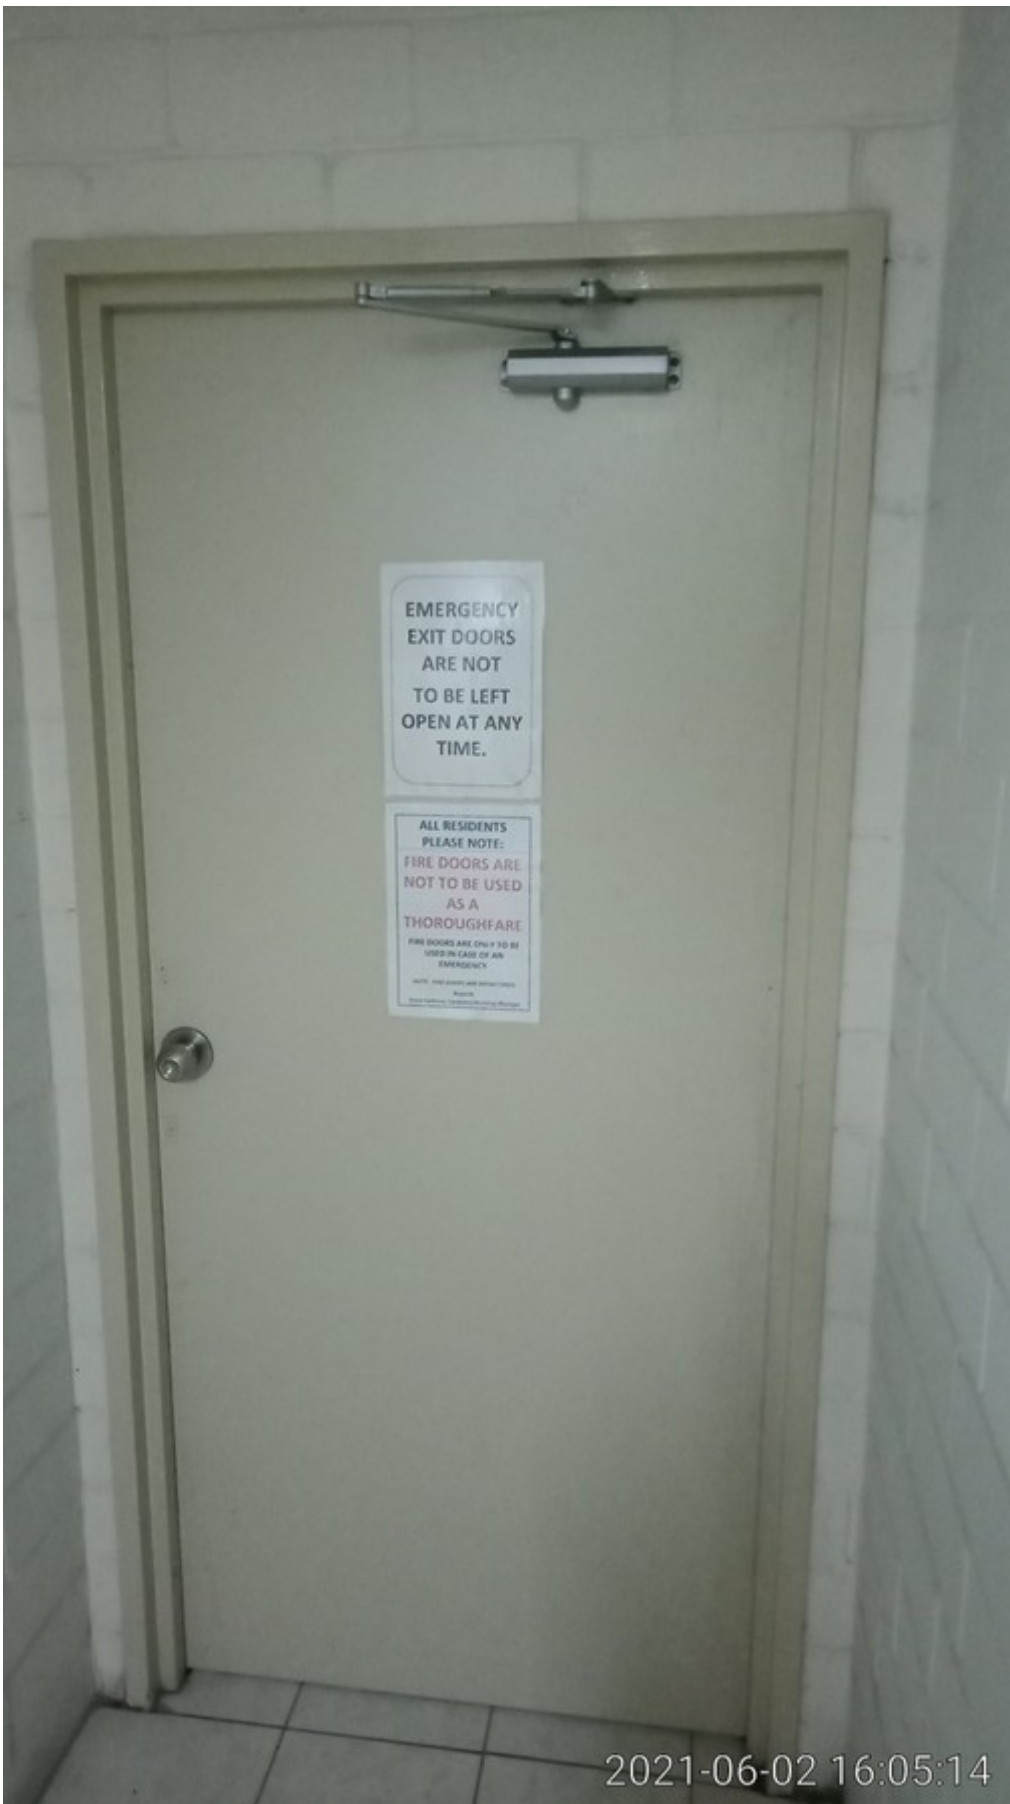
- a) Block A, with notice about thoroughfare and exit

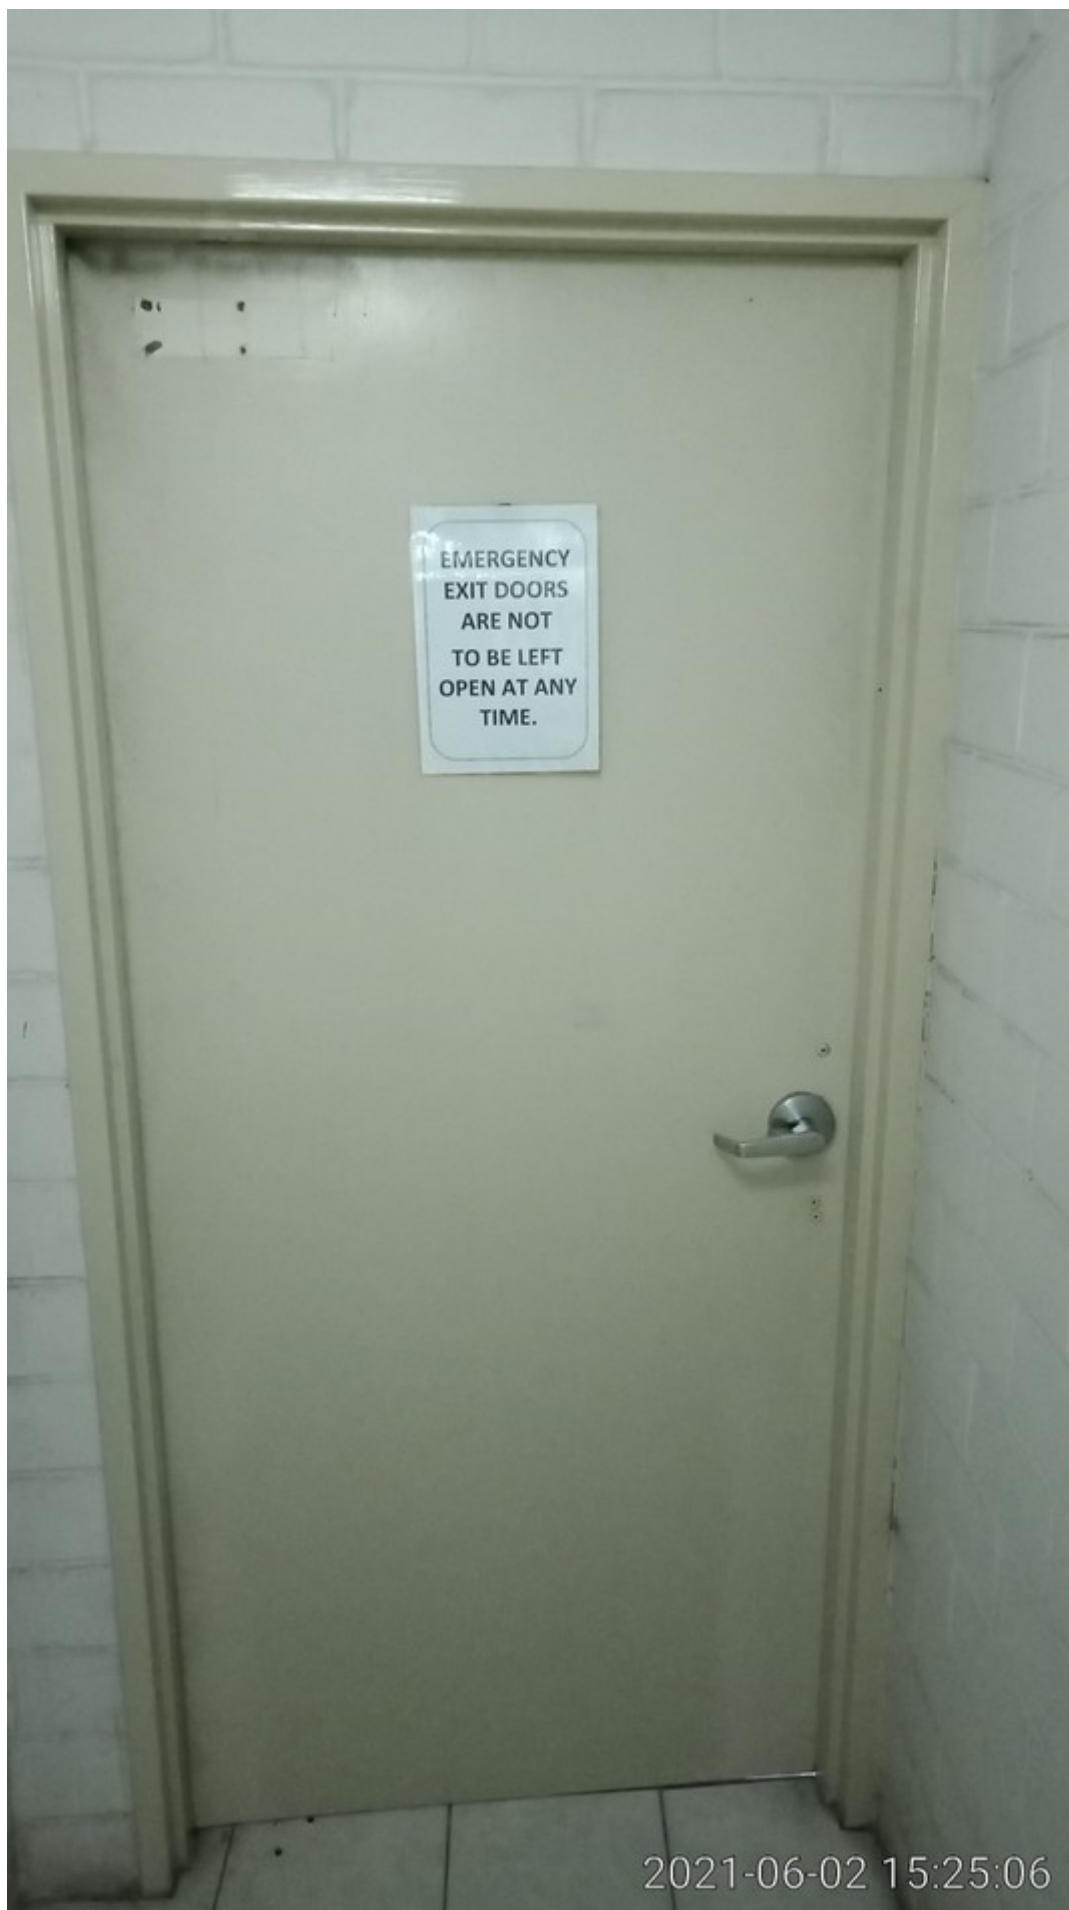
d) Block D, without signage for thoroughfare and exit

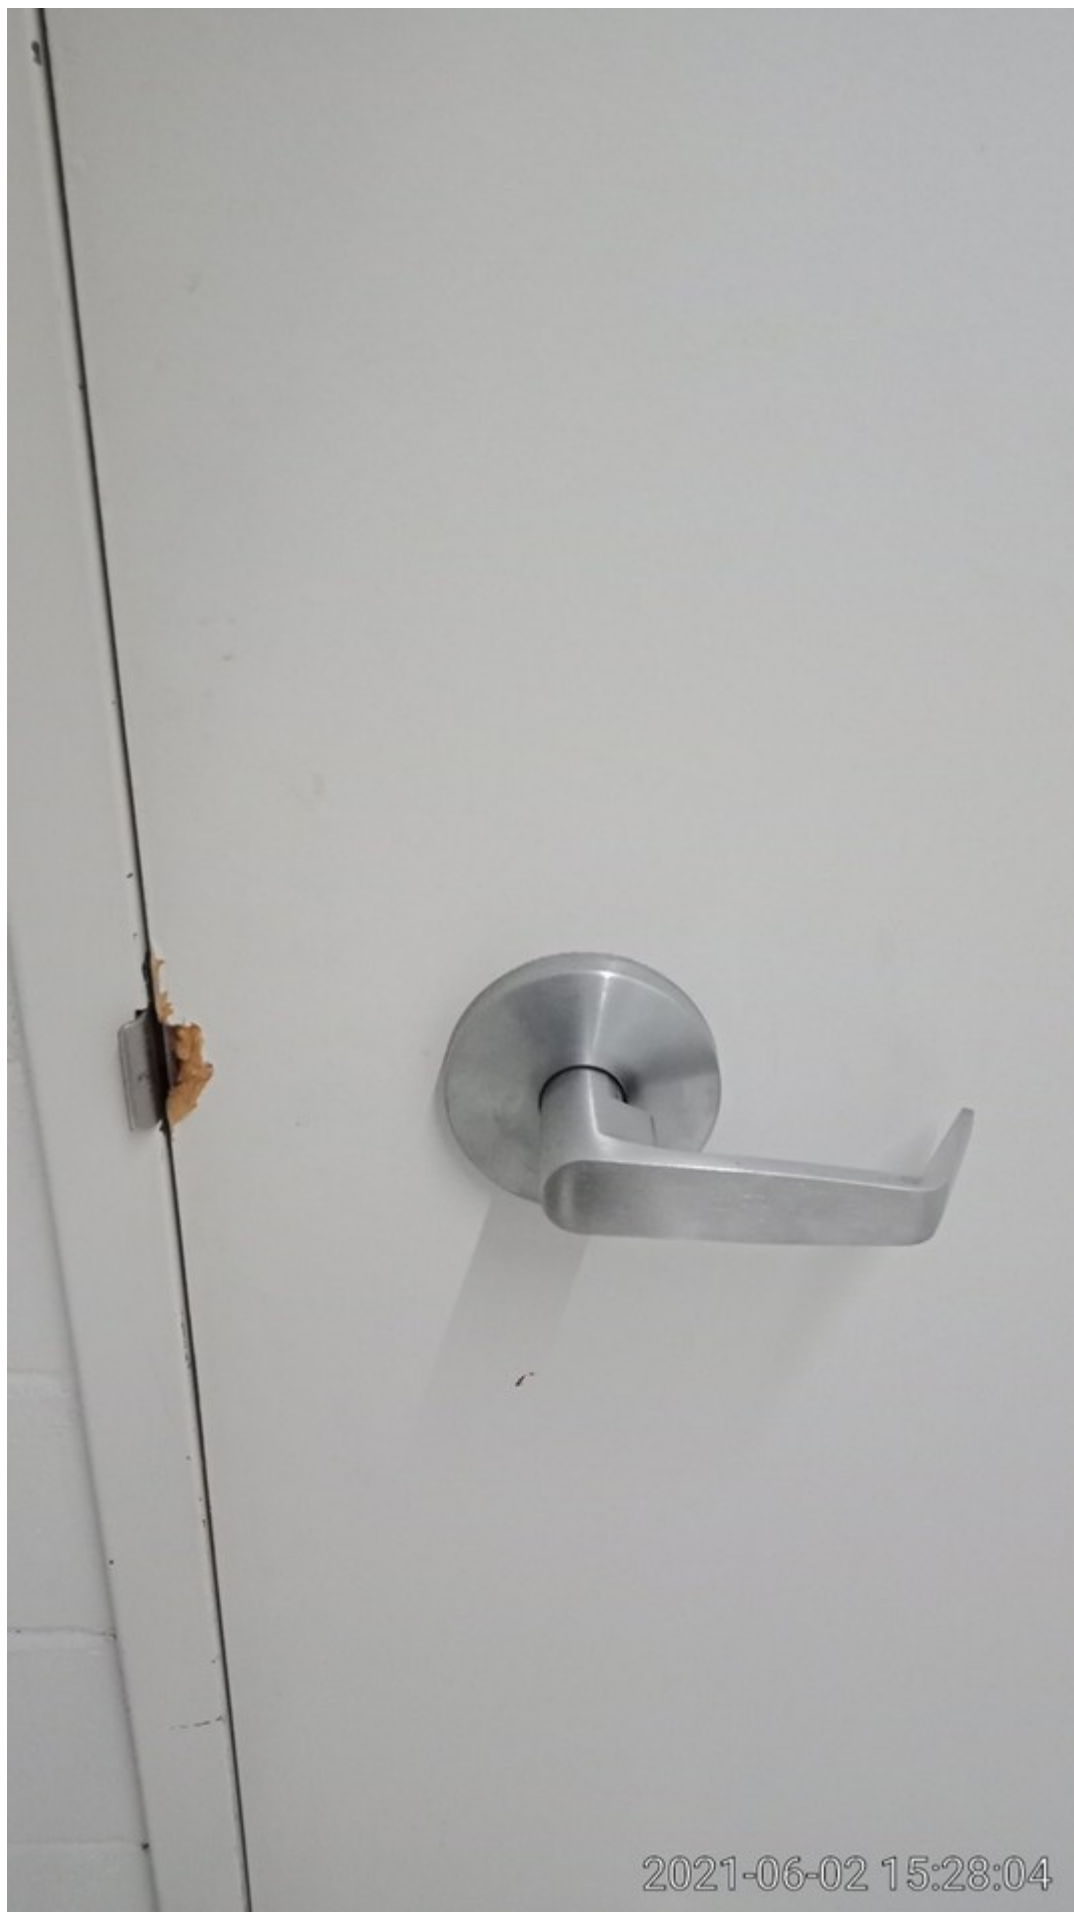
23 Damaged lock mechanism on fire door for two years – Block C ground floor
