Major upgrades on 26 townhouses in amount of \$92,950.00 in 2017 without evidence of work done

1 SP52948 – Solicitor Adrian Mueller, on behalf of owners corporation, confirming that maintenance of common property is compulsory and that some strata files are missing on 14th of November 2019

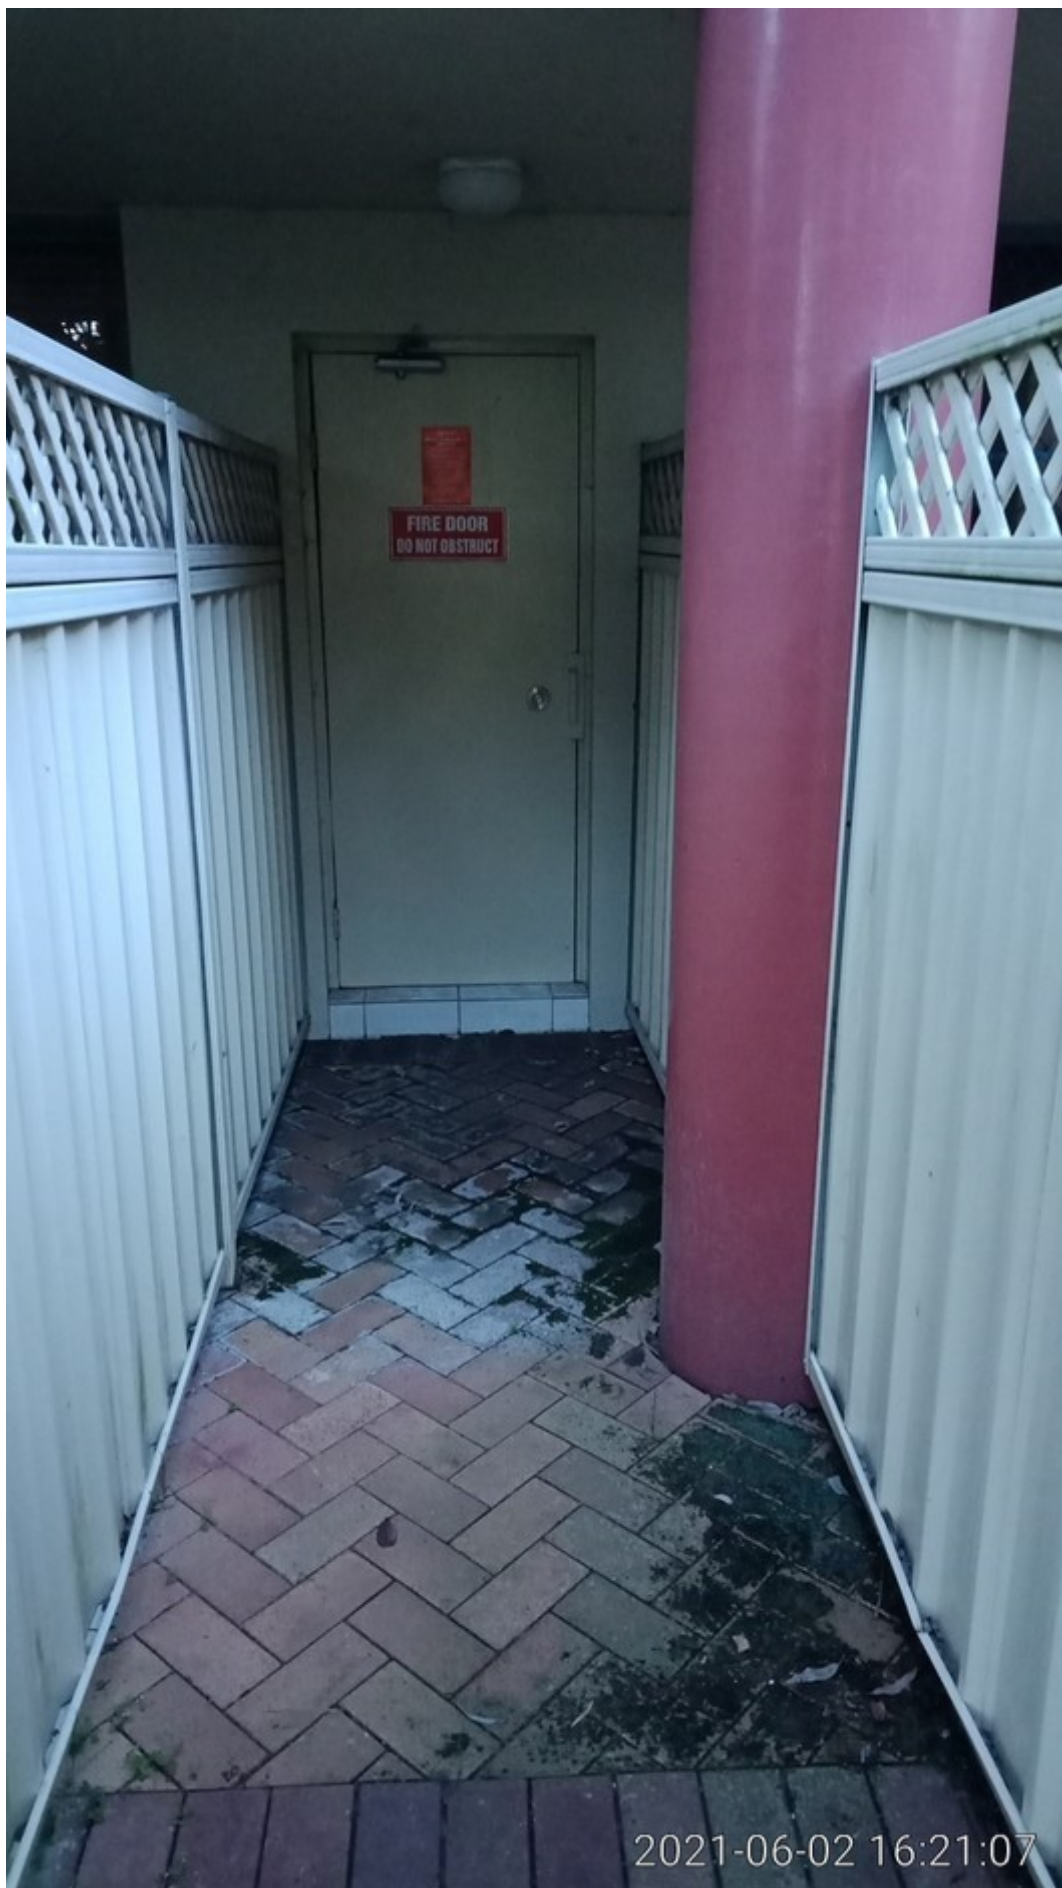
24 Appearance of pathway outside Block C fire door – slippery and mouldy for 14 months

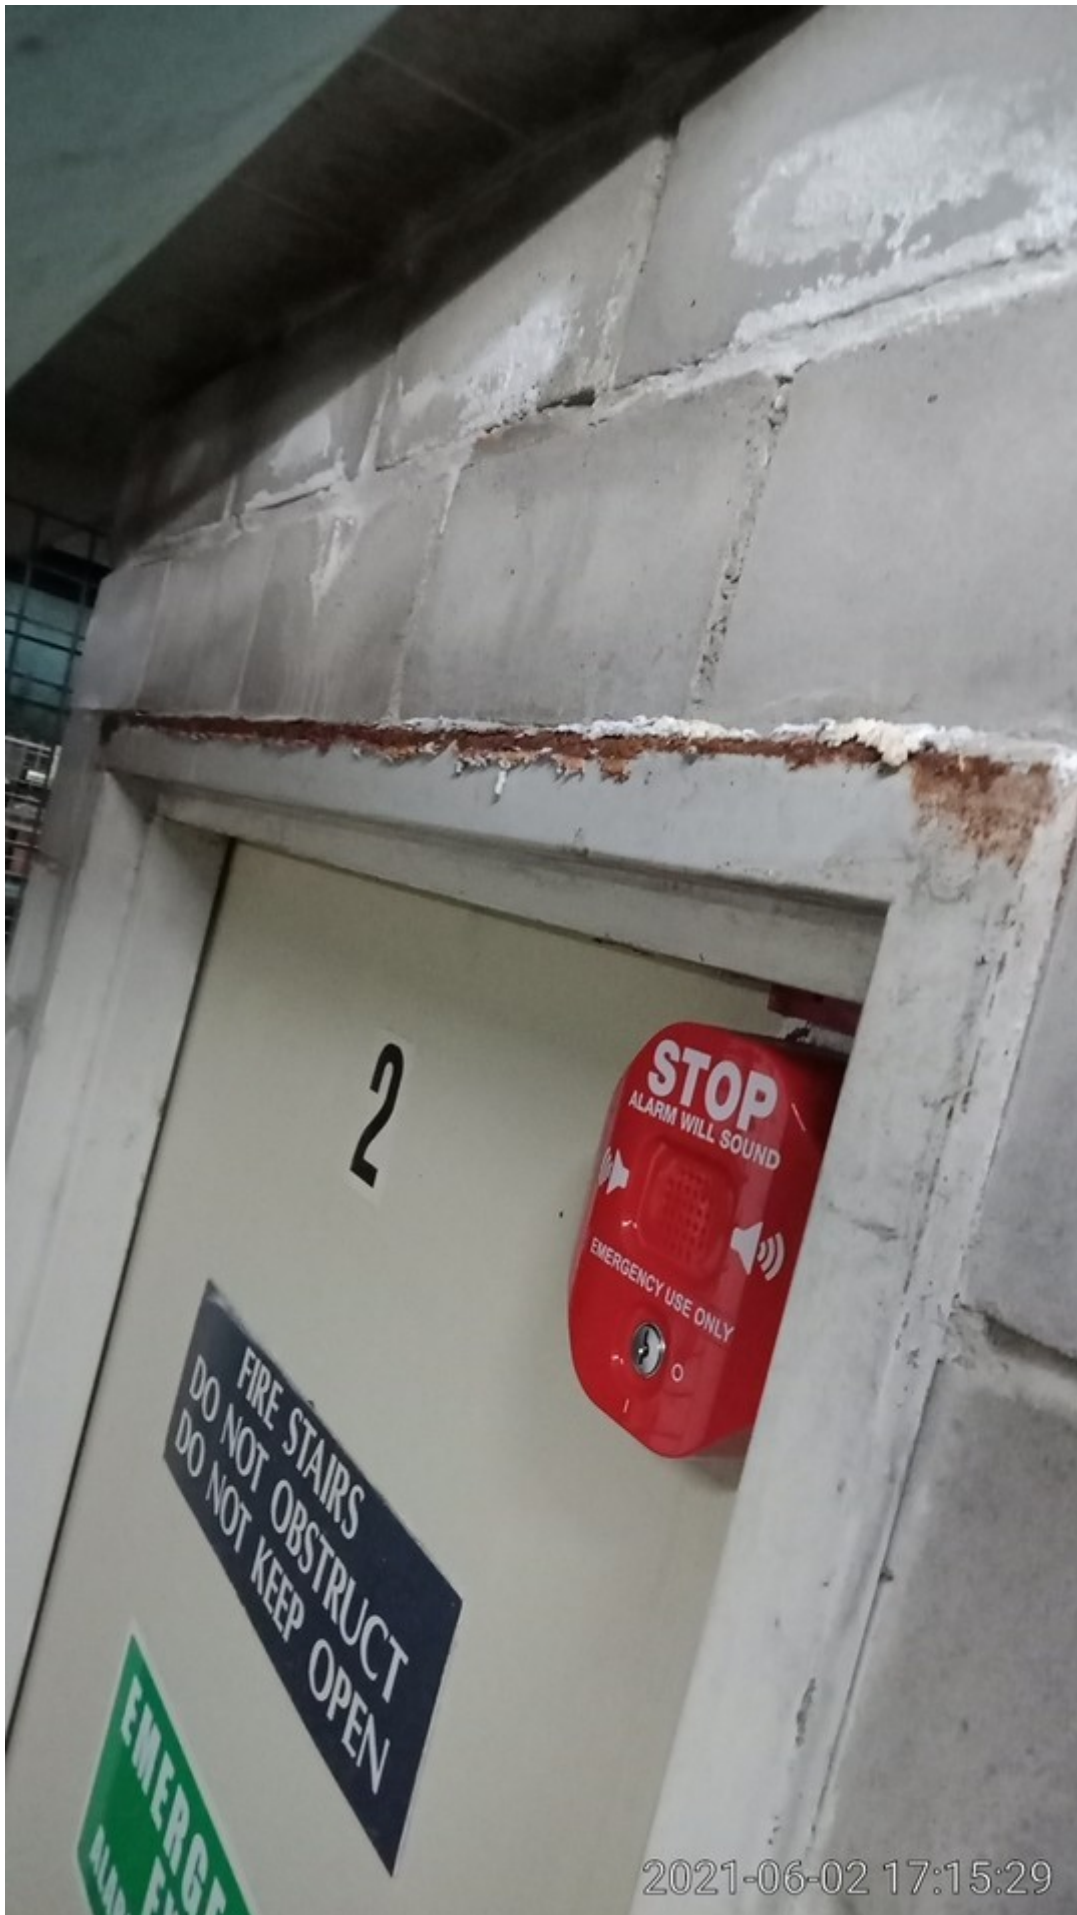
25 Rusted frame of fire door for six years – Block A basement

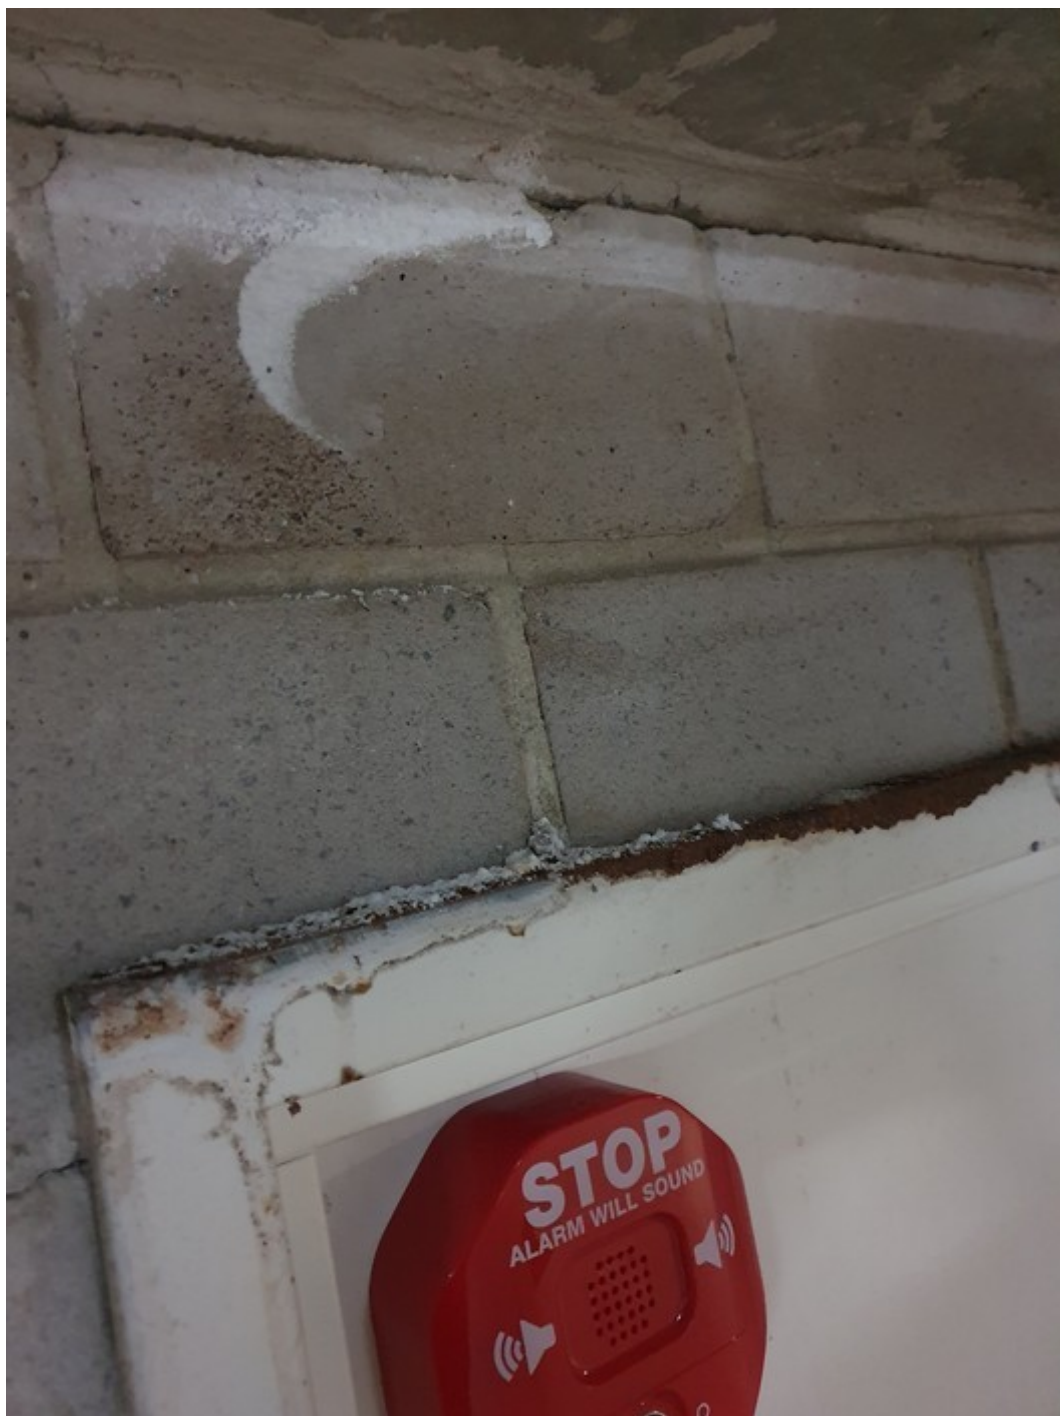
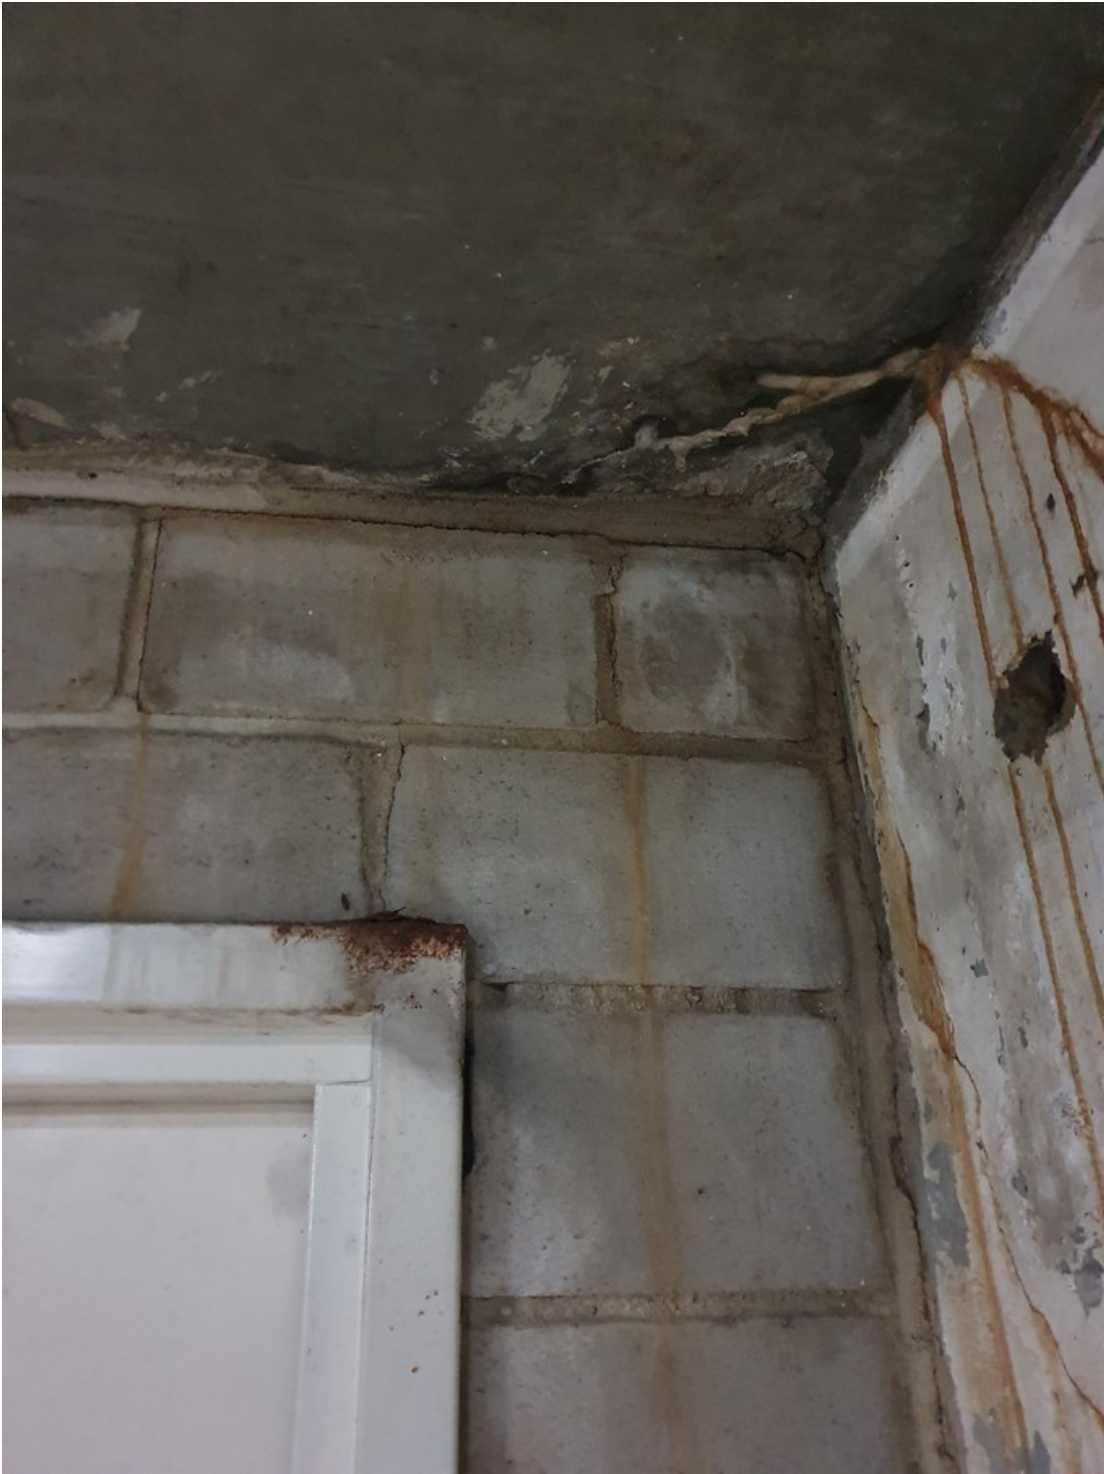
26 Rusted frame of fire door for six years – Block D basement

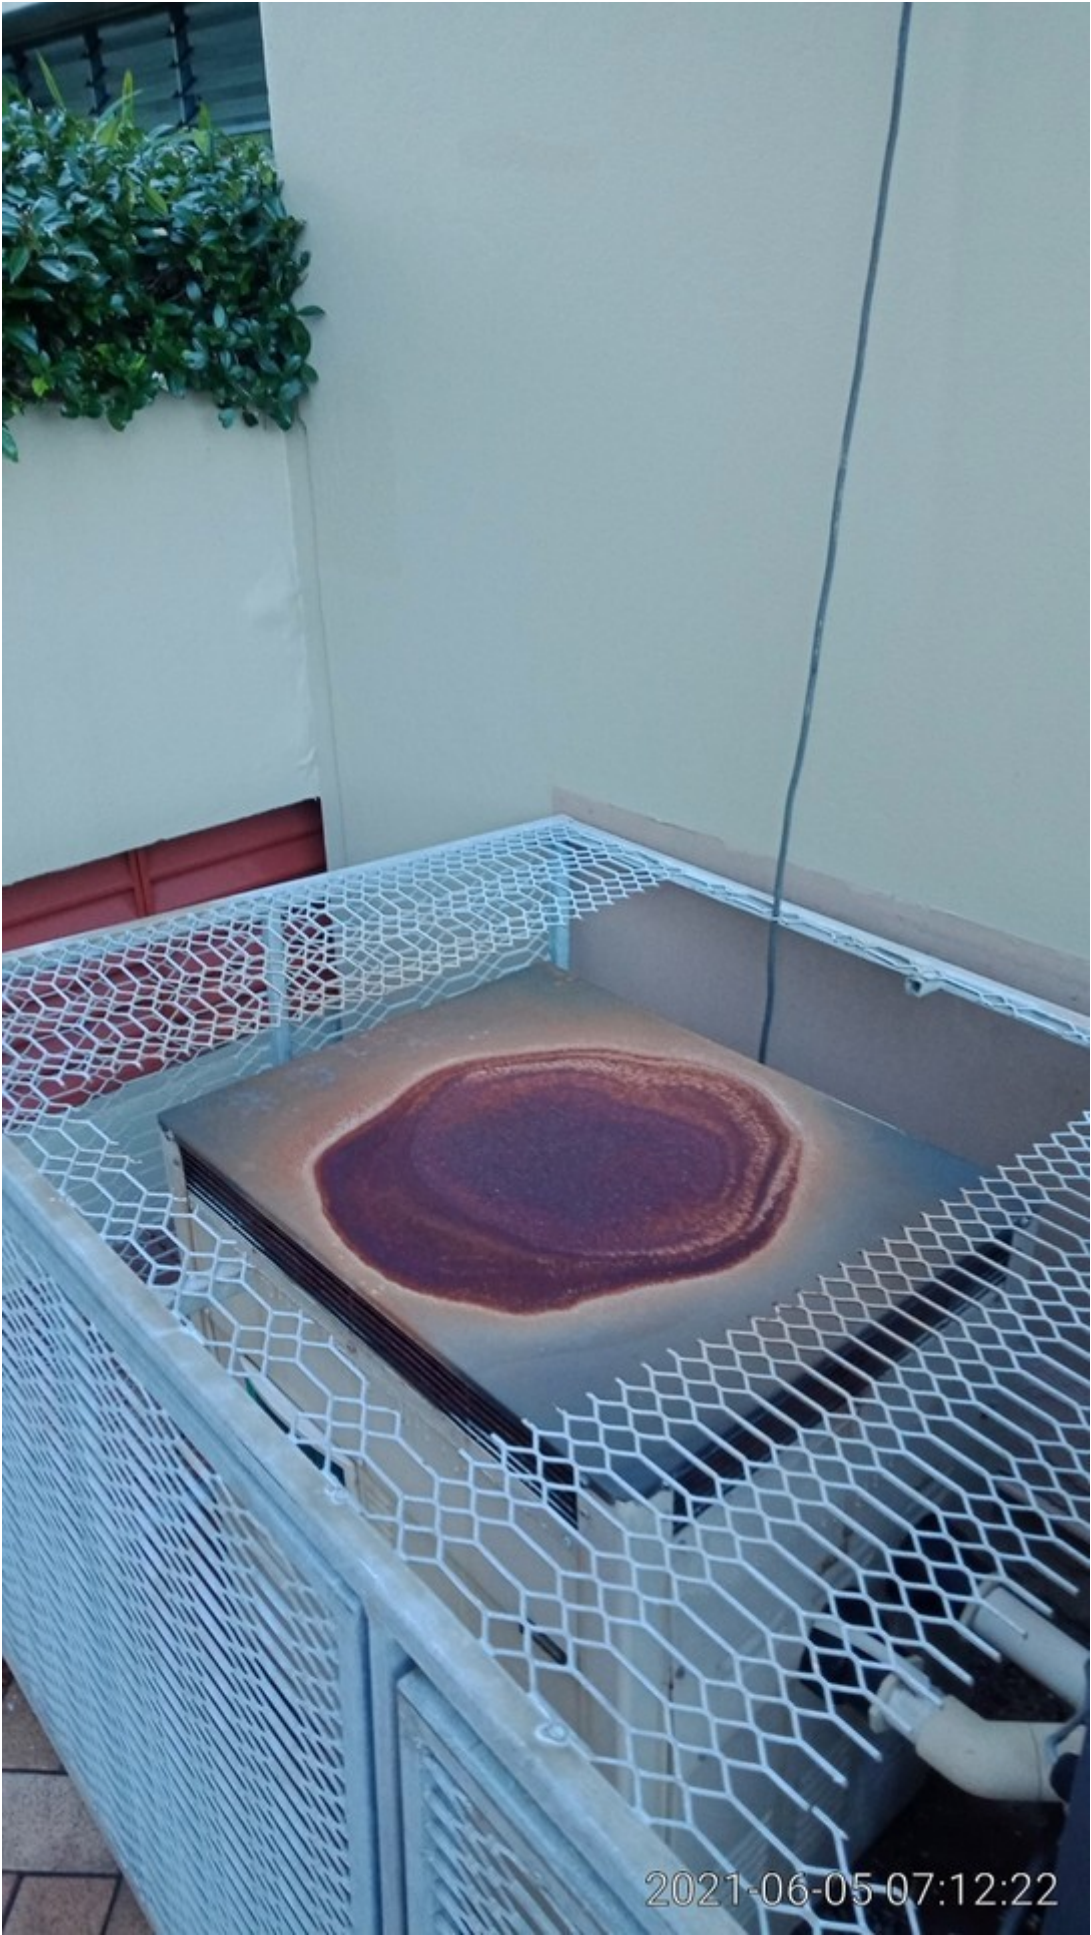
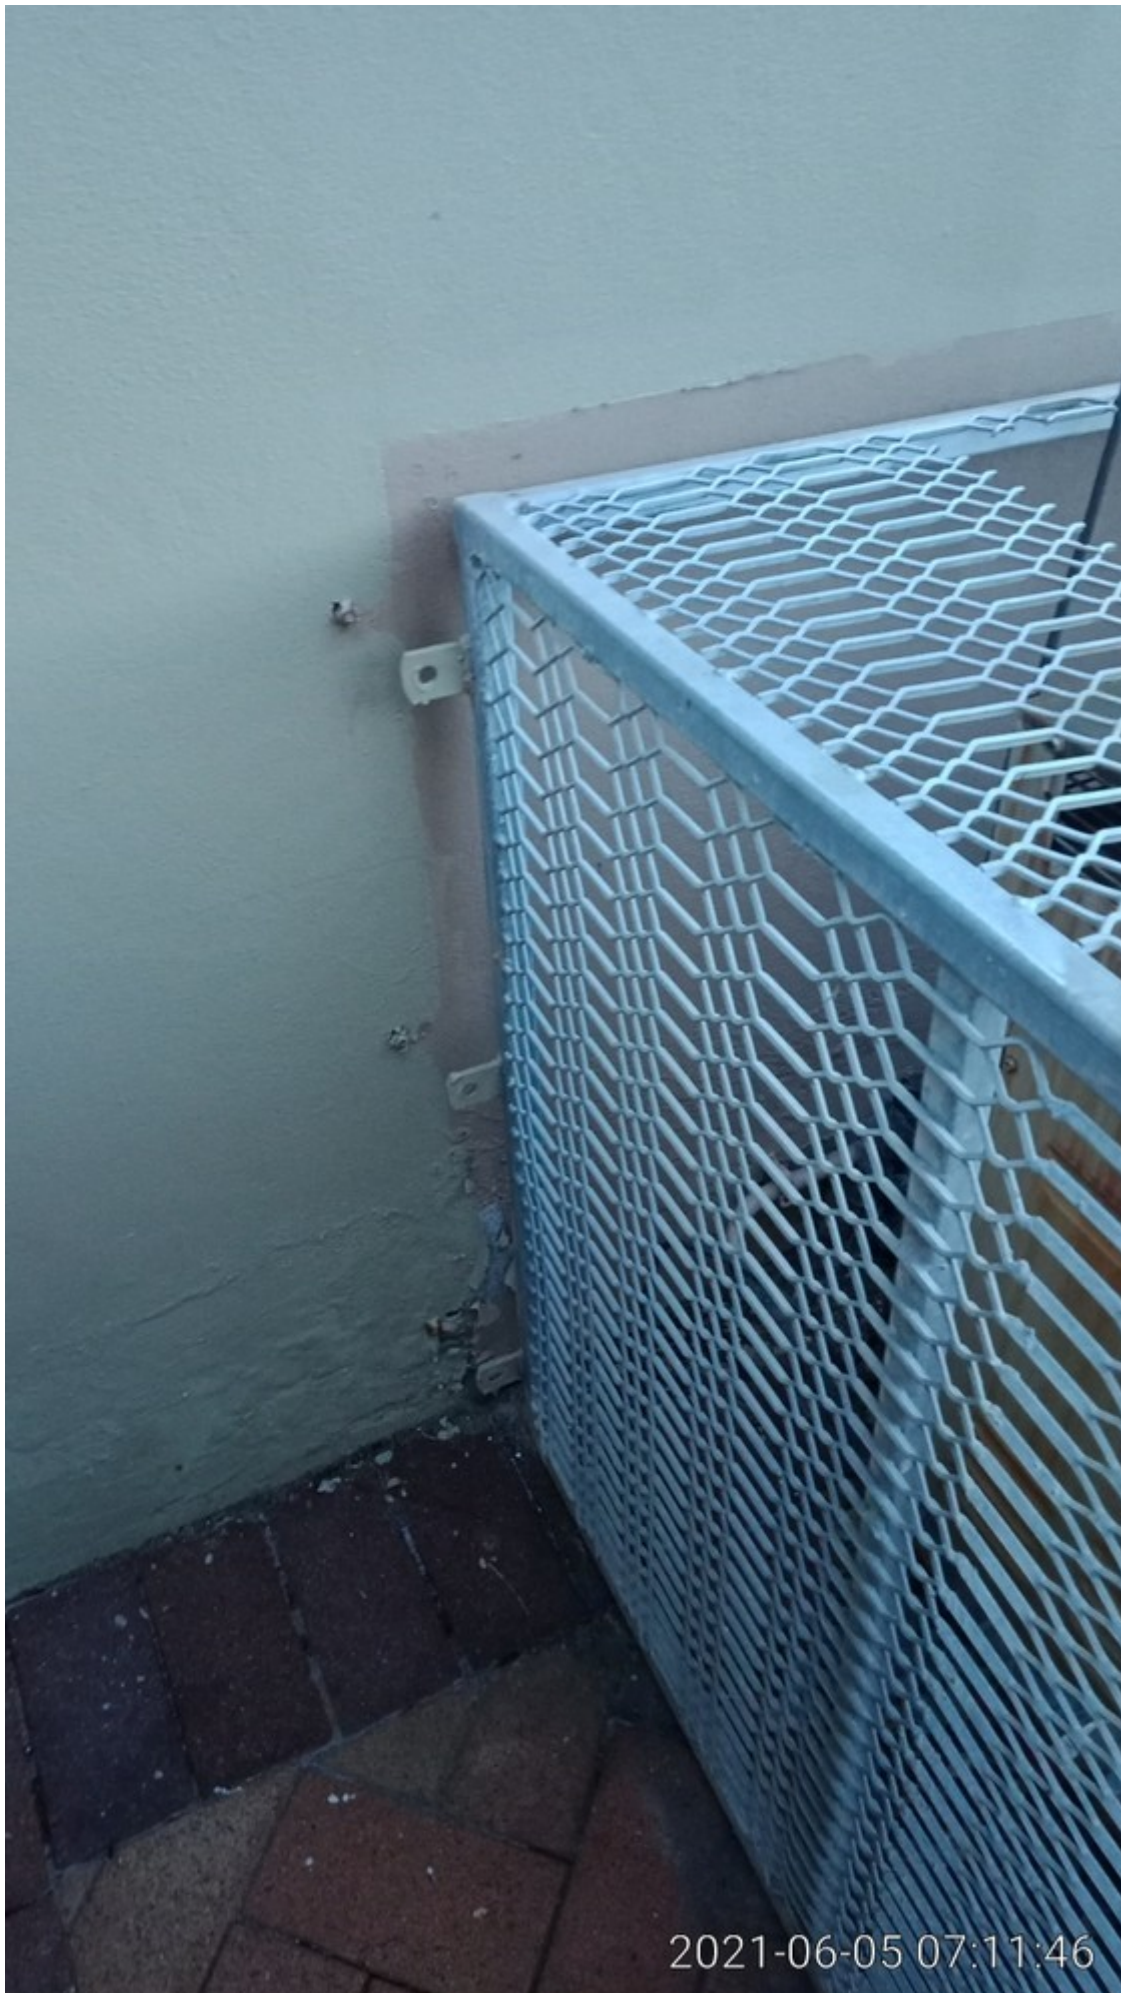
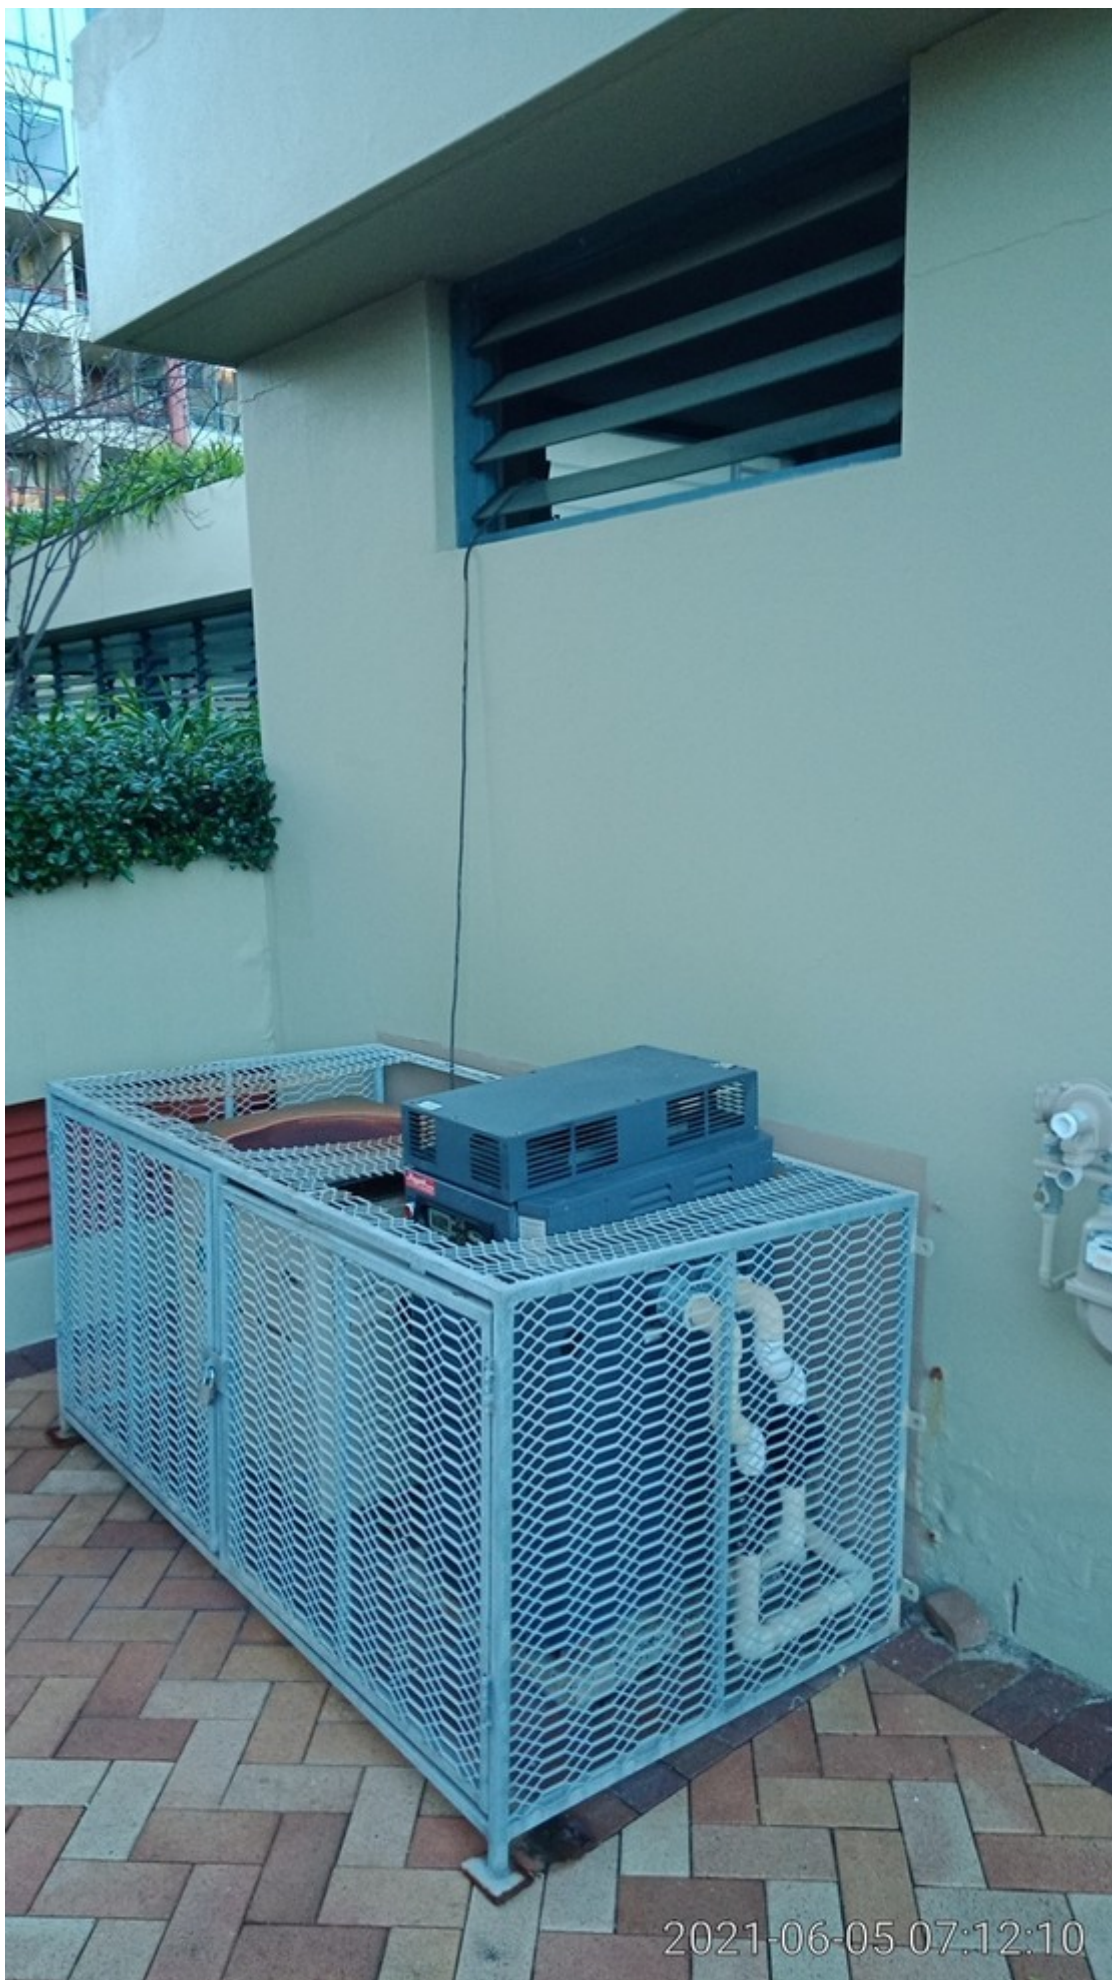
29 Unanchored metal mesh frame on swimming pool plant and unprotected hot surface close to power cable for four years

Metal frame not anchored to the wall, protruding and rusted bolts on unpainted swimming pool wall, hot and rusted surface not protected from weather elements and children who often play in the area, power cord located very close to hot surface which can create electrical hazard.

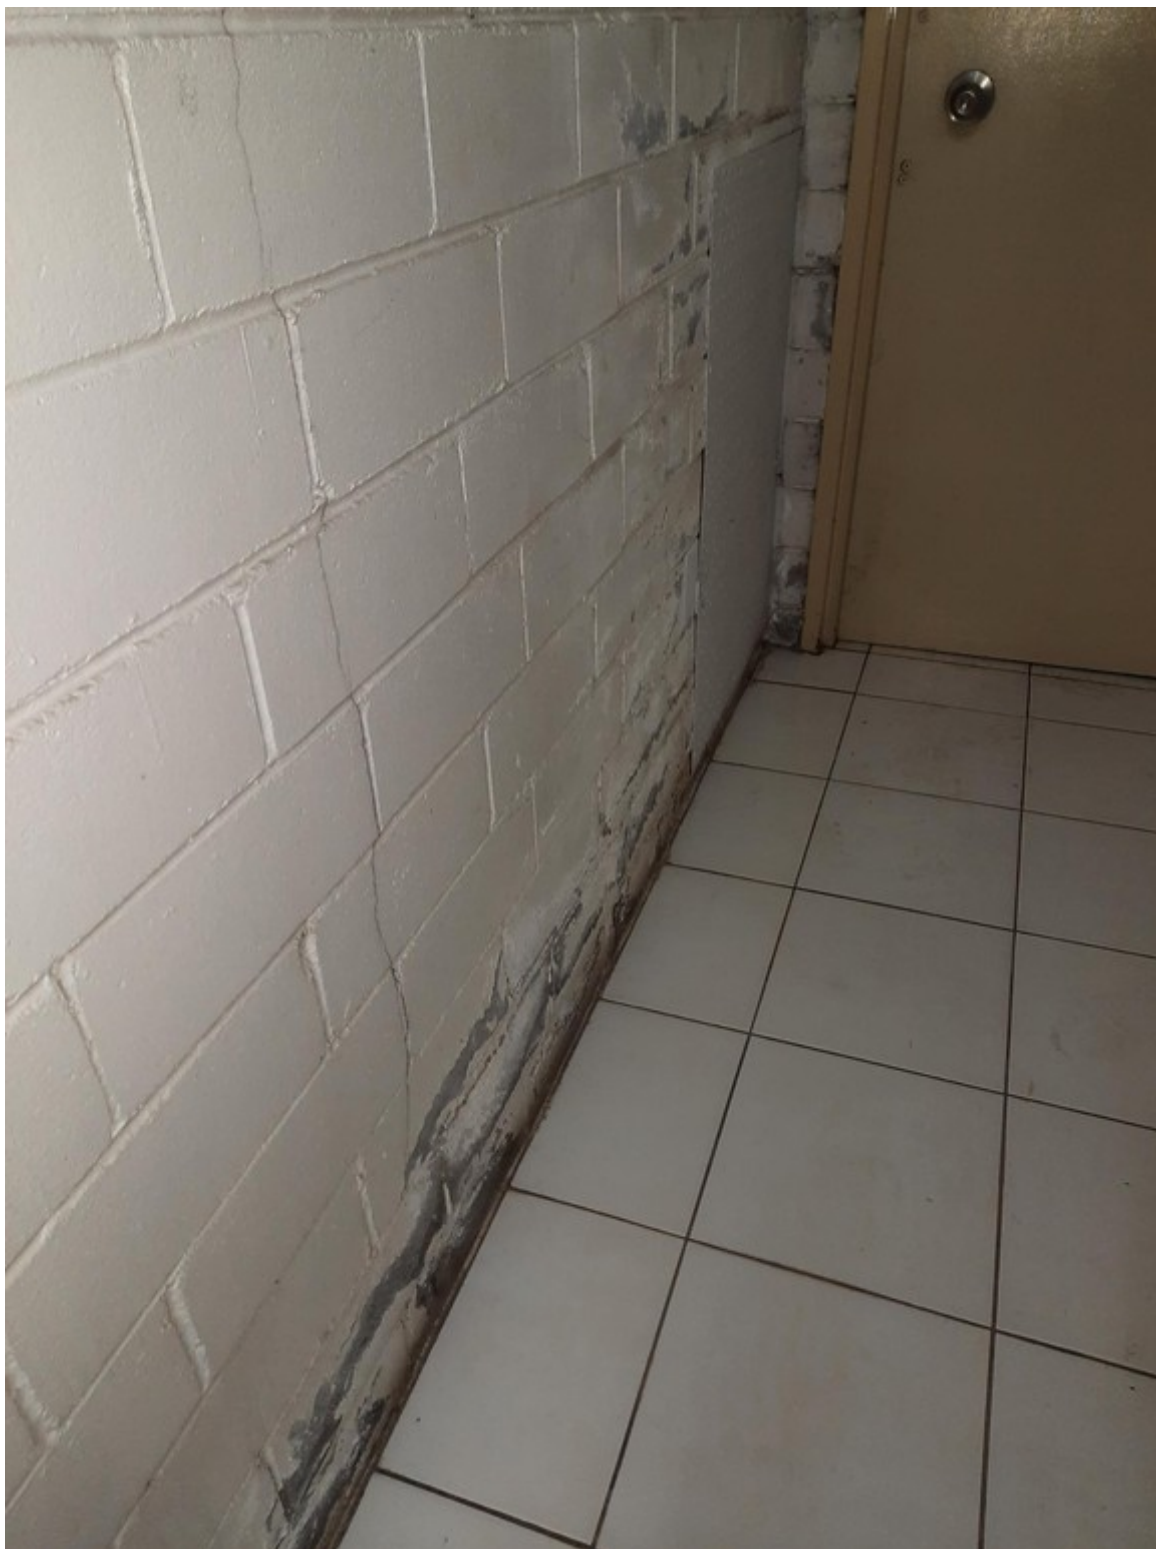
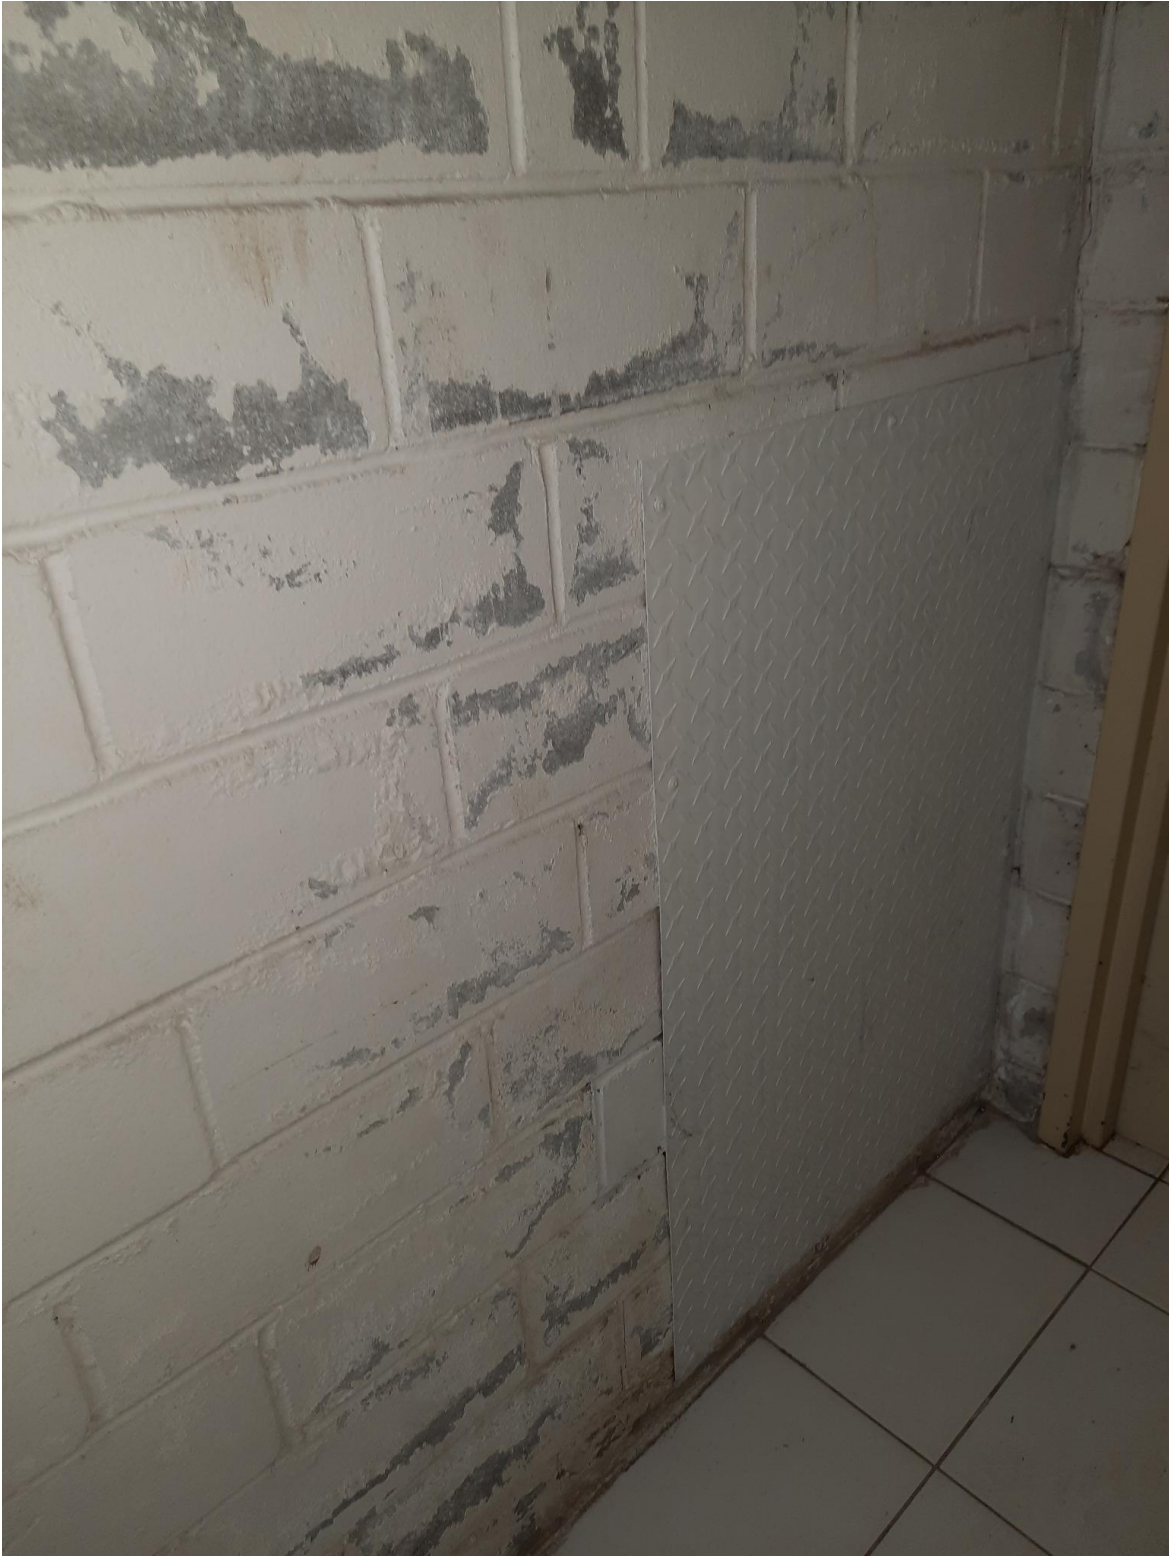
33 Example of water leak damages near fire door exit in Block C ground floor in June 2021

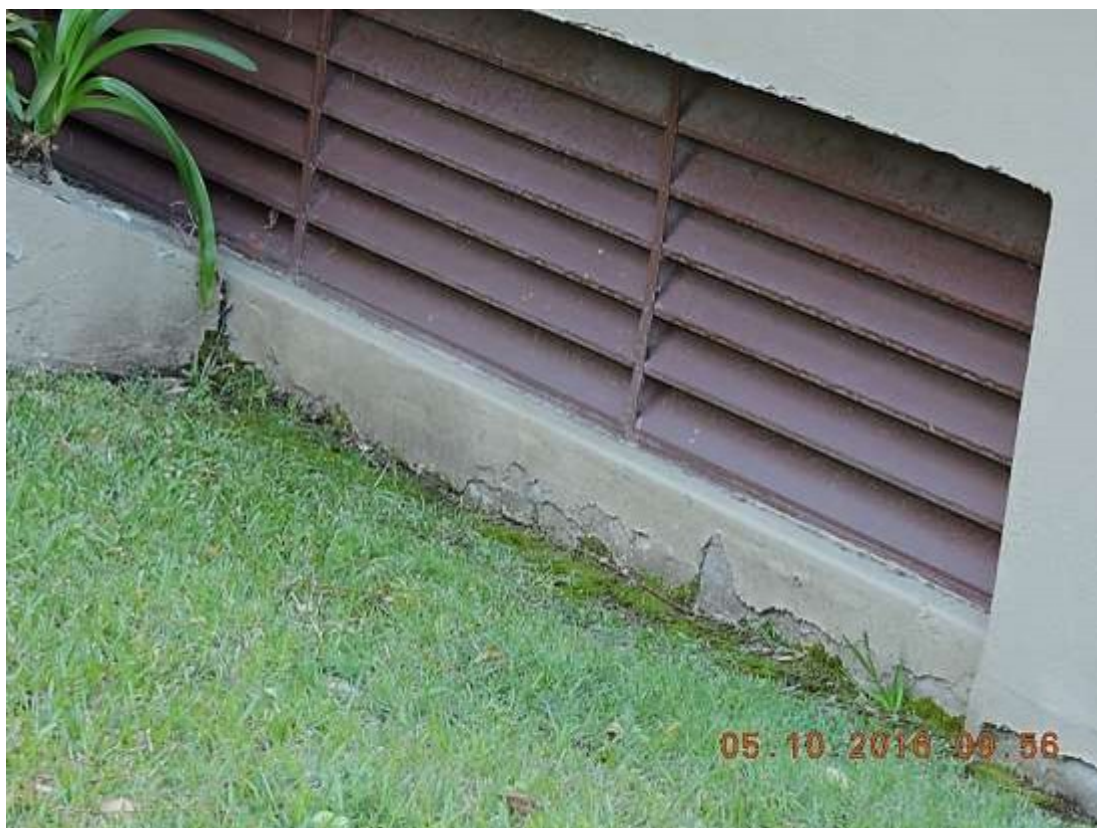
Initial status:

Instead of repairing the concrete cancer and cracks, simply cover it by piece of wood:

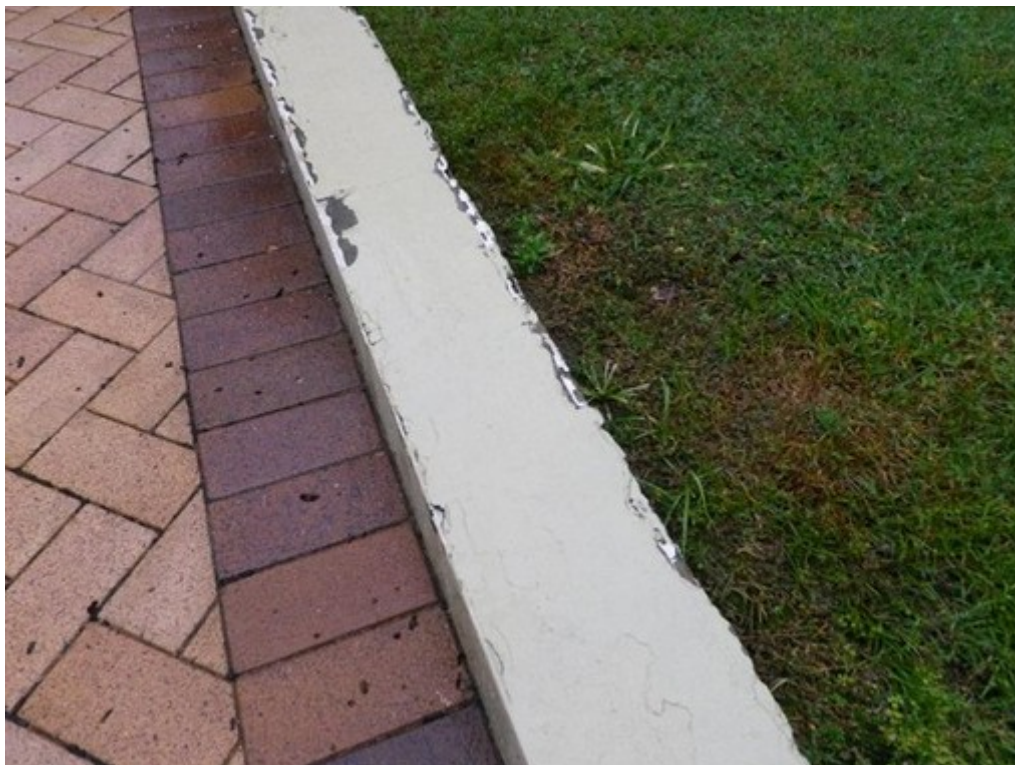
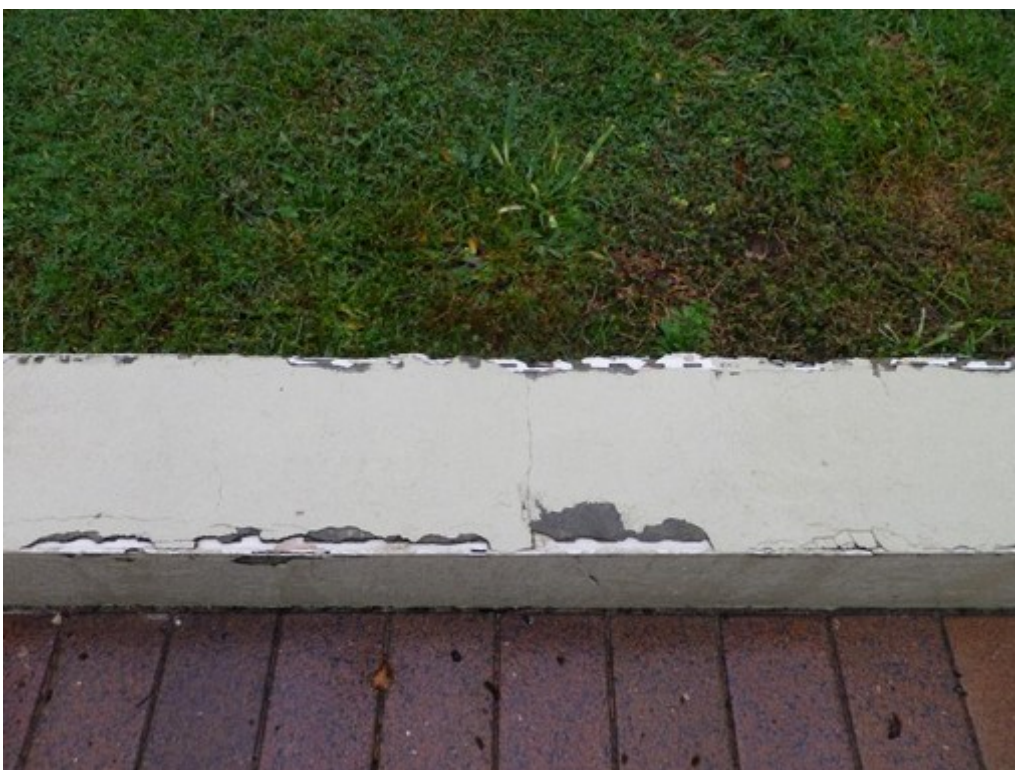
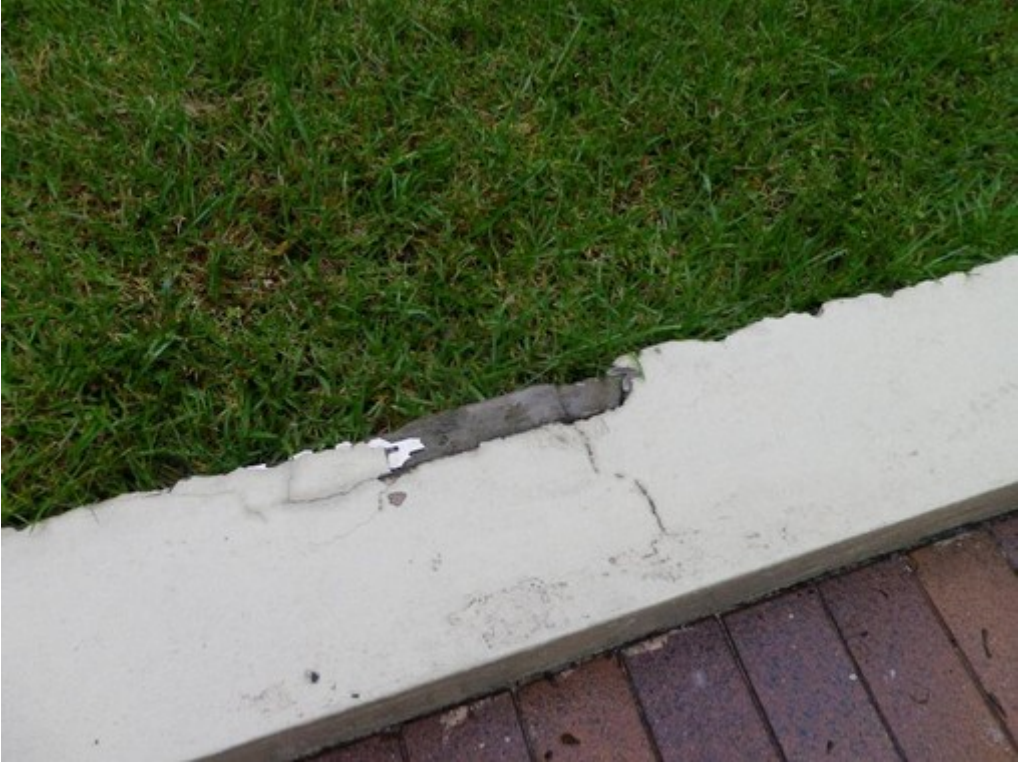
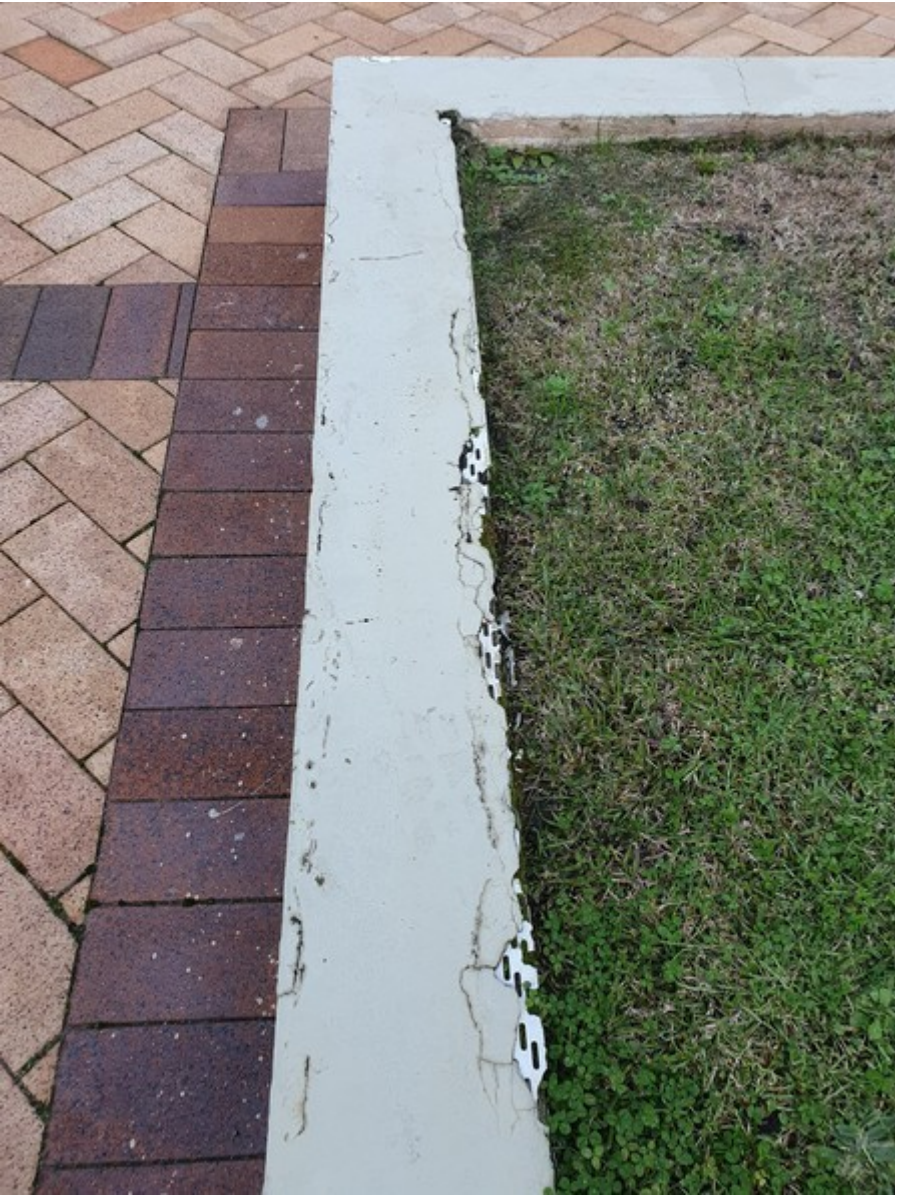
36 Injury hazard with garden bed walls and sharp edges with protruding plastic and metal pieces in areas where children play every day

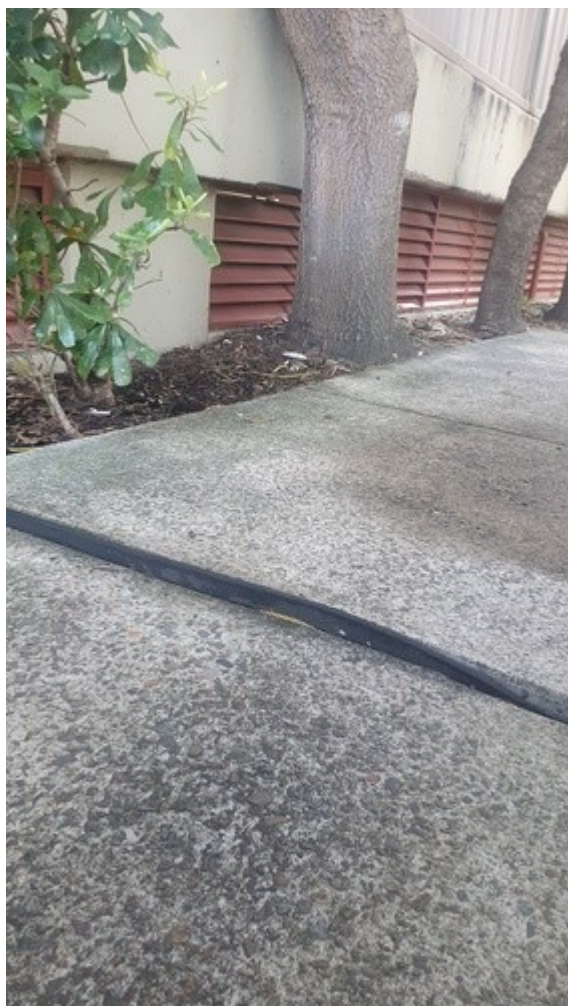
38 Tripping hazard with pavers not repaired since July 2012

One of examples of tripping risk behind Block D:
