Major upgrades on 26 townhouses in amount of \$92,950.00 in 2017 without evidence of work done

1 SP52948 – Solicitor Adrian Mueller, on behalf of owners corporation, confirming that maintenance of common property is compulsory and that some strata files are missing on 14th of November 2019

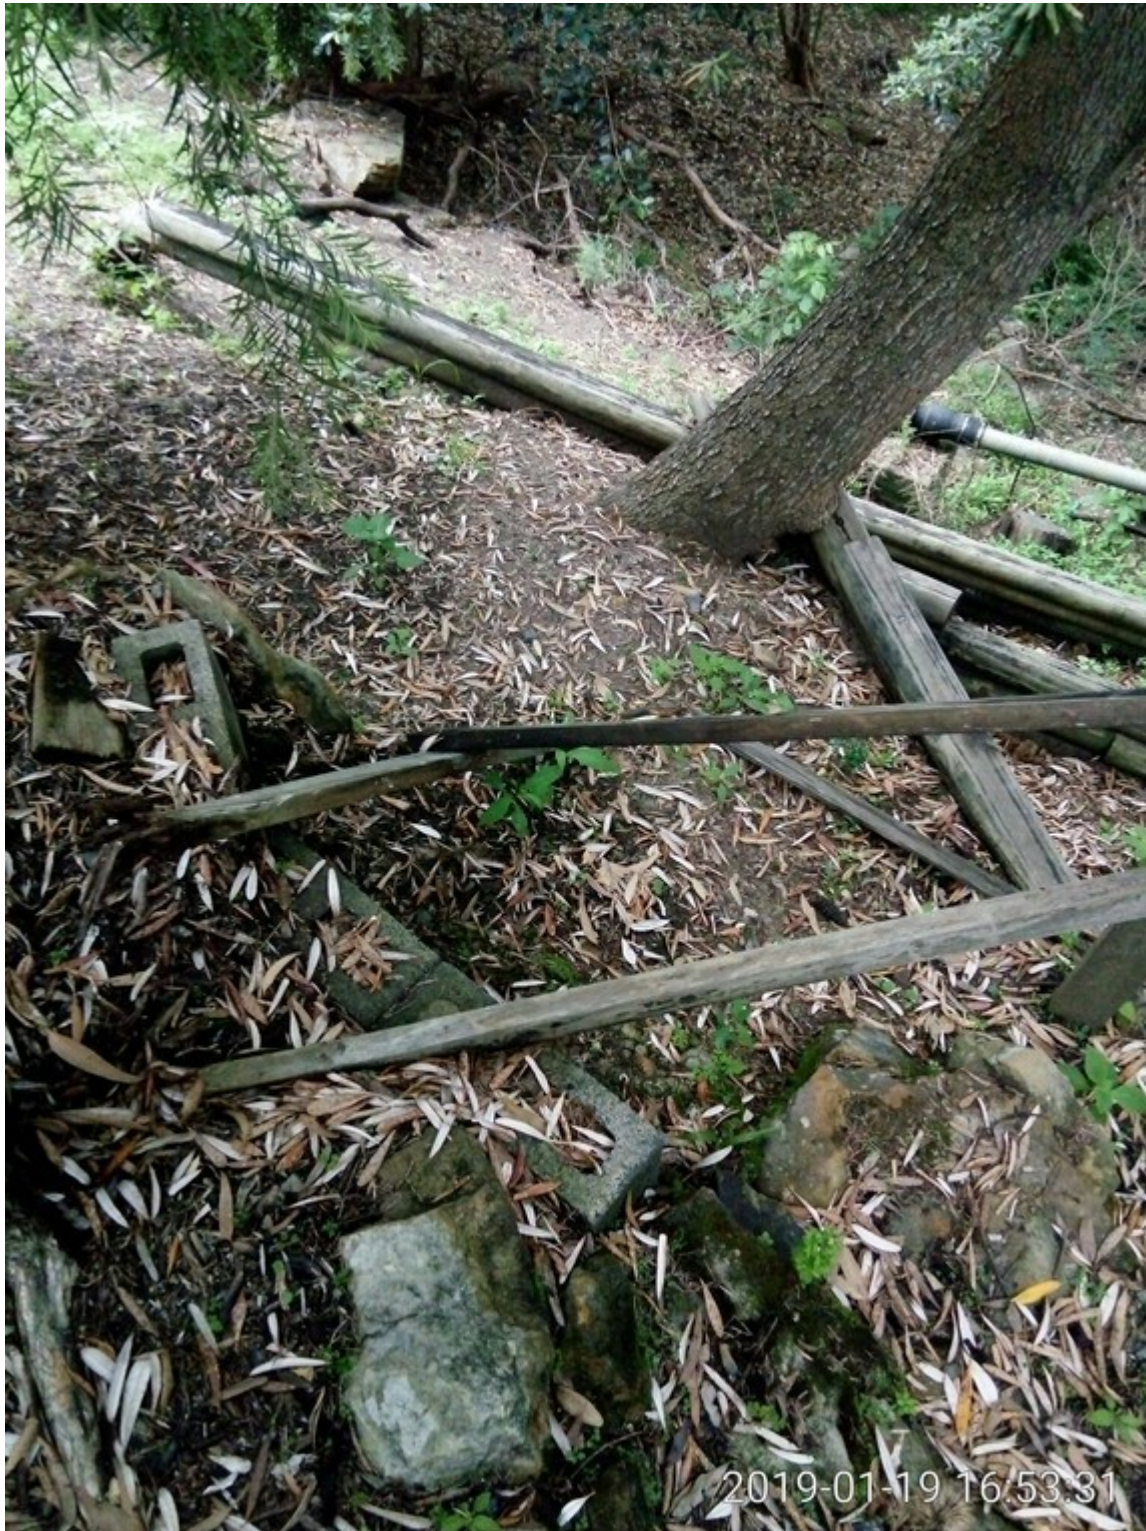
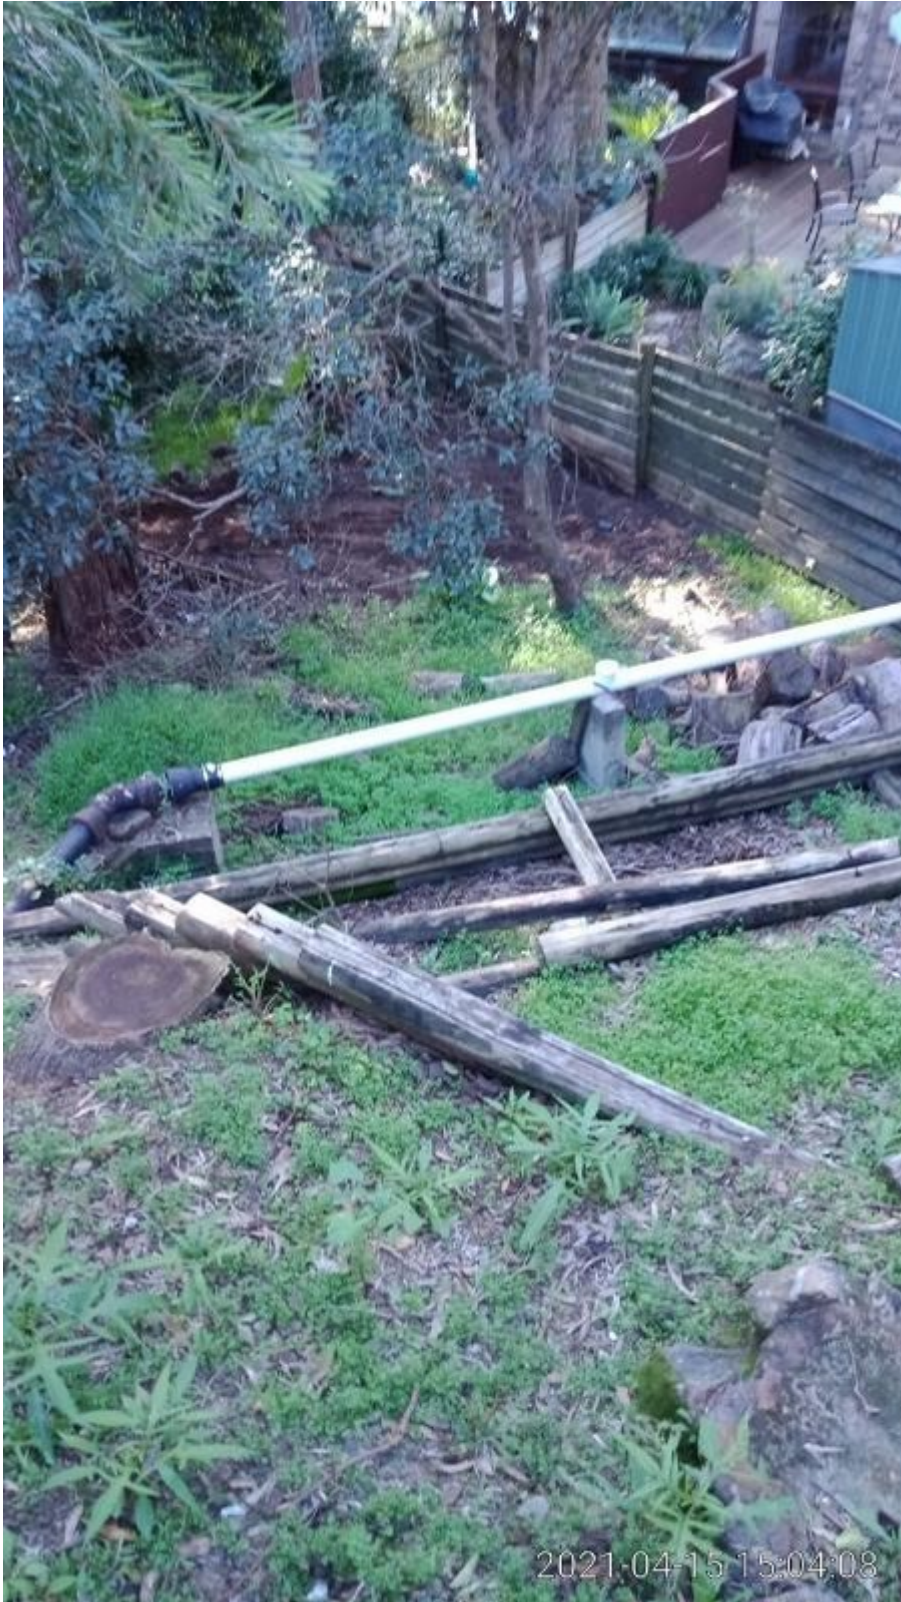
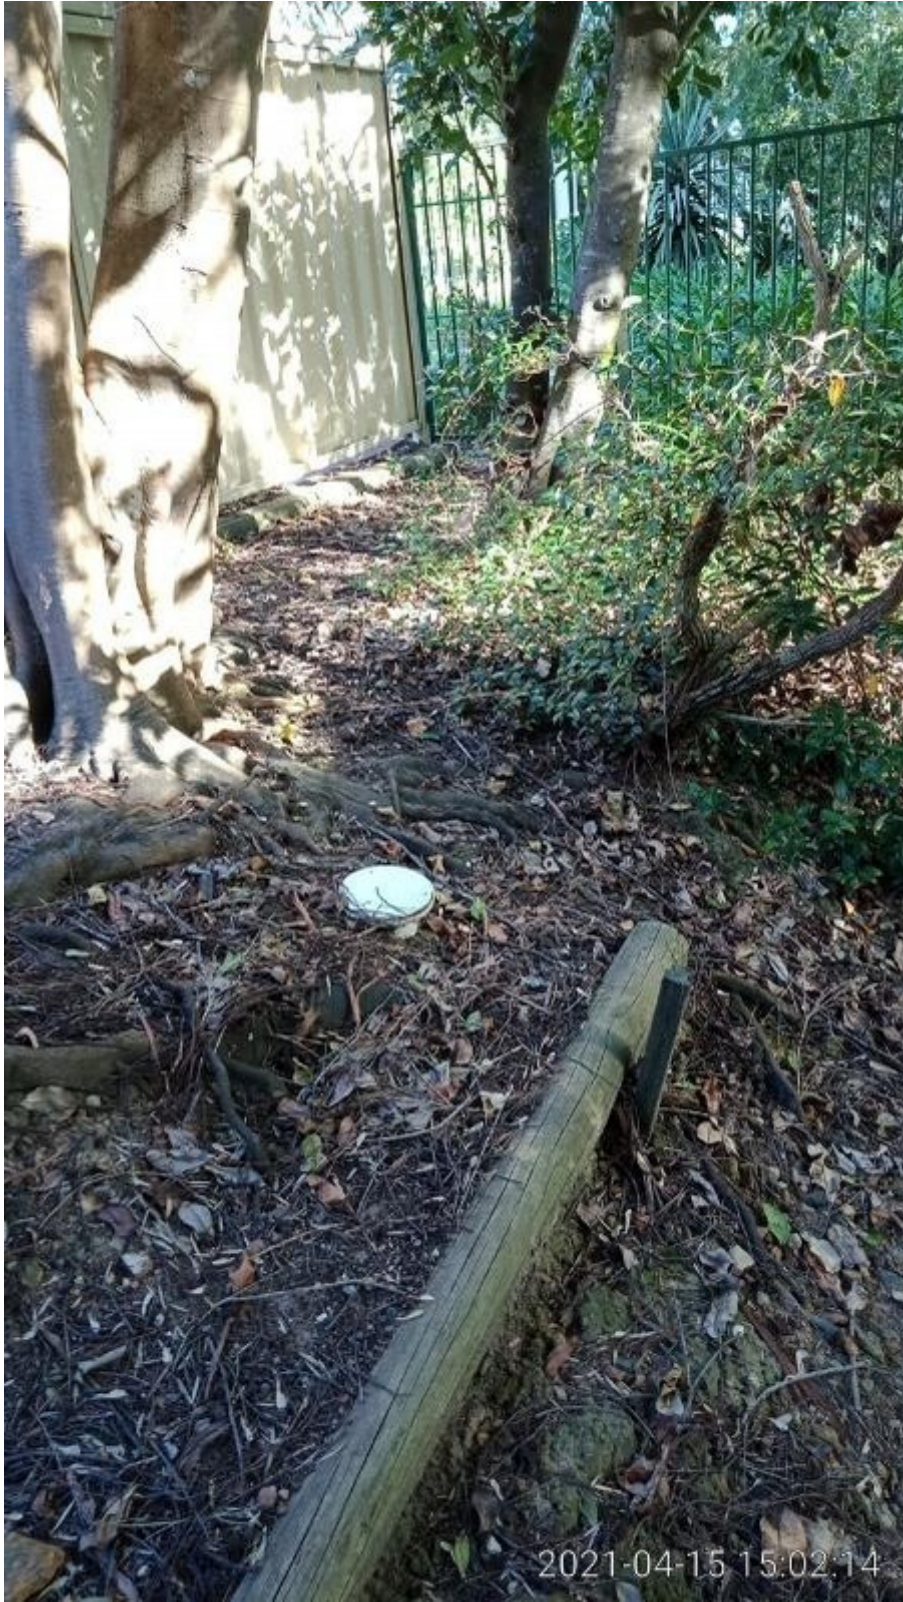
39 Wooden railings disappeared behind townhouses due to rot and not repaired since 2014

Most of railings started collapsing since 2015. Attempts to reason with strata managers to repair common property failed.

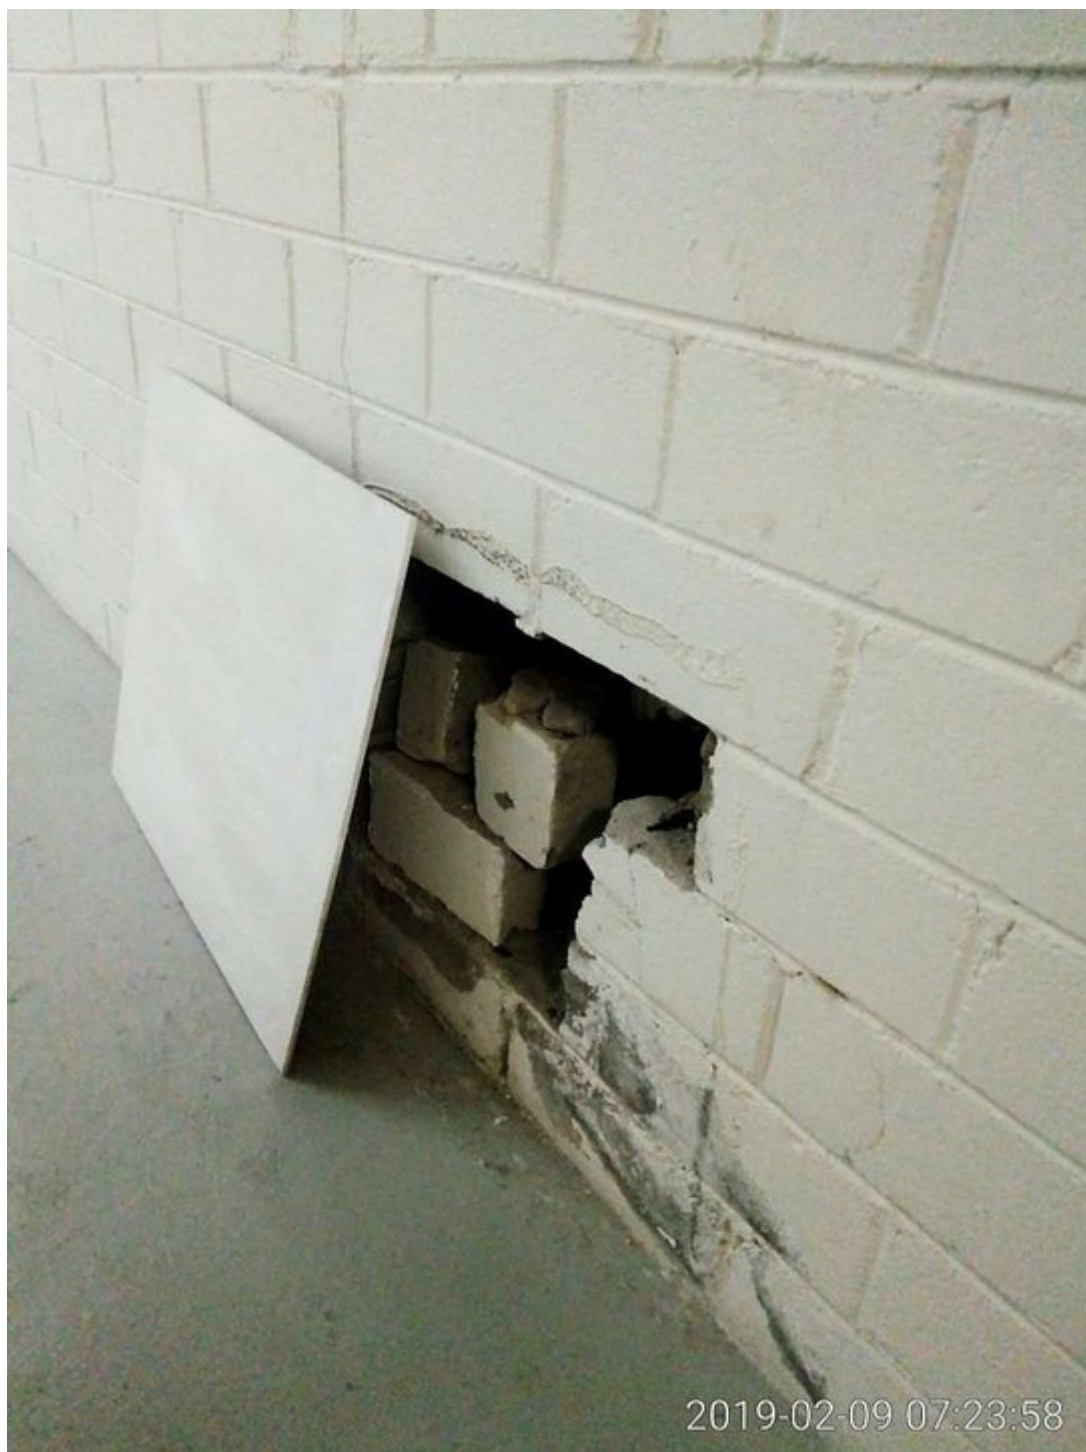
40 Example of water leak damages in Block C level 6 in October 2021

Request to properly repair the hole, open since 2019:

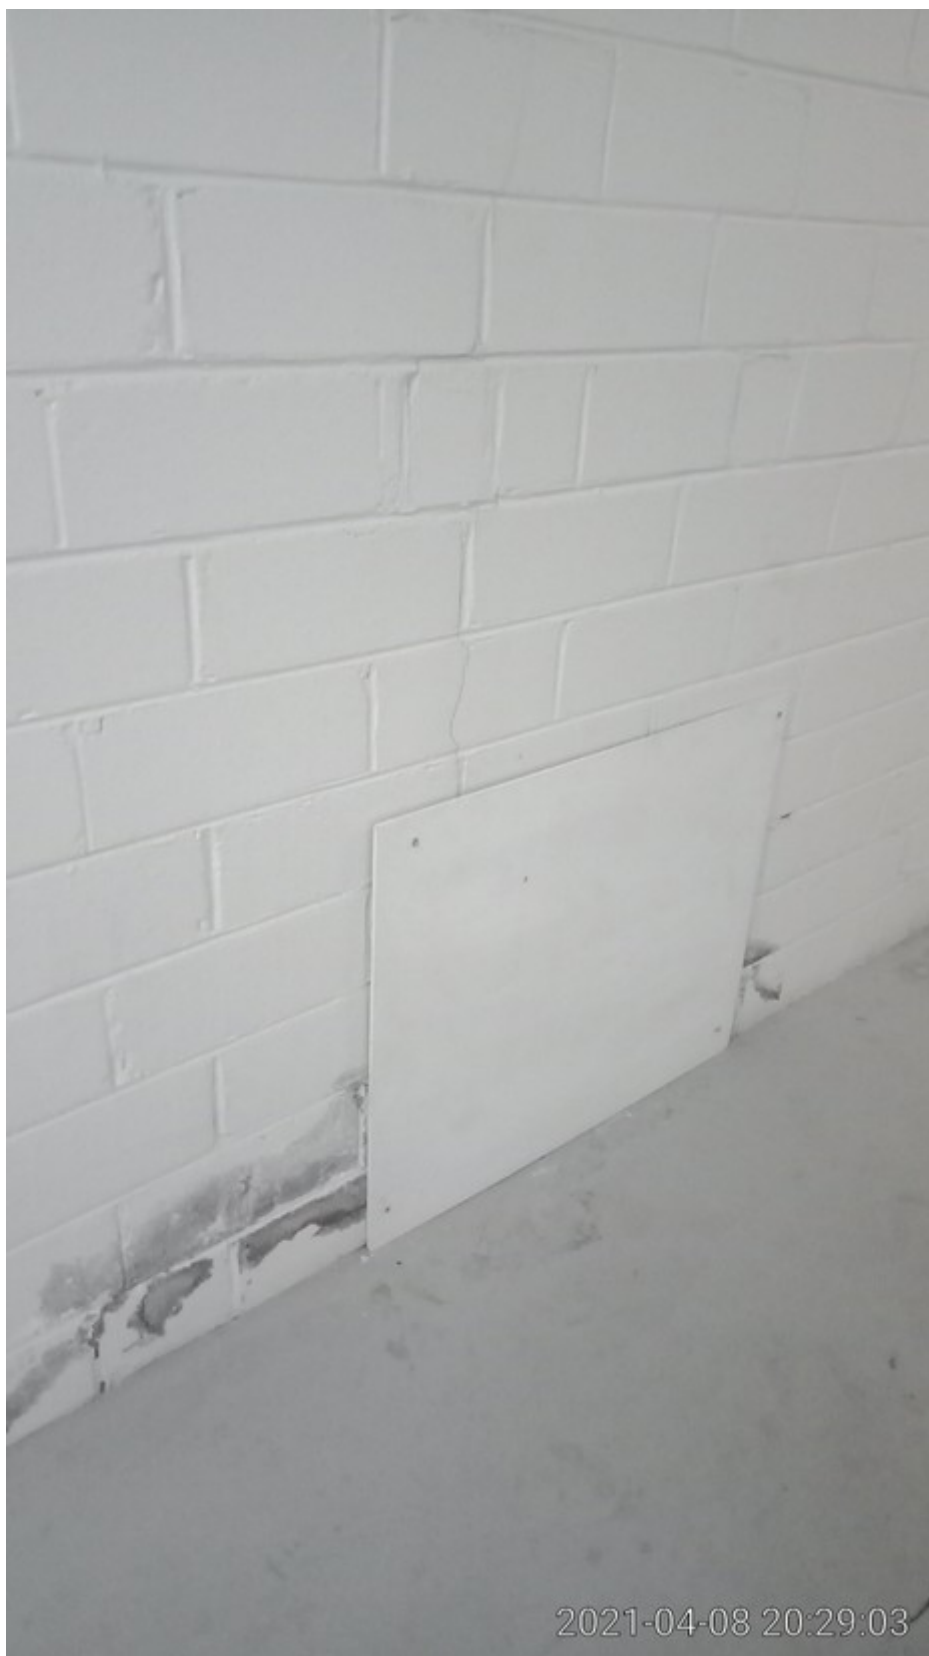
Instead of repair, the hole is simply covered:

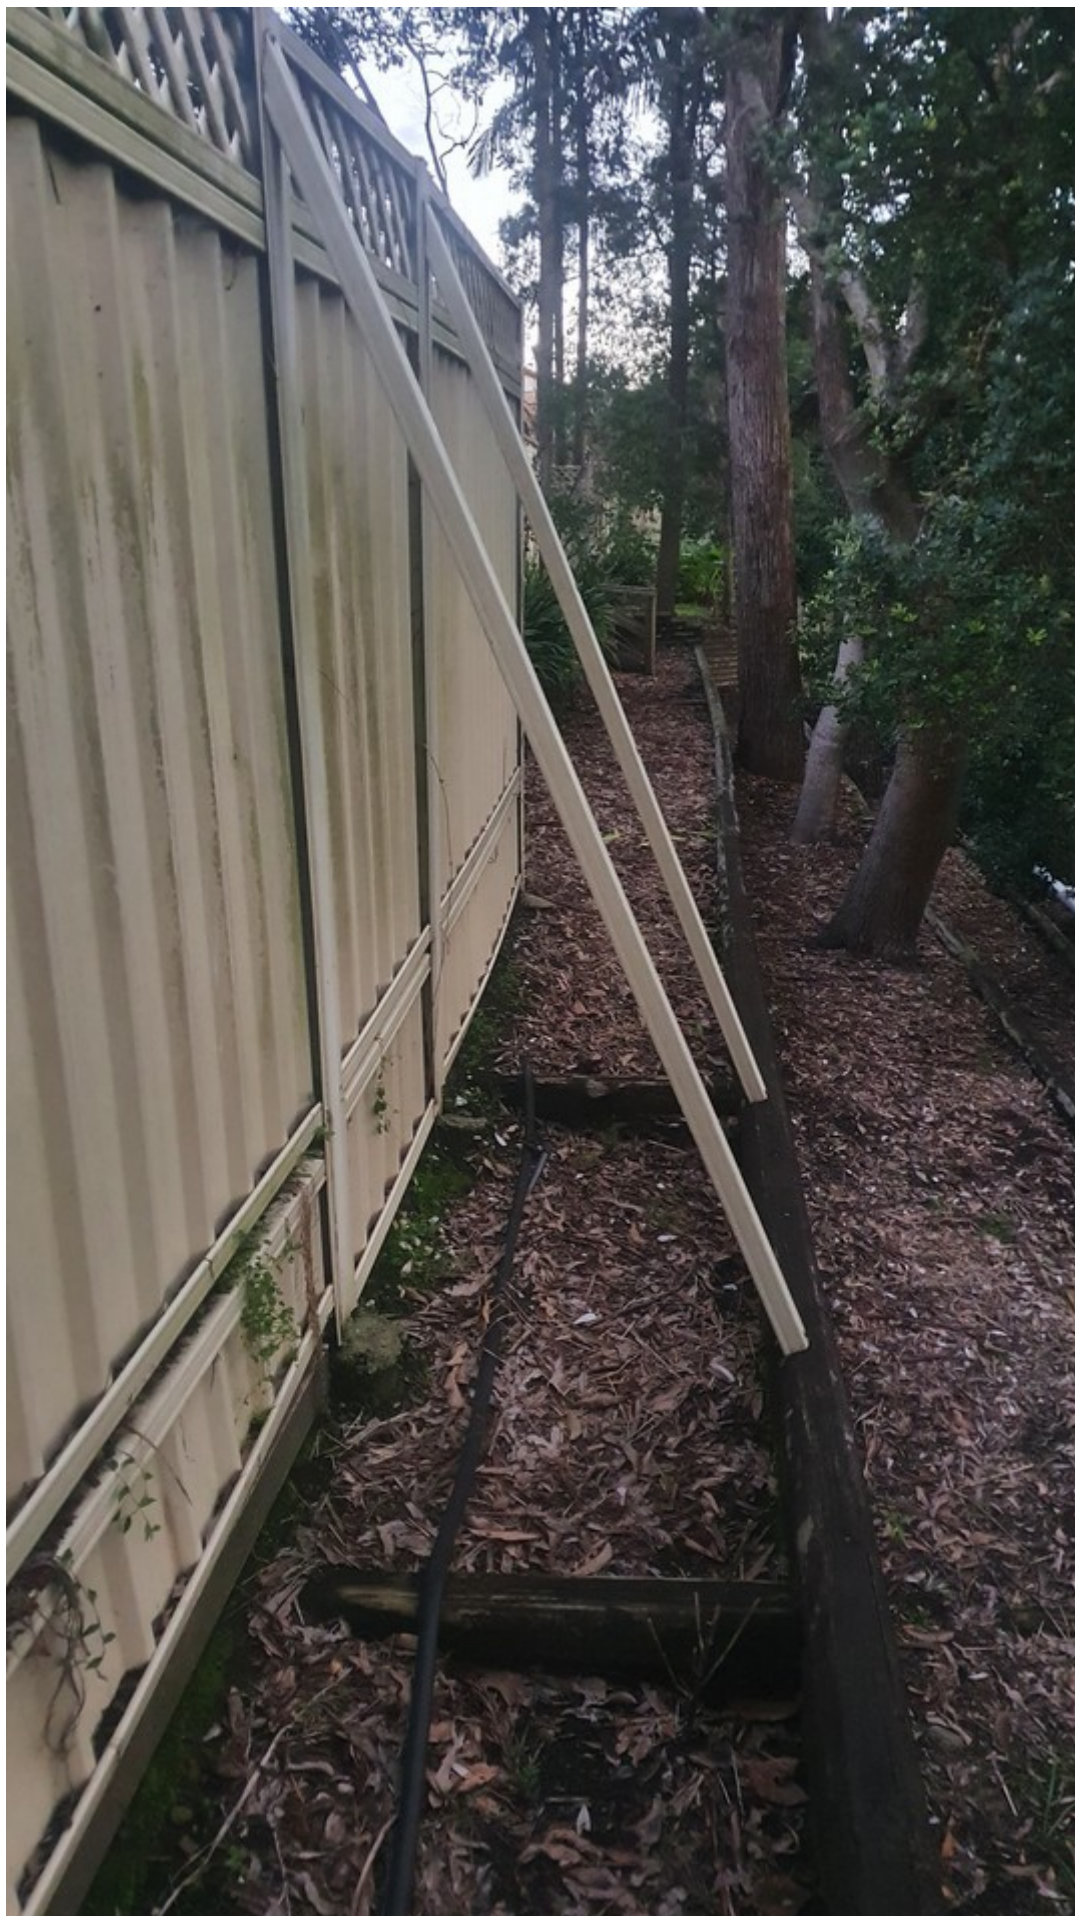
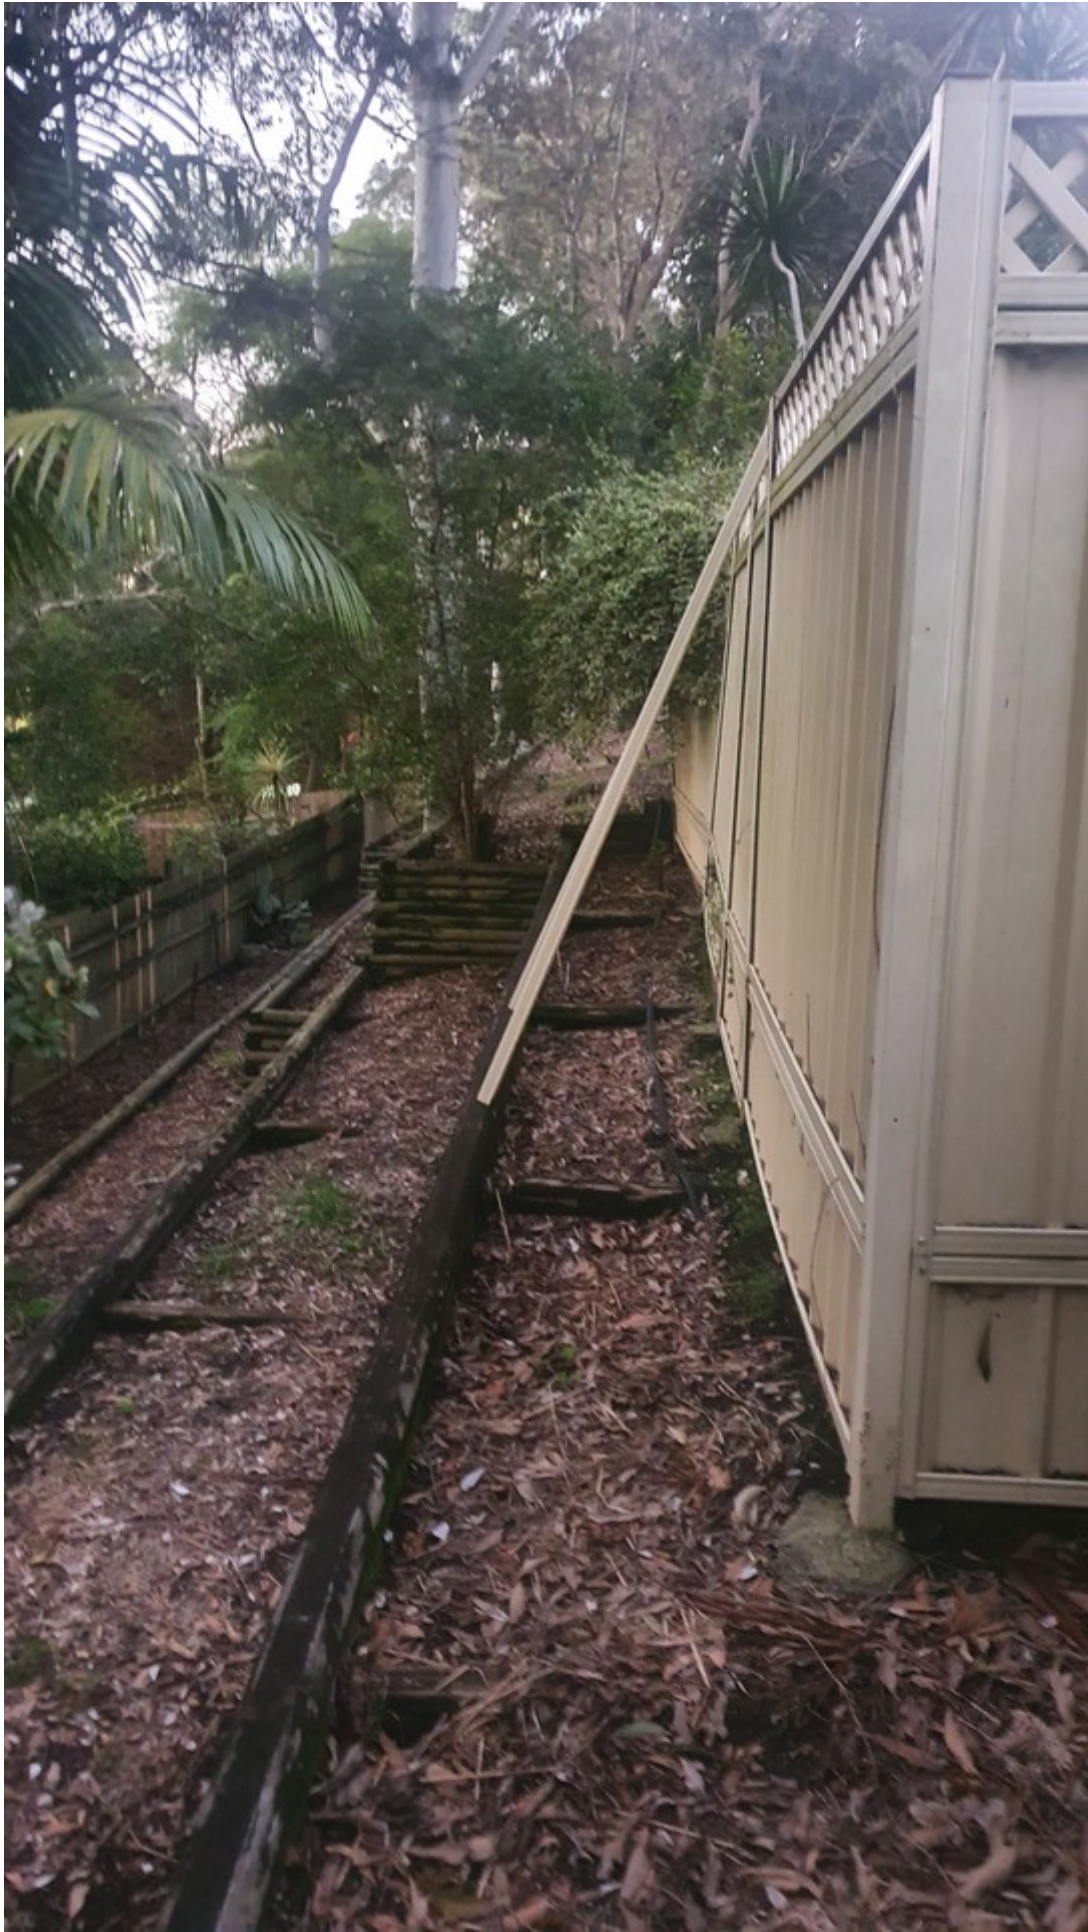
41 Townhouse colorbond fence not repaired for more than six years as of October 2021

- a) Wood railing will be removed.
- b) Colourbond fence was inspected. Slightly leaning but not loose. Spoke to [REDACTED] and we are leaving this at present. We have received no complaints from Townhouses regarding this.
- c) Light pole ground has been scheduled to be re-soiled and compacted.
- d) Confirming tree was previously removed. There is nothing we can do regarding the slope of the land.
- e) Not sure about painting project 2017?
- e) should be f) Metal fence slightly leaning to one side. Confirming we will straighten fence.

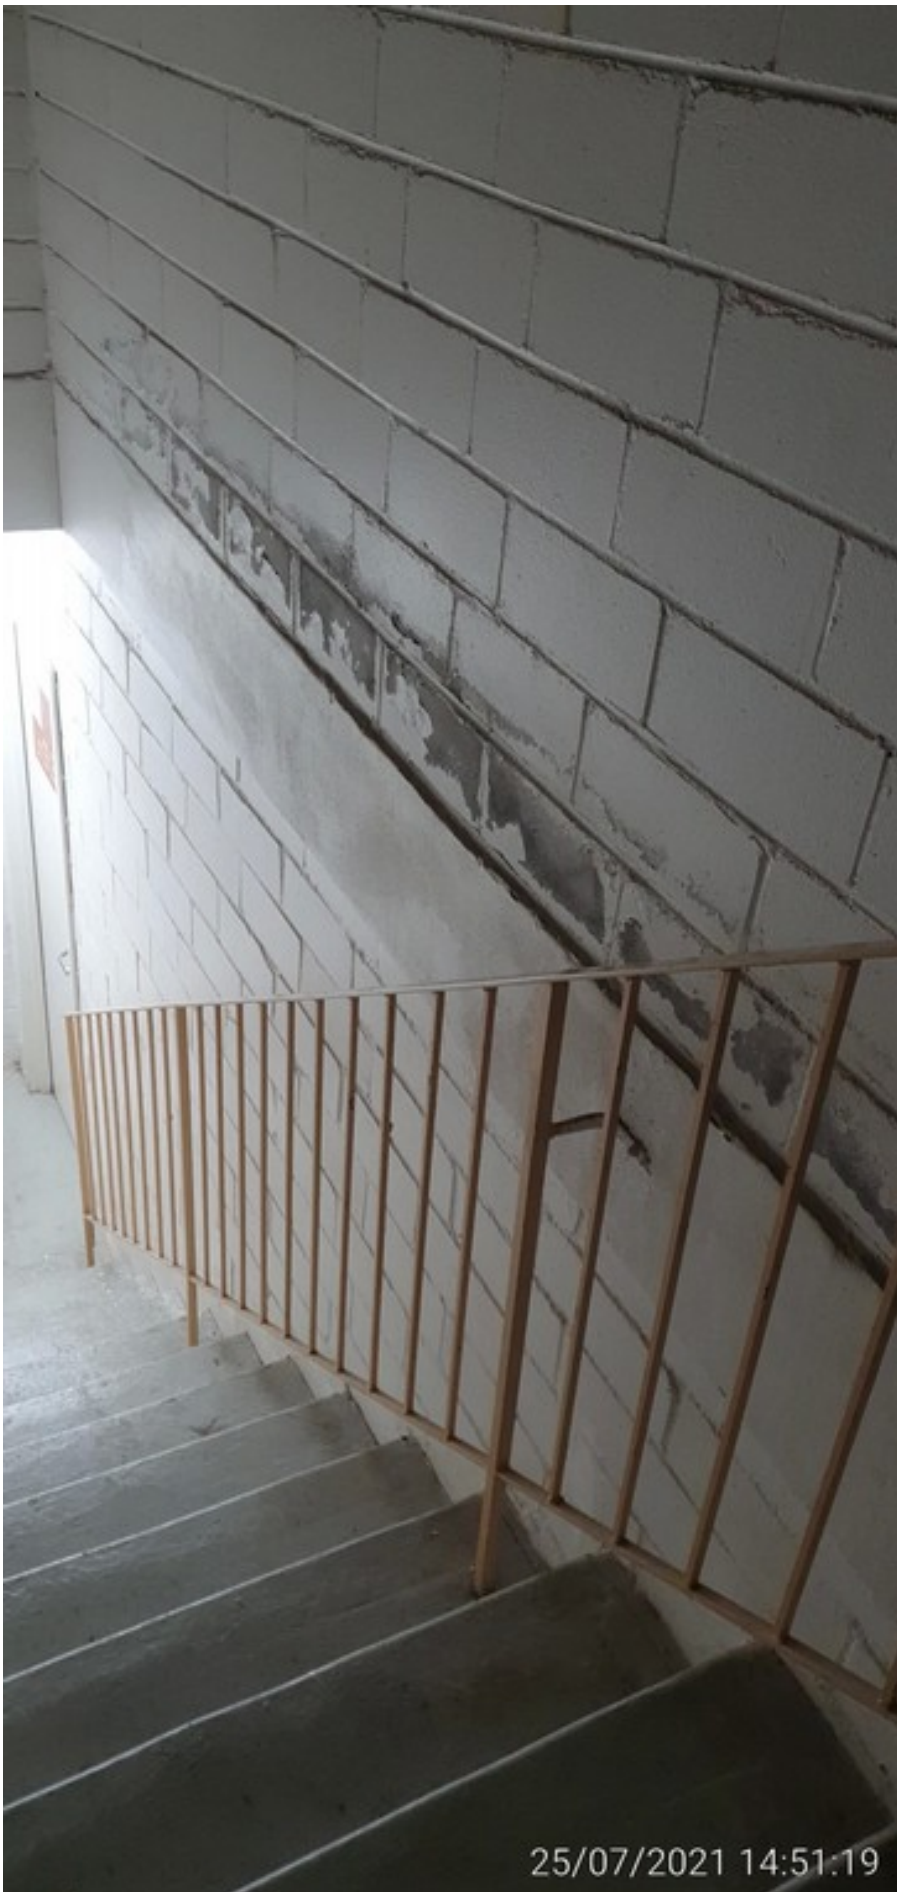
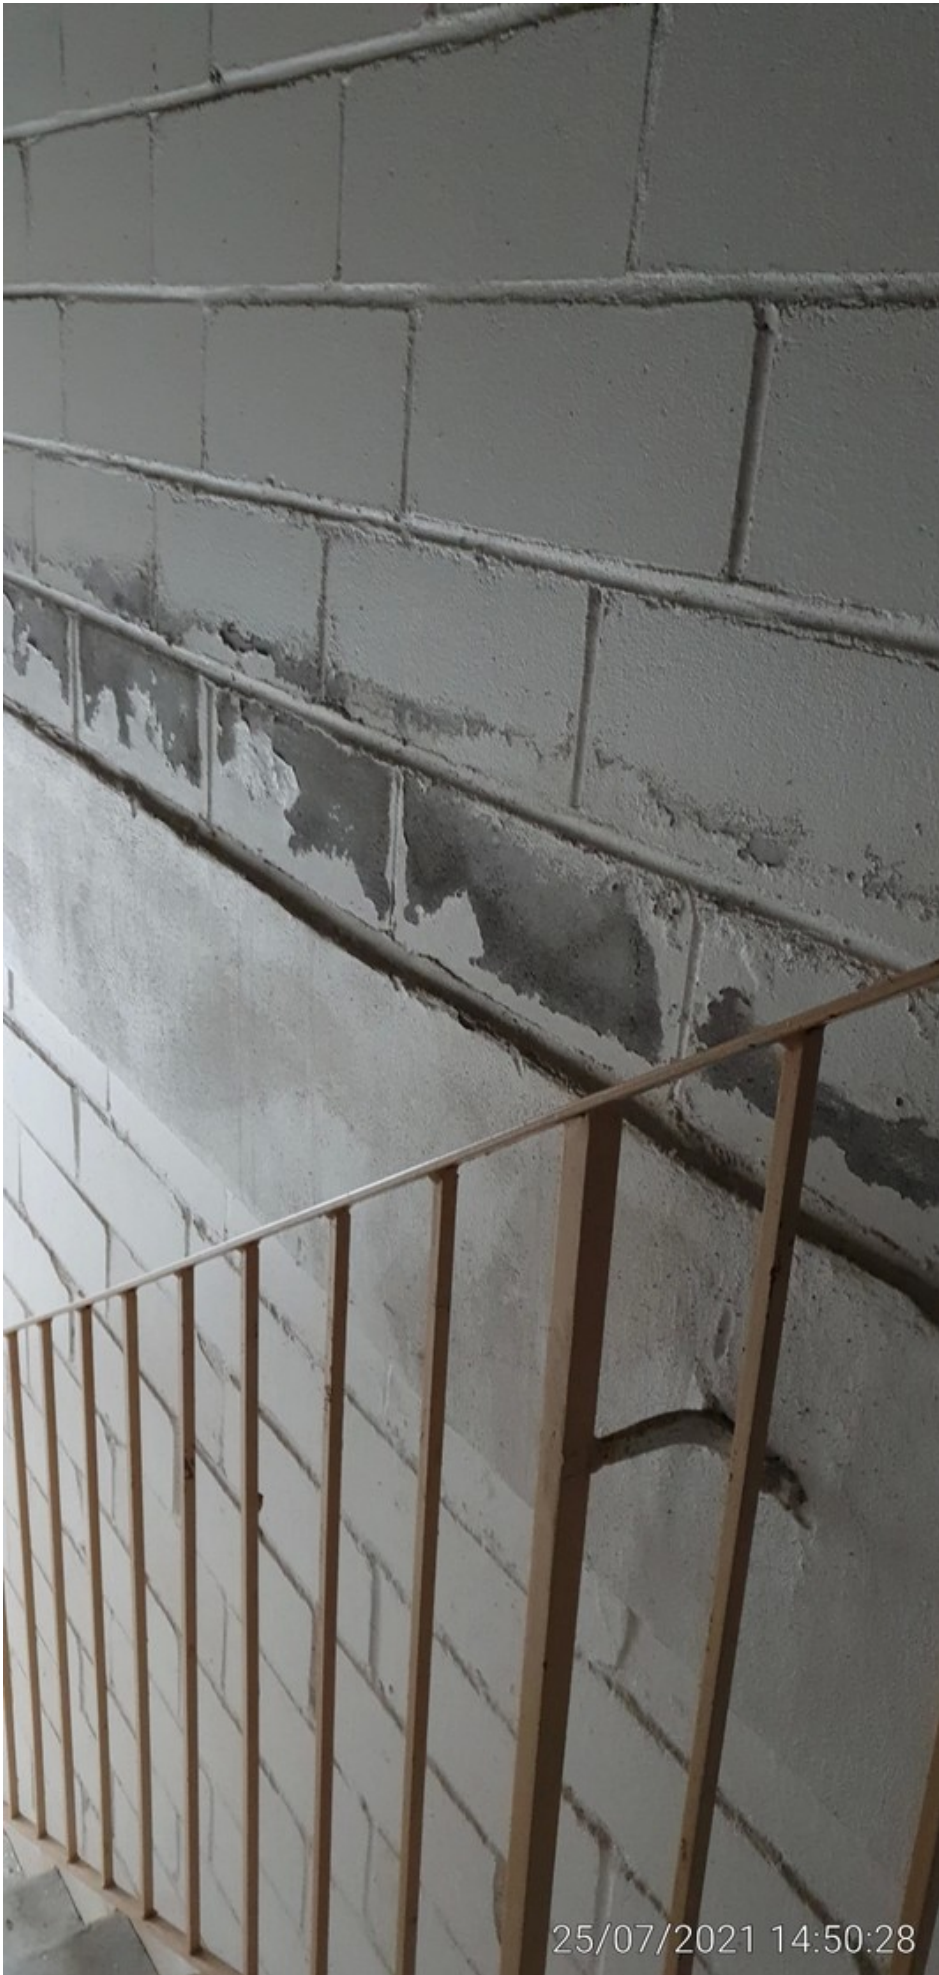
42 Long-term water leak damages under roof in Block B as of October 2021

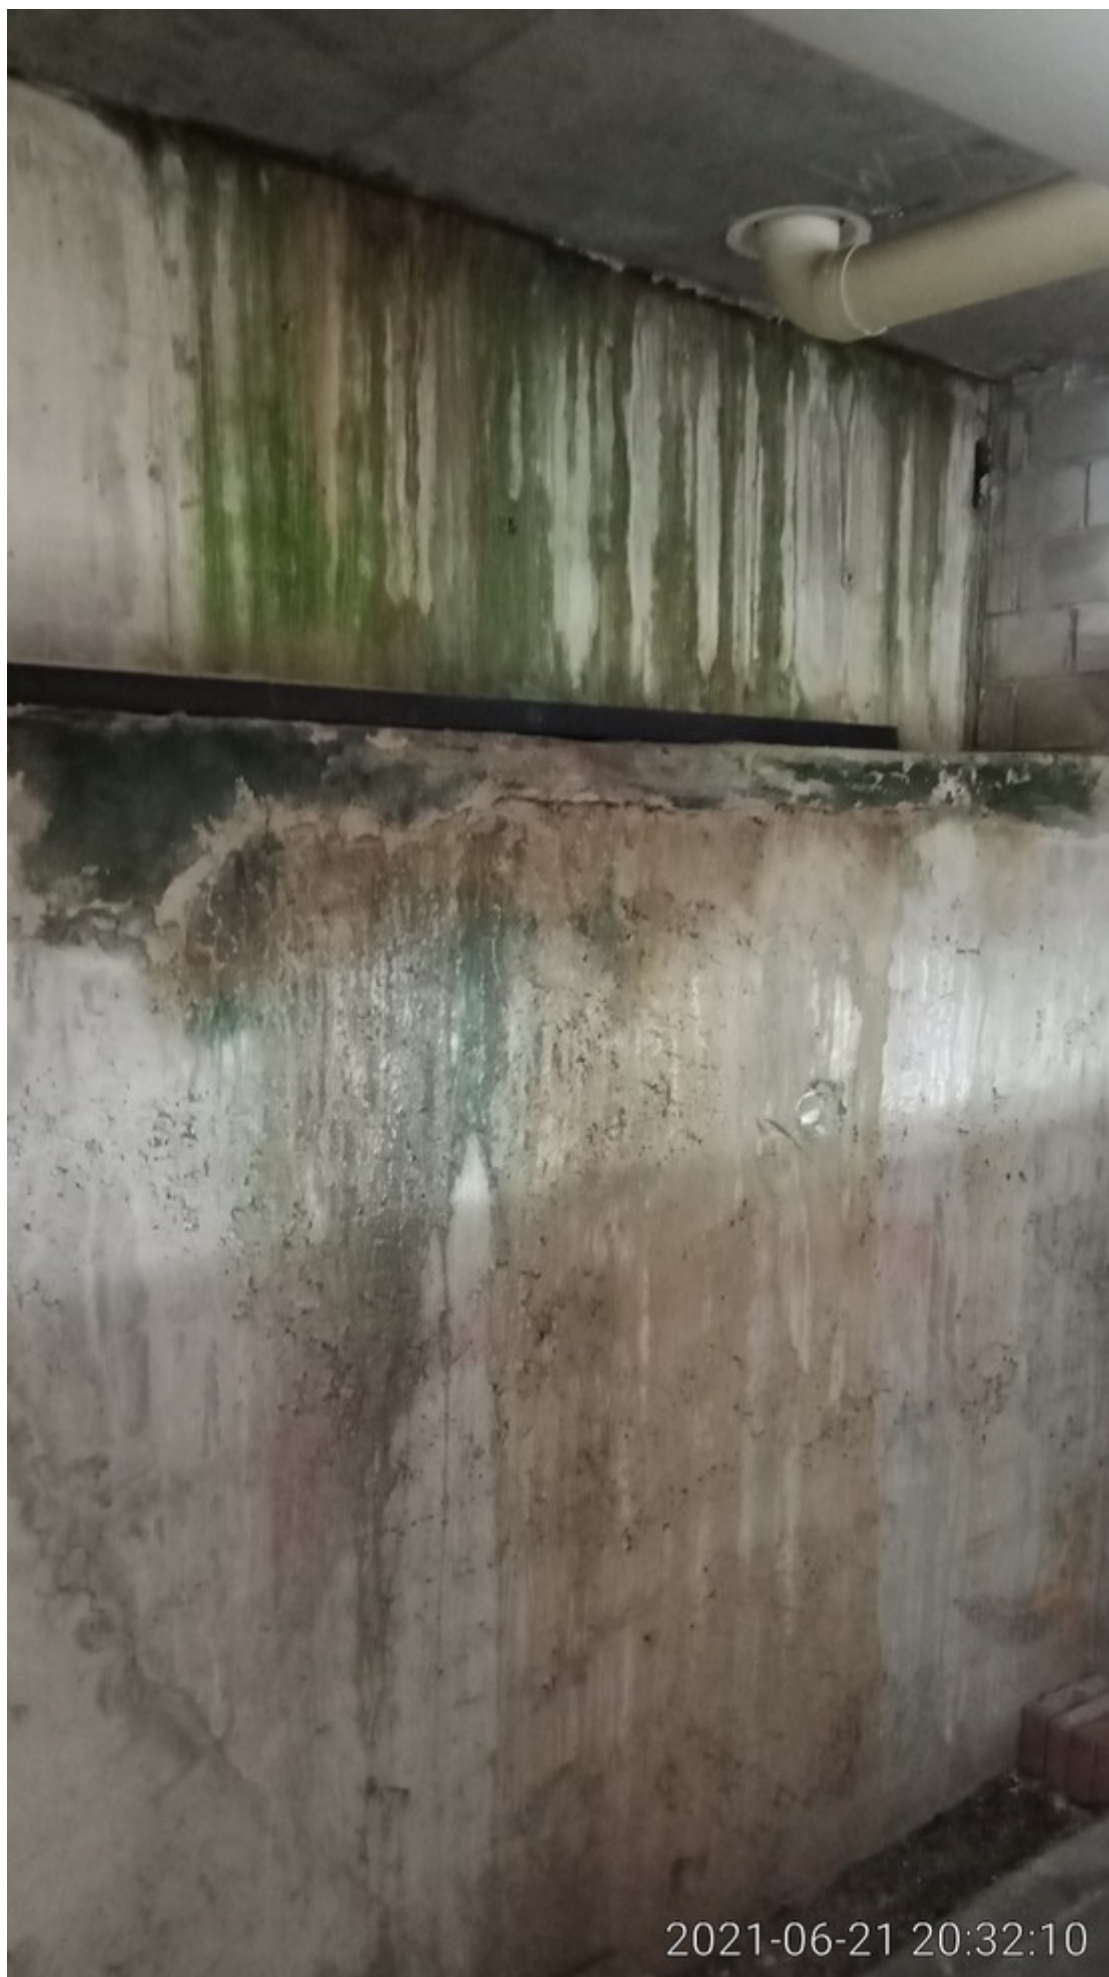
43 Long-term water leaks and health risks in basement of four buildings unresolved for more than seven years as of October 2021

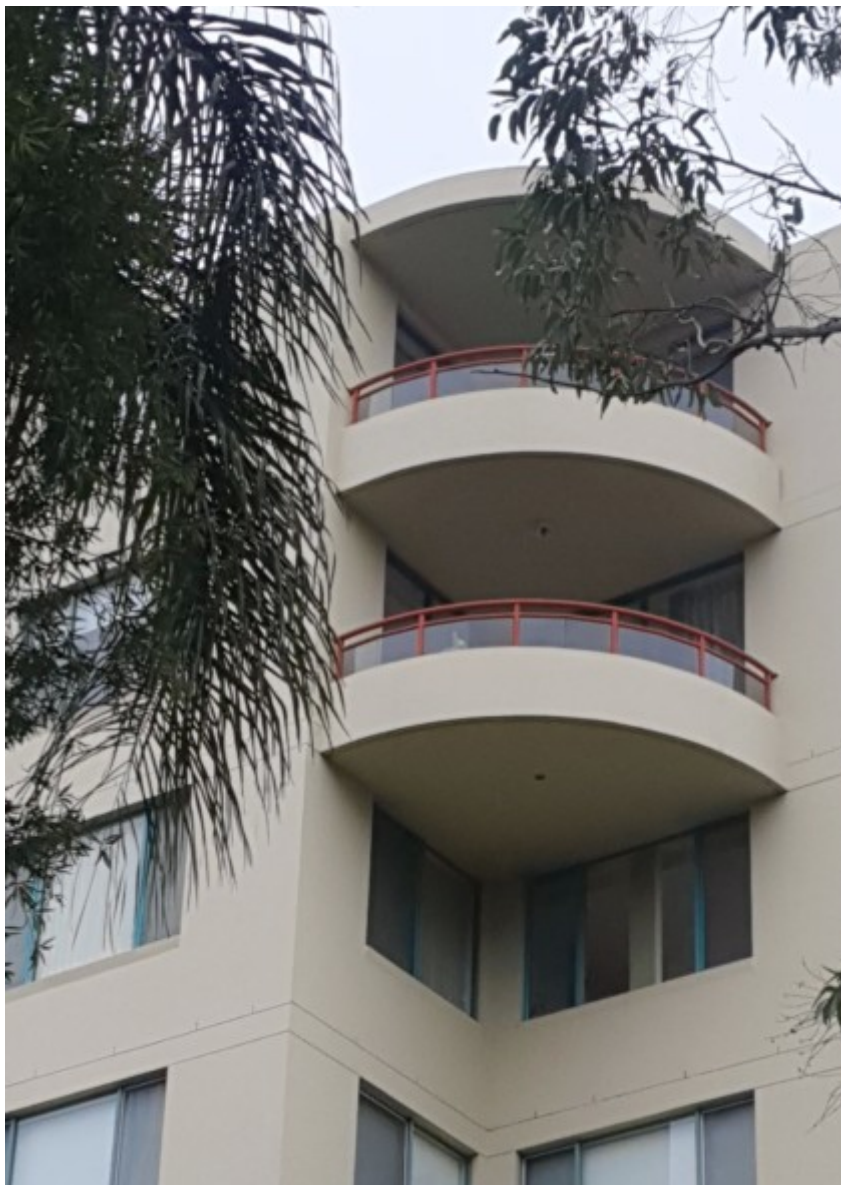
50 Electrical hazard due to missing balcony light cover and hole in concrete on level 6 Block
C

Similar problem with missing balcony light cover exists in Unit on level 7 Block B.

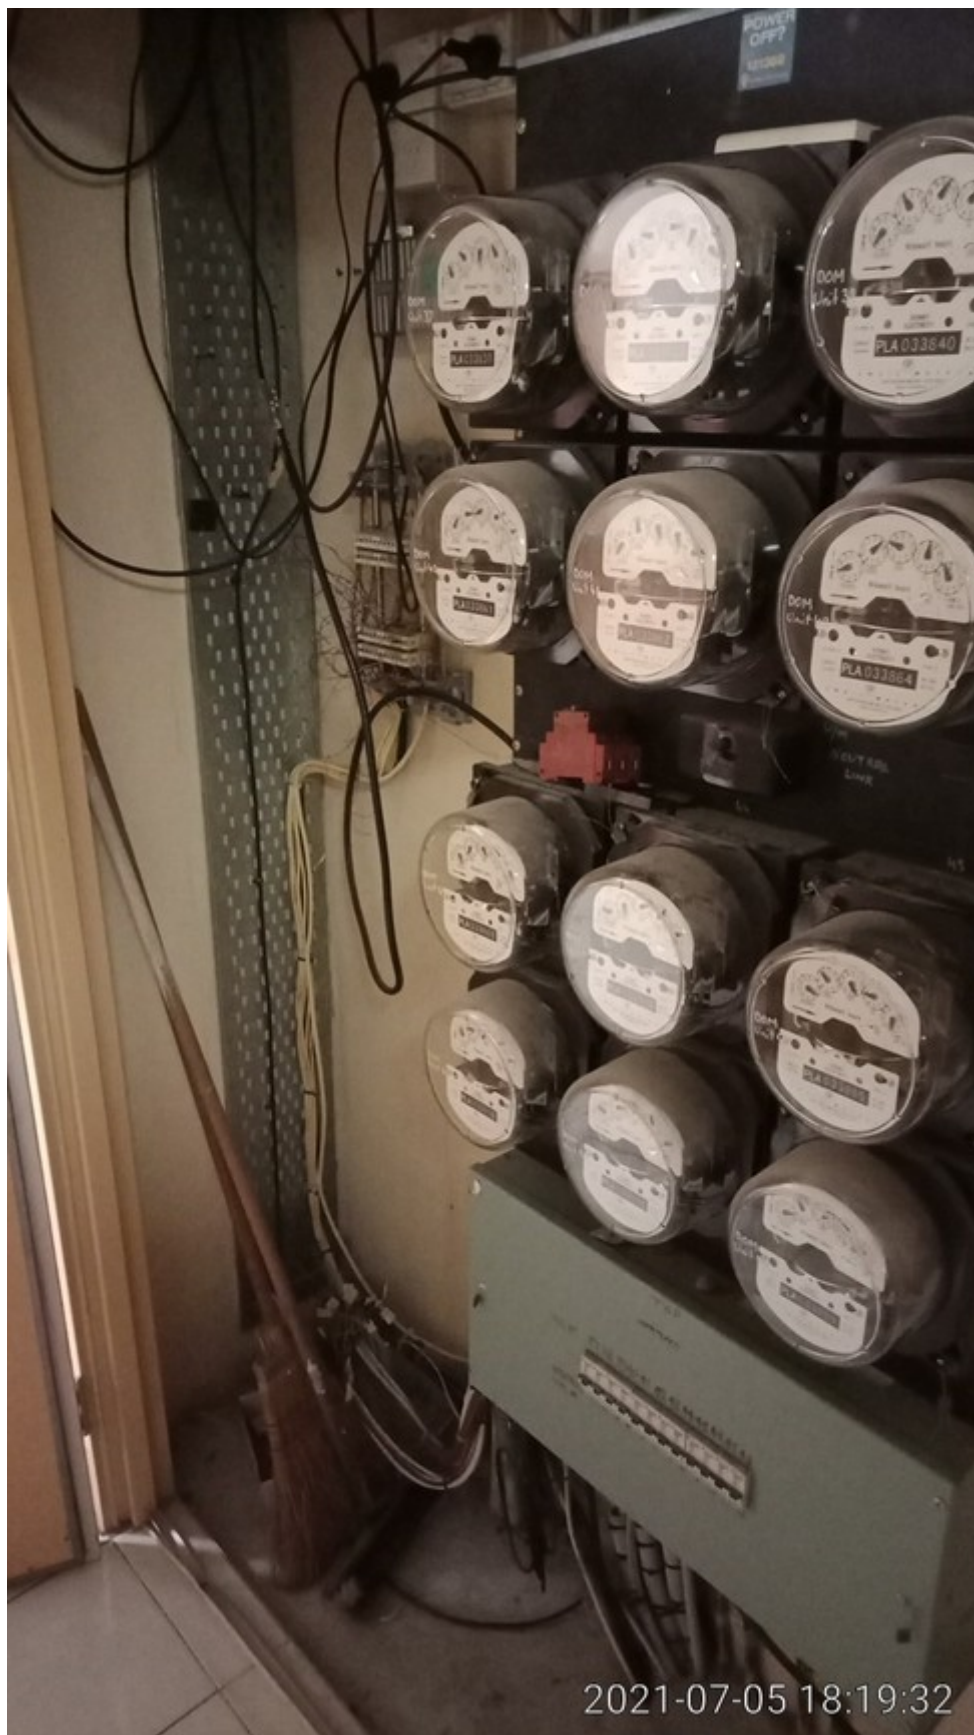
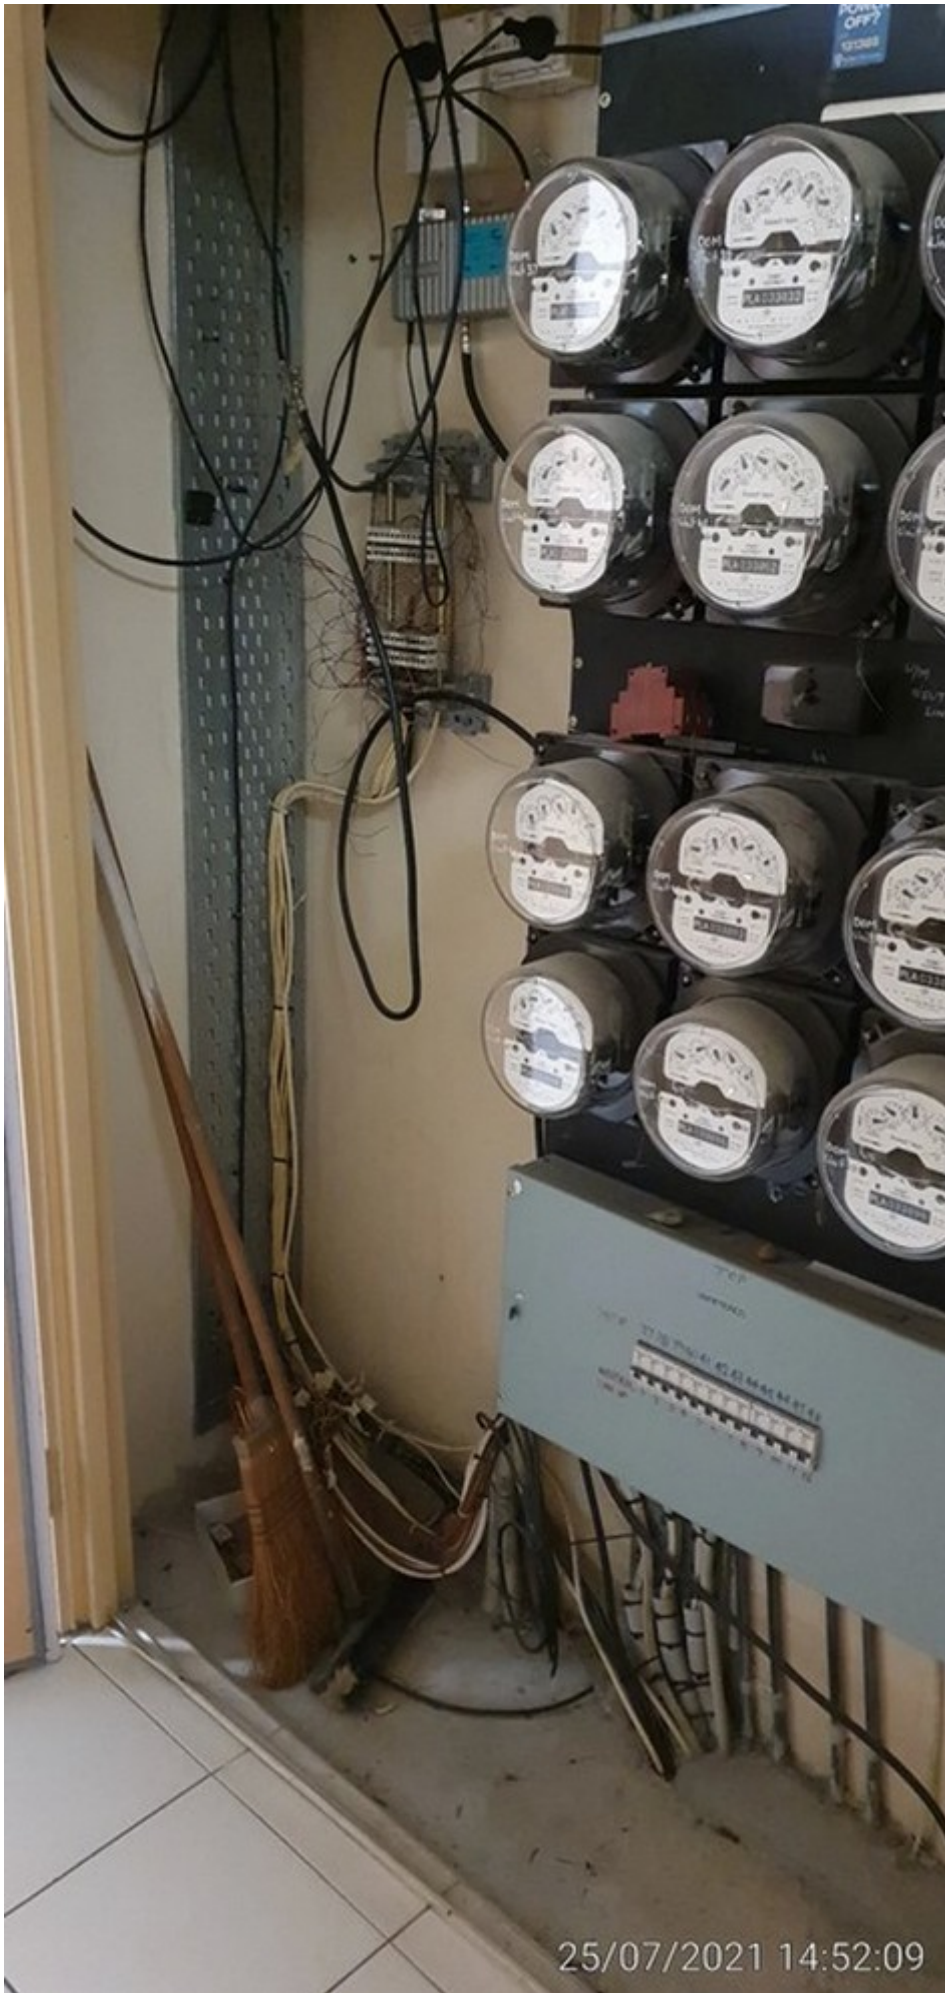
51 Cleaning equipment kept in telecom and electrical cabinet on level 7 Block B permanently
