Major upgrades on 26 townhouses in amount of \$92,950.00 in 2017 without evidence of work done

1 SP52948 – Solicitor Adrian Mueller, on behalf of owners corporation, confirming that maintenance of common property is compulsory and that some strata files are missing on 14th of November 2019

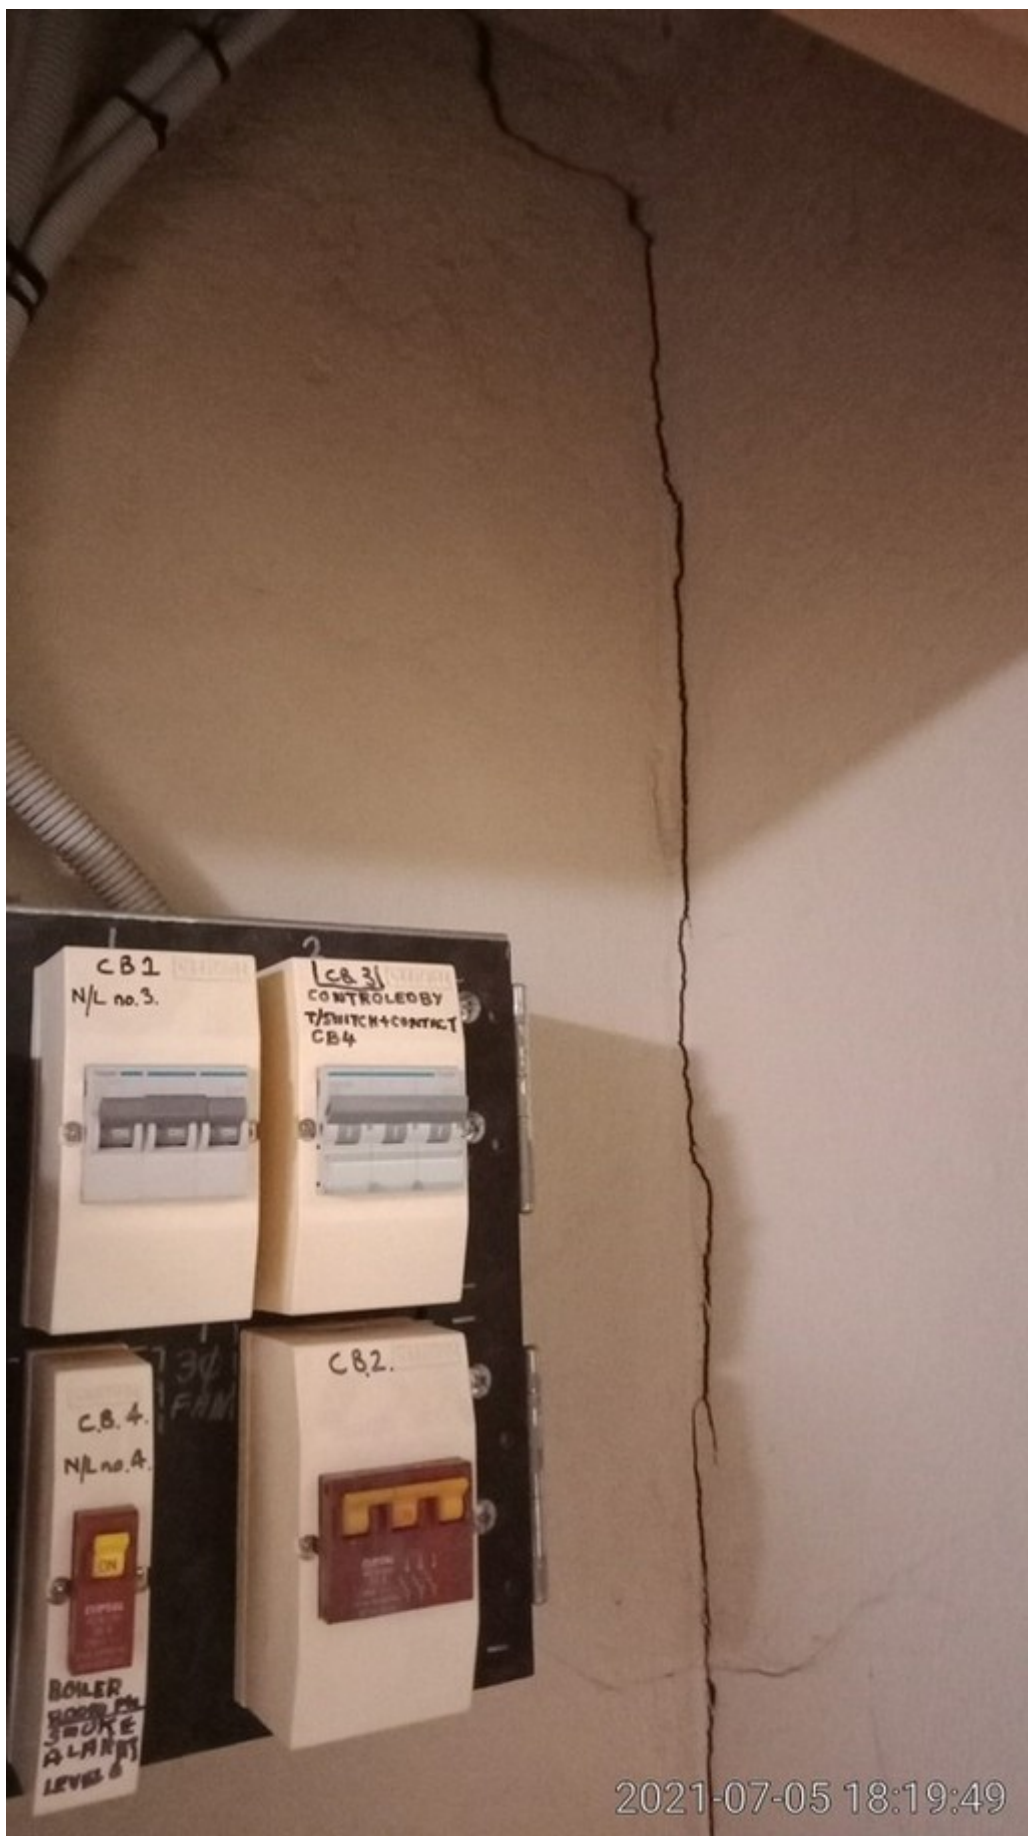
The wall inside the cabinet needs some repairs:

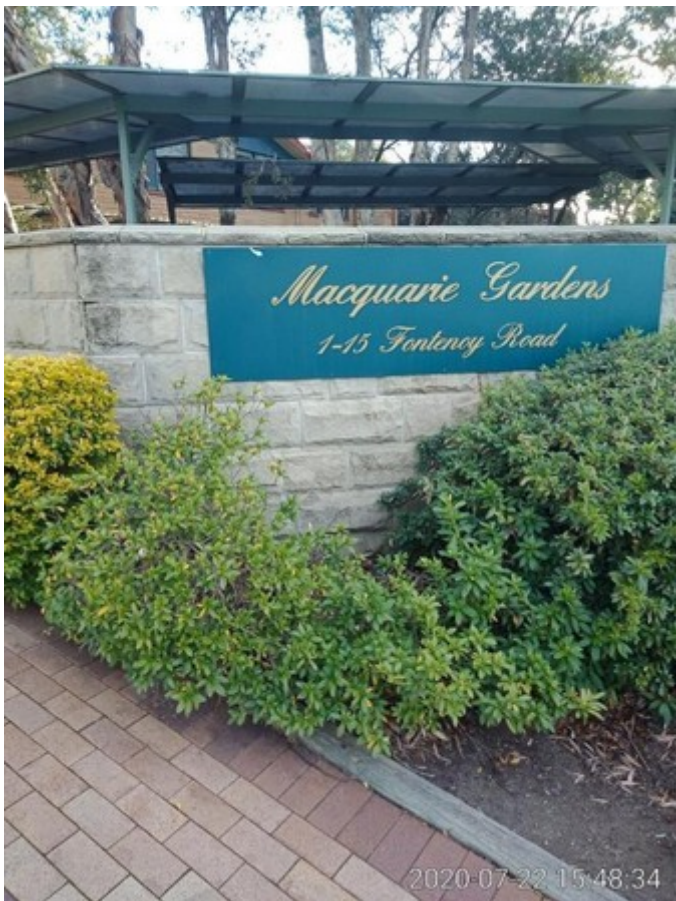
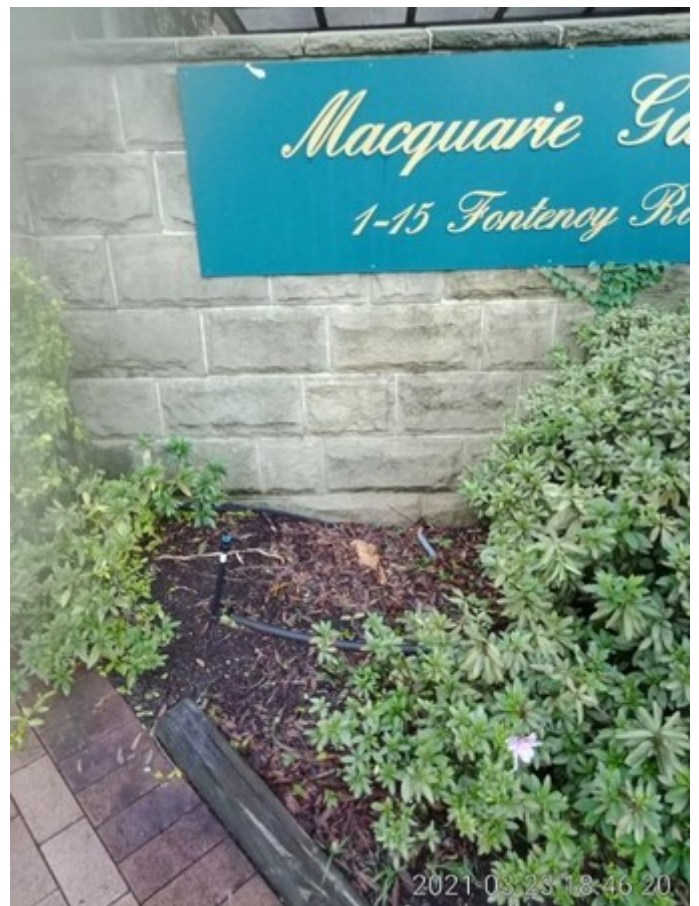
These shrubs are missing/dying for several years.

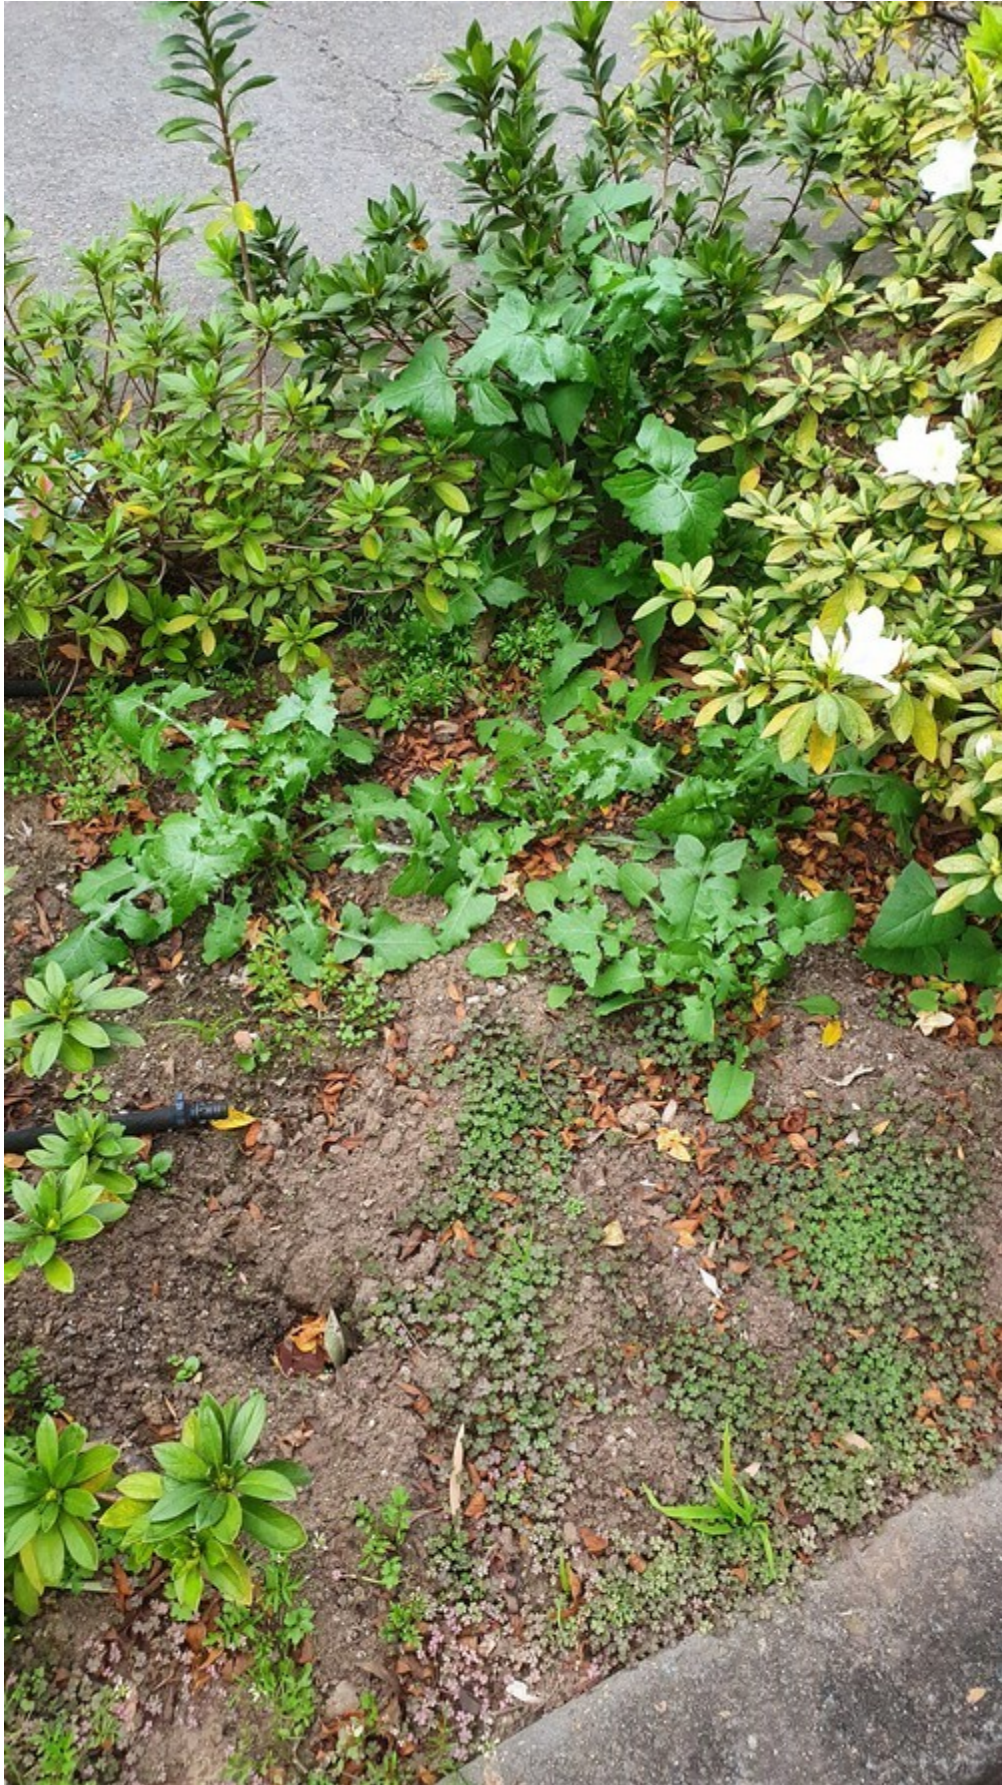
On same day, 28 July 2021, middle section of garden at the entrance of the complex is still missing lot of plans, has no mulching, and there is lot of weeds:

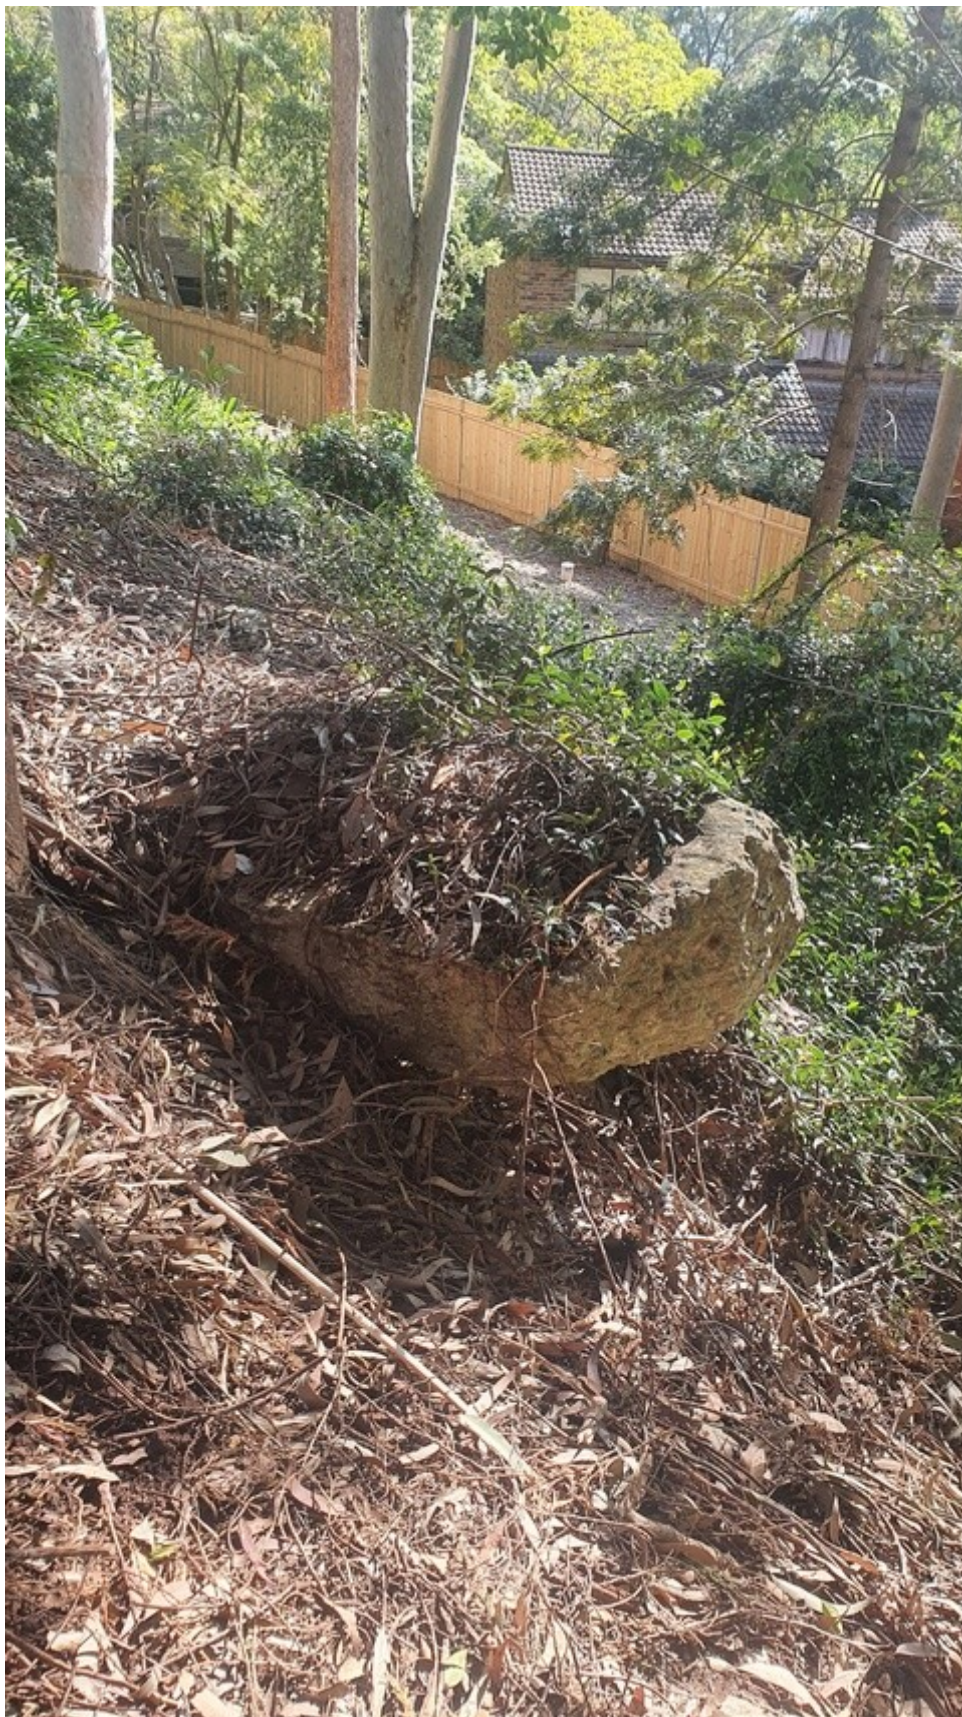
54 Large piece of concrete slab at risk of rolling down eroded soil behind townhouses – unattended for more than seven years as of 1st of October 2021

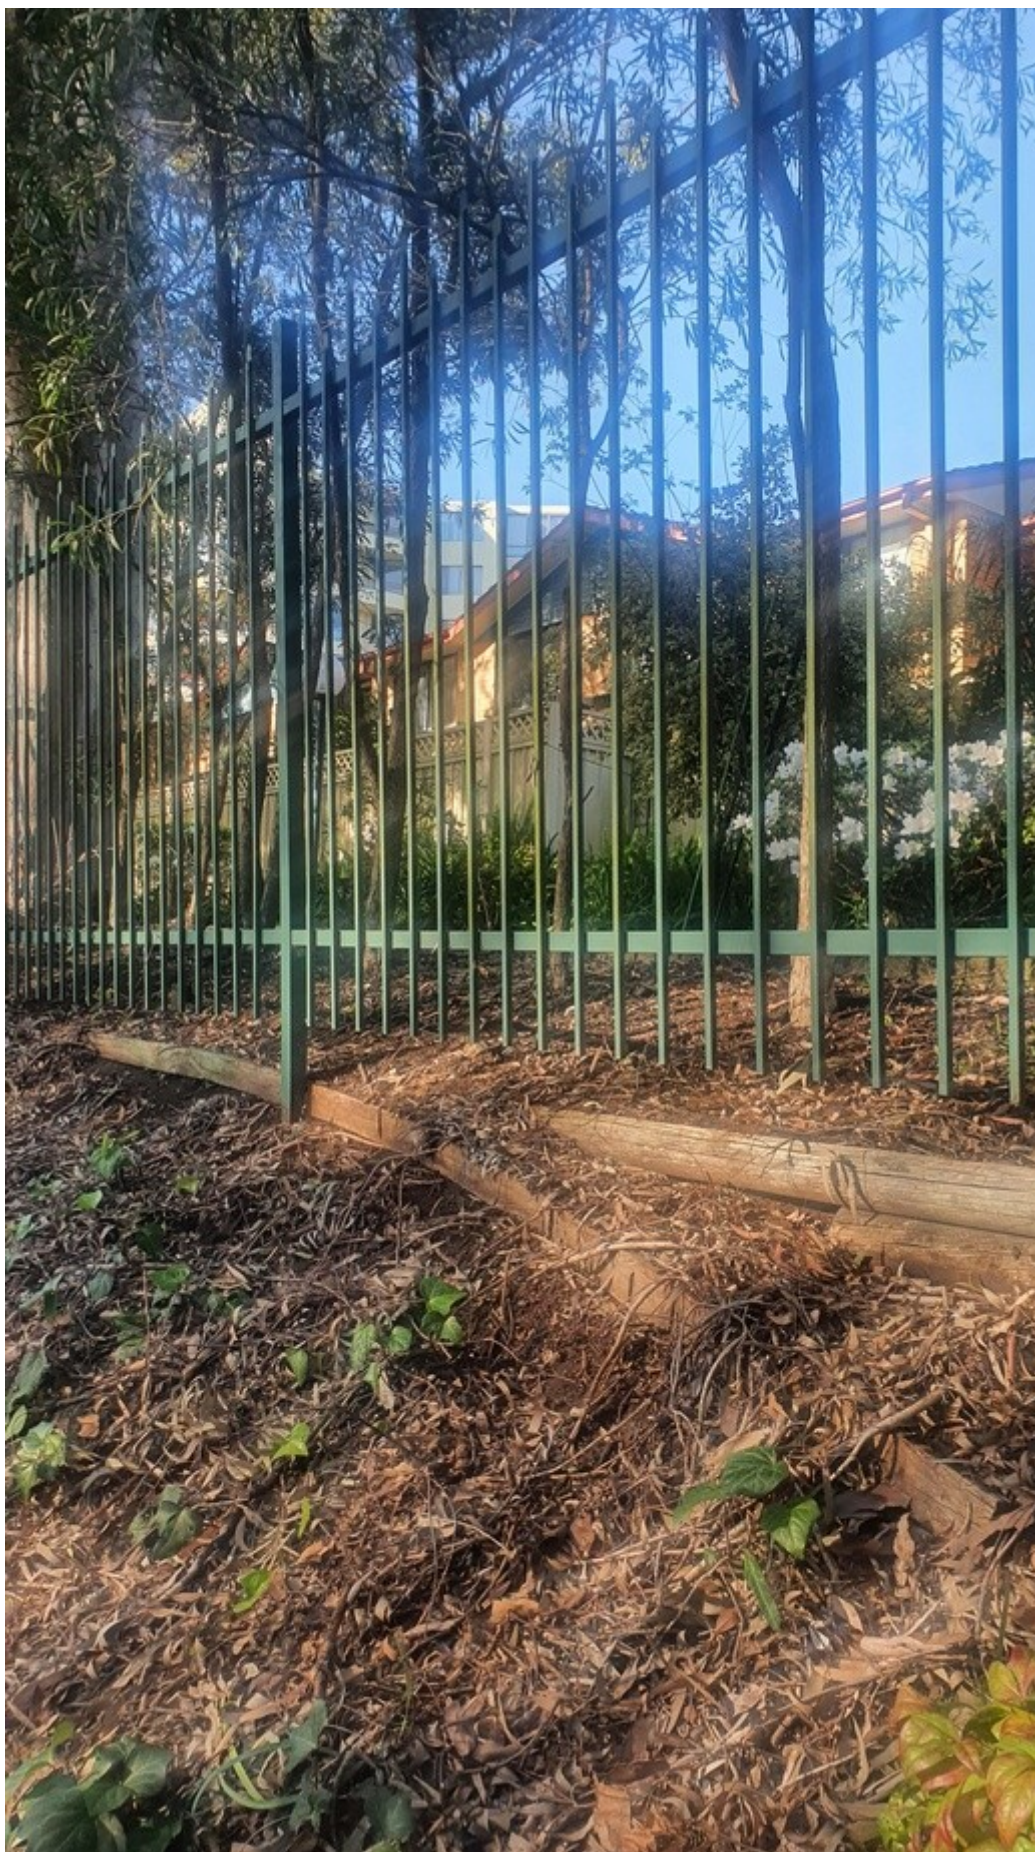
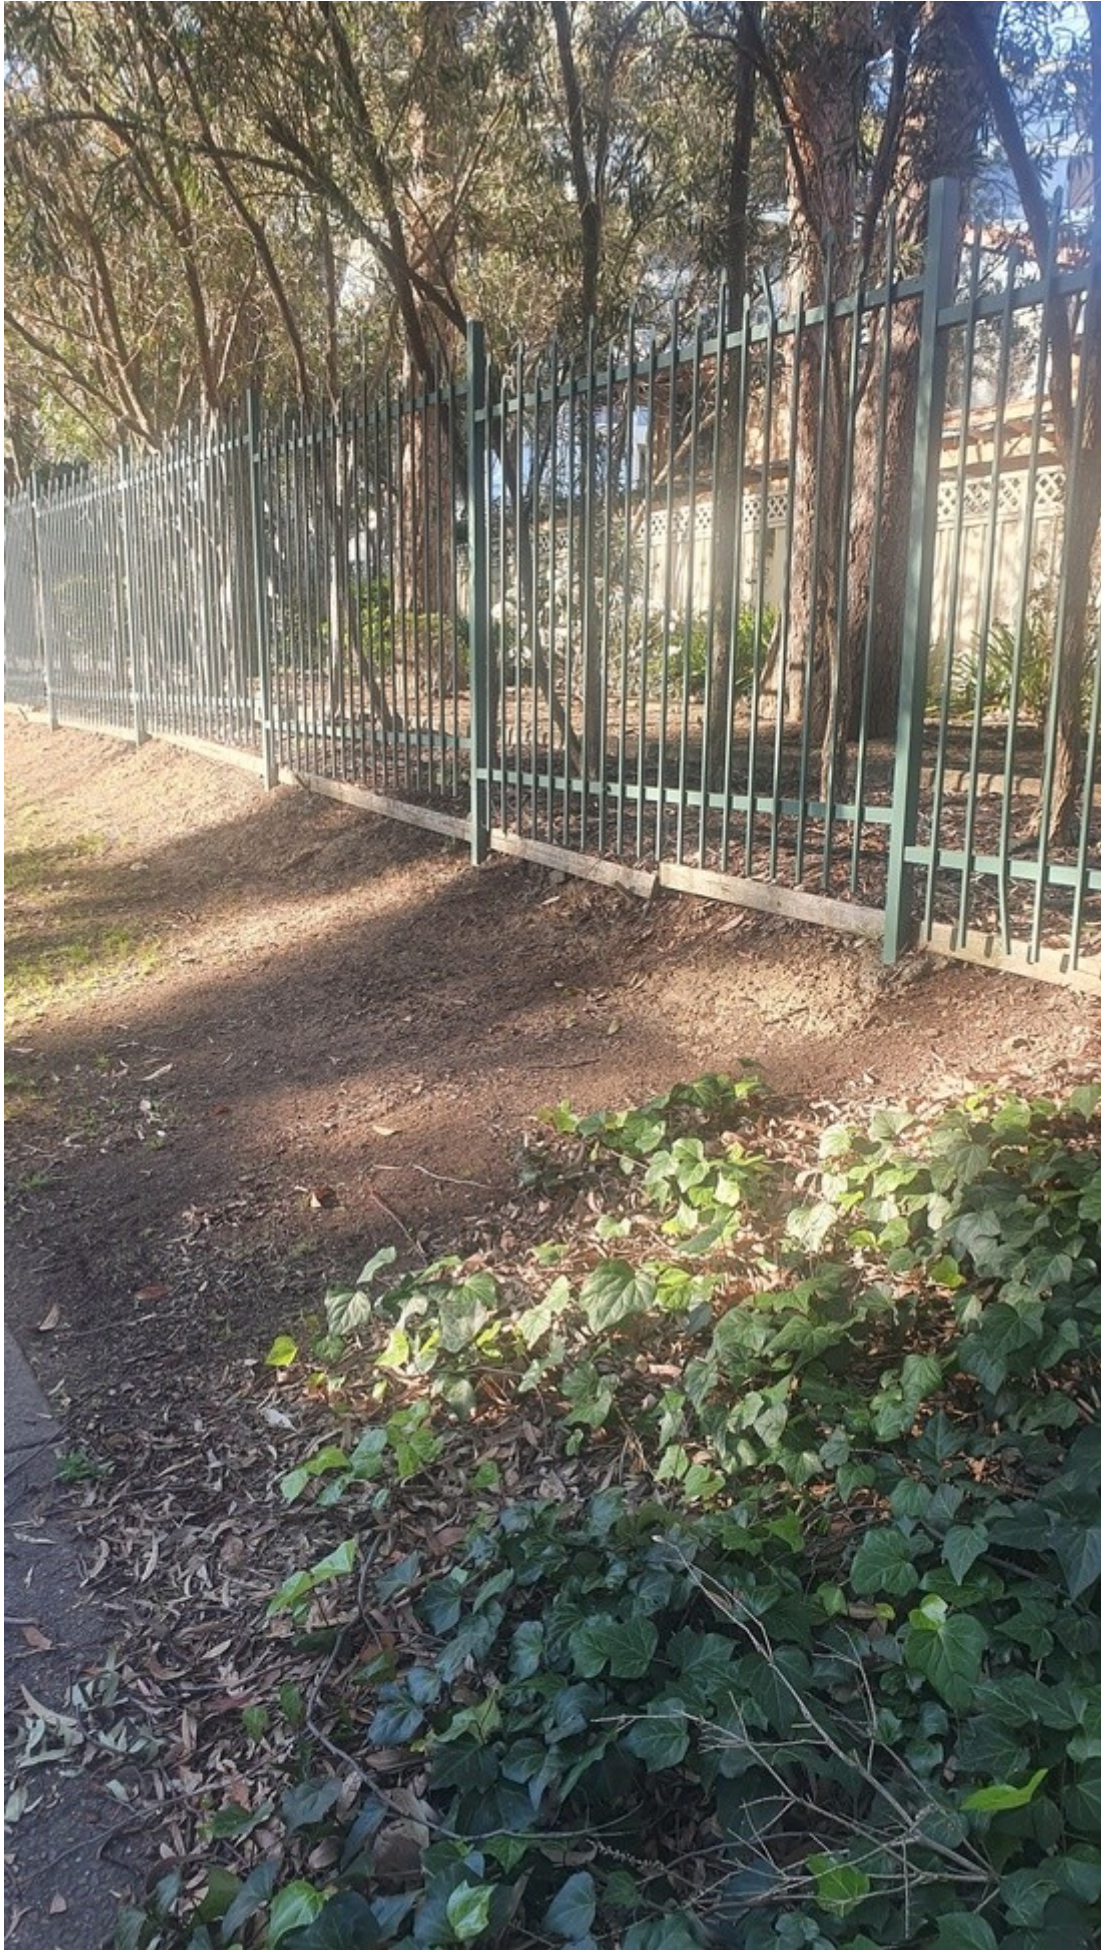
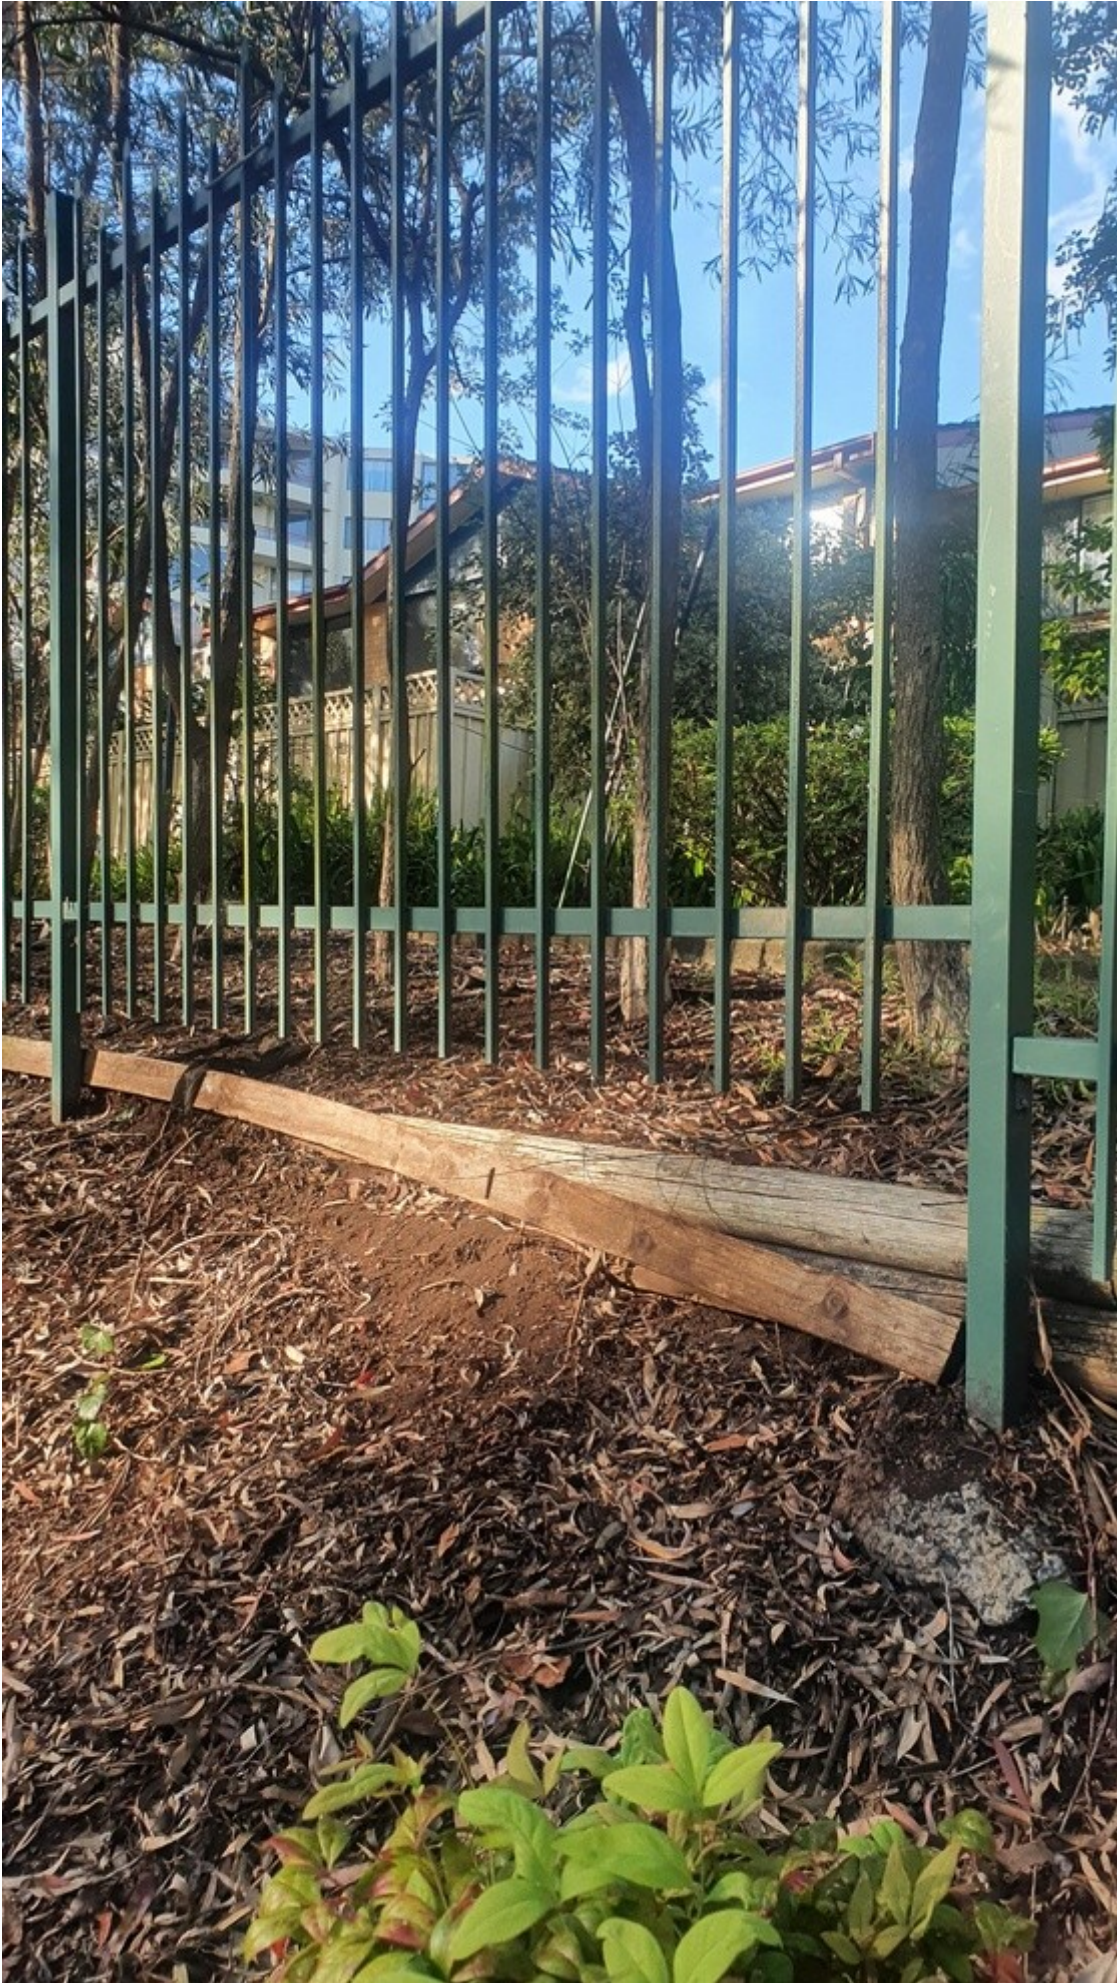
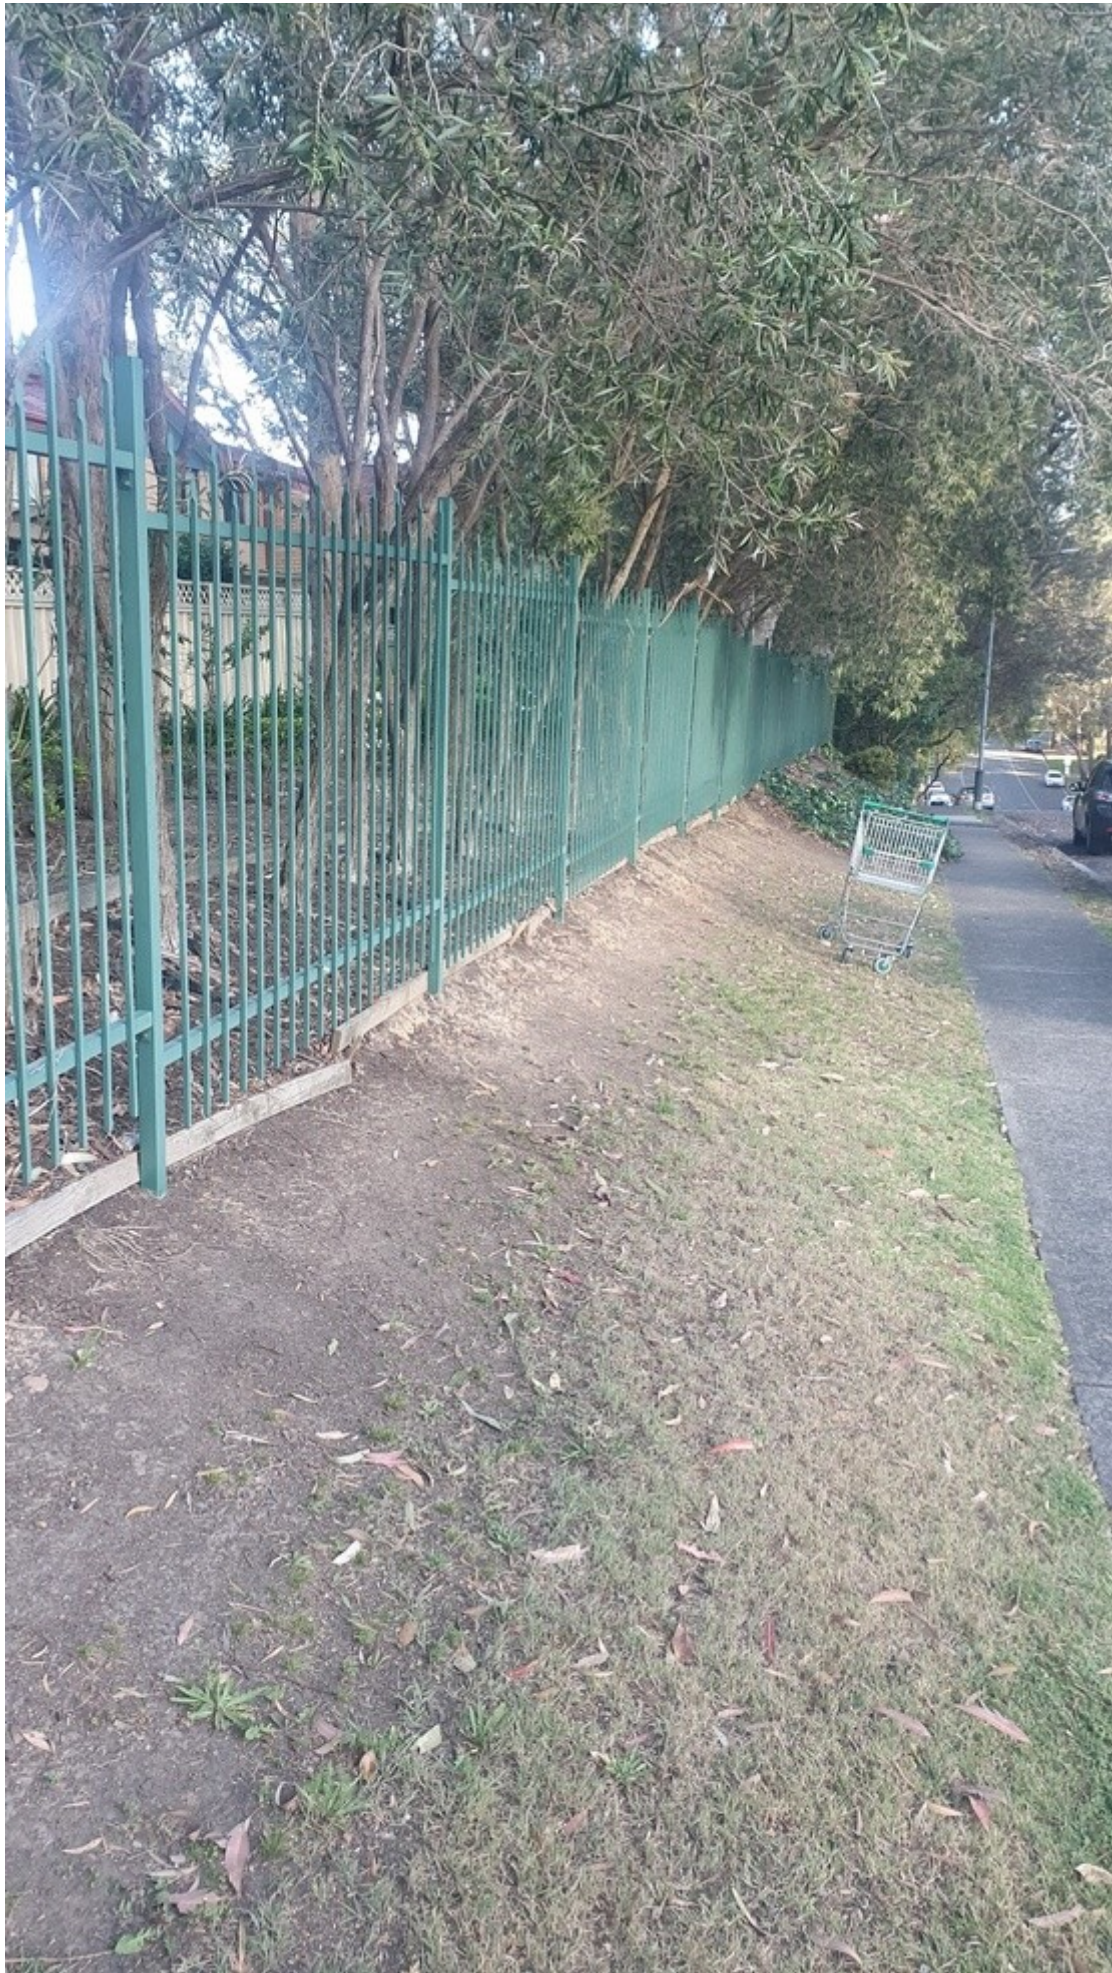
55 Eroded soil and fence in need of repairs towards Fontenoy Road as of 1st of October 2021
