Major upgrades on 26 townhouses in amount of \$92,950.00 in 2017 without evidence of work done

This document lists just some of the problems in the complex that can cause injury, health problems, or even death in dire circumstances.

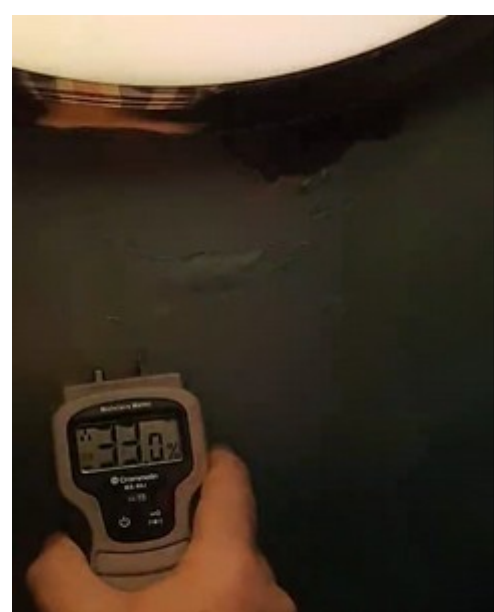
11 Lot 158 water leaks near electrical installation (lighting) on ceiling in sun-room

Photos take in sunroom of Lot 158 on 11th of May 2021:

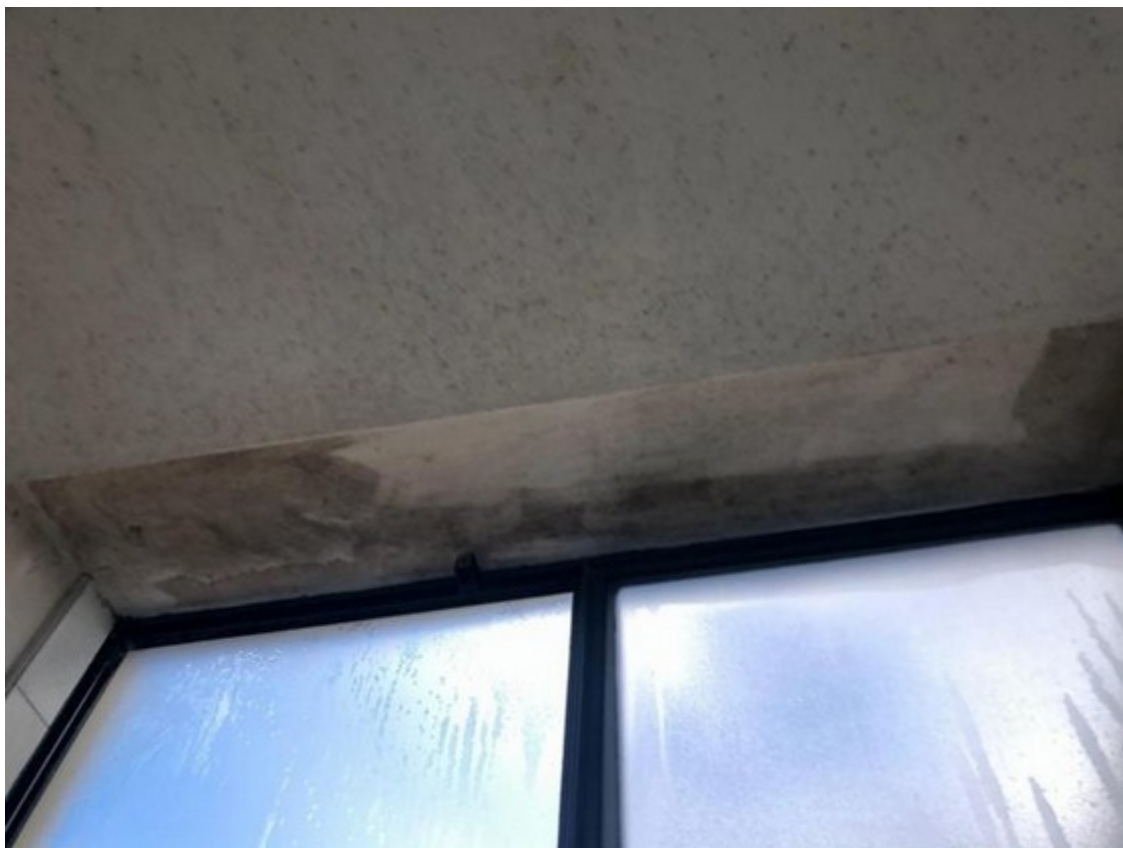
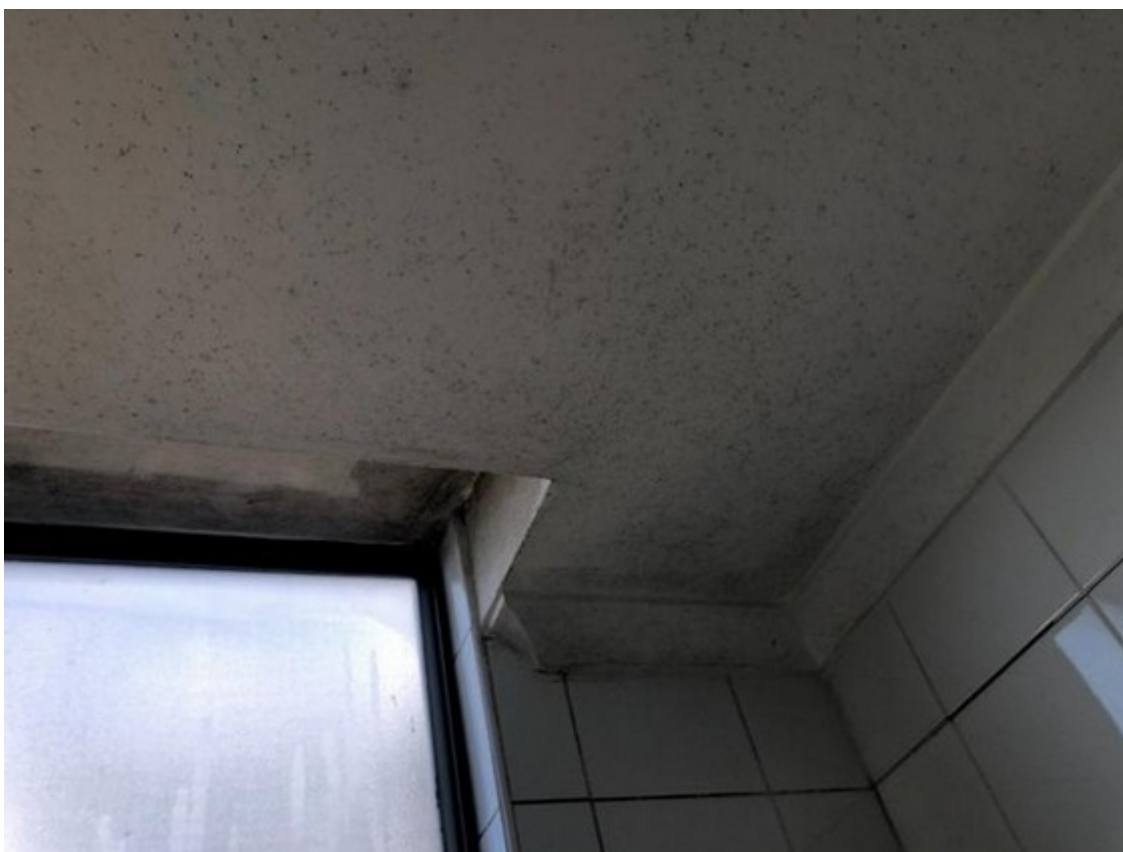
13 Lot 43 poor ventilation in bathrooms and increased health and safety risks, as reported in June 2020

On 13th of June 2020, Lot 158 documented problems with water leaks and dampness in bathrooms of Lot 43 (top floor in Block B), which created not only serious health risks, but also dangers of water entering electrical installations.

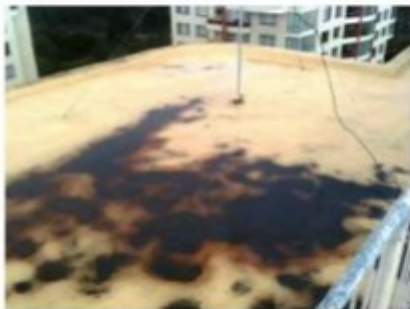
The falls to the drainage are insufficient and improving the existing falls should also be considered. The internal units were not inspected for any water penetration via the roof slab.

Standing water to flat roof deck, Block A

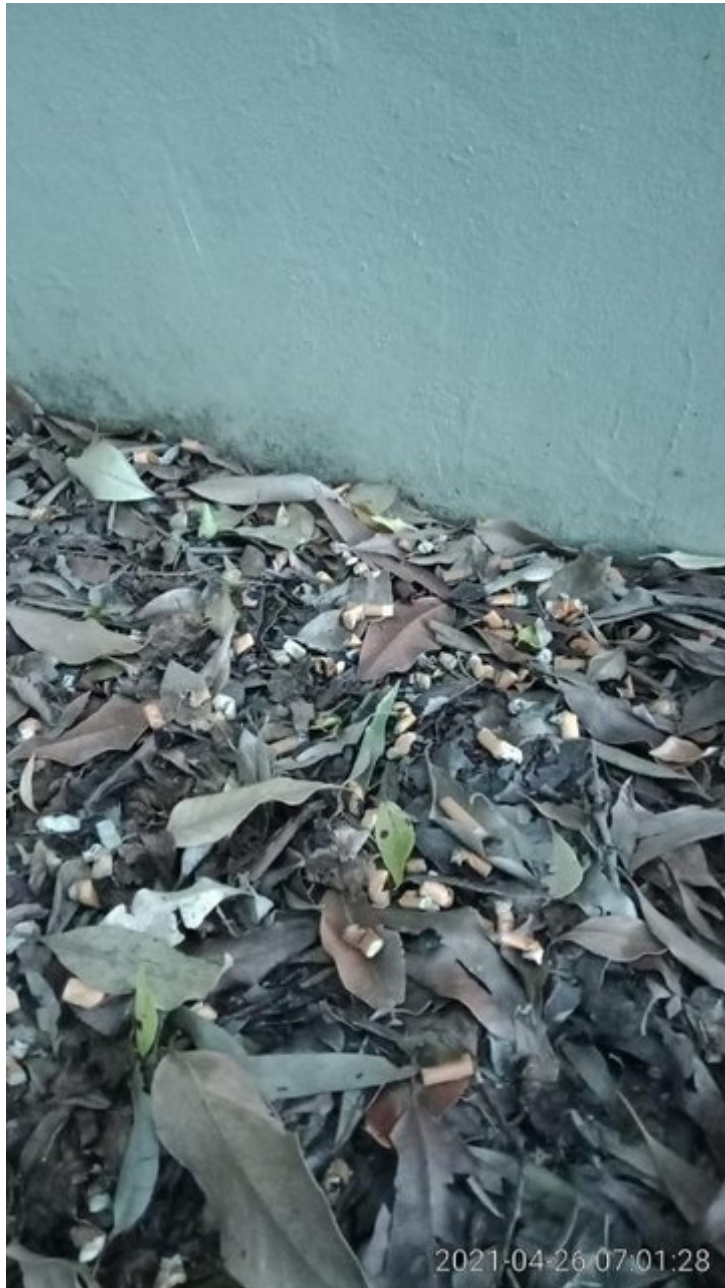
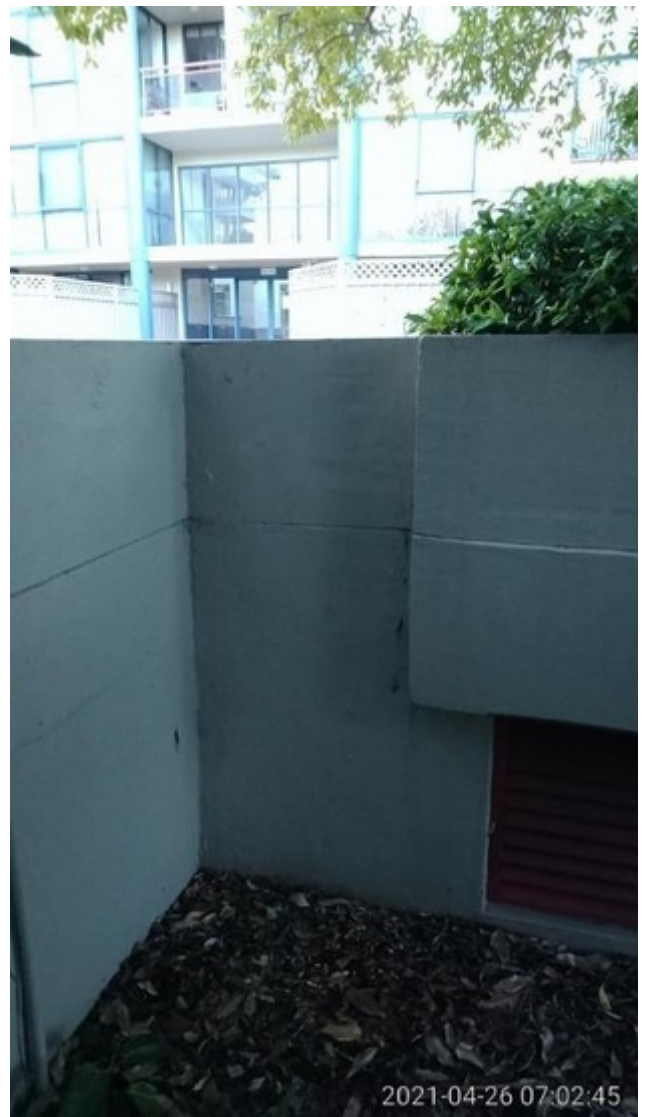
Garden area near Block D, flooded with cigarette butts and not cleaned. Apart from obvious pollution to the nature, dry leaves and branches can easily start the unintentional fire as well.

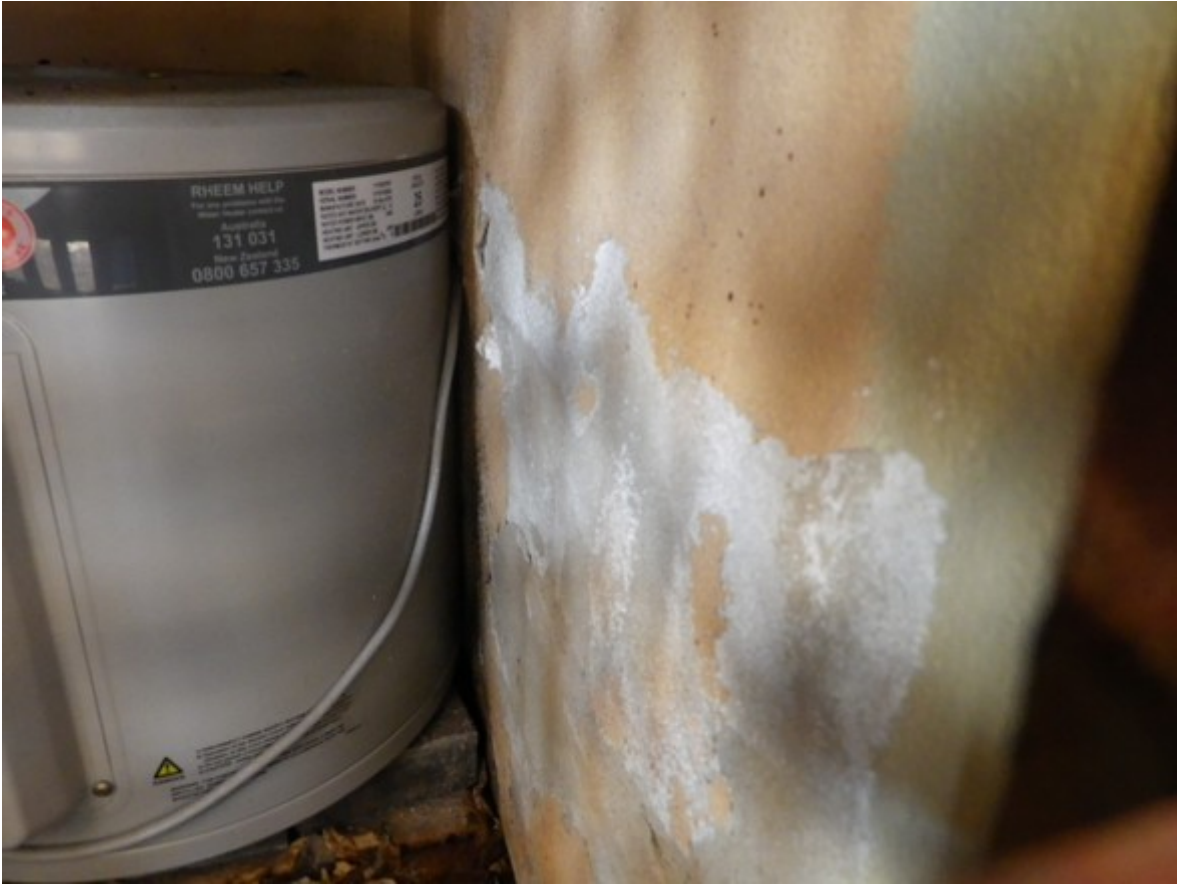
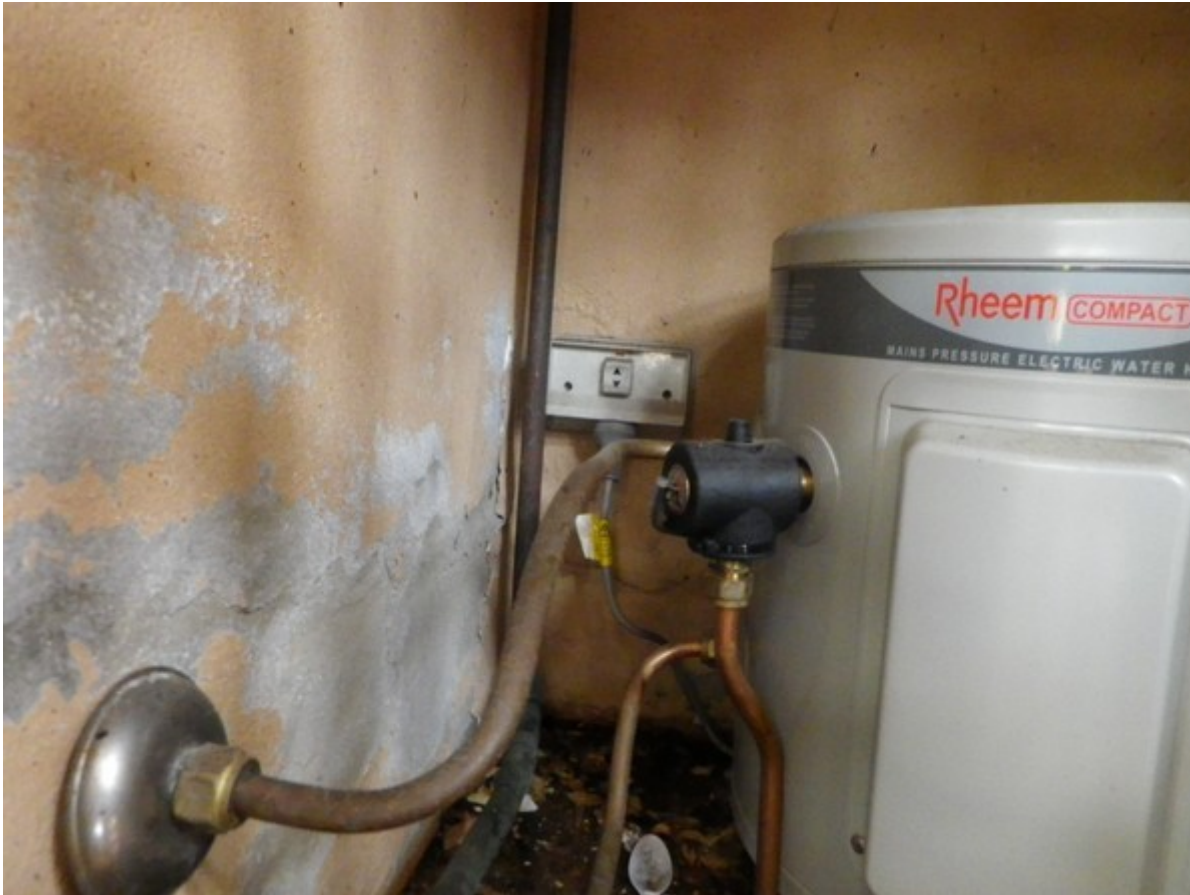
17 BBQ area below sink high fire safety risks for four years

For the last four years, ever since alleged major upgrades in the complex, the BBQ area has been repeatedly repainted, repaired, and allegedly "maintained with high quality of services without evidence of warranties". This was reported numerous times.

- a) Walls damaged by long-term water penetration and leaks,
- b) Piece of PVC pipe protruding through the wall,
- c) Rusted hoses,
- d) Rusted pipes,
- e) Potential for electrical hazards because water leakages and wall damages appear to be close to wall socket,
- f) Dry leaves could create fire hazard,
- g) Water wastage?

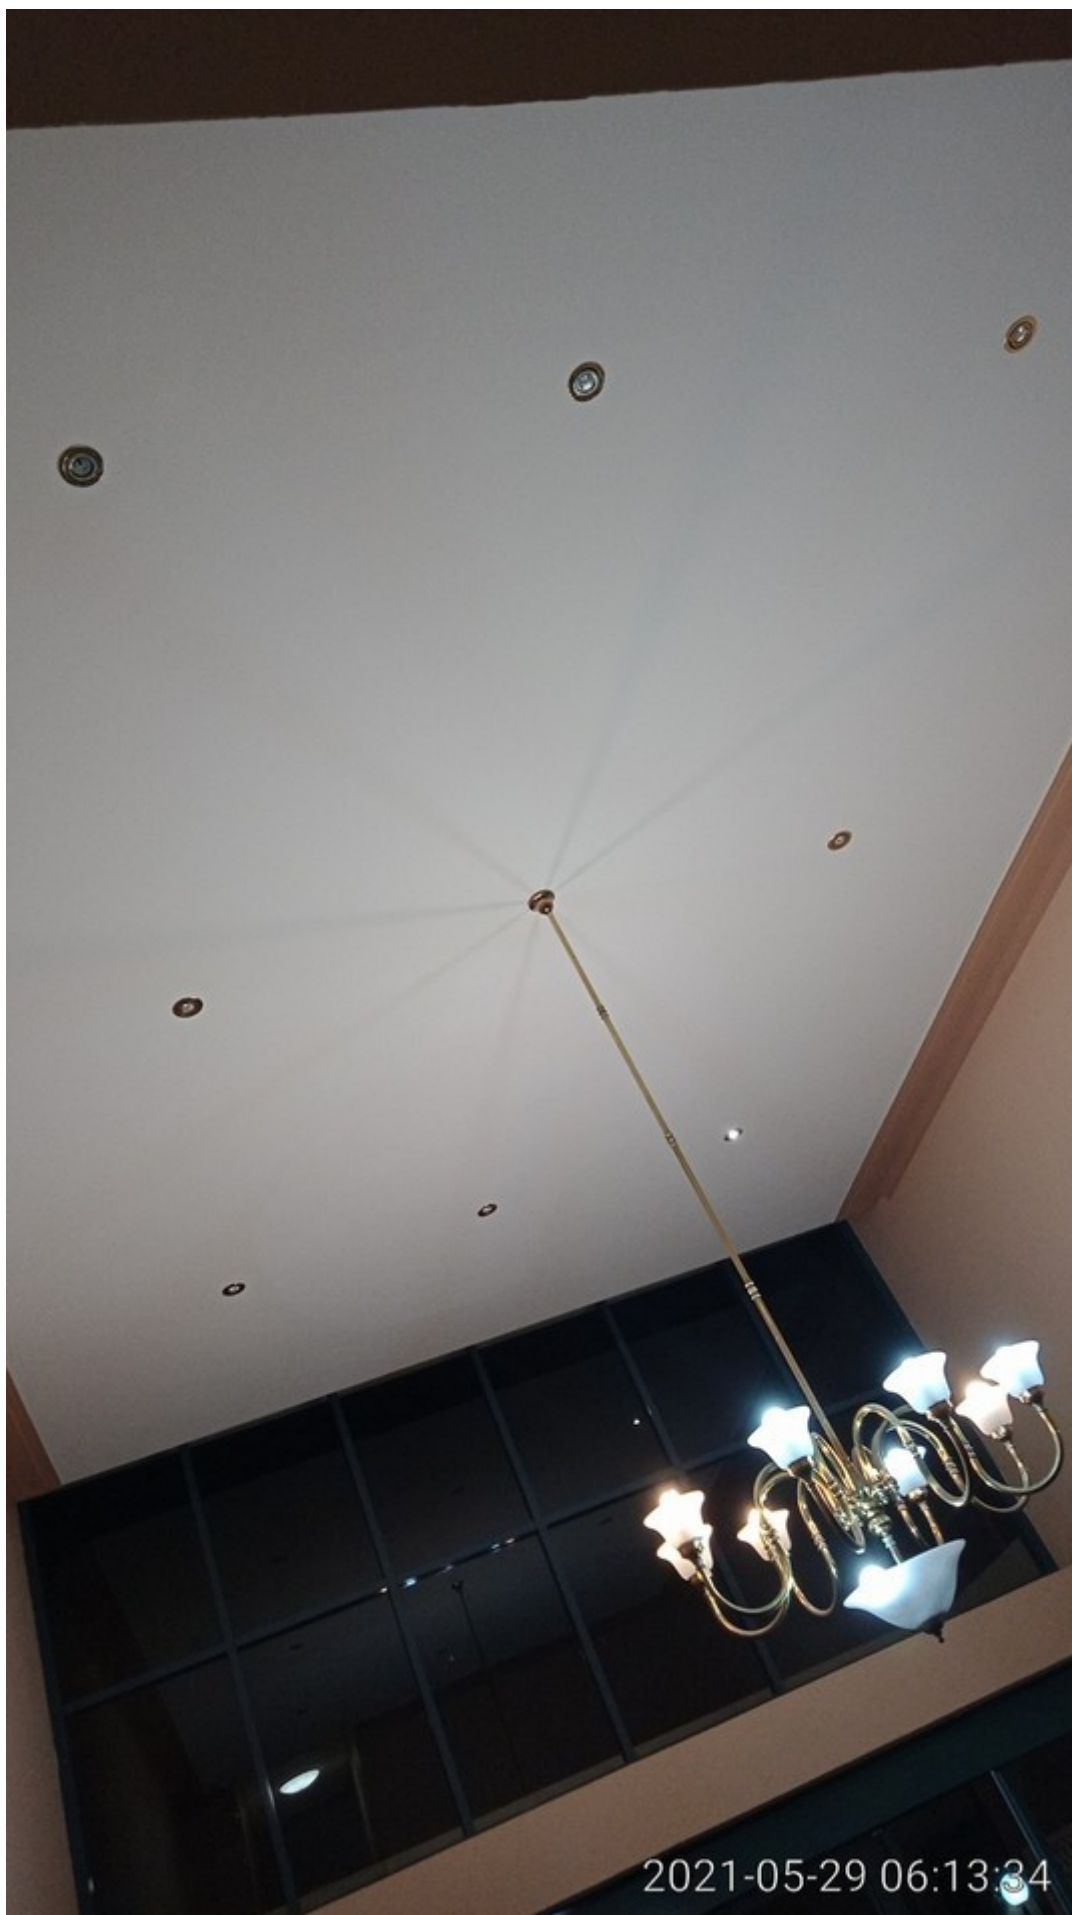
b) Block B, none of eight down-lights operational

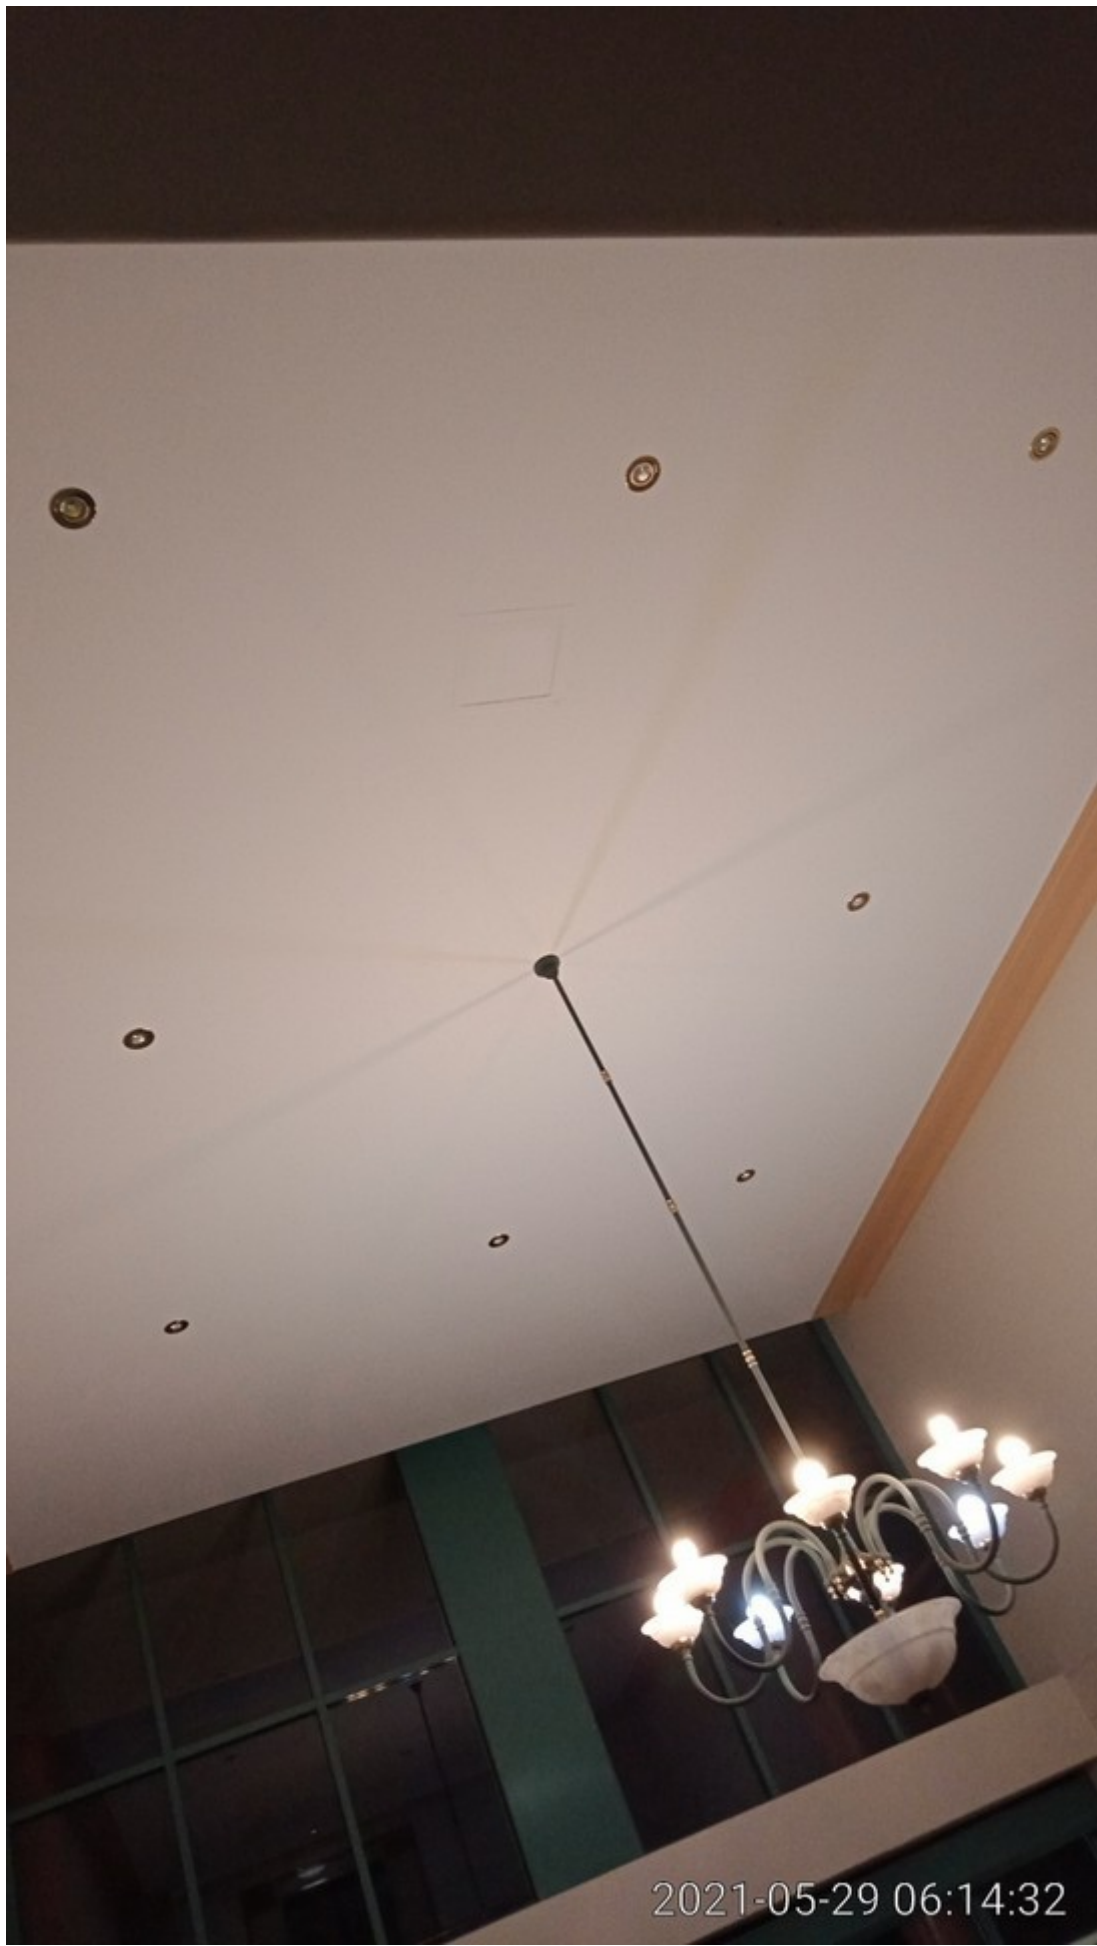
c) Block C, none of eight down-lights operational

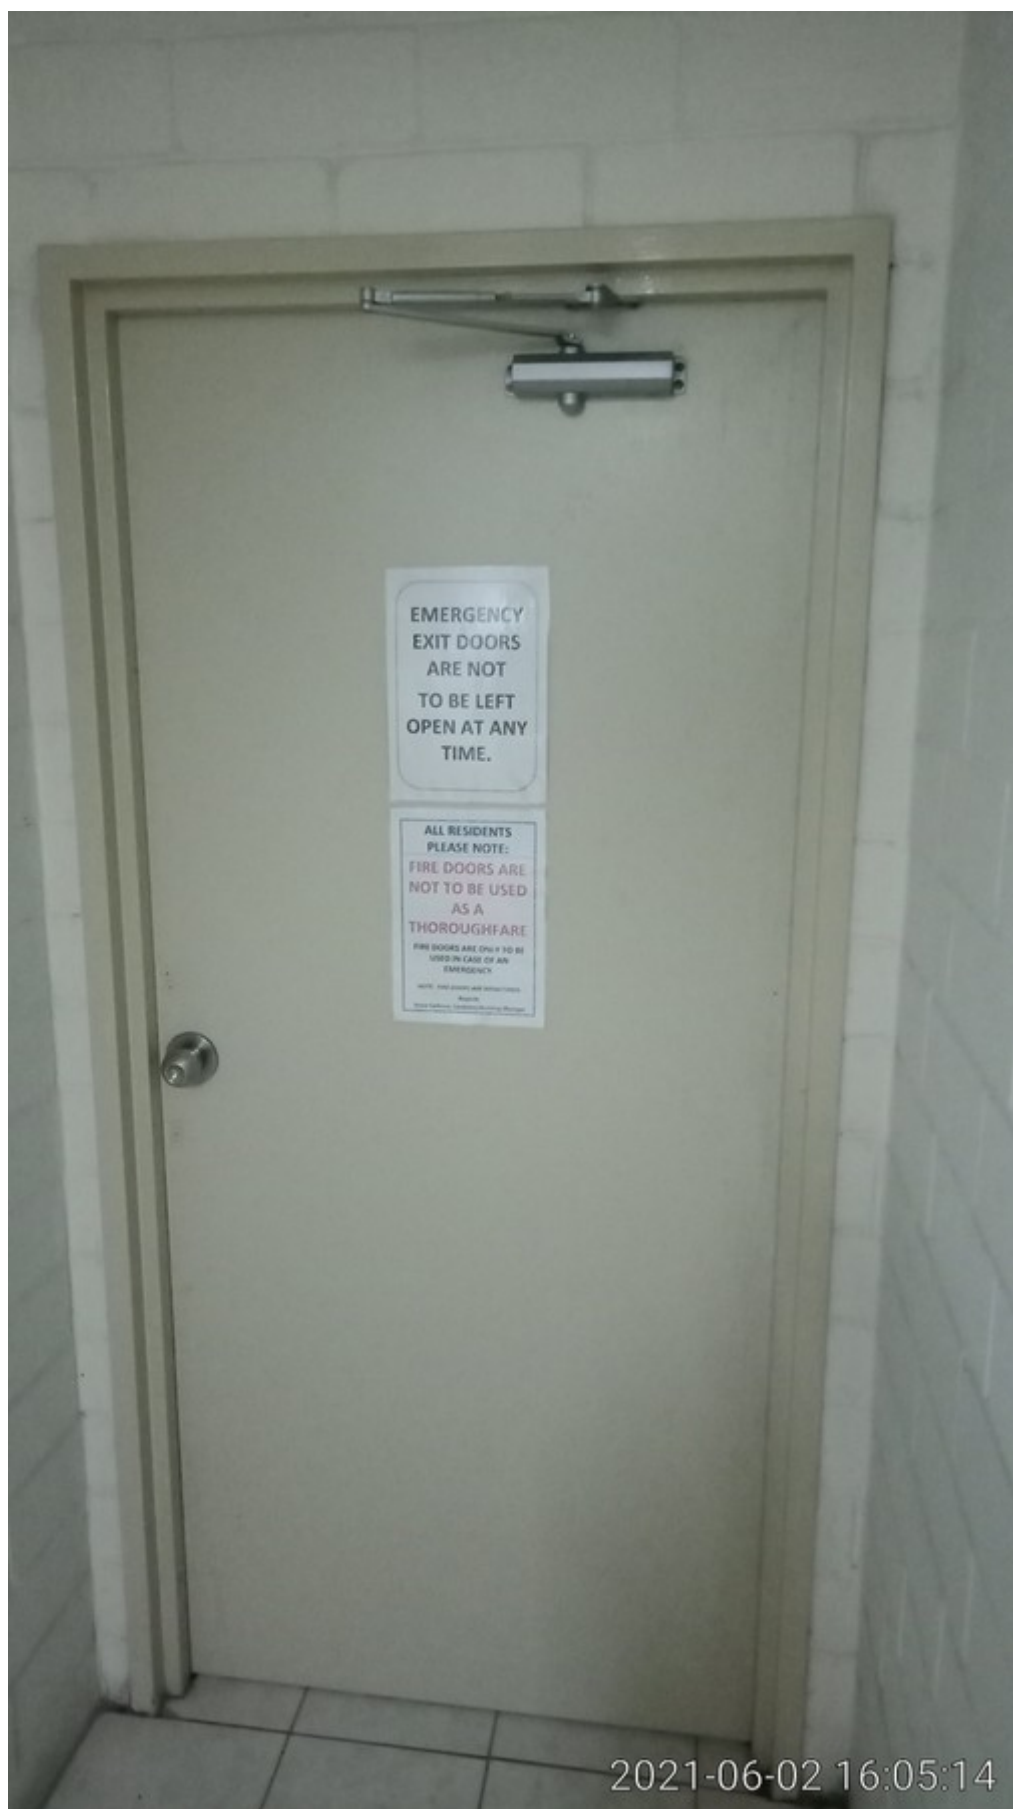
a) Block A, with notice about thoroughfare and exit

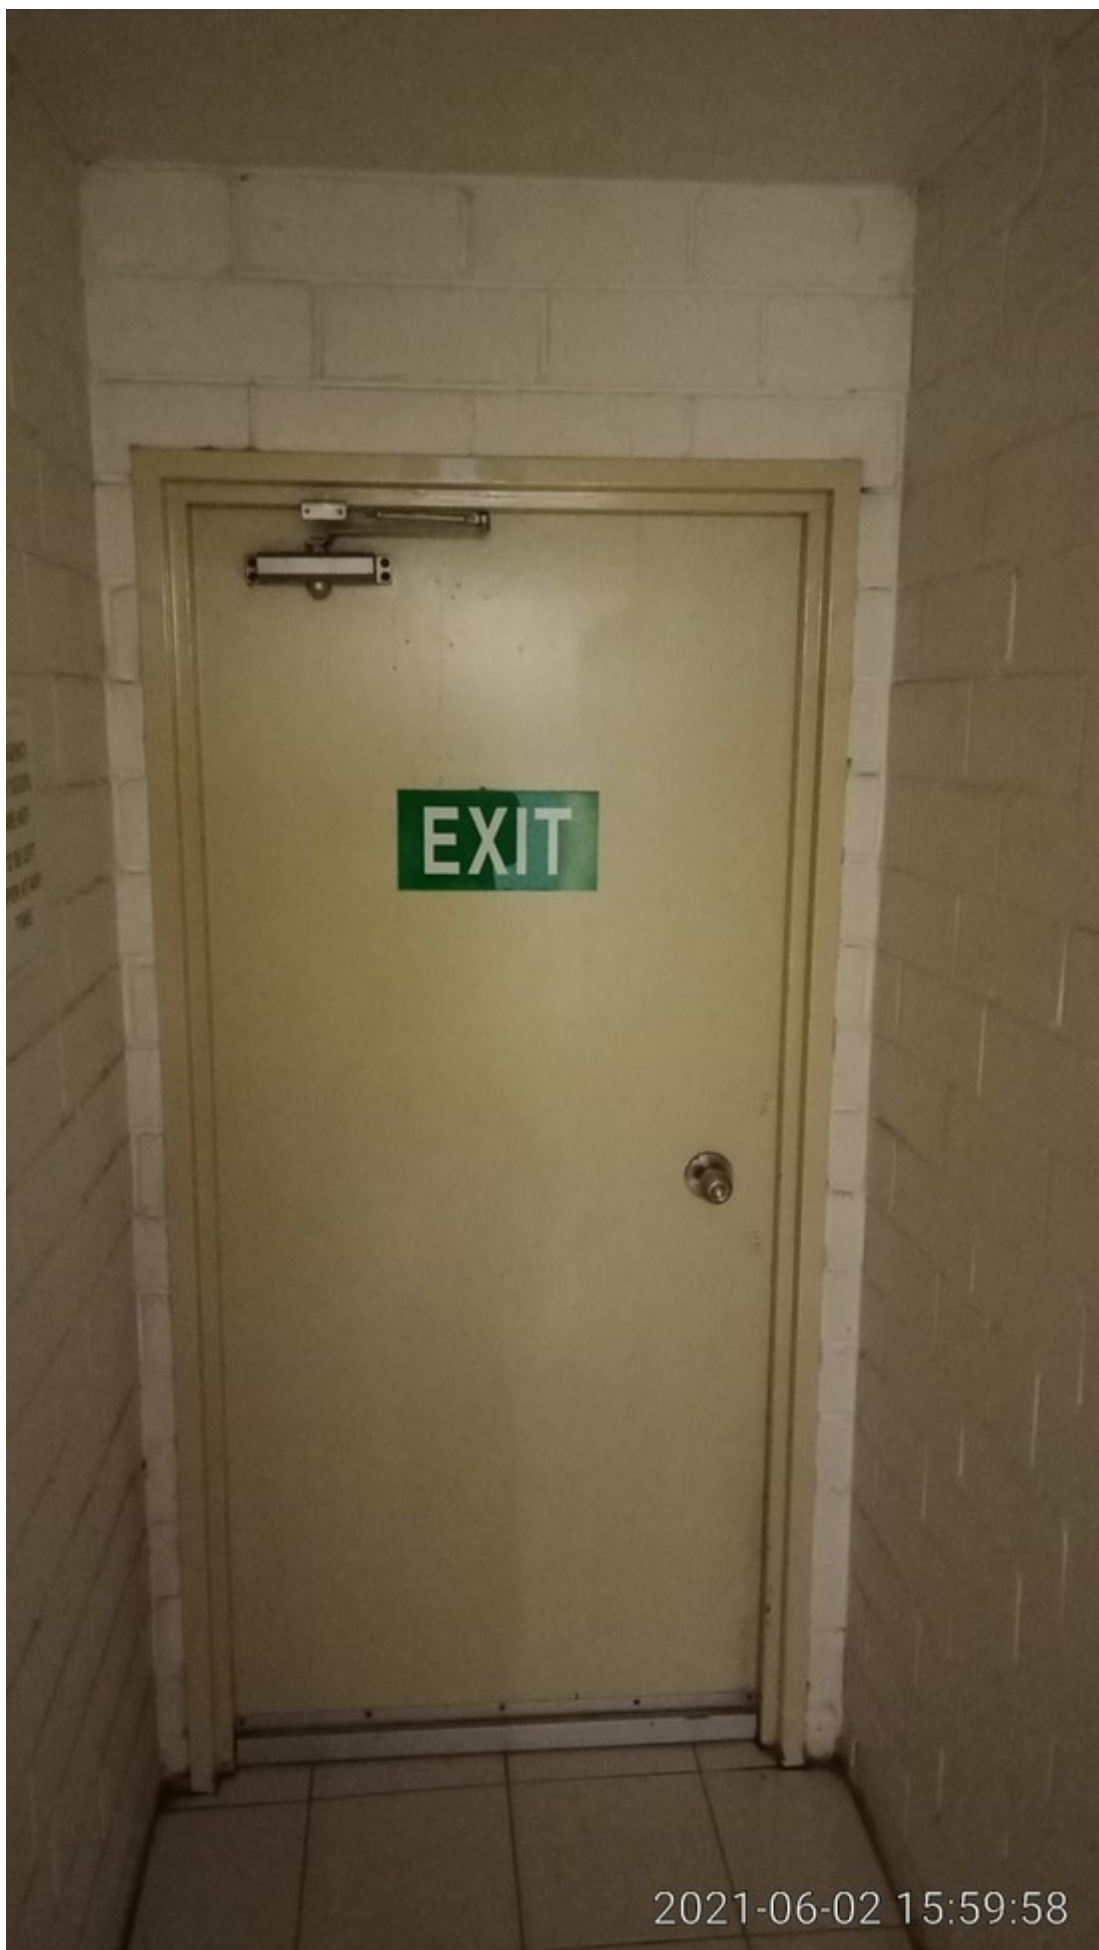
b) Block B, without signage for thoroughfare and keeping the door open

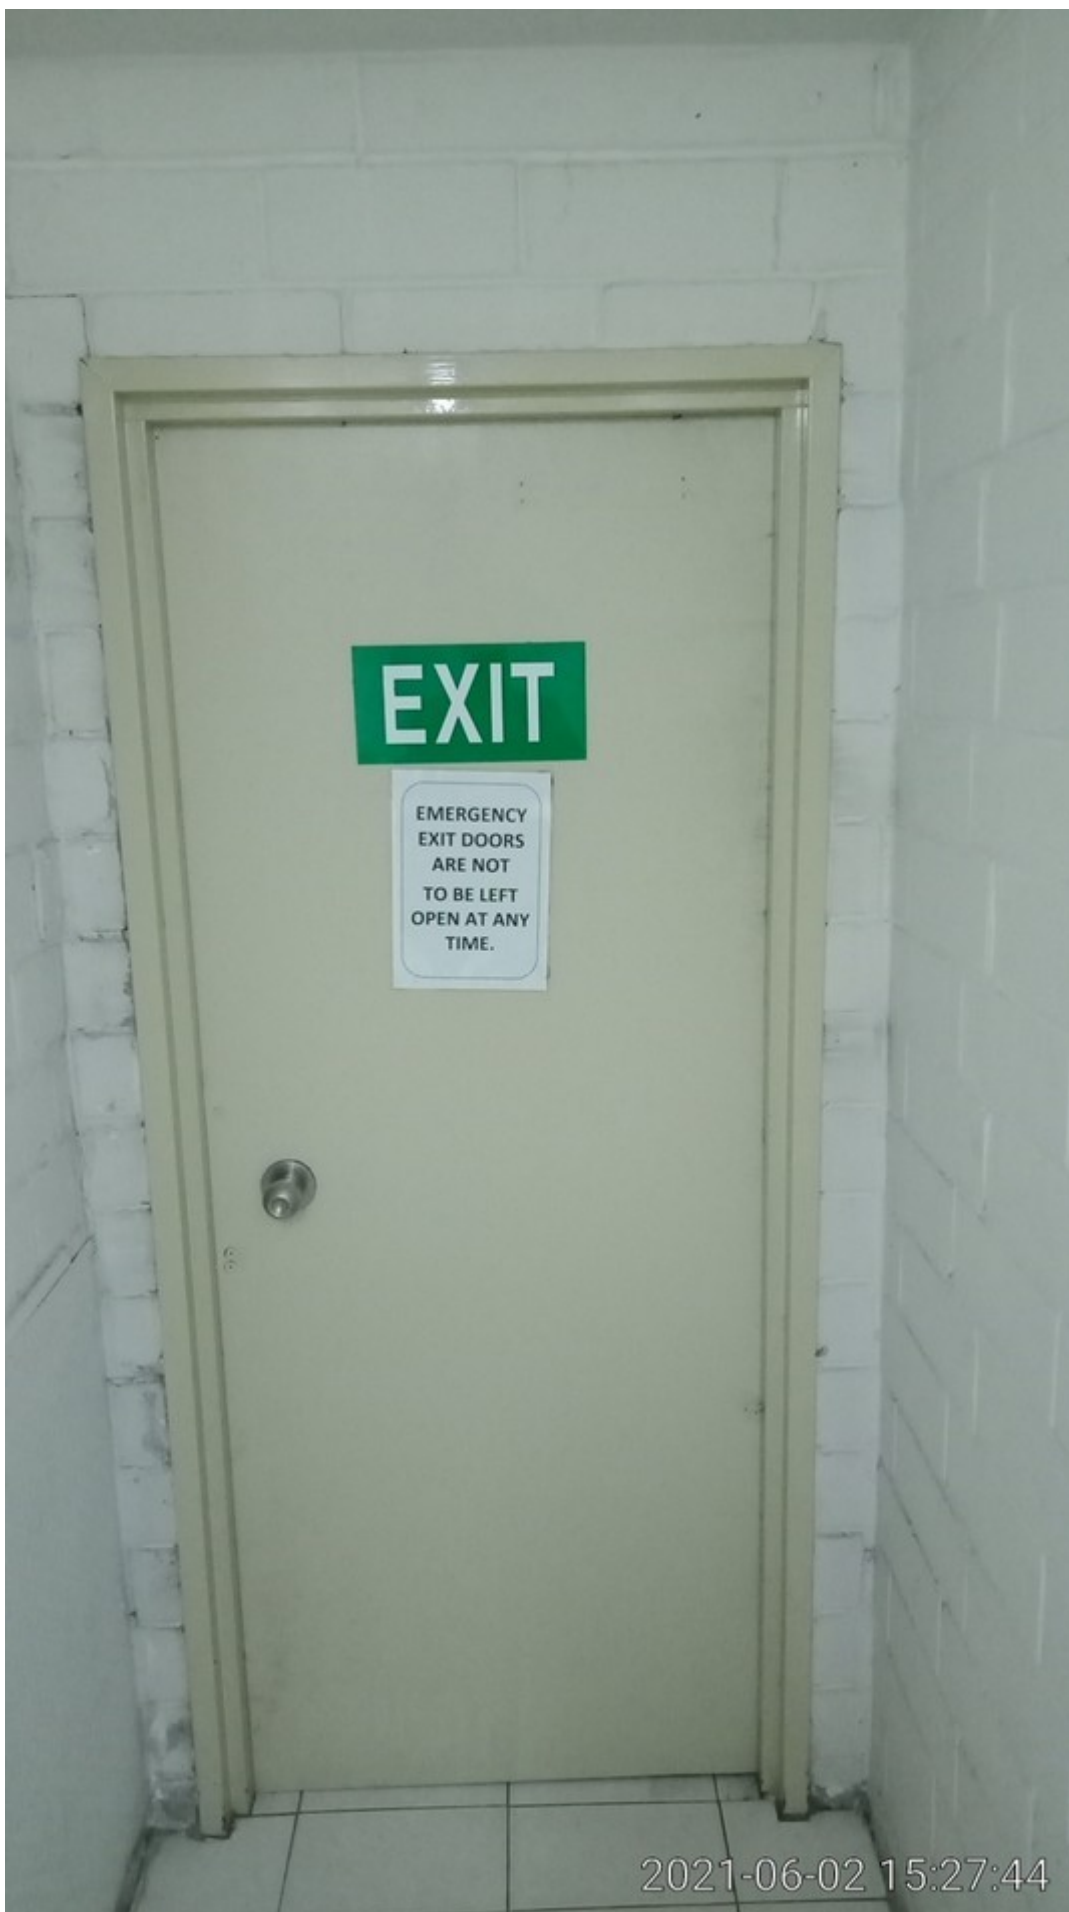
c) Block C, without notice for thoroughfare

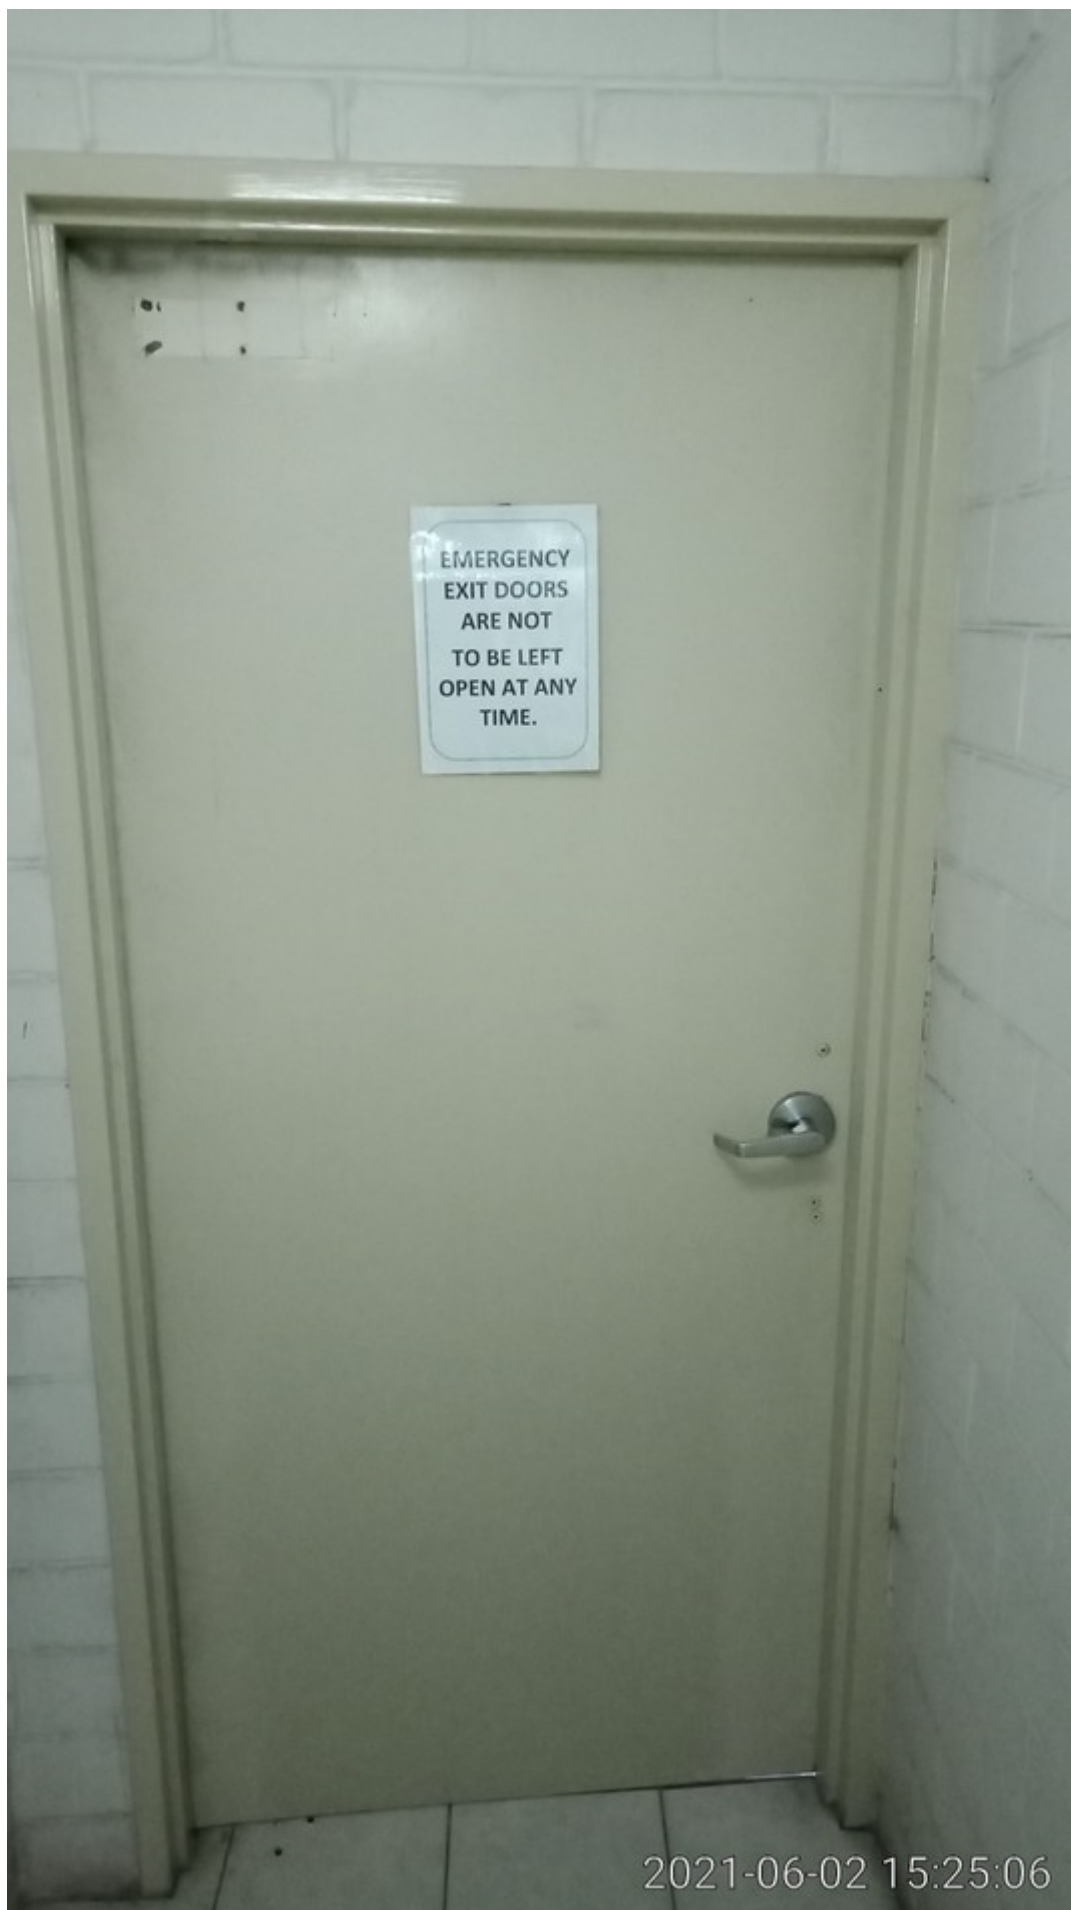
d) Block D, without signage for thoroughfare and exit

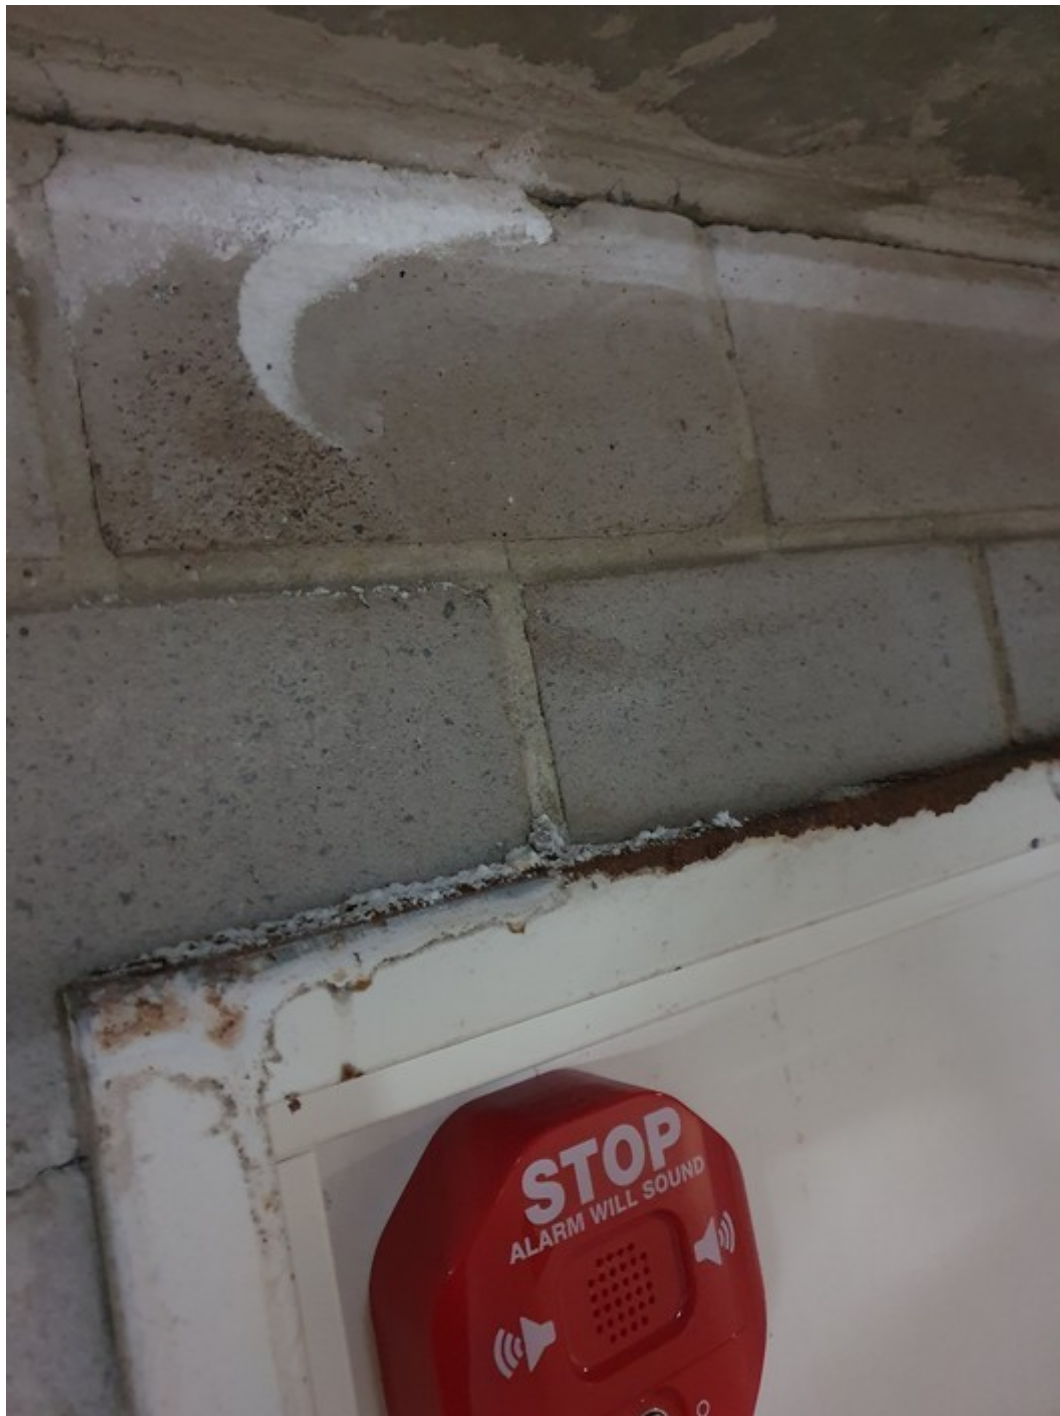
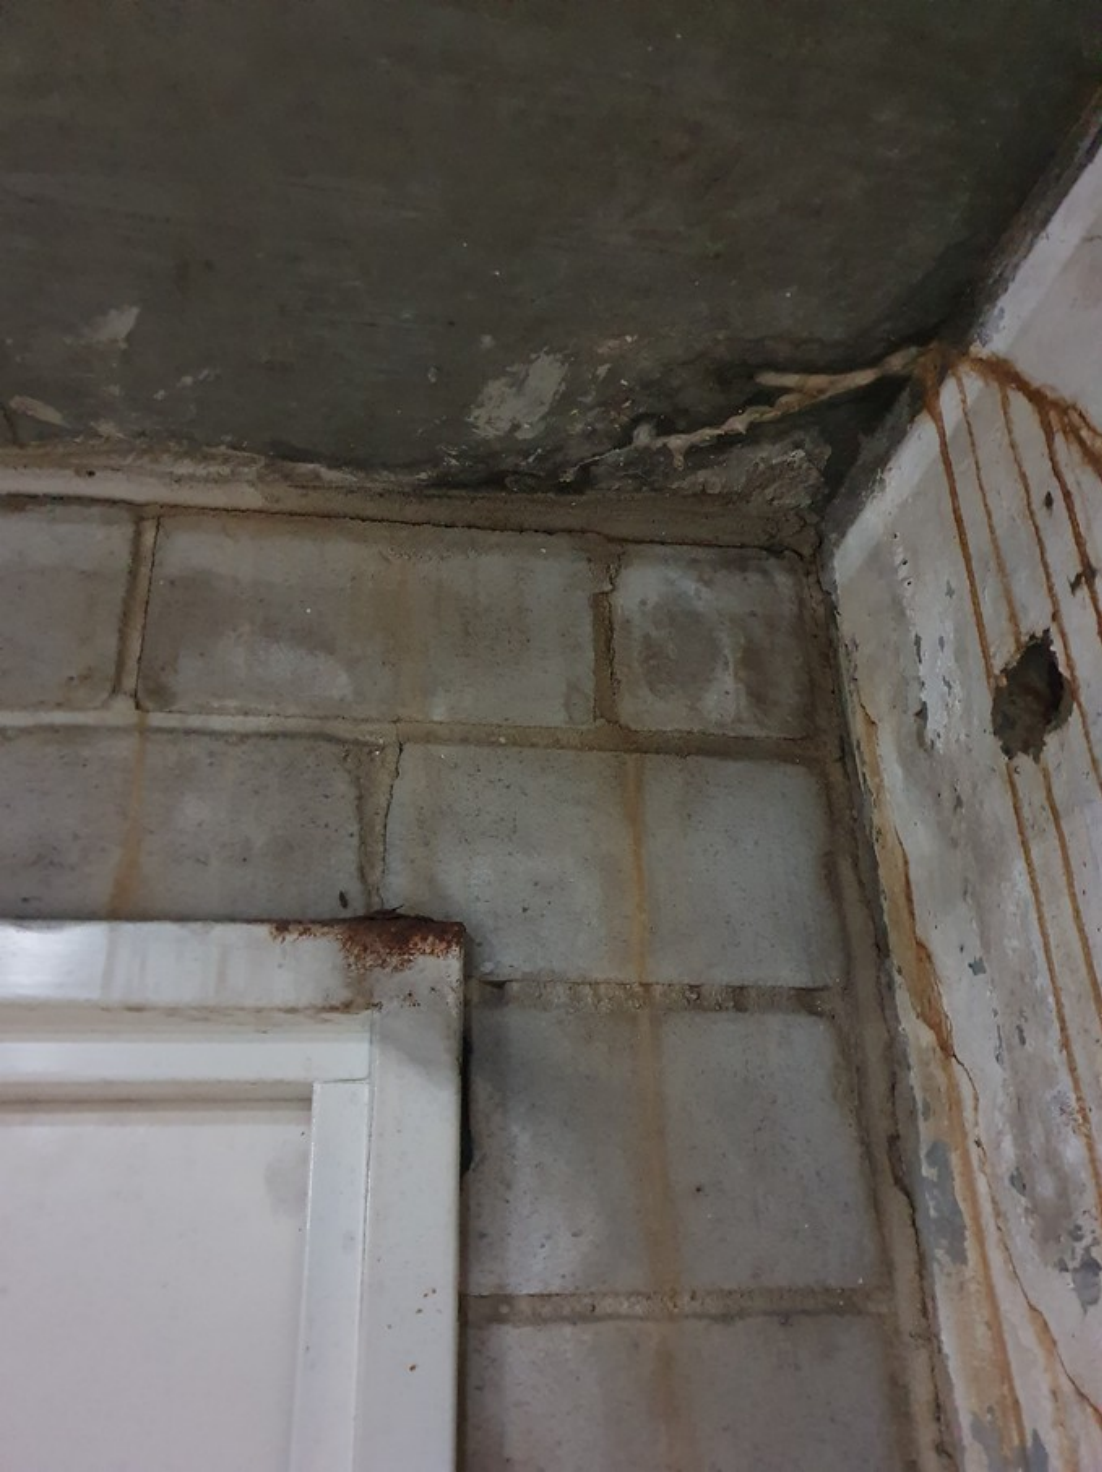
25 Rusted frame of fire door for six years – Block D basement
