Major upgrades on 26 townhouses in amount of \$92,950.00 in 2017 without evidence of work done

This document lists just some of the problems in the complex that can cause injury, health problems, or even death in dire circumstances.

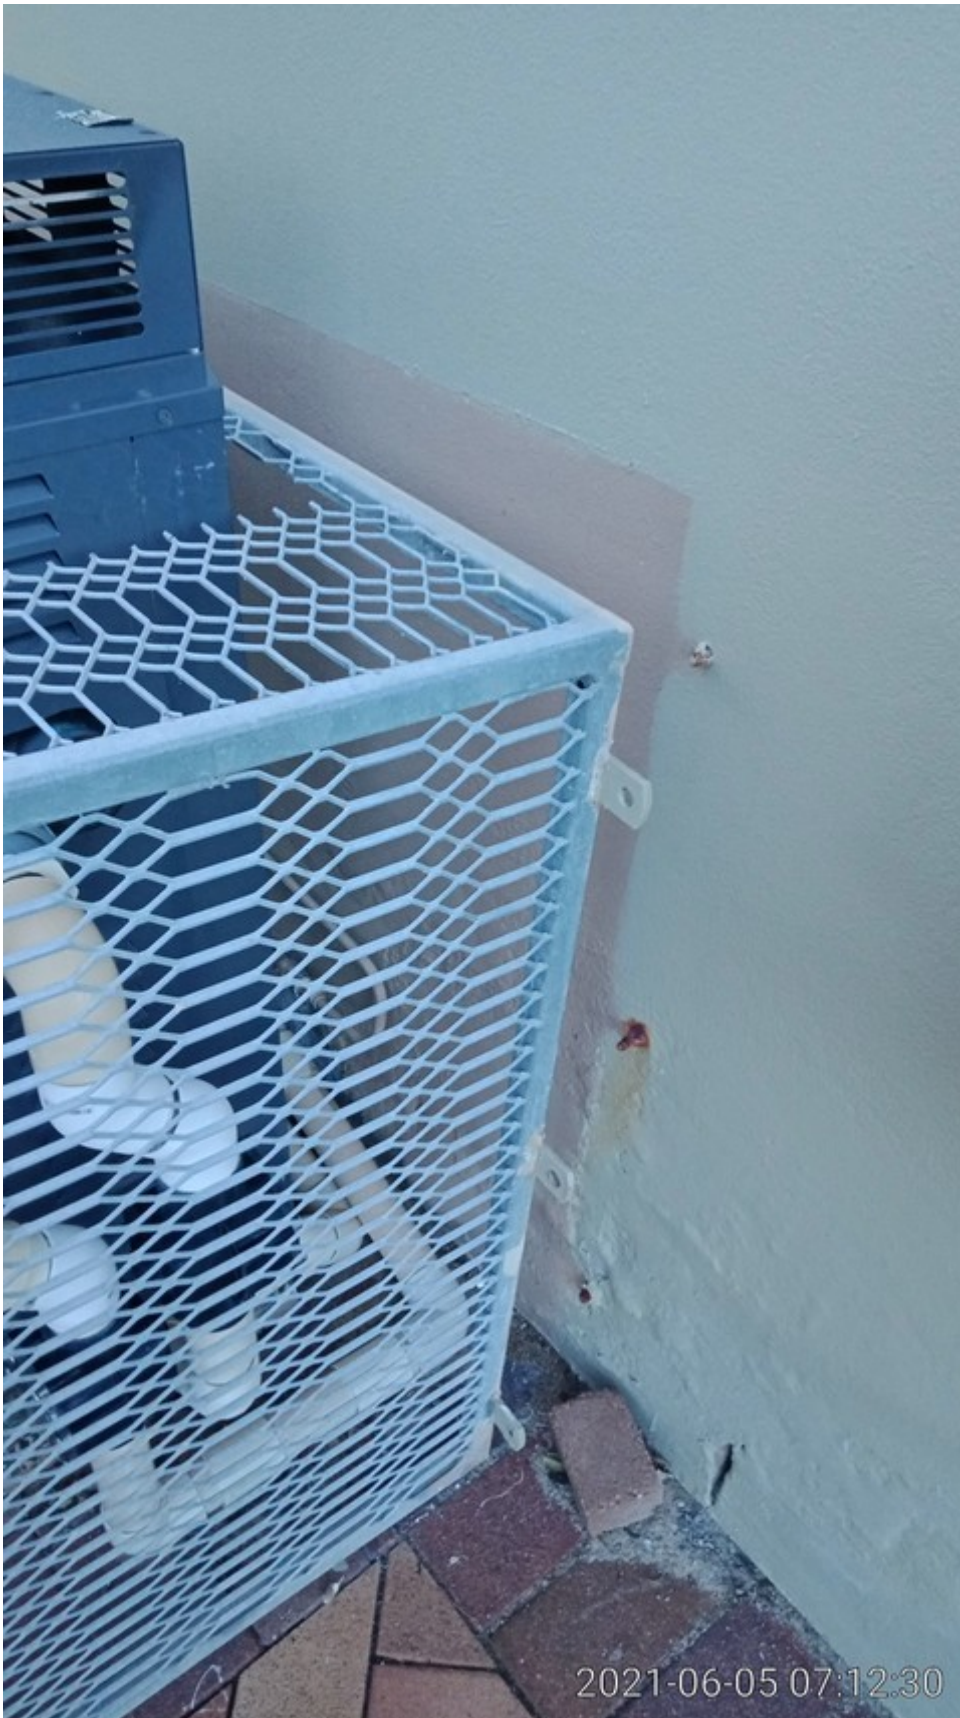
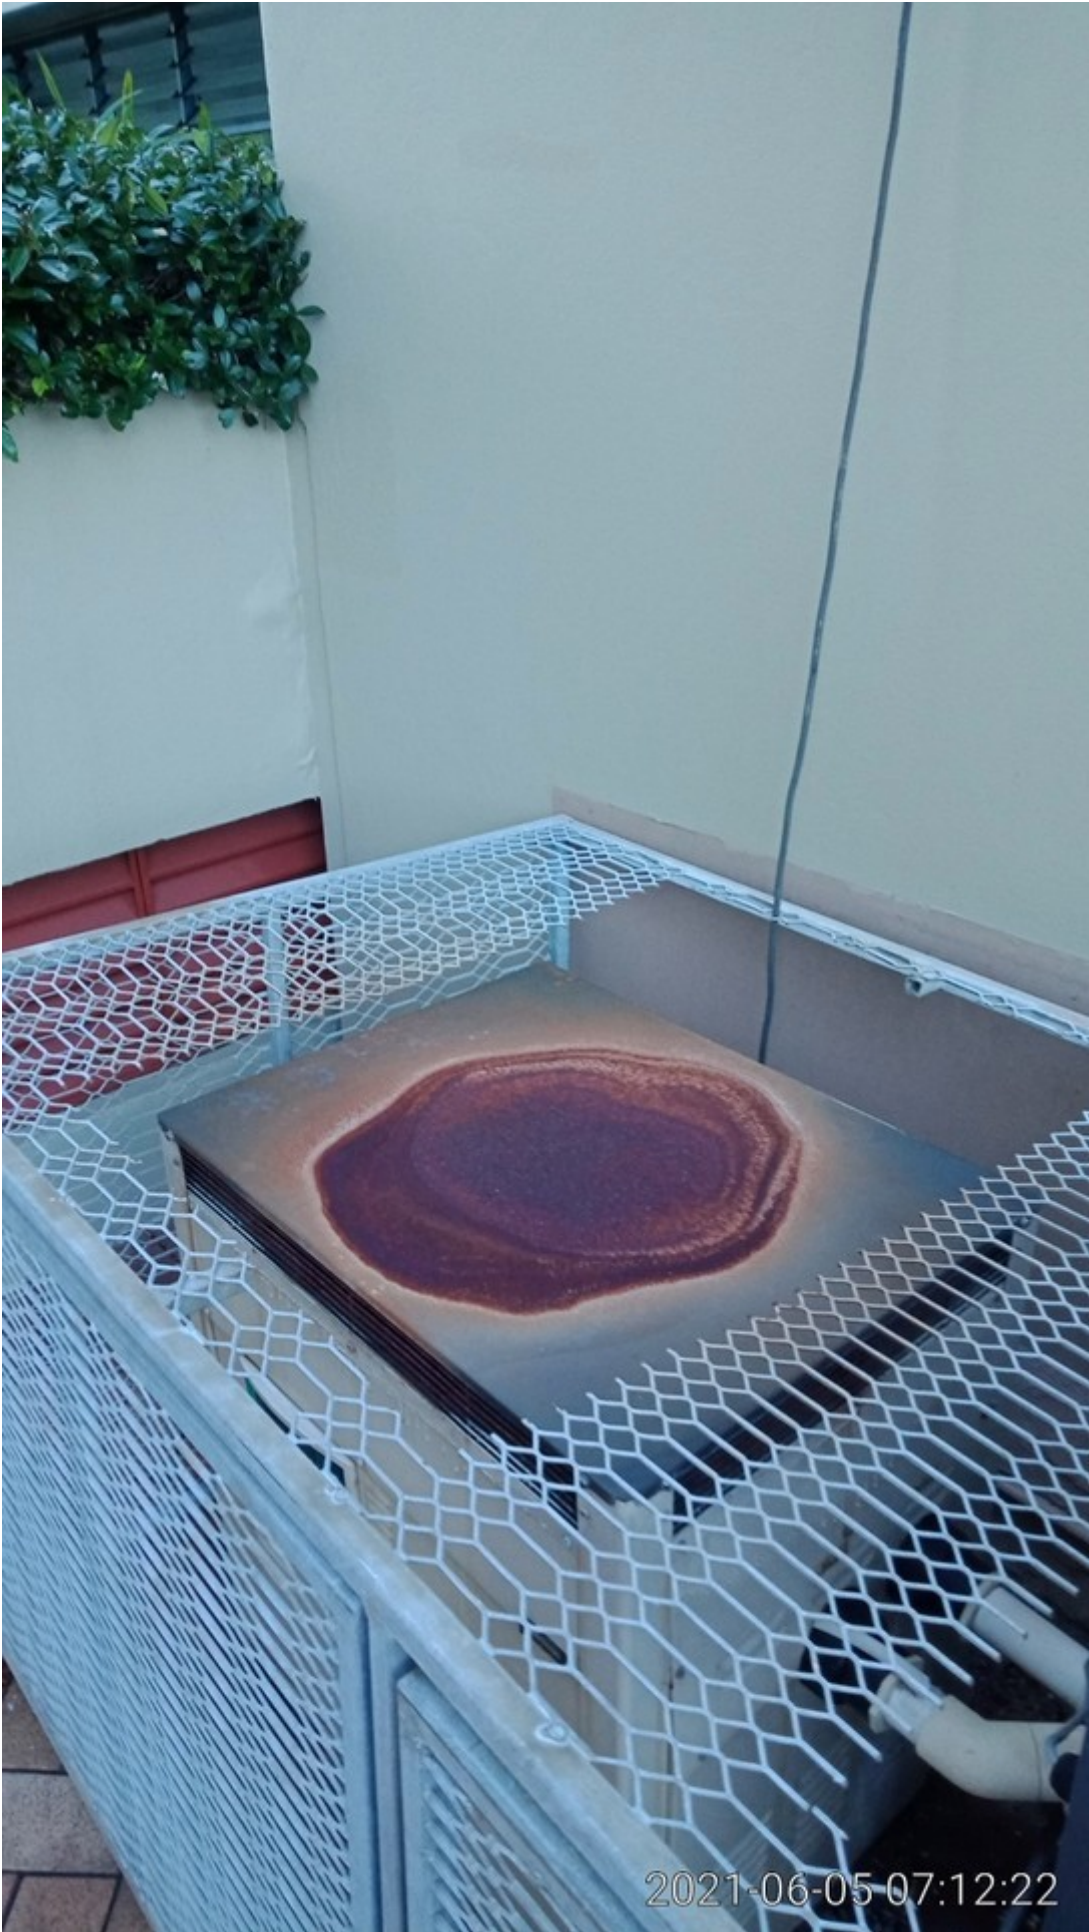
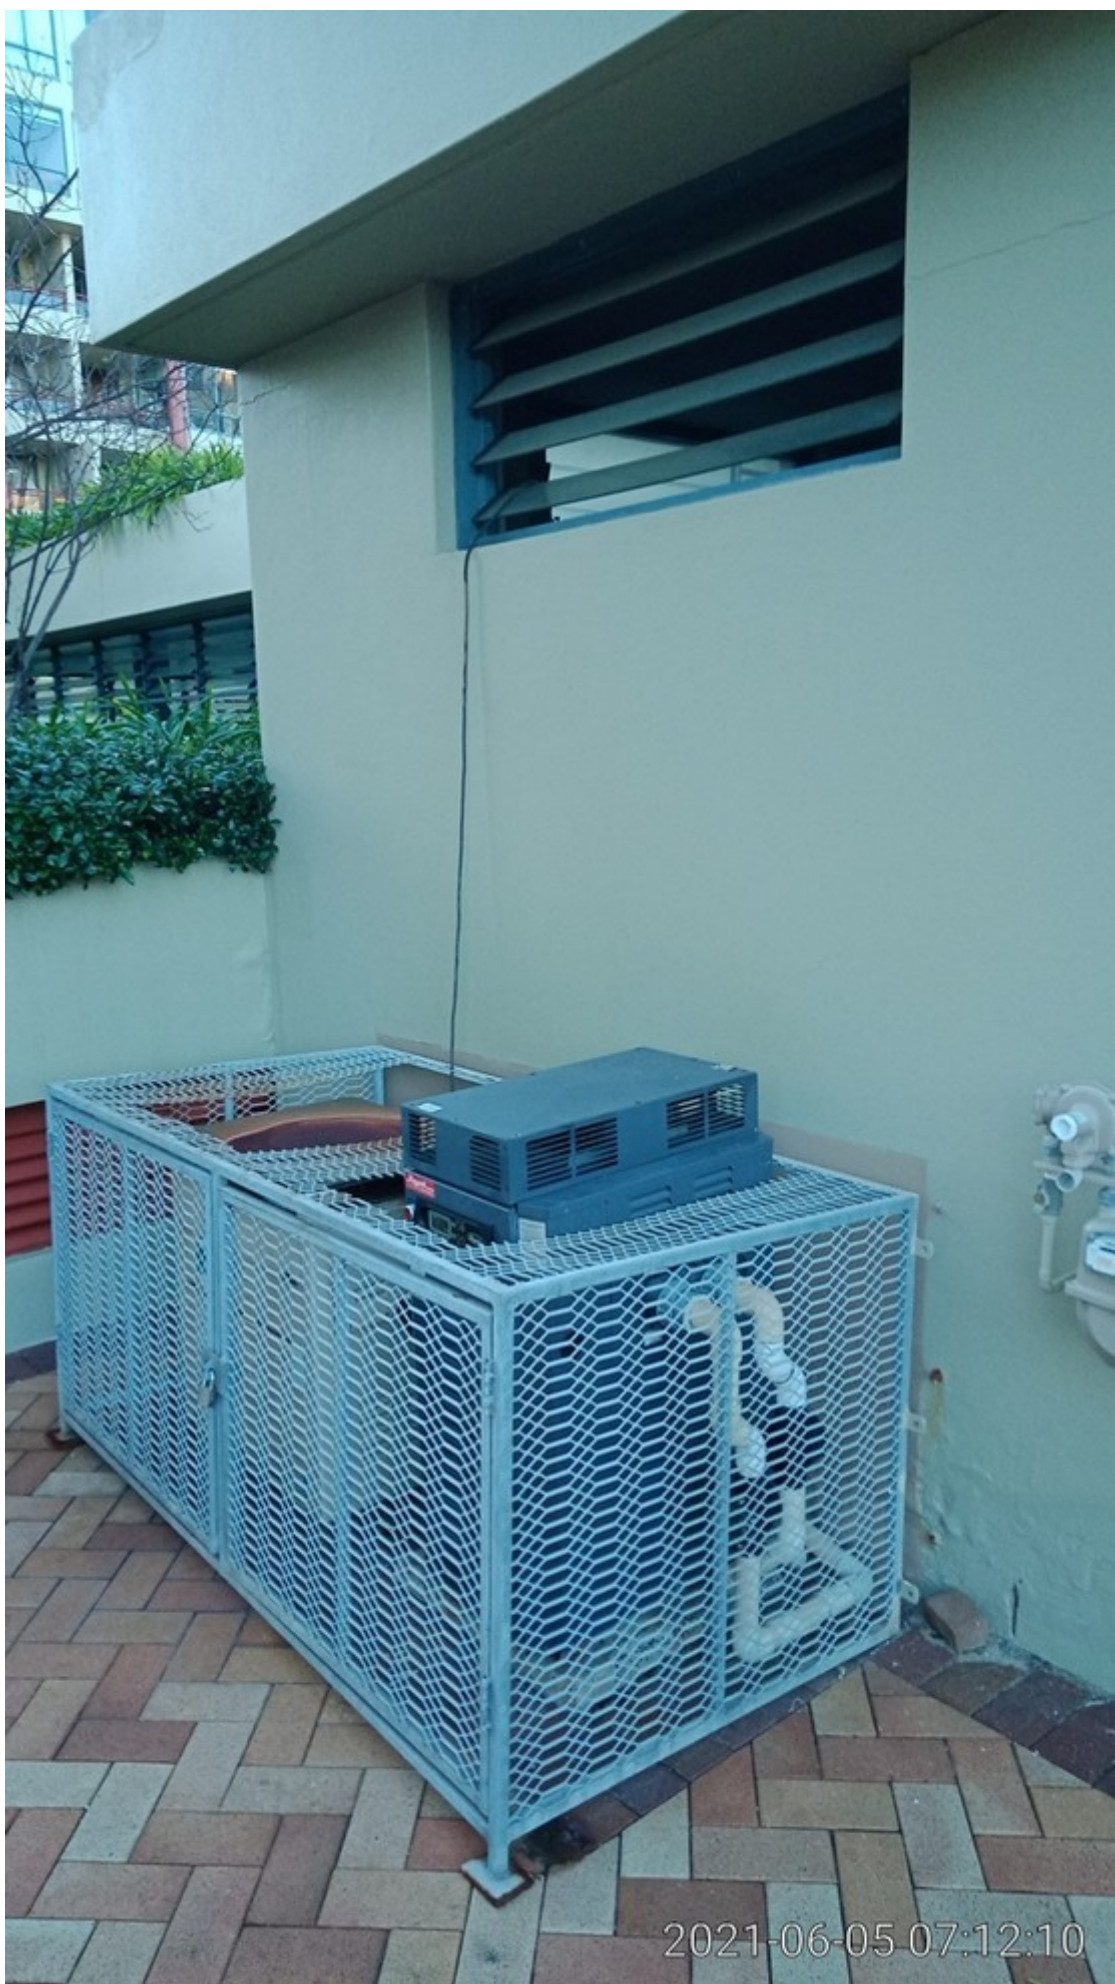
28 Unanchored metal mesh frame on swimming pool plant and unprotected hot surface close to power cable for four years

Metal frame not anchored to the wall, protruding and rusted bolts on unpainted swimming pool wall, hot and rusted surface not protected from weather elements and children who often play in the area, power cord located very close to hot surface which can create electrical hazard.

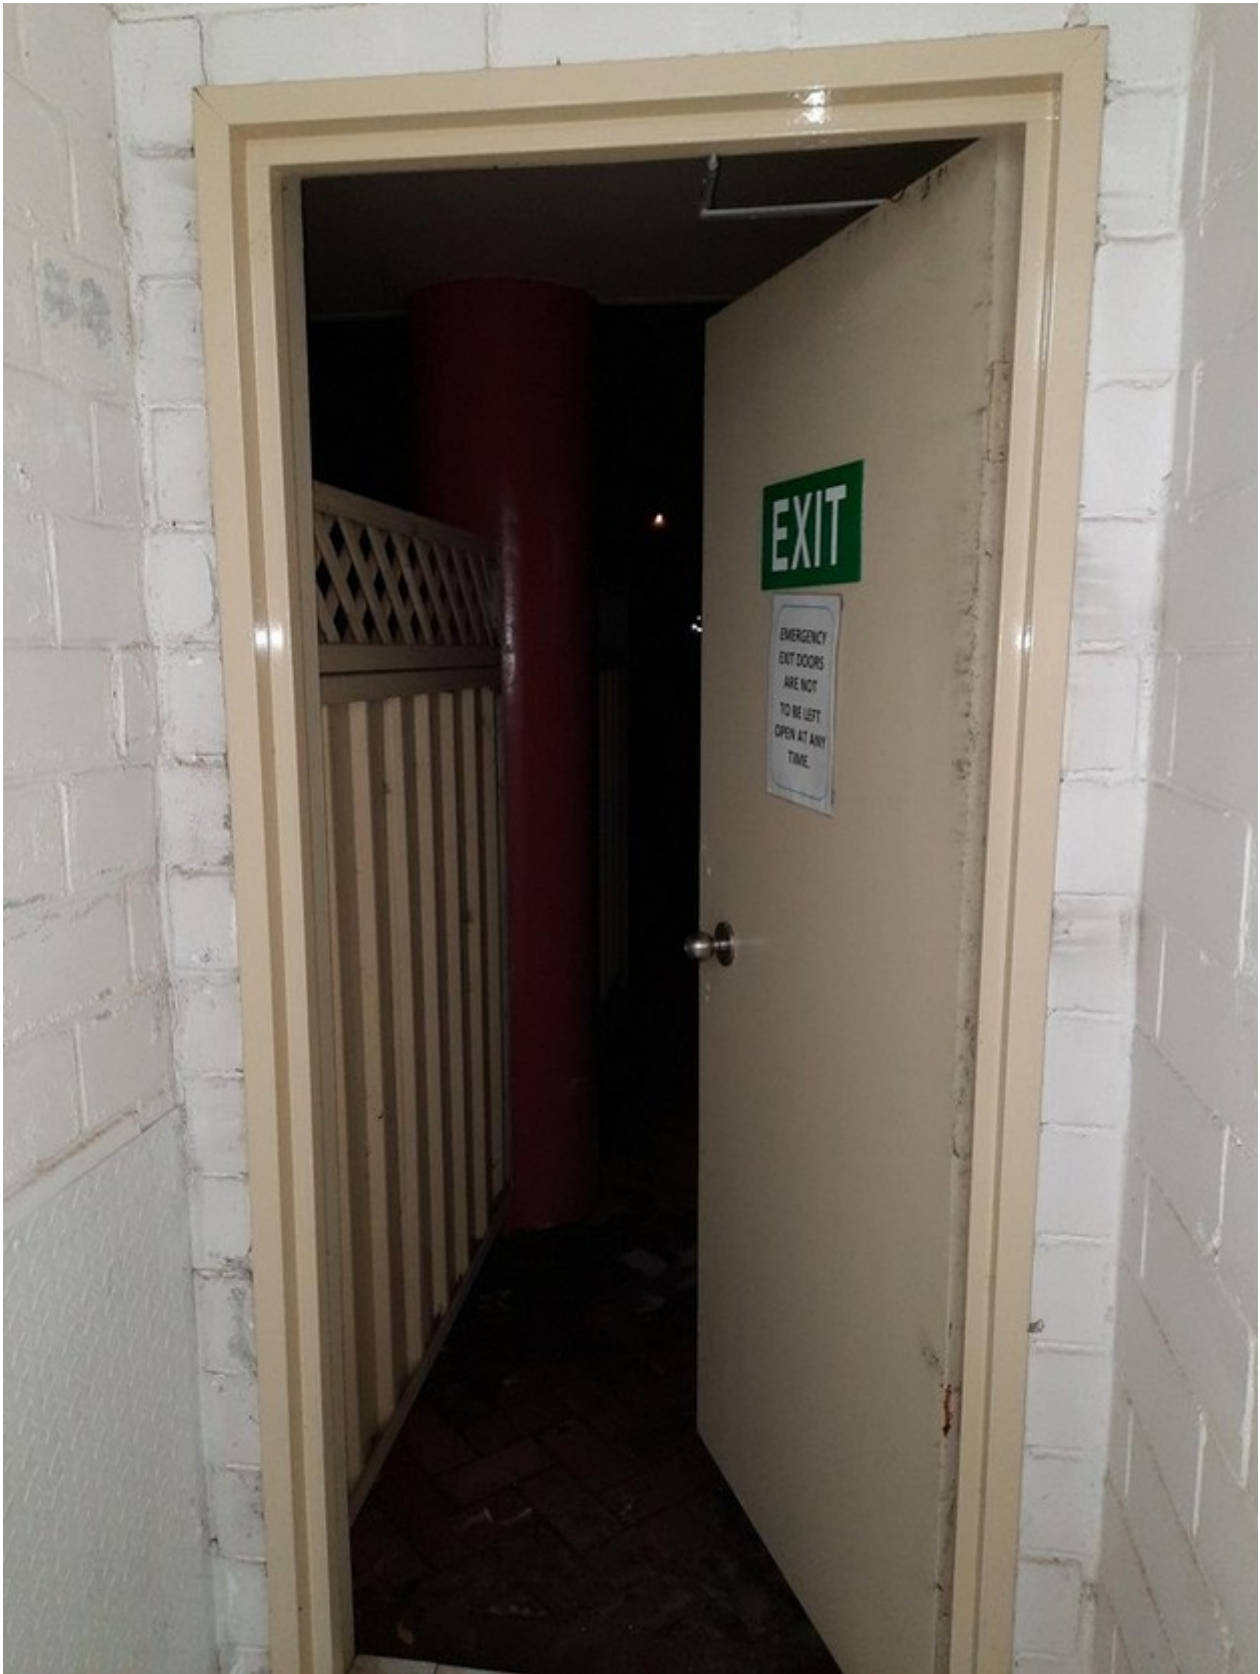
Fire exit, ground floor behind Block C, light out of order since 31 May 2021. Photo taken on 22 June 2021:

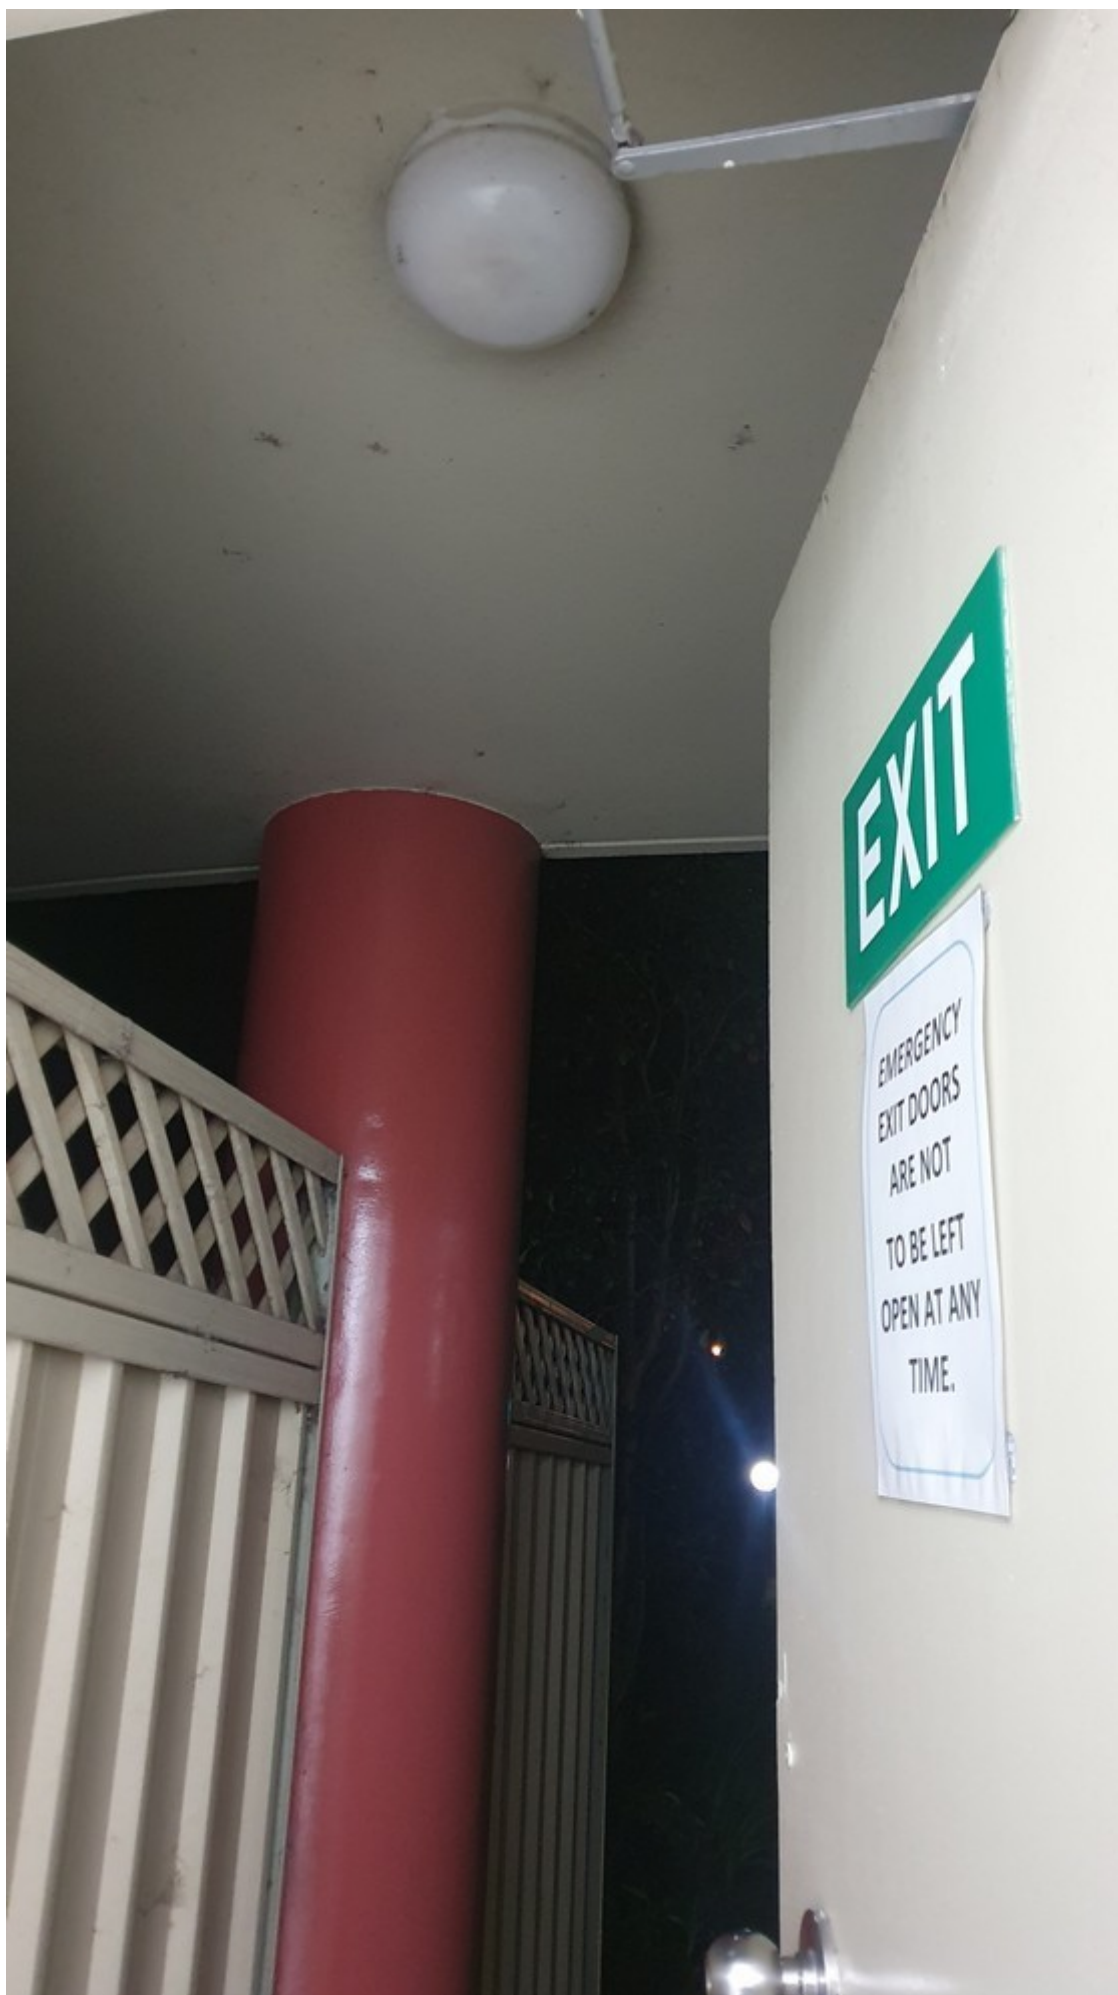
Photo taken on 21st of July 2021:

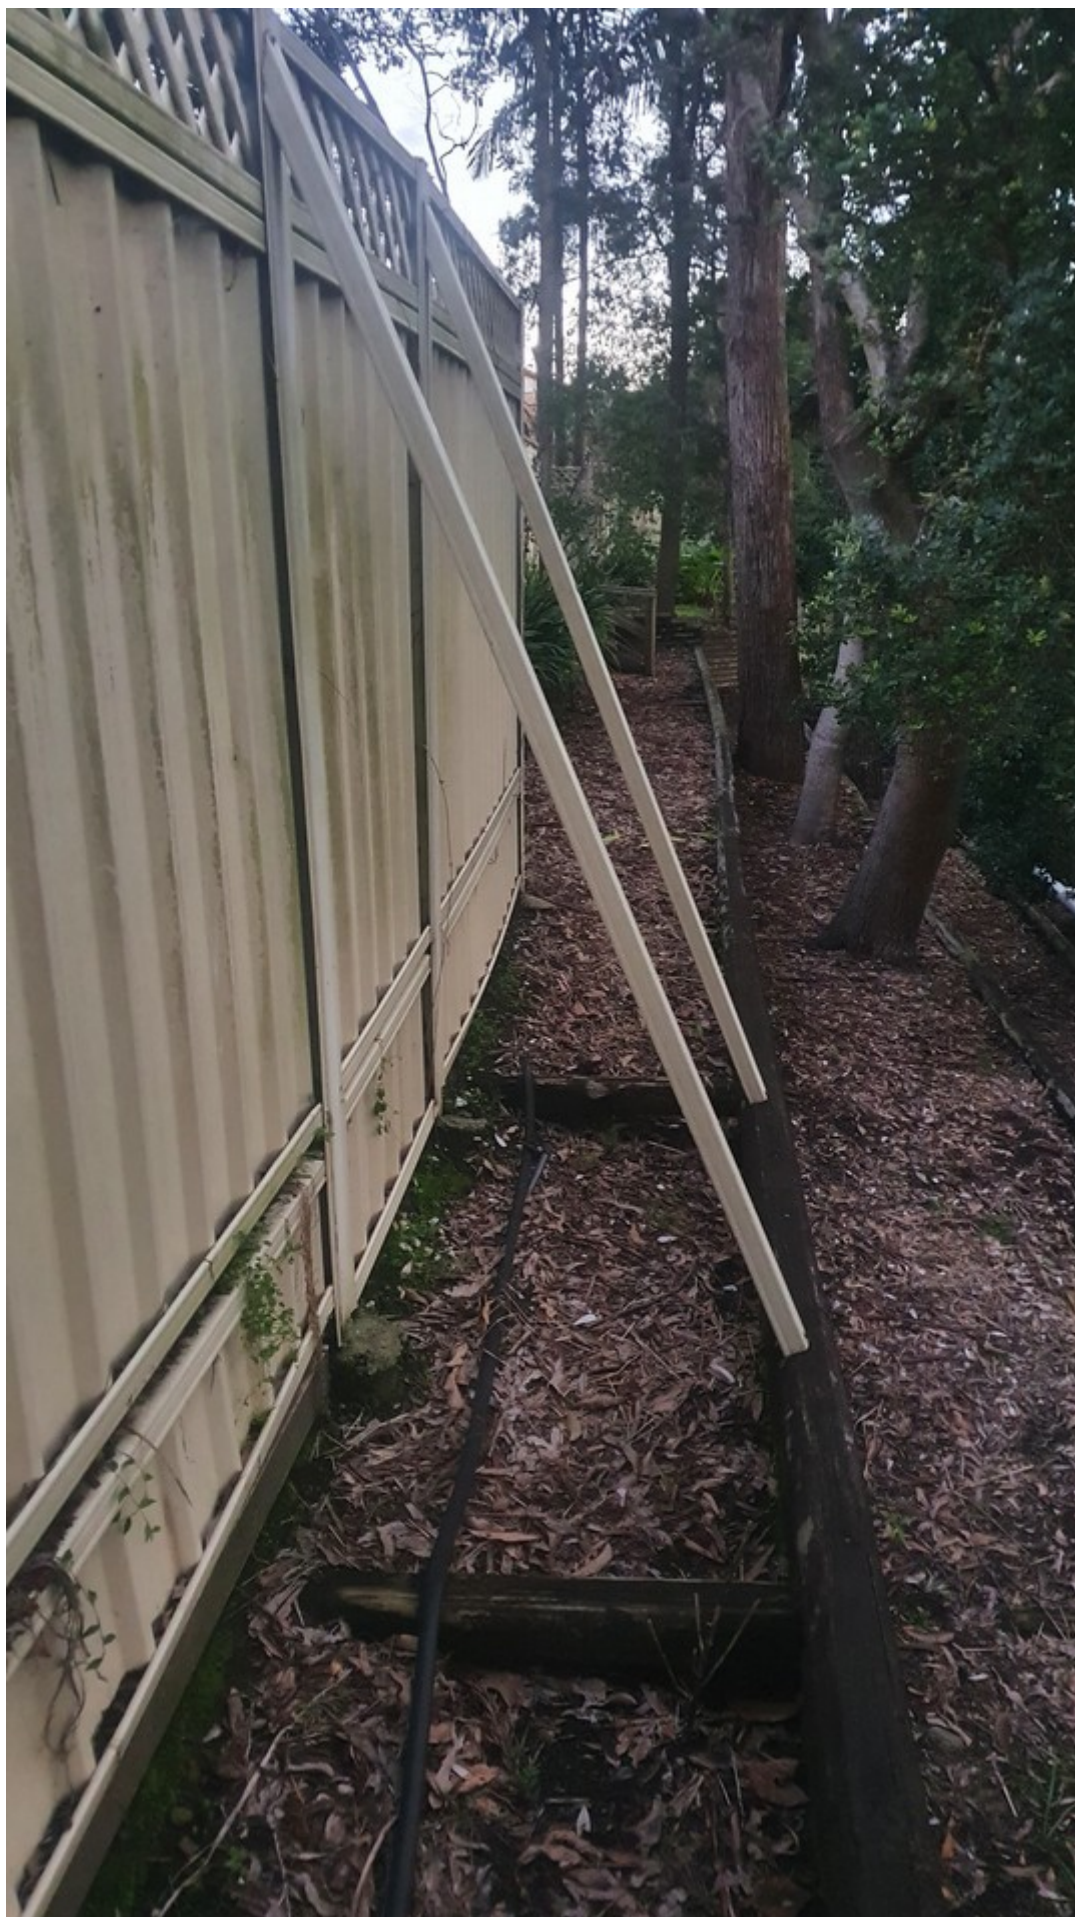
40 Townhouse colorbond fence not repaired for more than six years

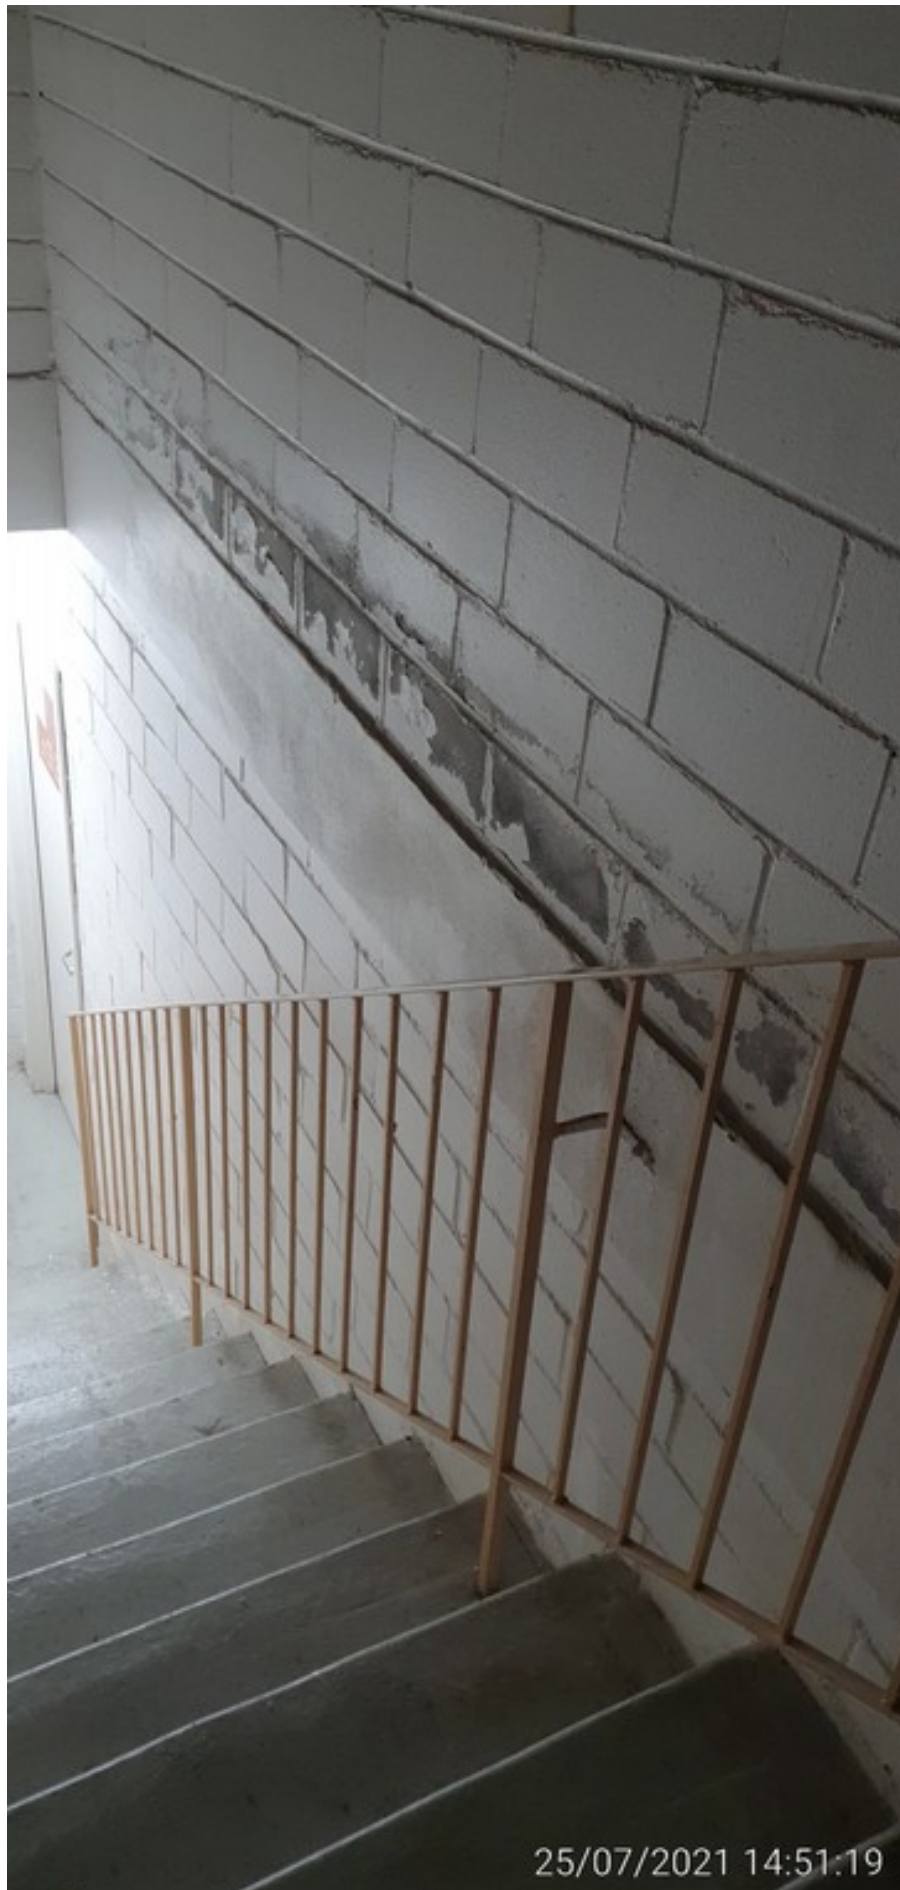
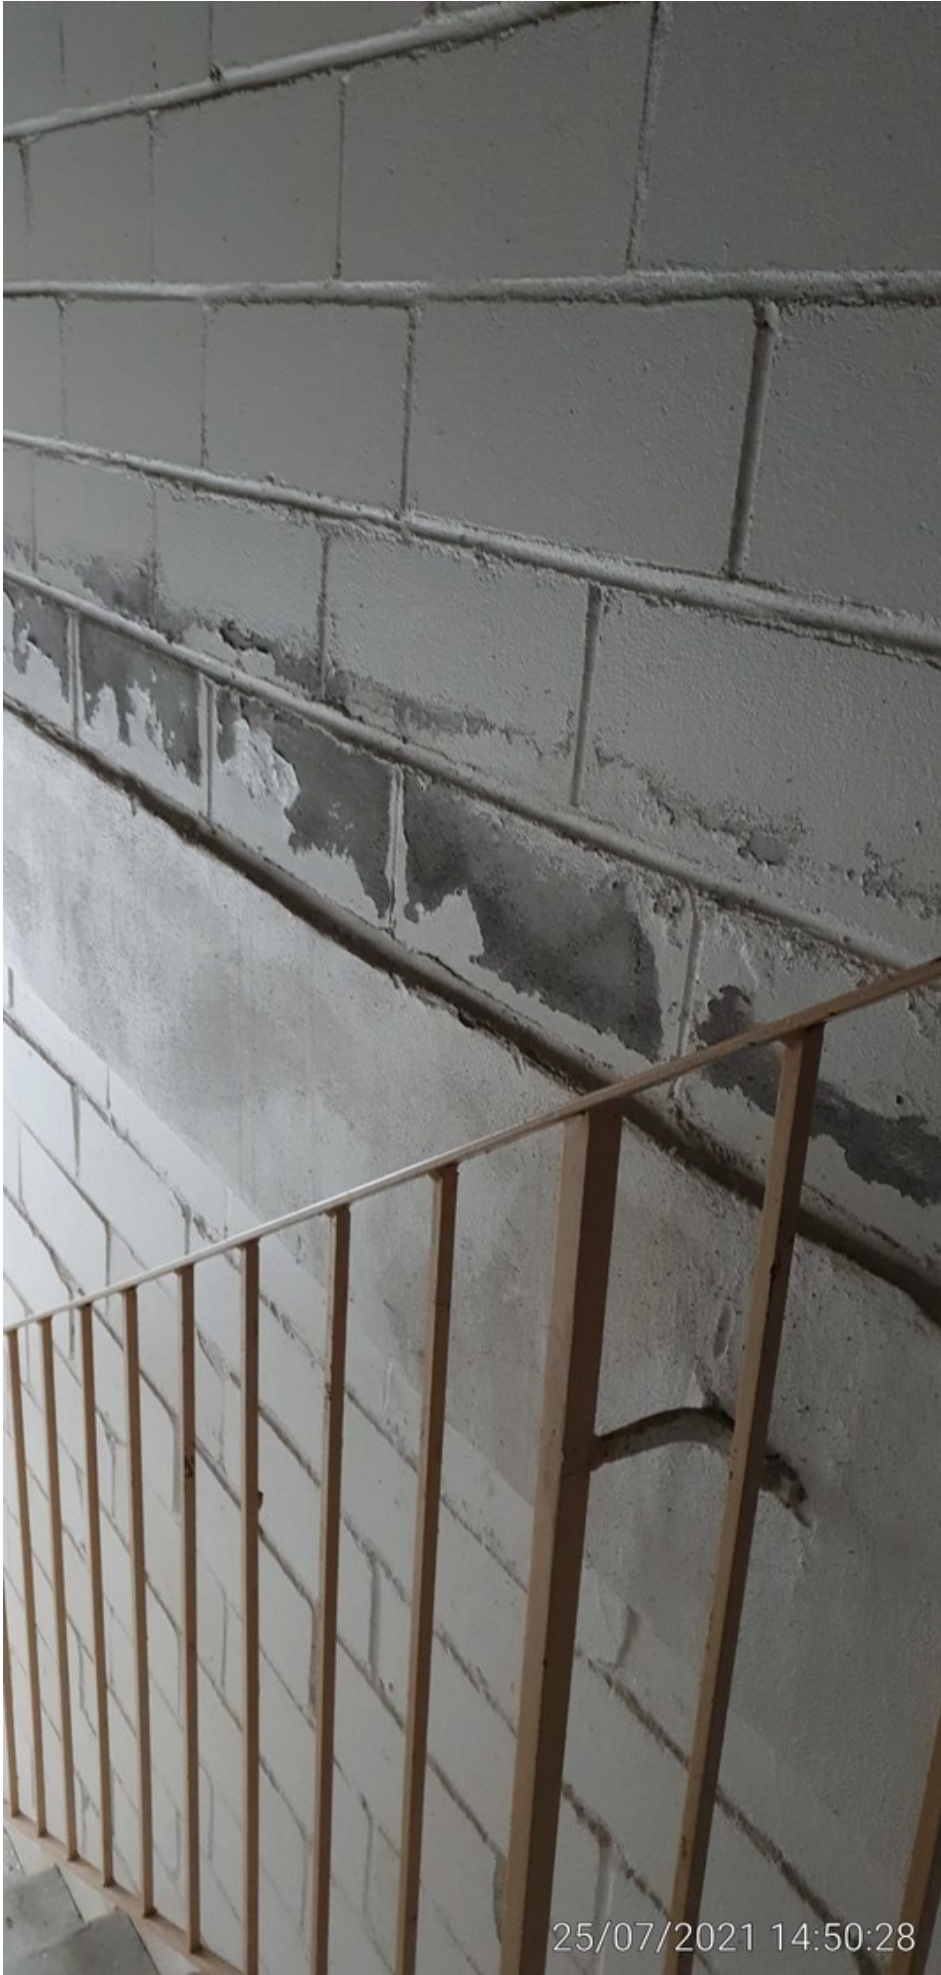
41 Long-term water leak damages under roof in Block B

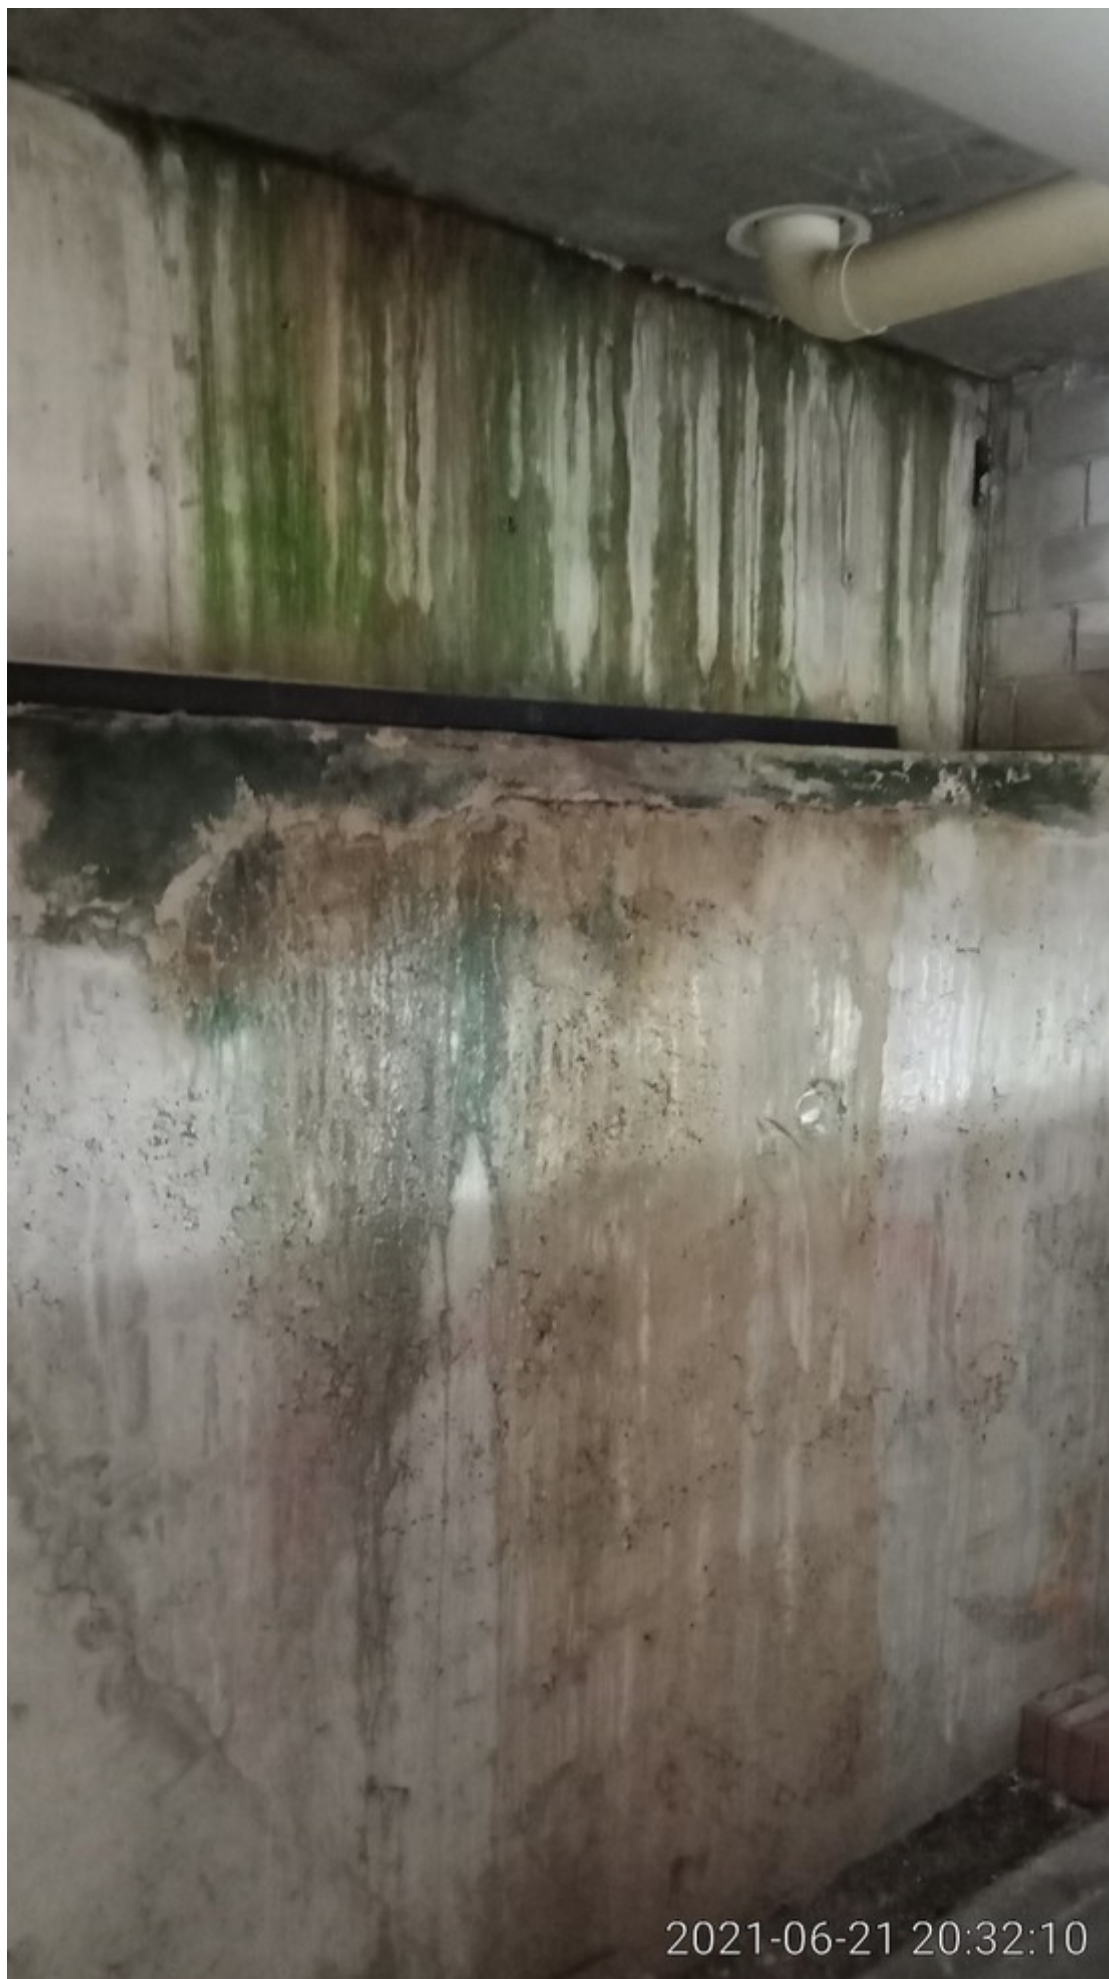
42 Long-term water leaks and health risks in basement of four buildings

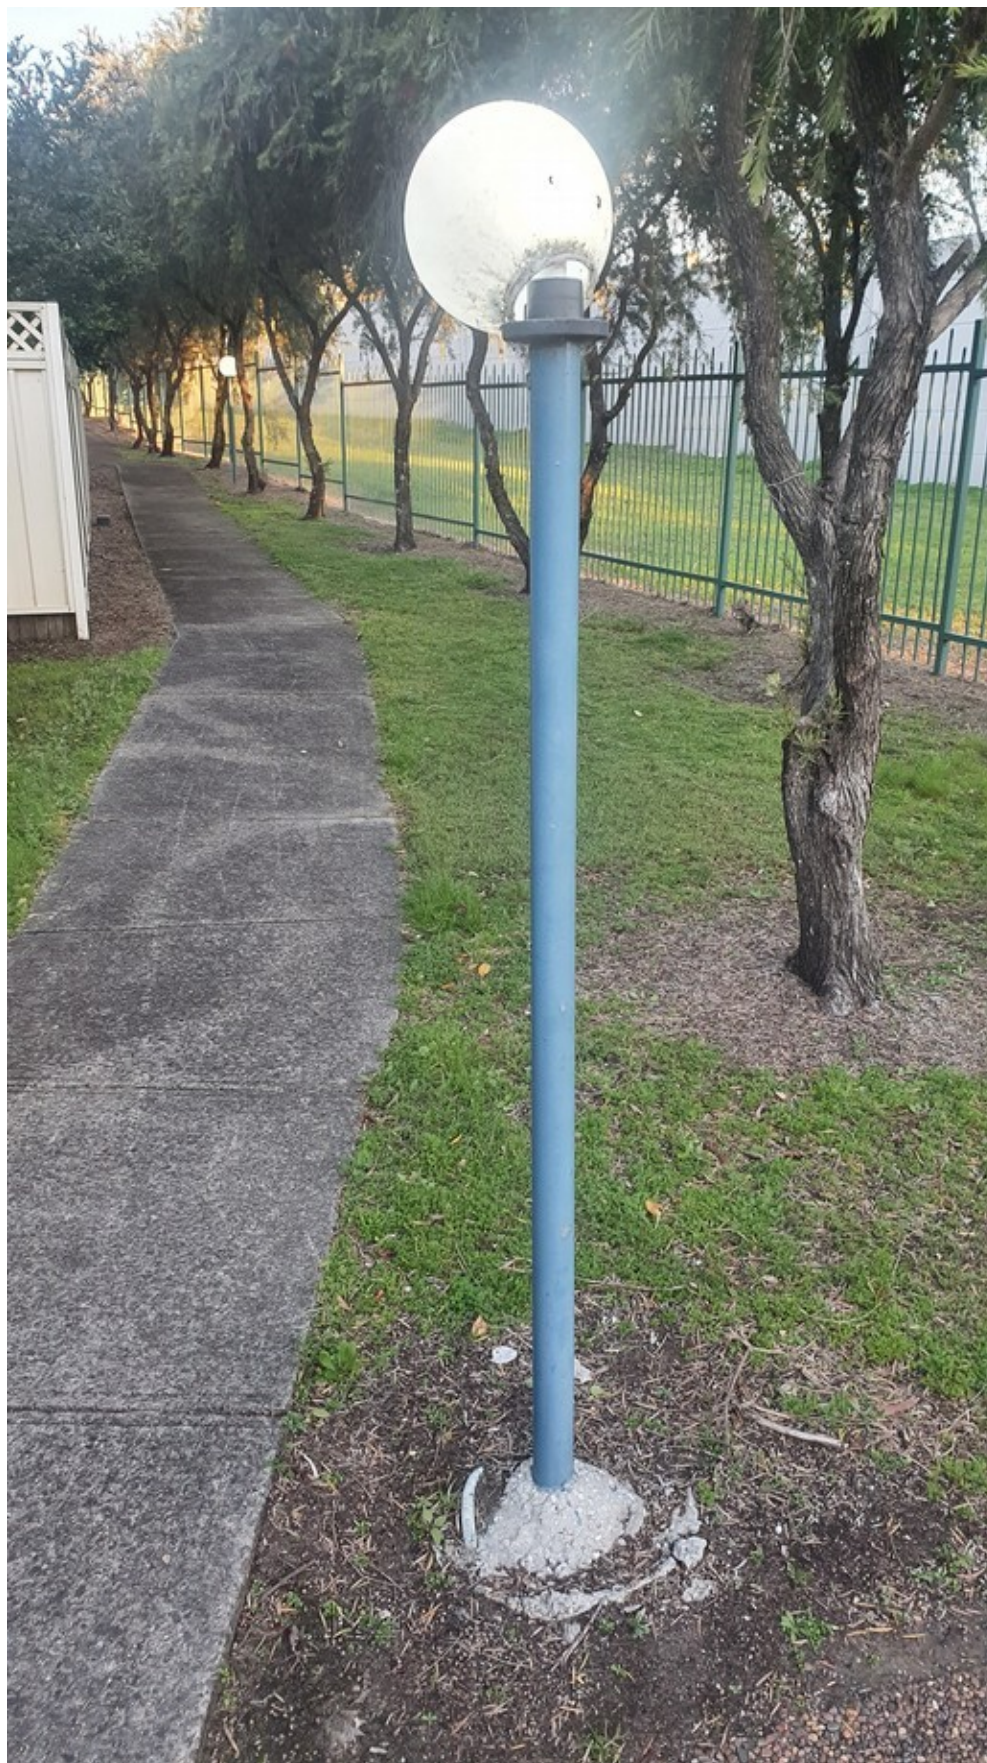
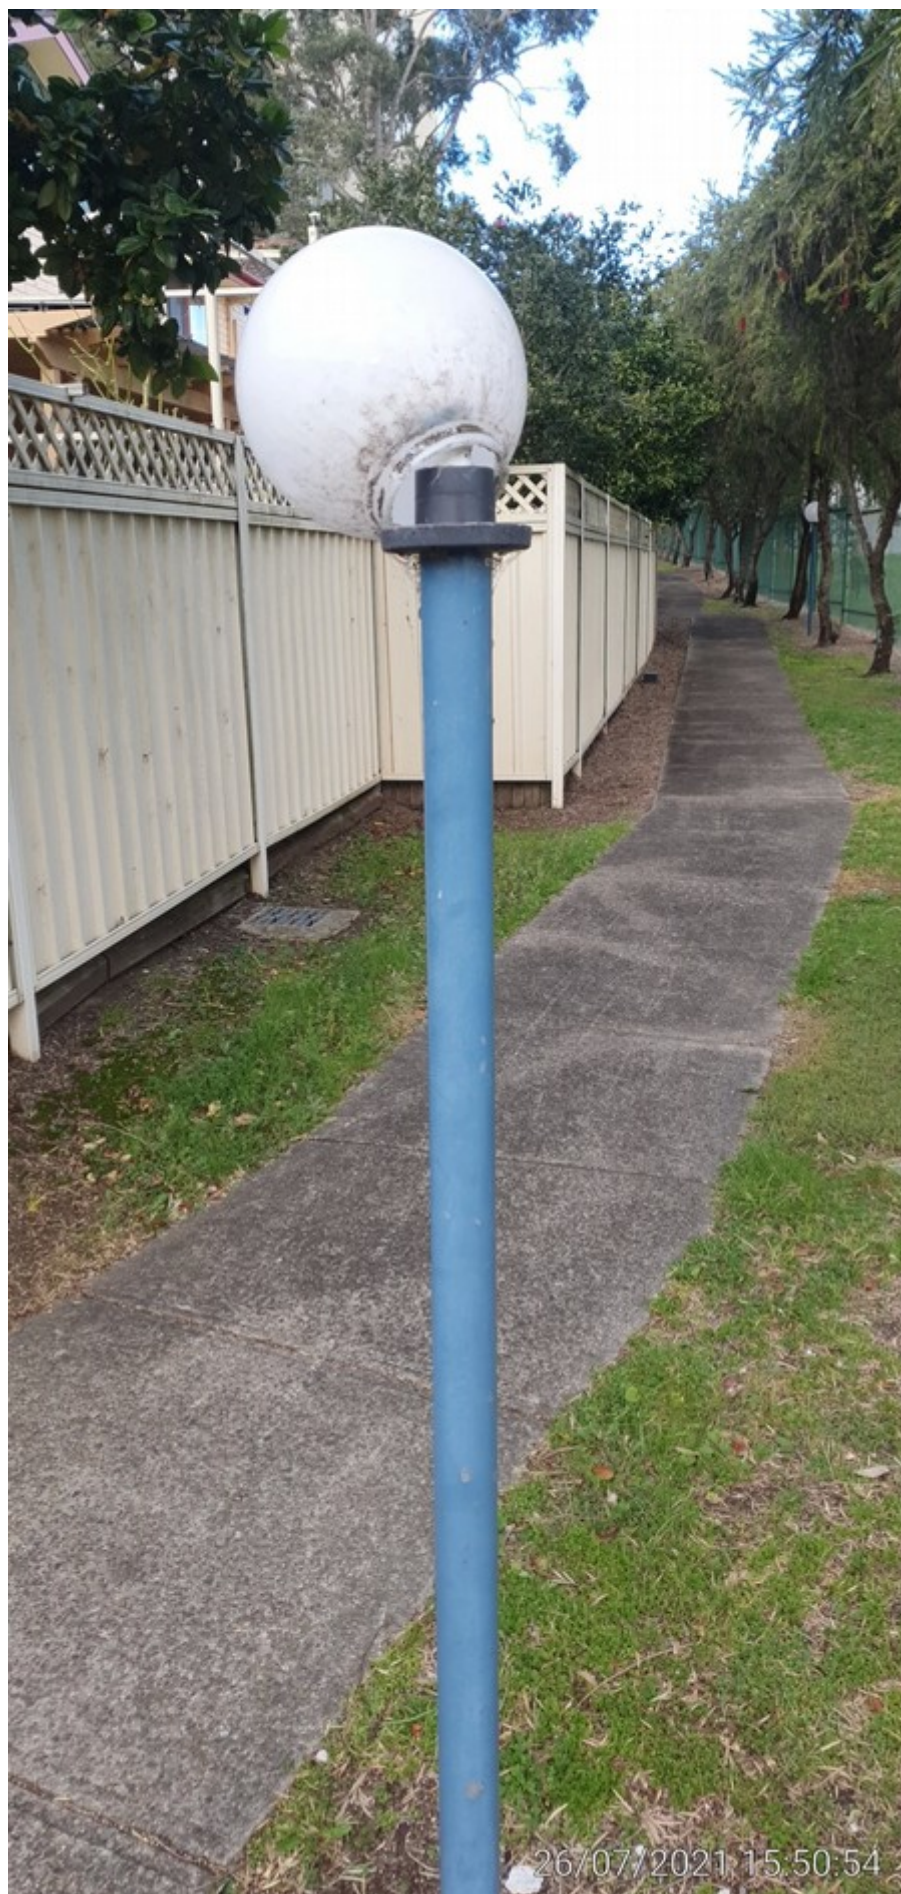
49 Unsafe light post behind townhouse near car wash area

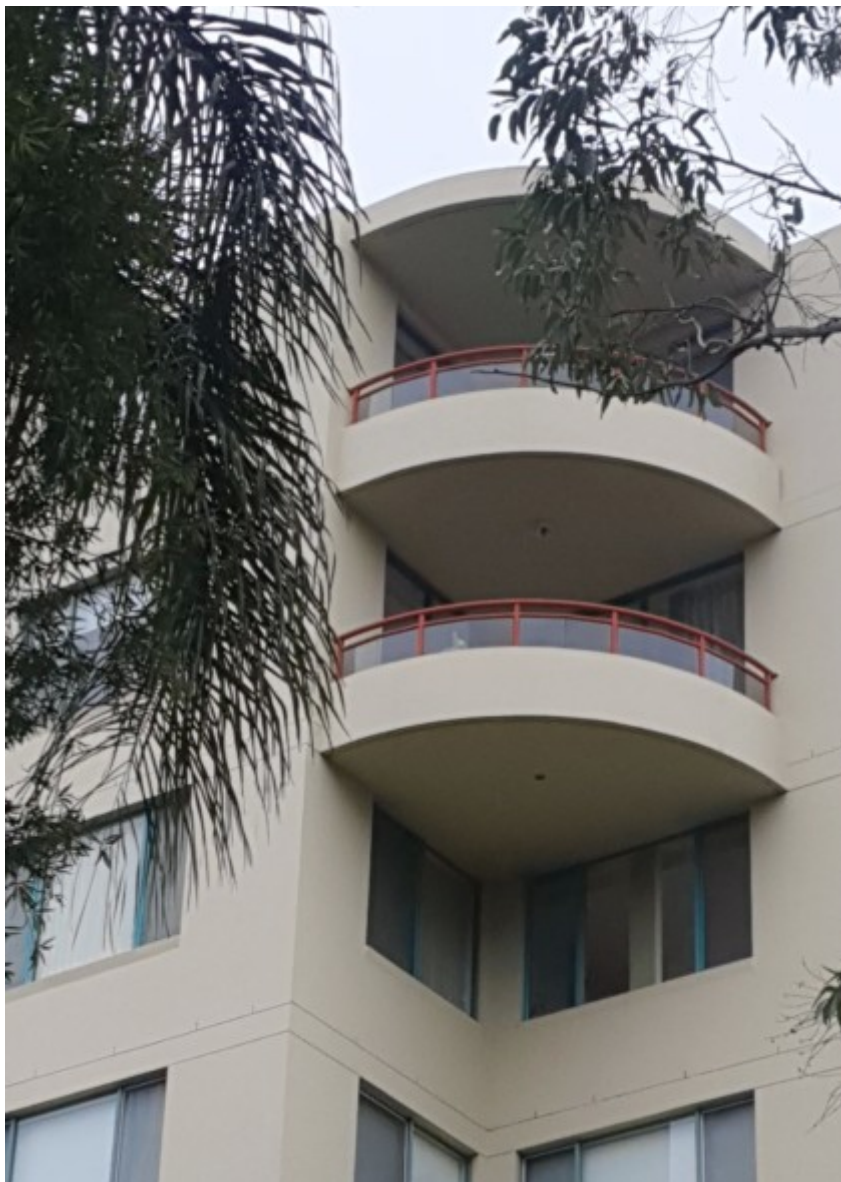
50 Electrical hazard due to missing balcony light cover and hole in concrete on level 6 Block
C
