Major upgrades on 26 townhouses in amount of \$92,950.00 in 2017 without evidence of work done

This document lists just some of the problems in the complex that can cause injury, health problems, or even death in dire circumstances.

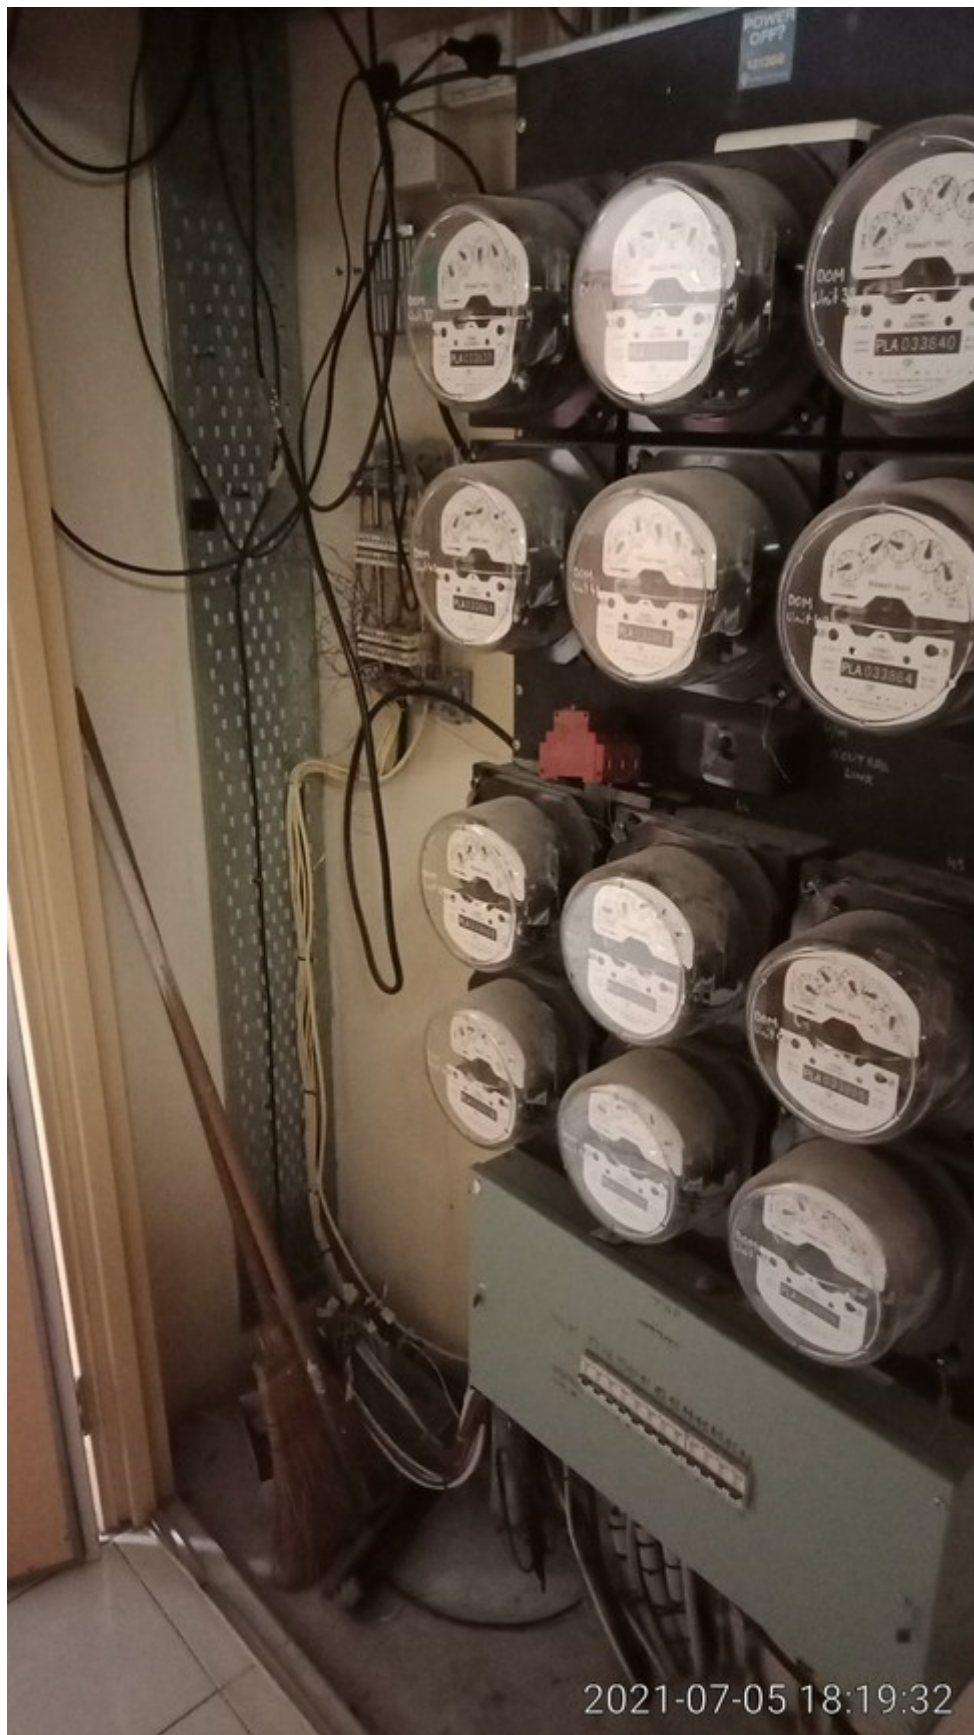
51 Cleaning equipment kept in telecom and electrical cabinet on level 7 Block B permanently (photos taken on 5 and 25 July 2021)

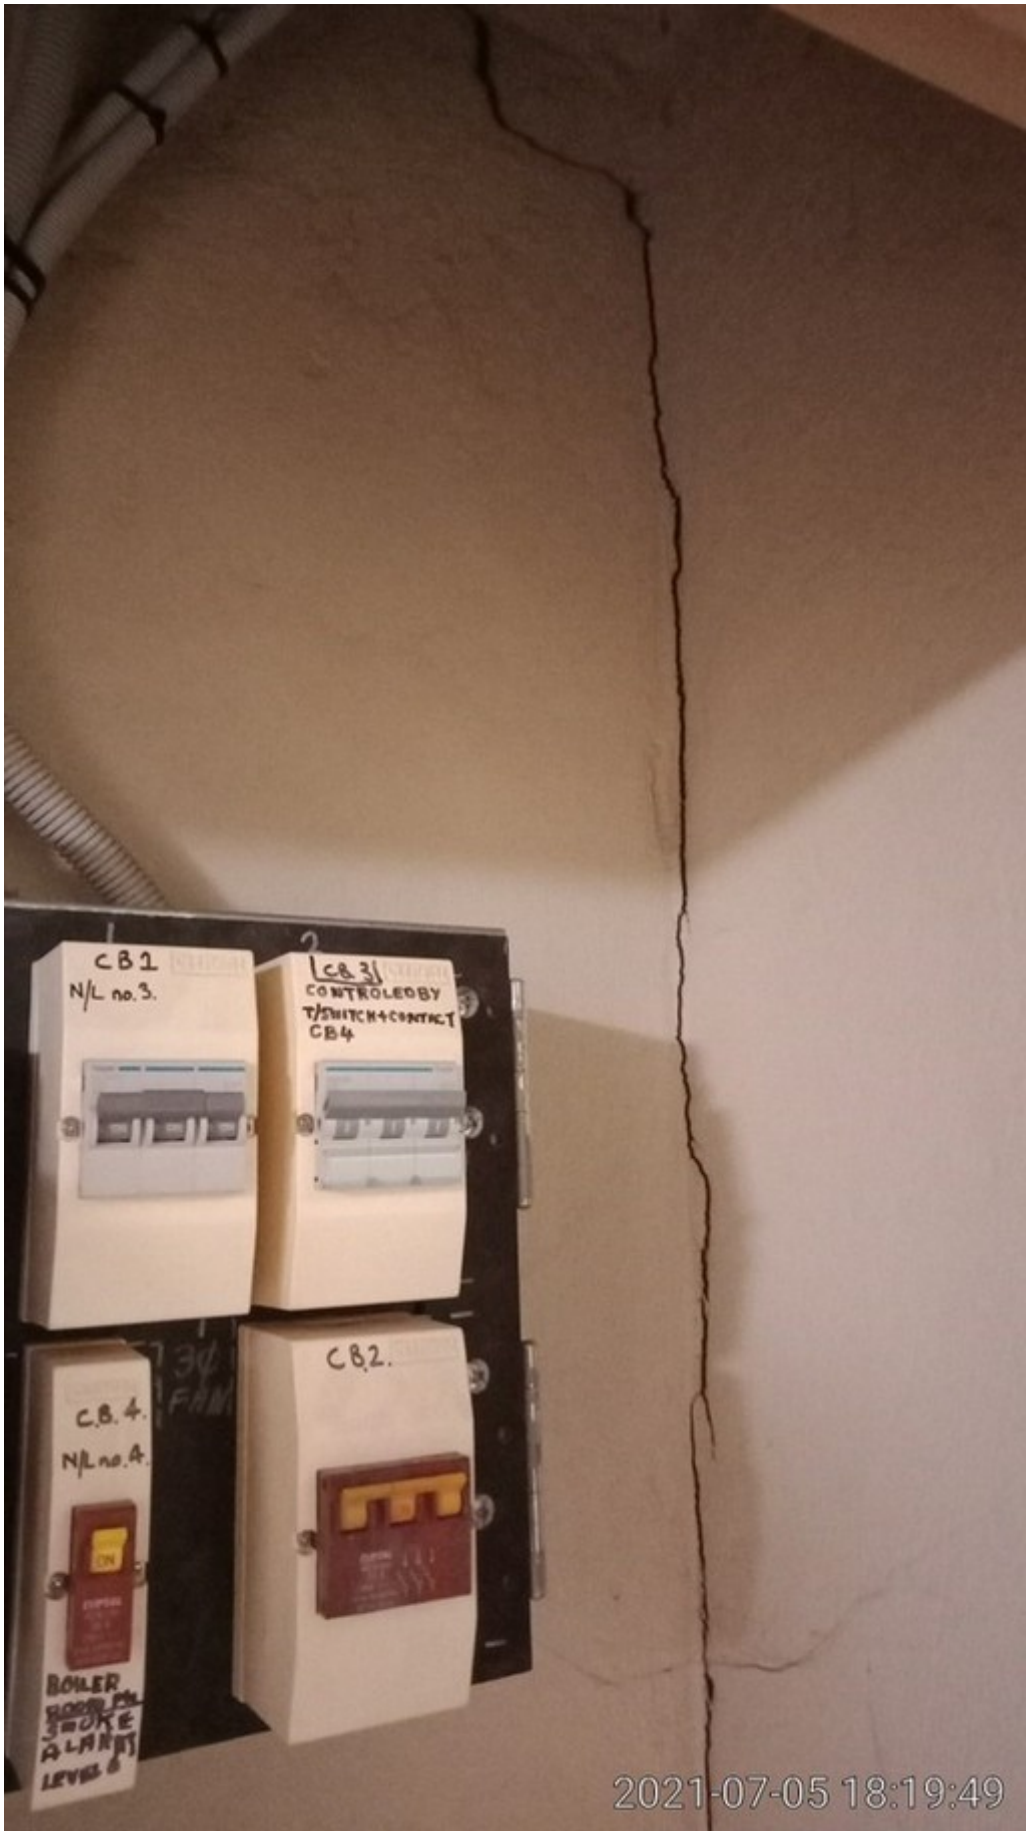
The wall inside the cabinet needs some repairs:

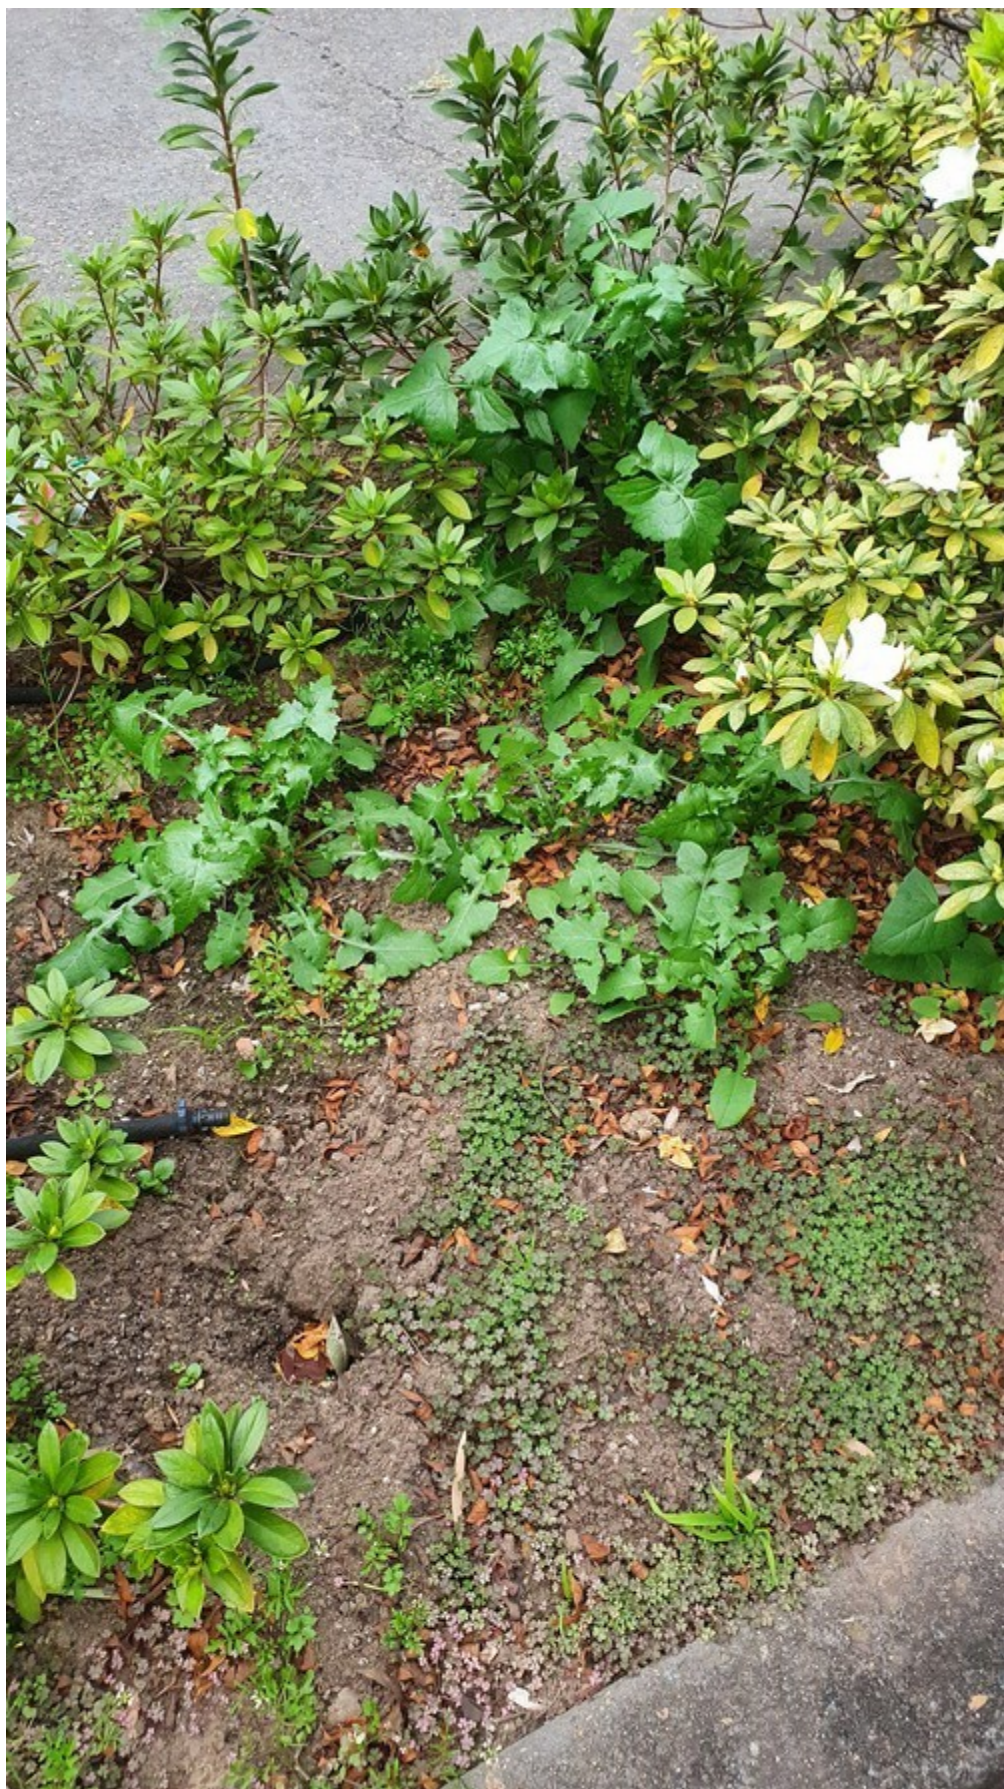
On same day, 28 July 2021, middle section of garden at the entrance of the complex is still missing lot of plans, has no mulching, and there is lot of weeds:
