**T H O M S O N**  
ELEVATOR CONSULTANCY SERVICES

## LIFT AUDIT REPORT

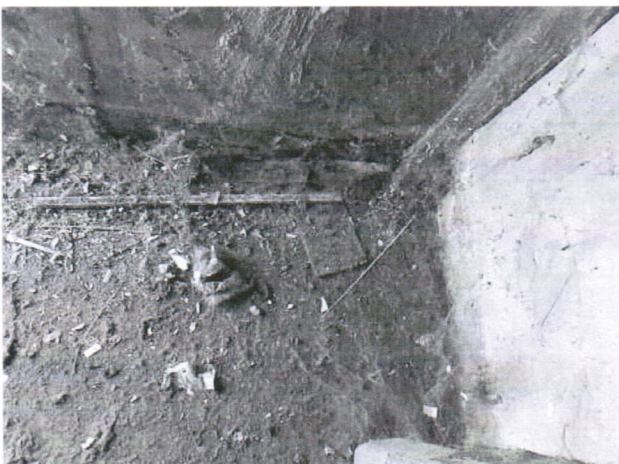
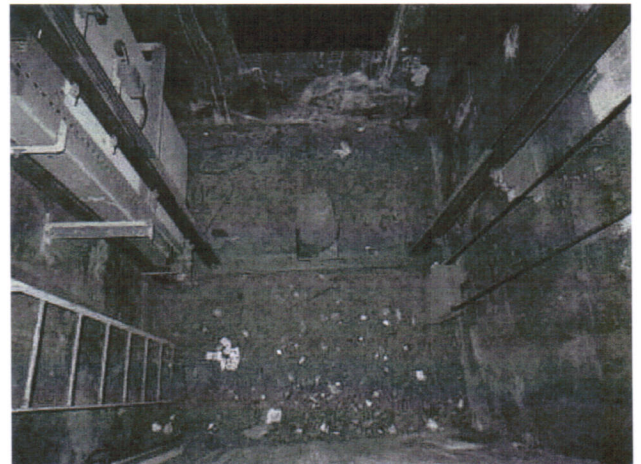
The lift pits for lifts 1, 2 & 3 are filthy and have not been cleaned in a long time

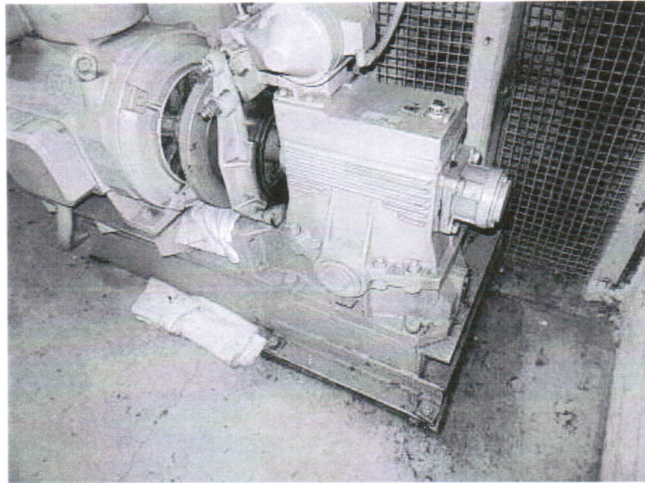
Lift 1 – the lift machine requires cleaning and resealing to stop oil leaks

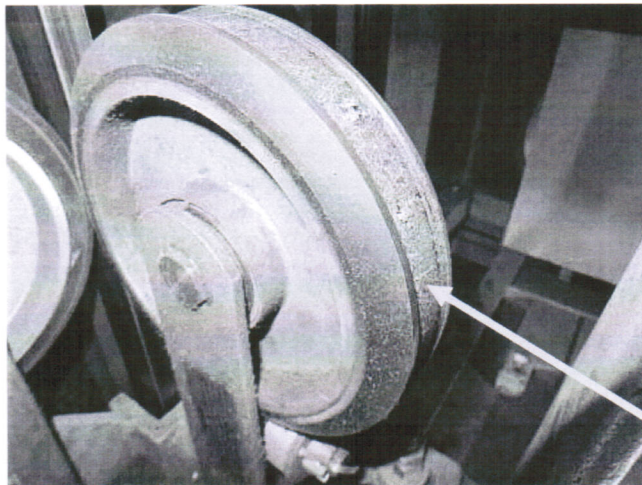
Lift 1 – worn lift car guide rollers need to be replaced ASAP

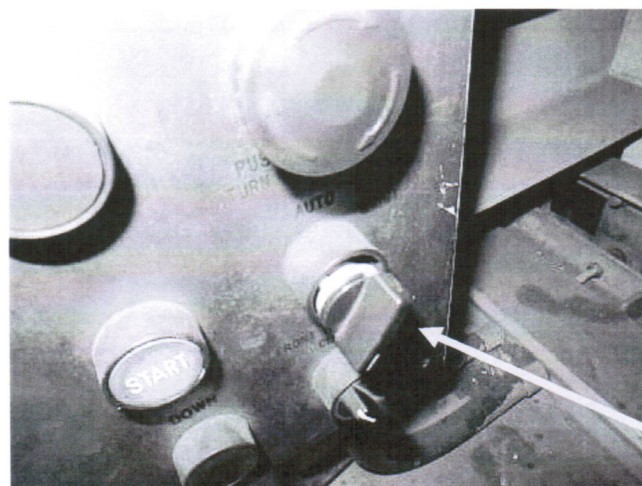
Lift 2 – the broken maintenance switch on top of the lift car needs to be replaced

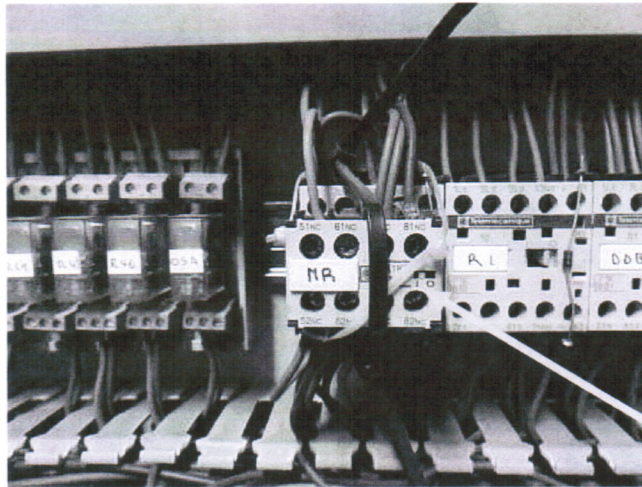
Lift 2 – broken auxiliary contact on MR relay needs to be repaired or replaced

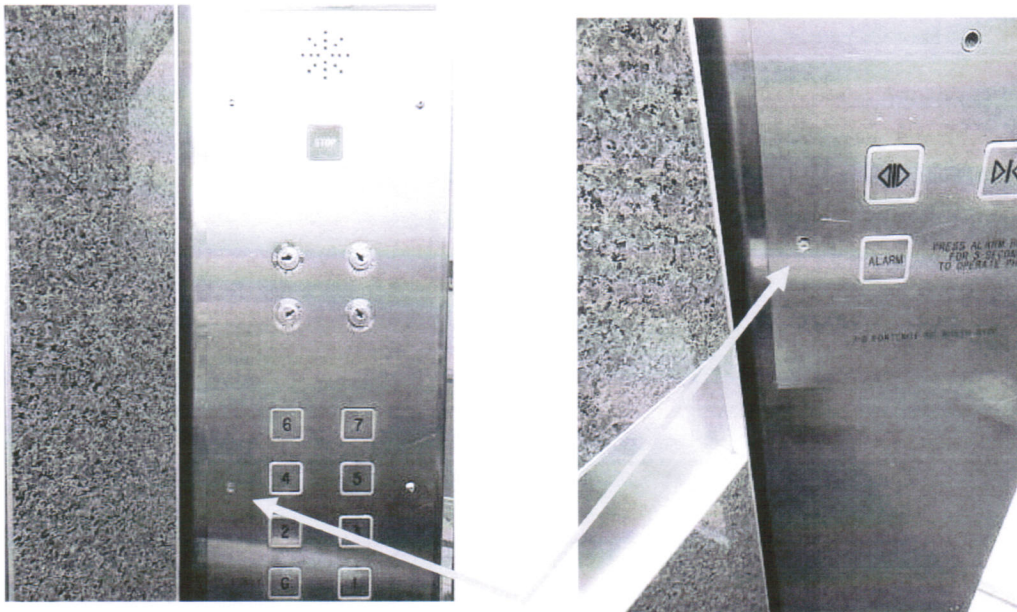
Missing screws need to be replaced in all car operating panels

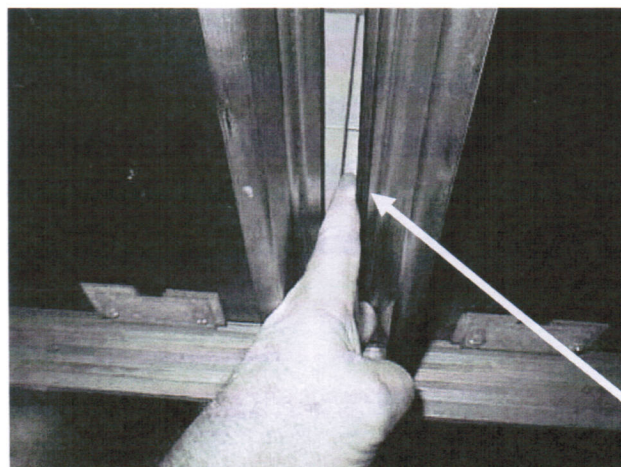
Several landing door upthrusts require adjustment

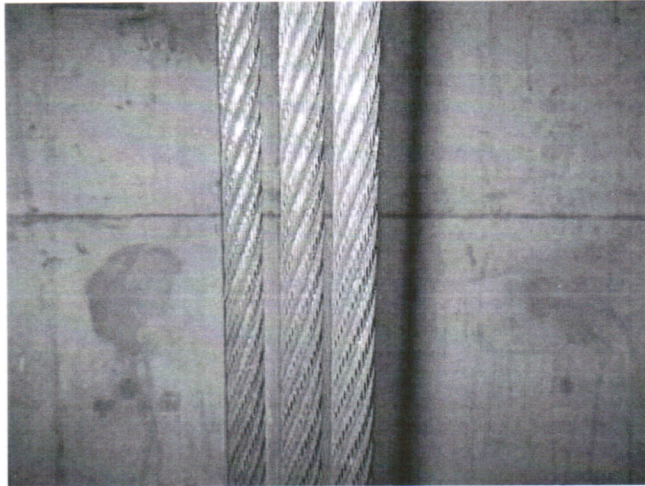
Lift 4 – rusted lifting ropes need to be replaced immediately

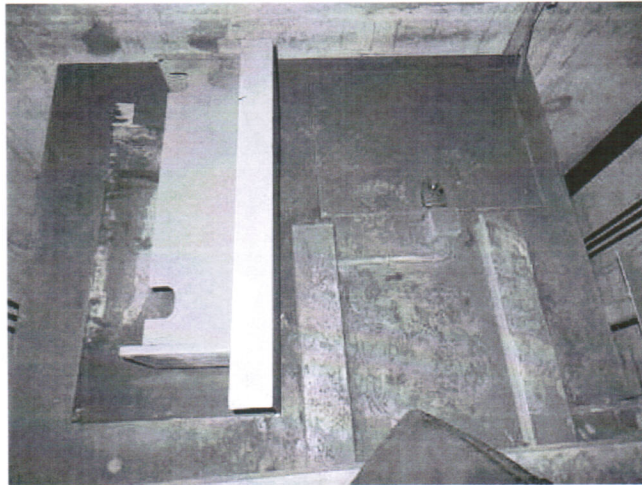
Lift 4 - Red rust dust on top of the lift car

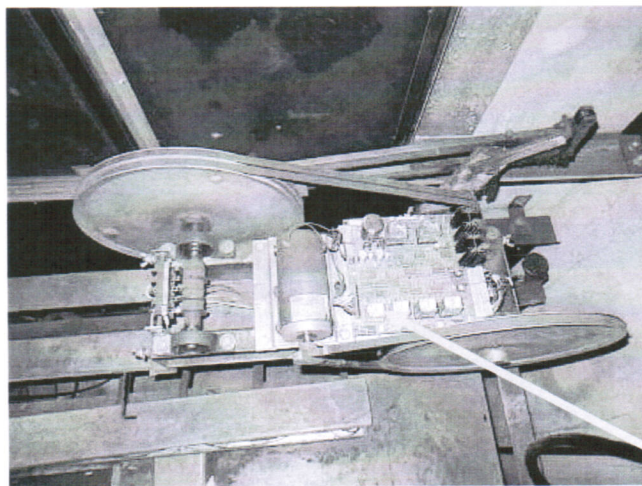
Lift 4 – the power door operator cover needs to be refitted ASAP

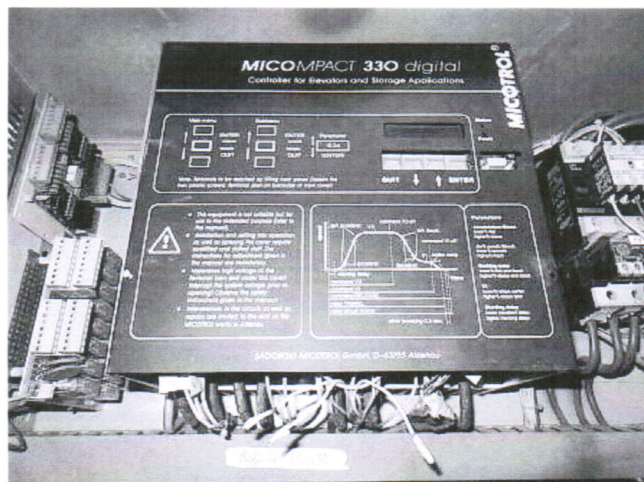
The VVAC drive unit is obsolete with no new replacement parts available

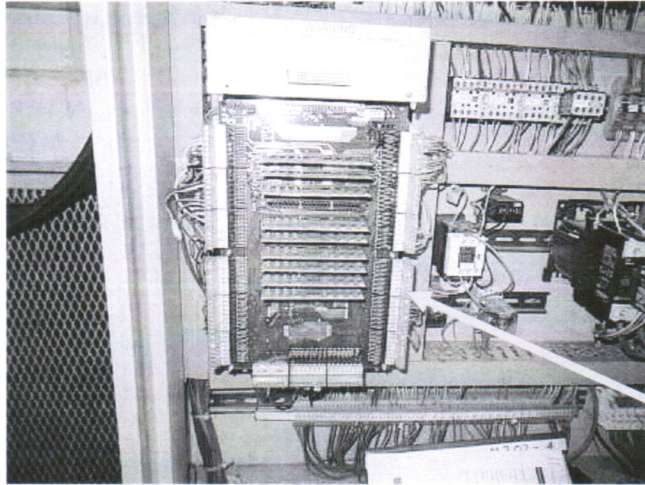
The lift controller microprocessor is an old design however parts are still available. There are numerous separate boards which all plug into a central rack arrangement

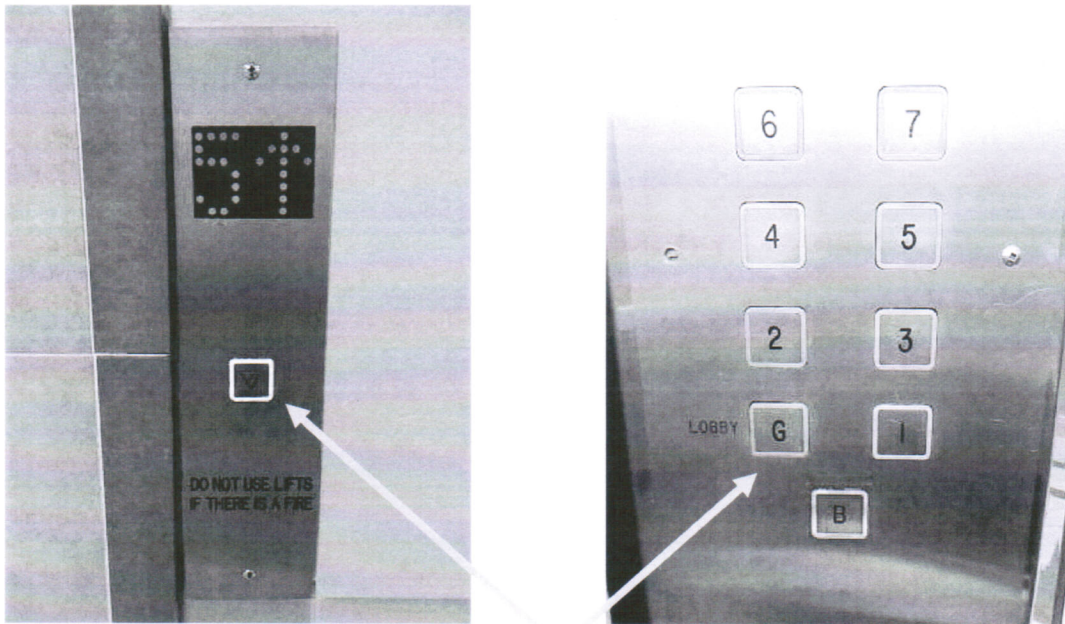
All lift car and landing buttons are obsolete with no new replacement parts available
