Hazard & Risk audit report for

Macquarie Gardens

1-15 Fontenoy Rd

Evaluation of Macquarie Gardens

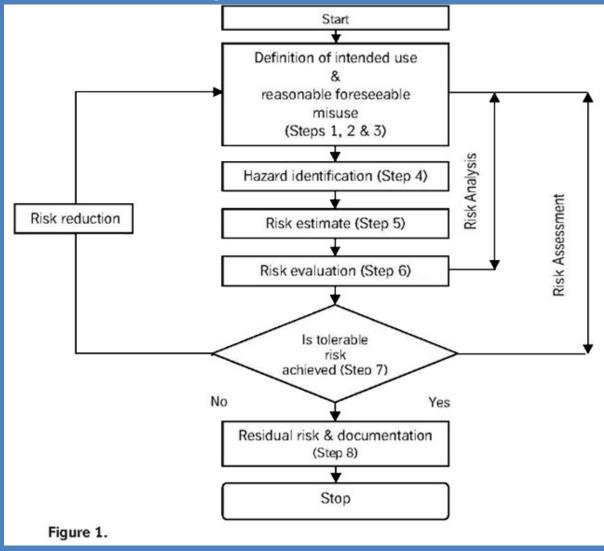
The step-by-step process is shown in Figure 1.

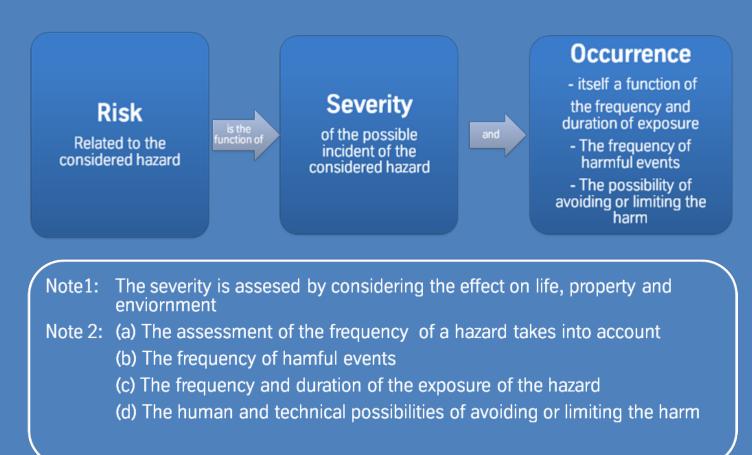
• Figure2:

The cause and effect of each hazard is assessed in terms of probability of occurrence of the hazard and the severity of its effect(s). The combination of severity and frequency quantifies the risk associated with the hazard. Figure 2 is a schematic representation of risk assessment.

Schematic representation of risk assessment
