Major upgrades on 26 townhouses in amount of \$92,950.00 in 2017 without evidence of work done

1 SP52948 – Solicitor Adrian Mueller, on behalf of owners corporation, confirming that maintenance of common property is compulsory and that some strata files are missing on 14th of November 2019

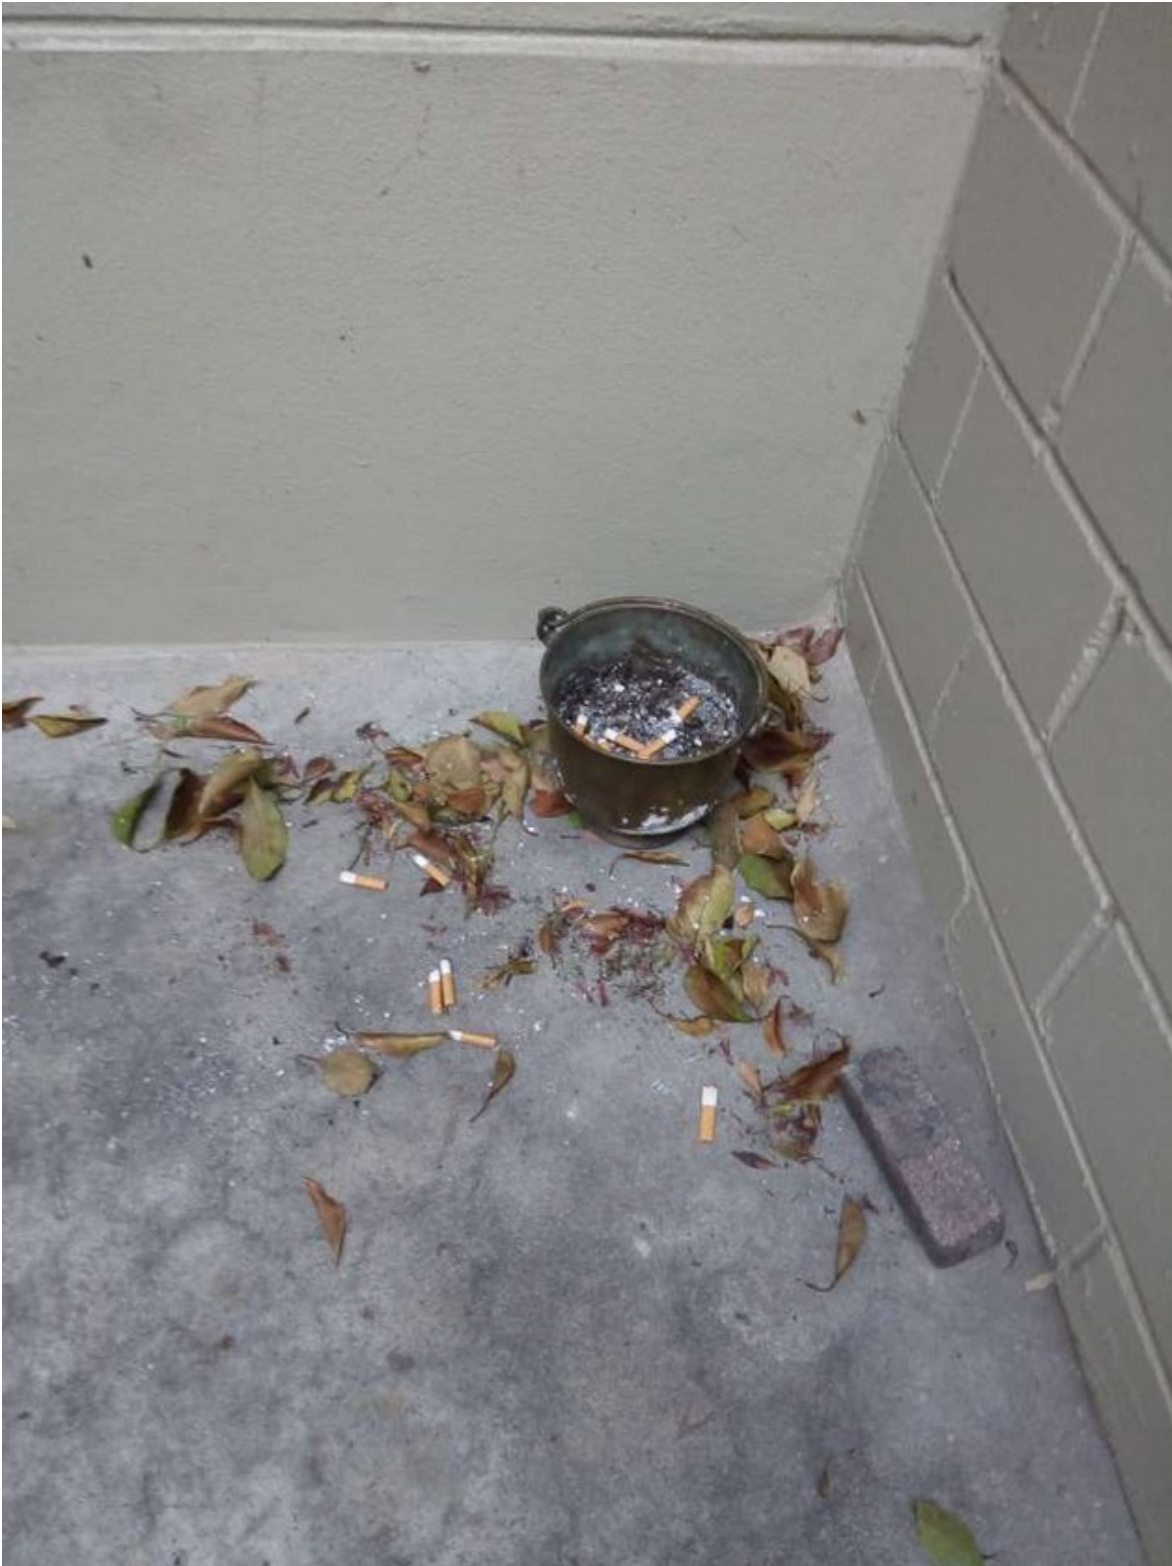
Example of smoking near fire door 2 below Block A in November 2018:

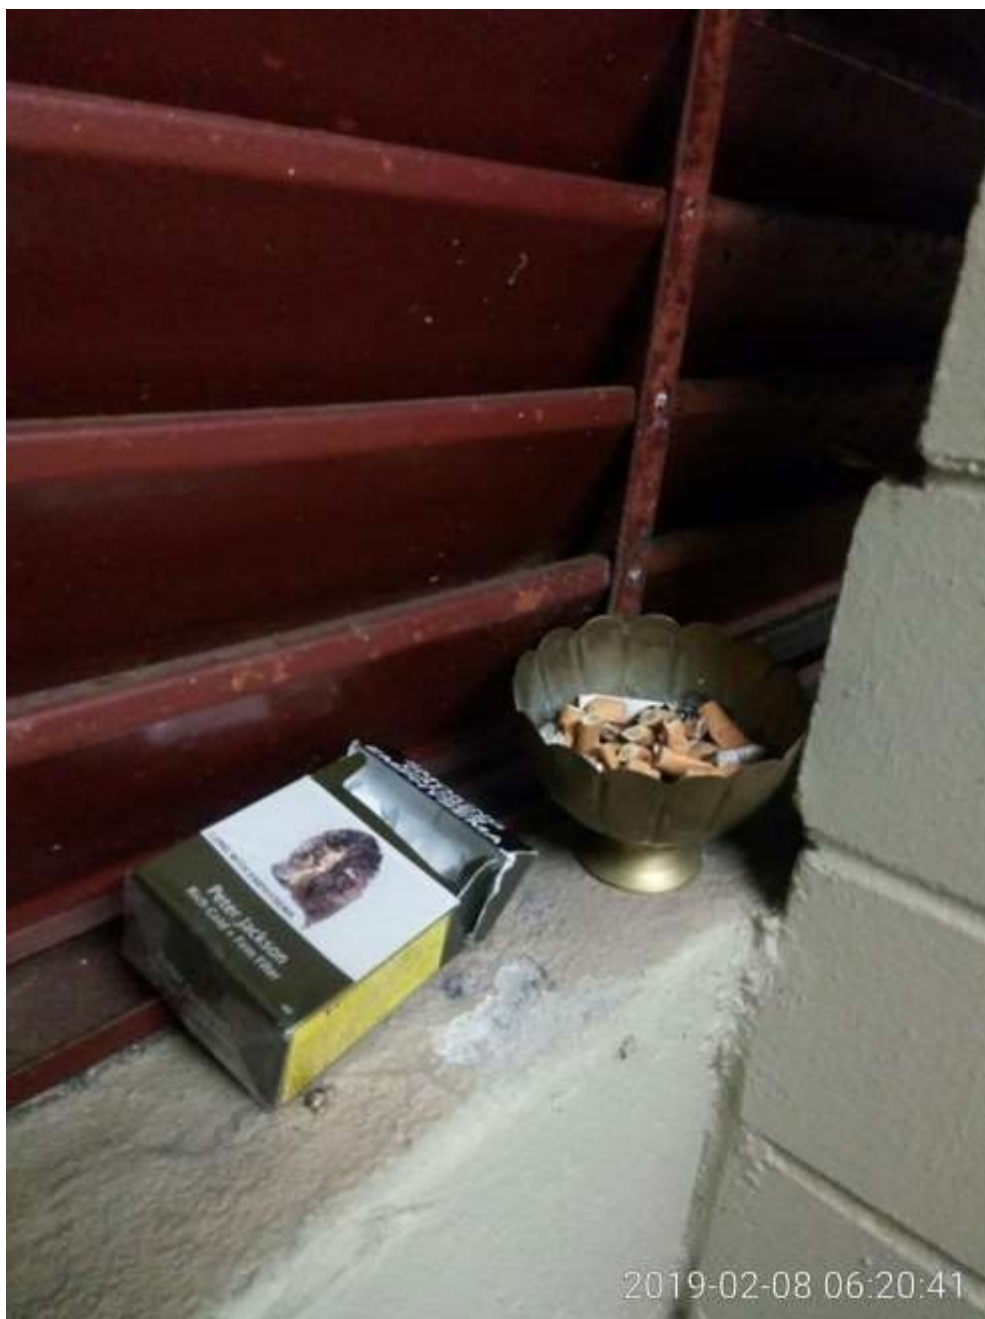
Example of hiding cigarette butts near louvres behind fire door 2 below Block A in February 2019:

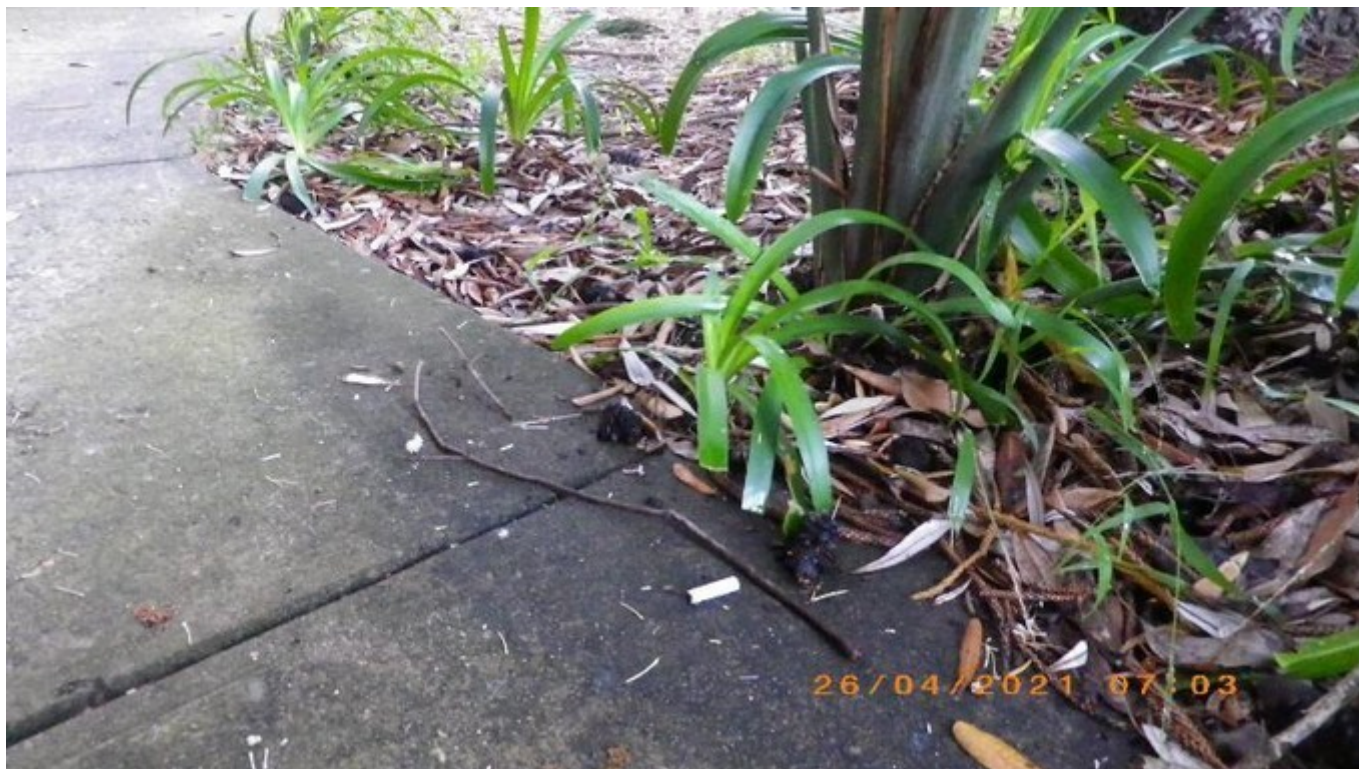
17 Smoking in the complex continue to be a serious fire safety risk – Block D garden pathway where lot of dry barks and leaves cover the grounds

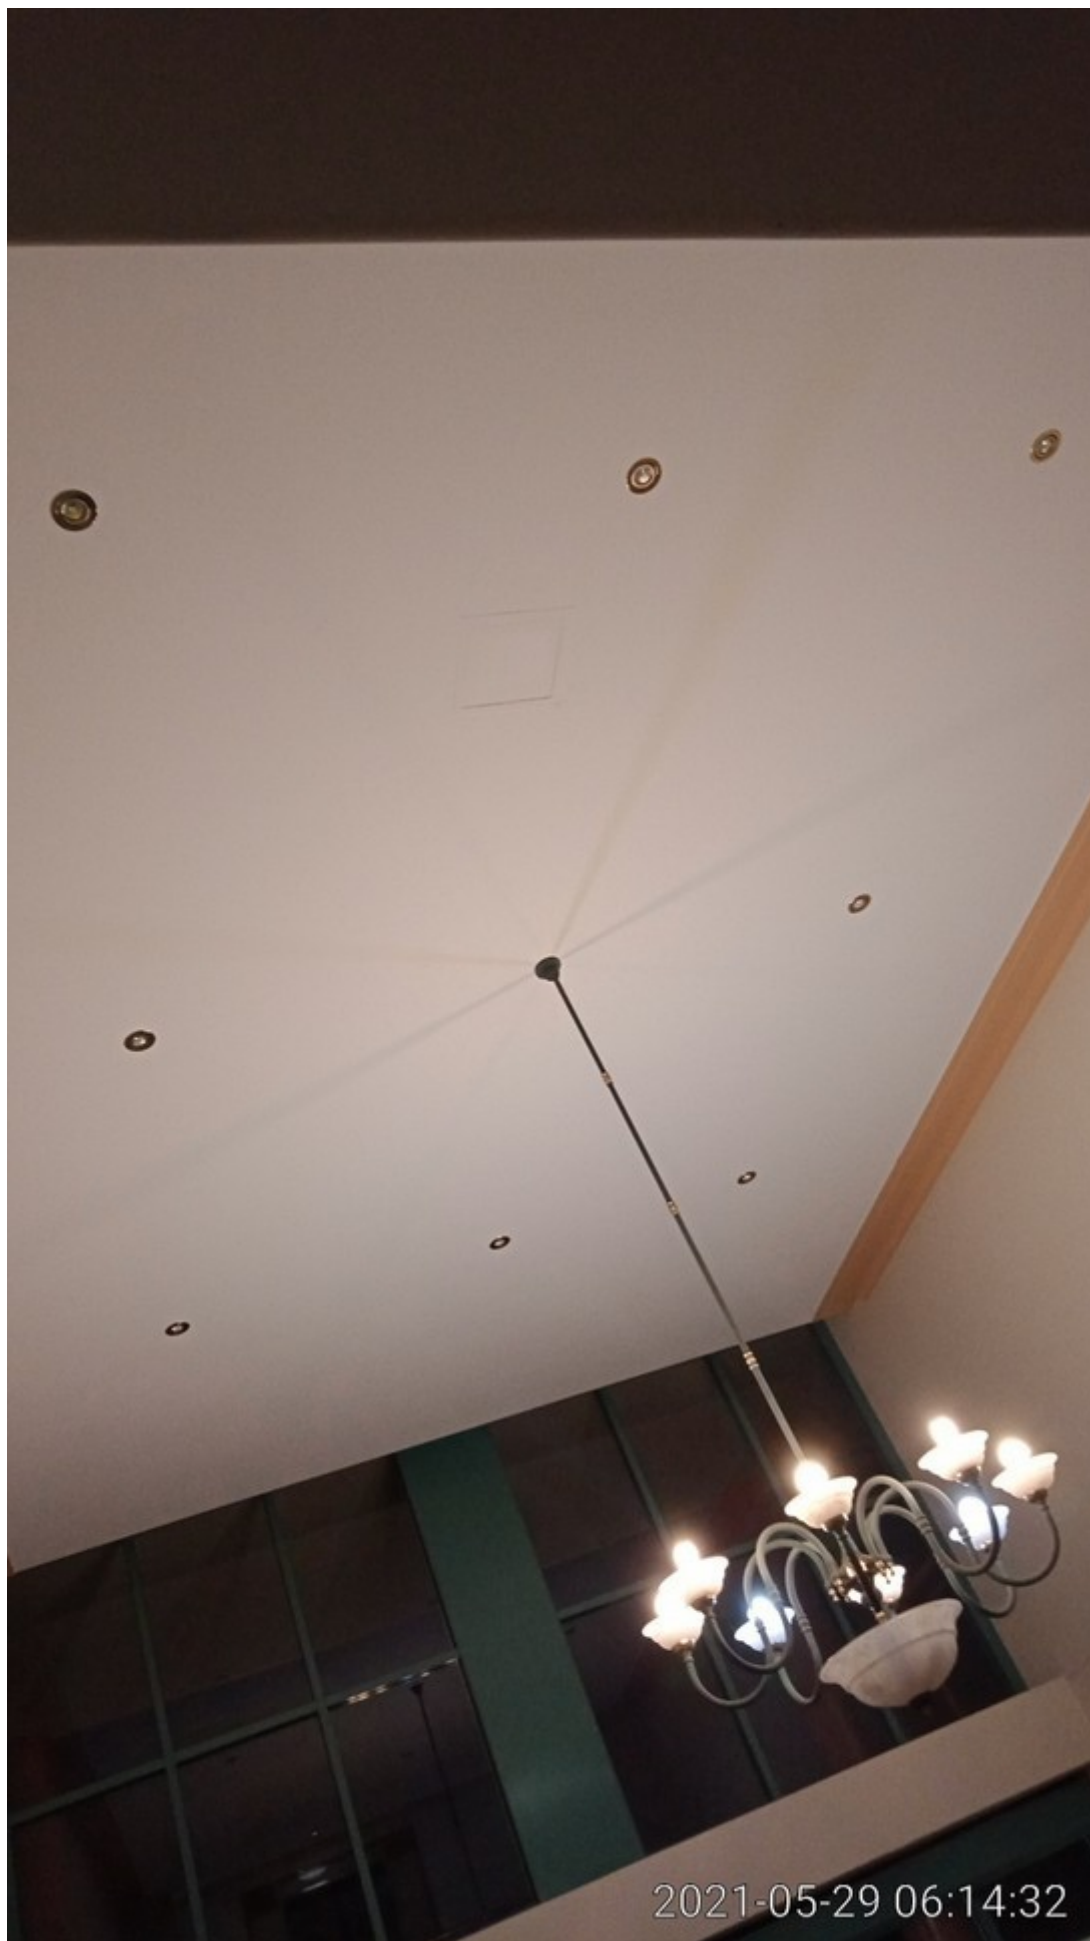
c) Block C, none of eight down-lights operational

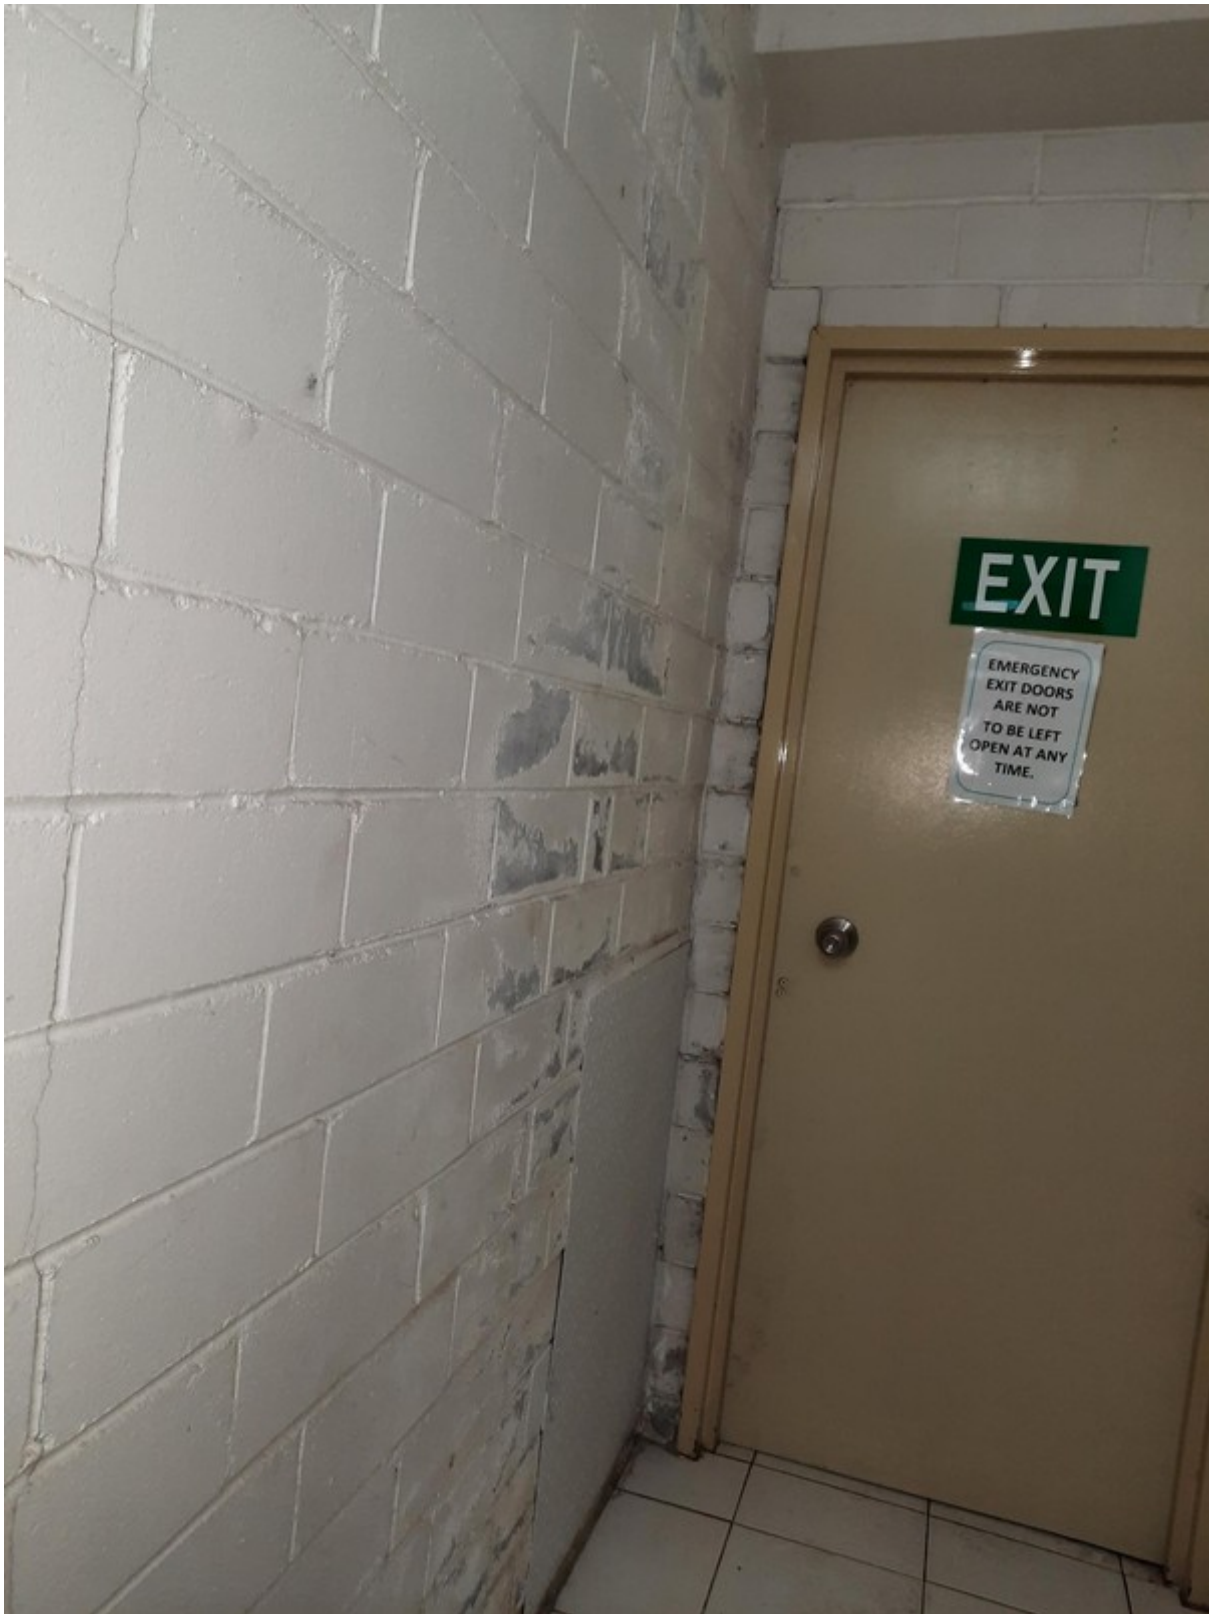
33 Example of water leak damages near fire door exit in Block C ground floor in June 2021

Wall was repainted in July 2021, but the metal plate stayed as is on 1st of October 2021.
