Major upgrades on 26 townhouses in amount of \$92,950.00 in 2017 without evidence of work done

This document lists just some of the problems in the complex that can cause injury, health problems, or even death in dire circumstances.

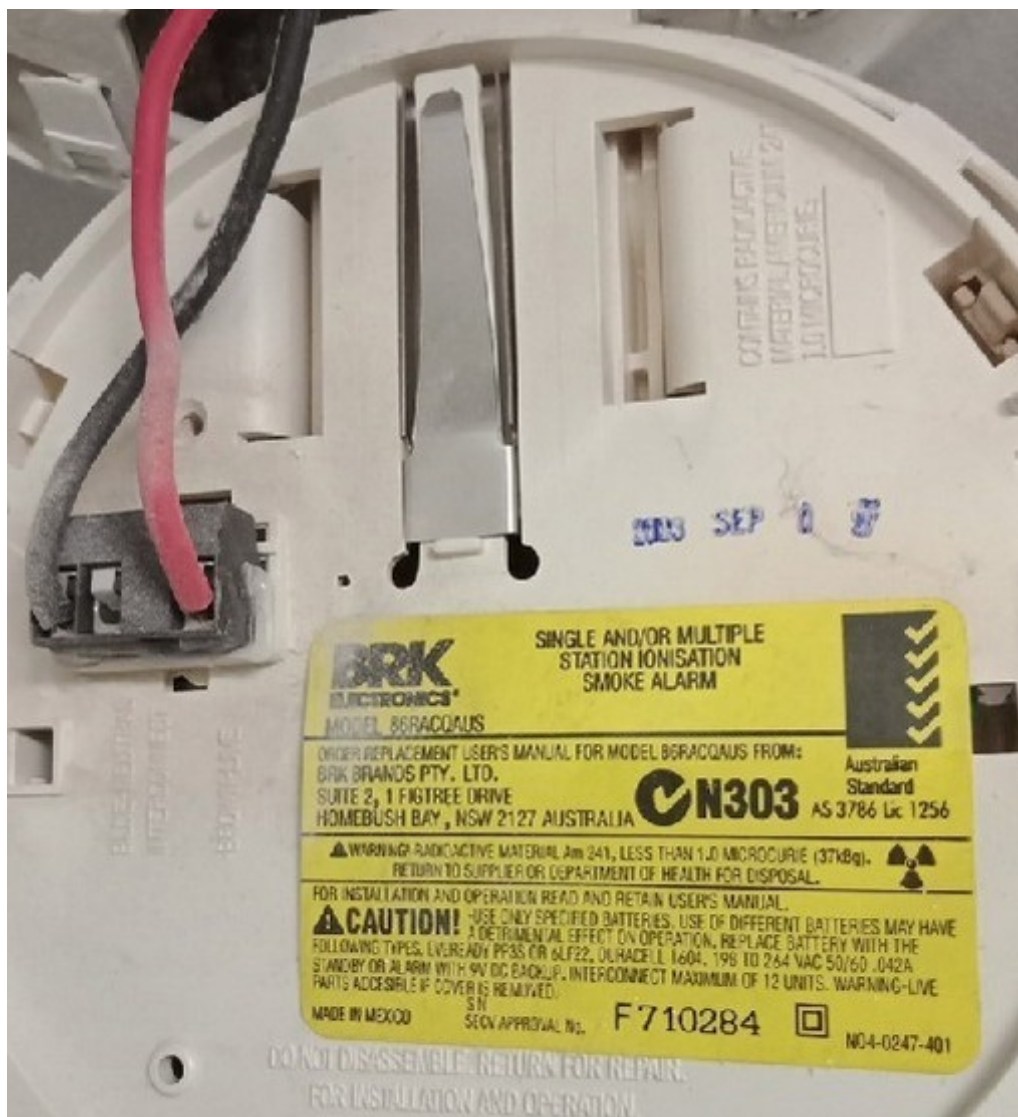
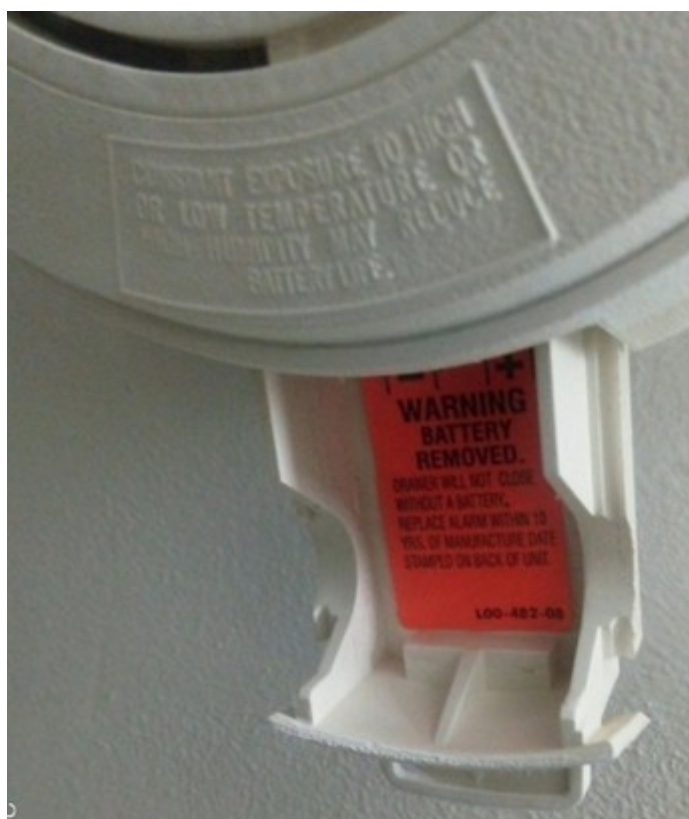
Foyer near main bathroom and kitchen (manufacture date 2008, expired in 2019)

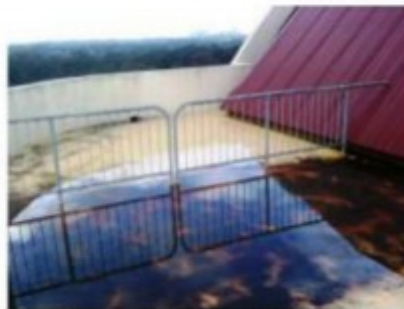
Standing water to flat roof deck, Block A

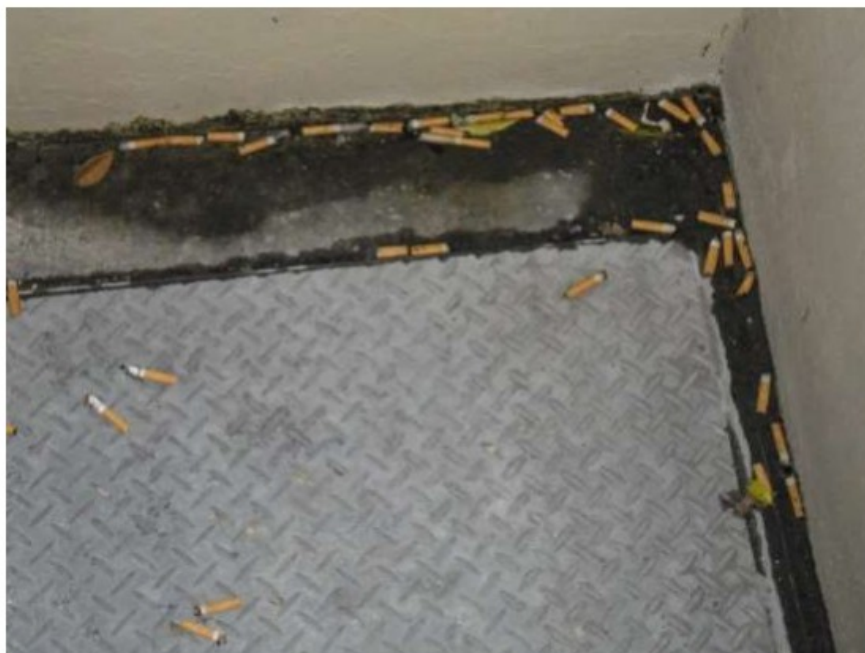
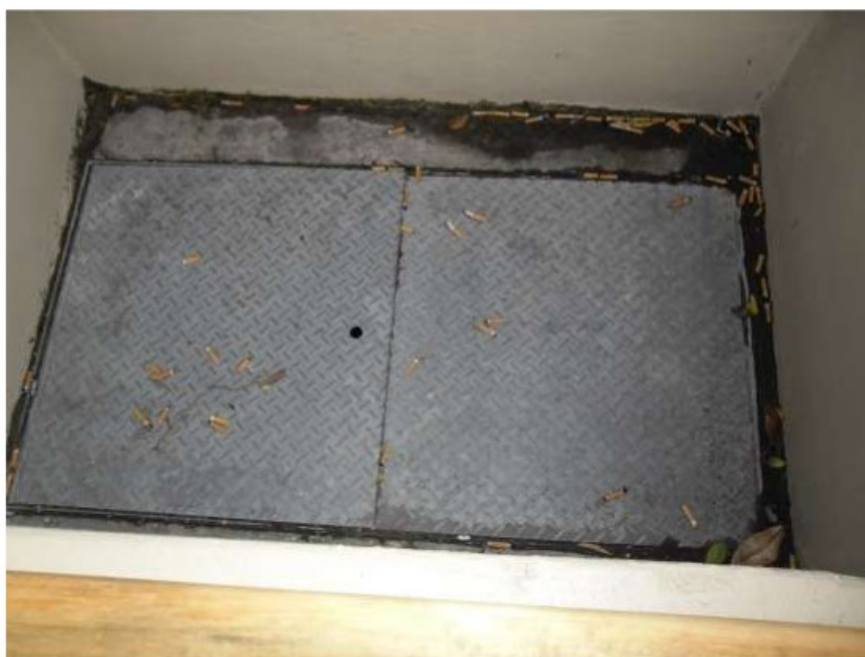
Example of cigarette butt litter on 24th of November 2014:

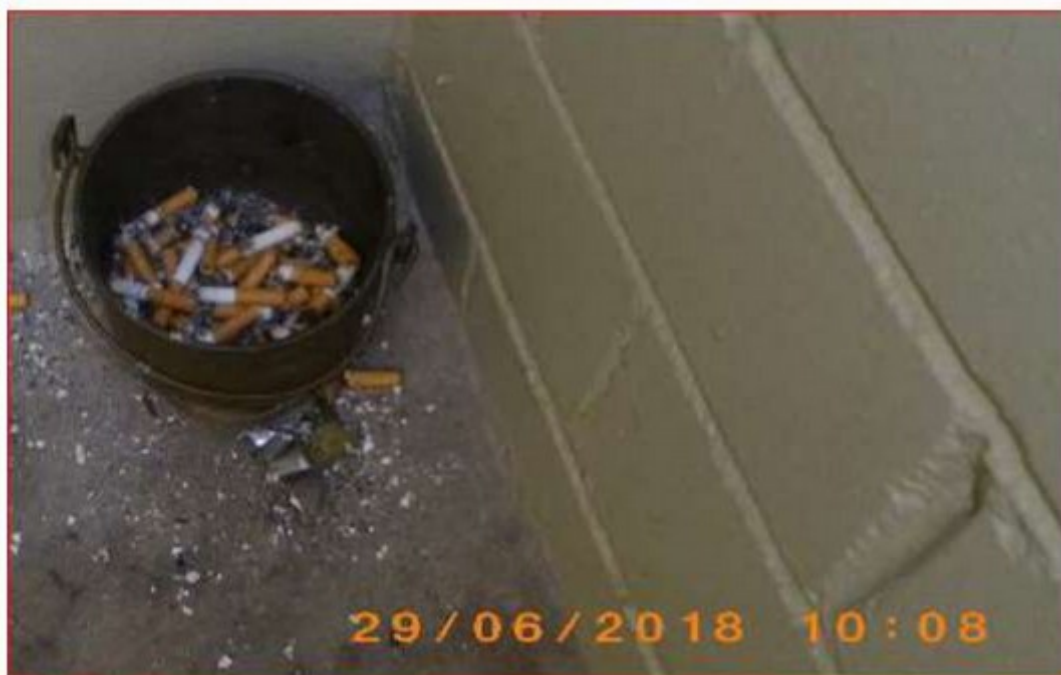
Examples of smoking near fire door 2 below Block A in June and July 2018:

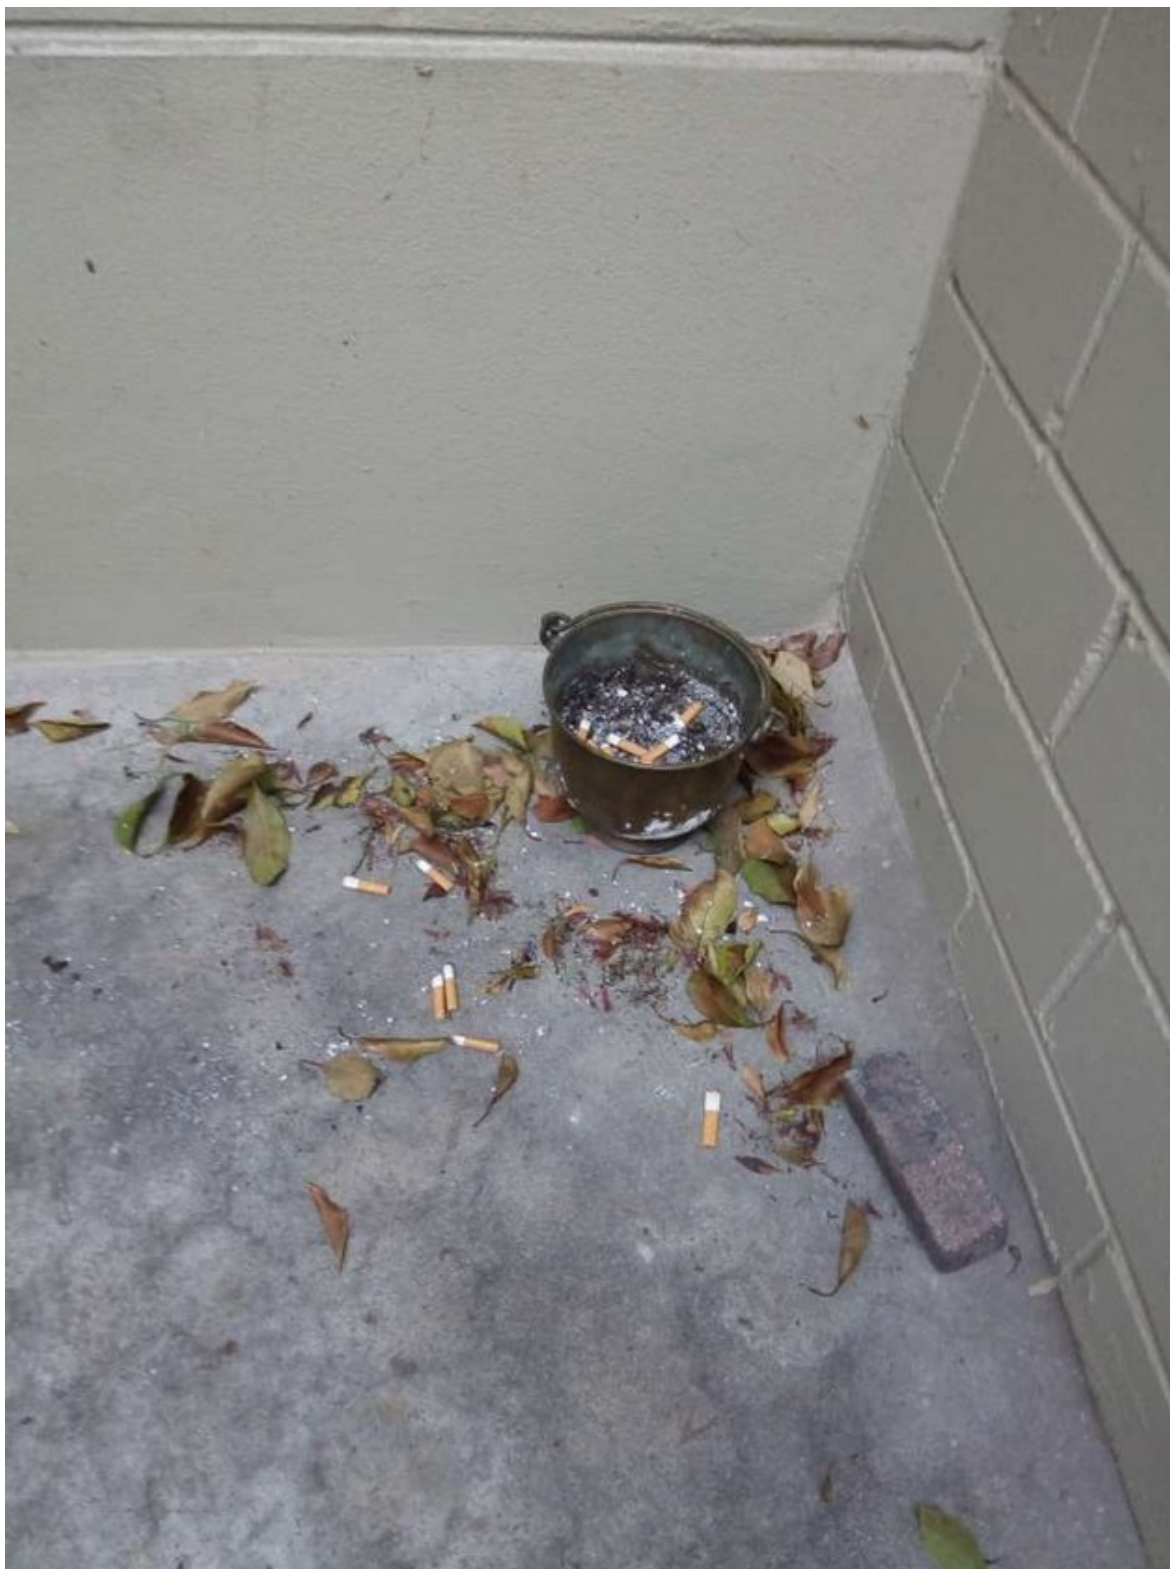
Example of smoking near fire door 2 below Block A in November 2018:

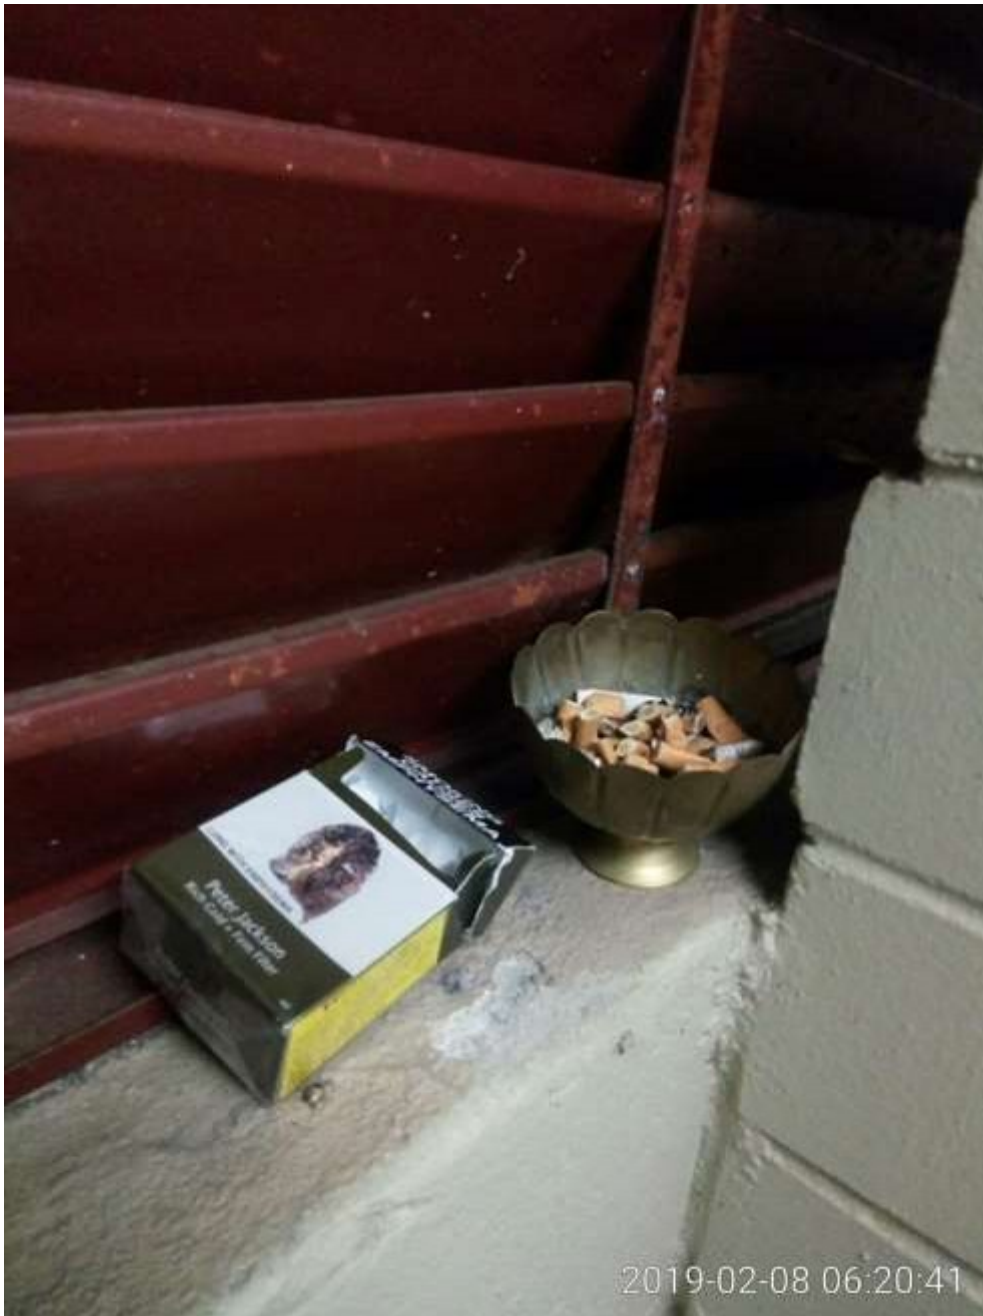
Example of hiding cigarette butts near louvres behind fire door 2 below Block A in February 2019:

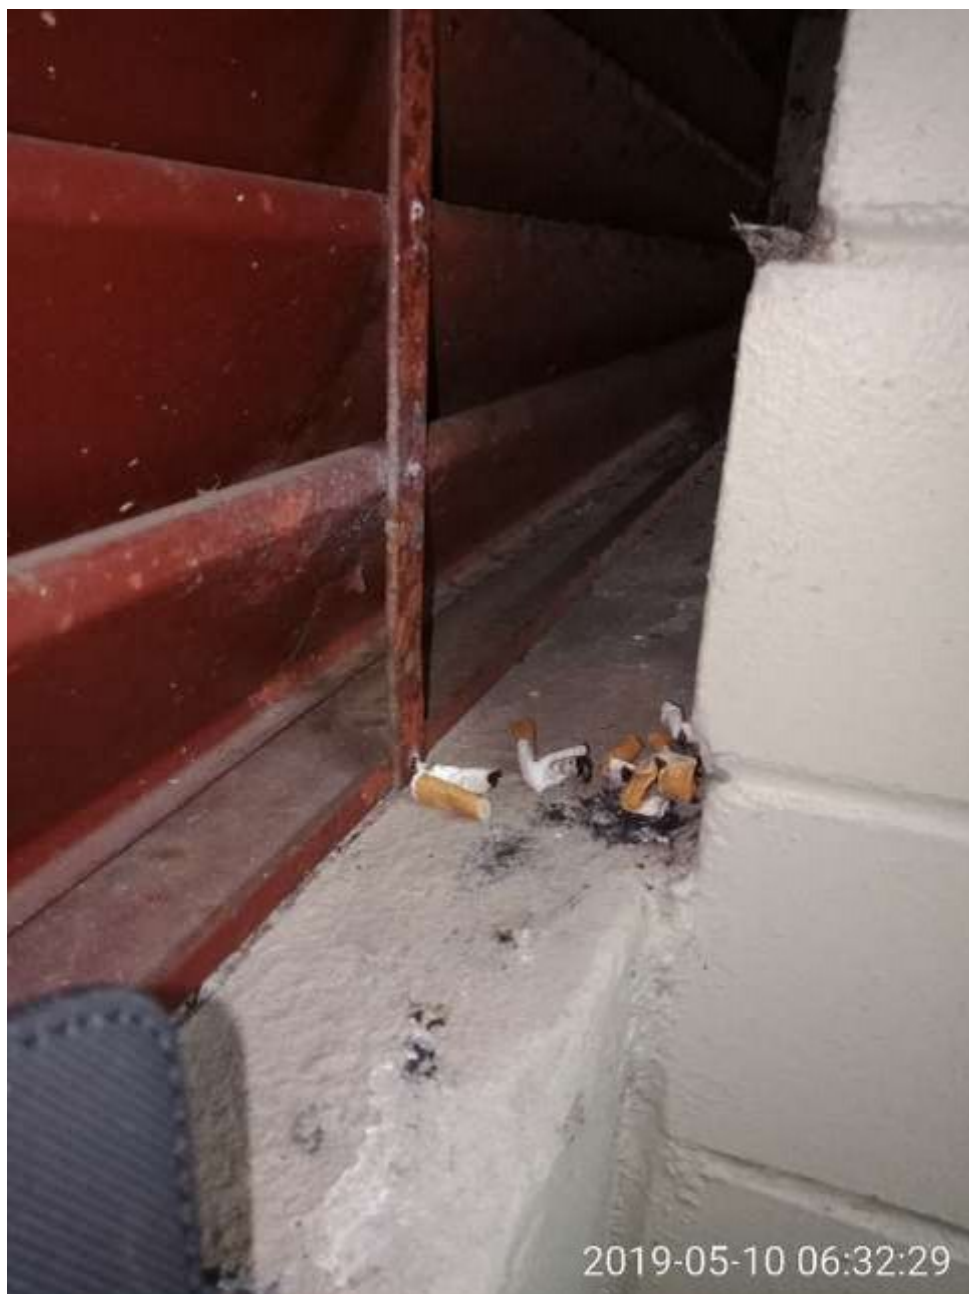
Example of hiding cigarette butts near louvres behind fire door 2 below Block A in May 2019:

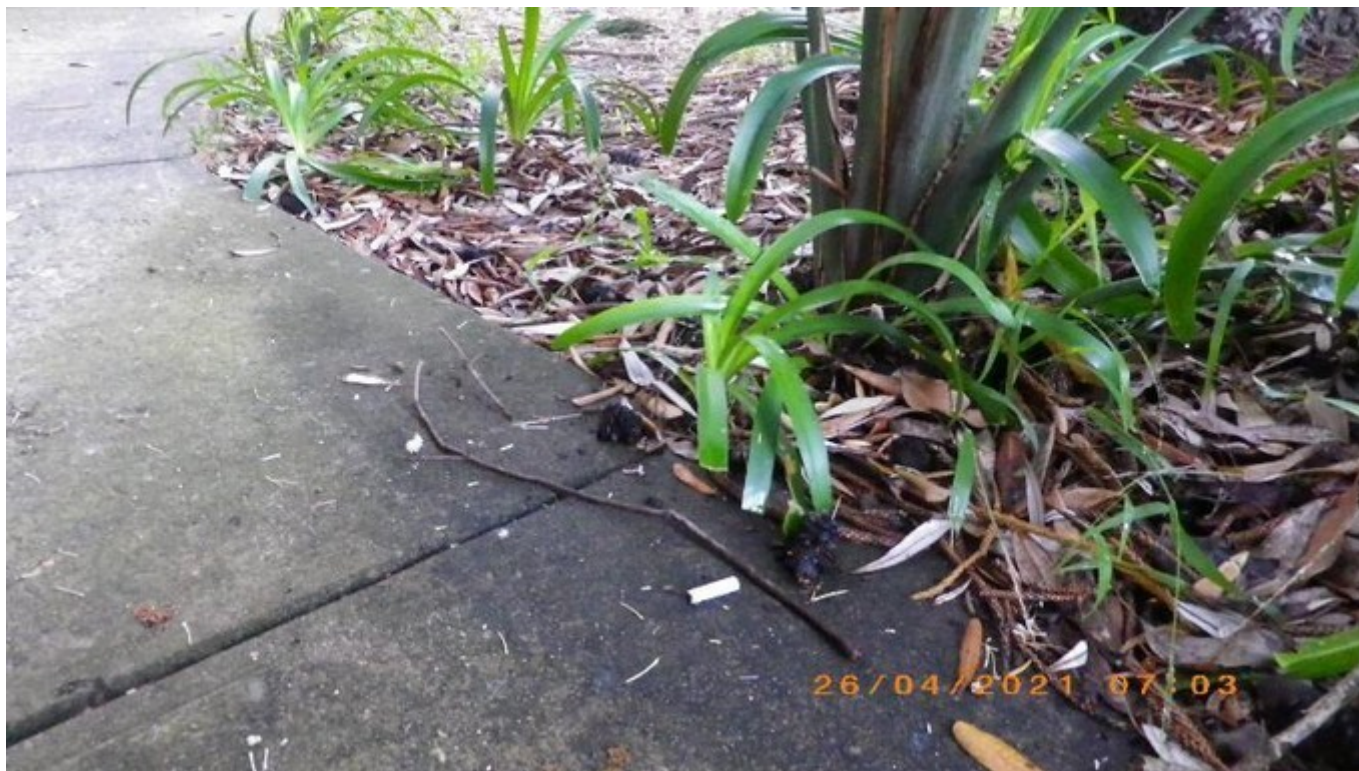
16 Smoking in the complex continue to be a serious fire safety risk – Block D garden pathway where lot of dry barks and leaves cover the grounds

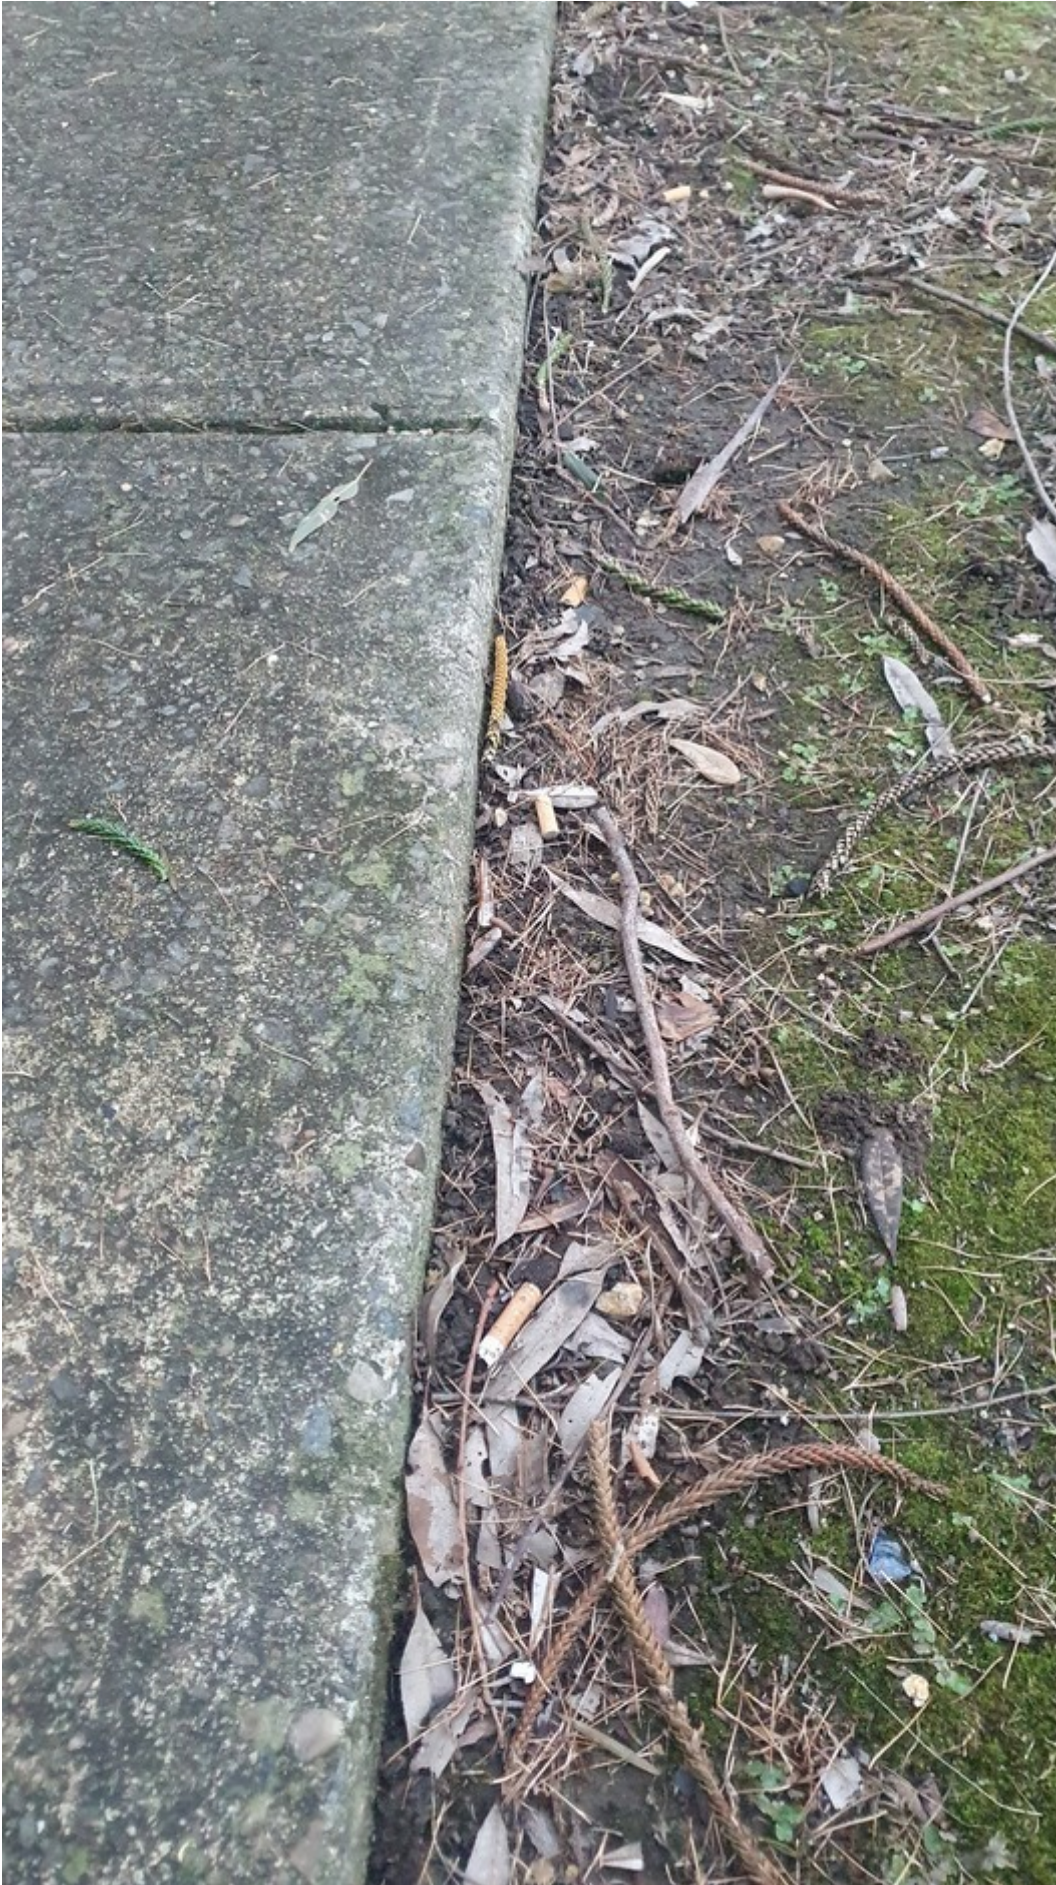
Photo taken on 16th of July 2021 prove the same problem is still in existence:

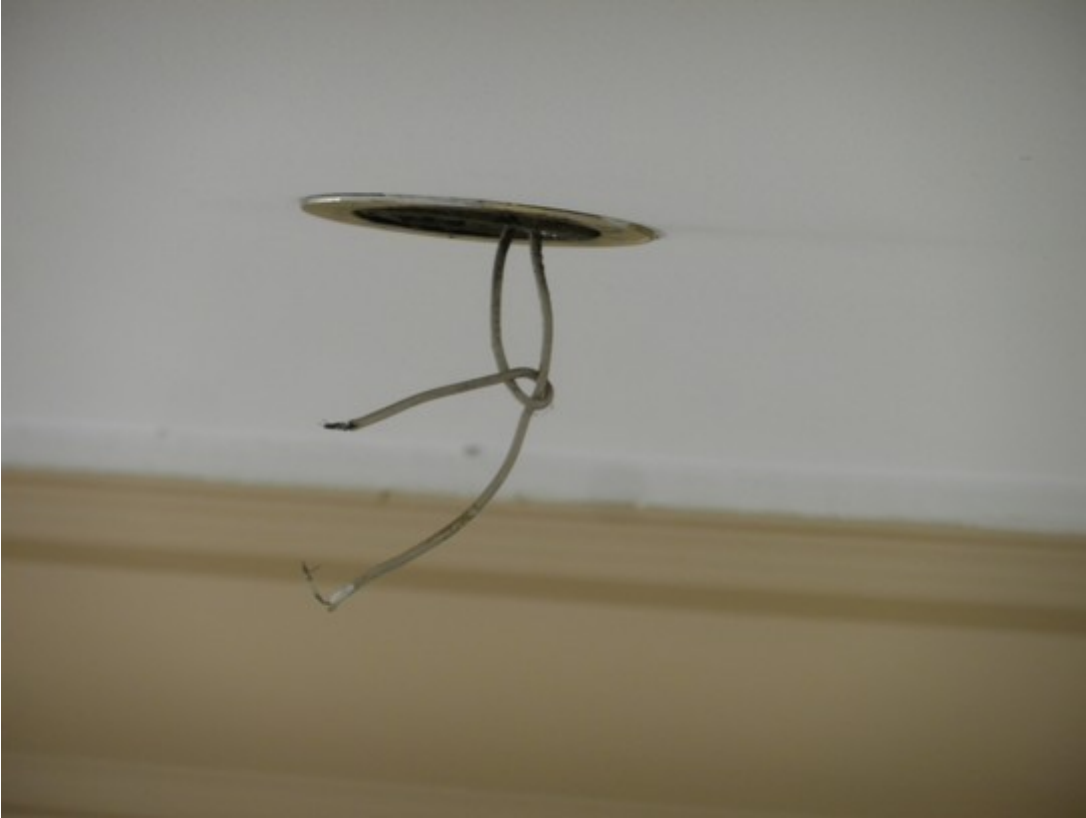
18 Electrical wires on ceiling for one down-light in Block D foyer for more than one year

Reported to strata managers repeatedly, Still an unresolved issue.

Not only down-light is not operational but potentially live wires are protruding from the ceiling.

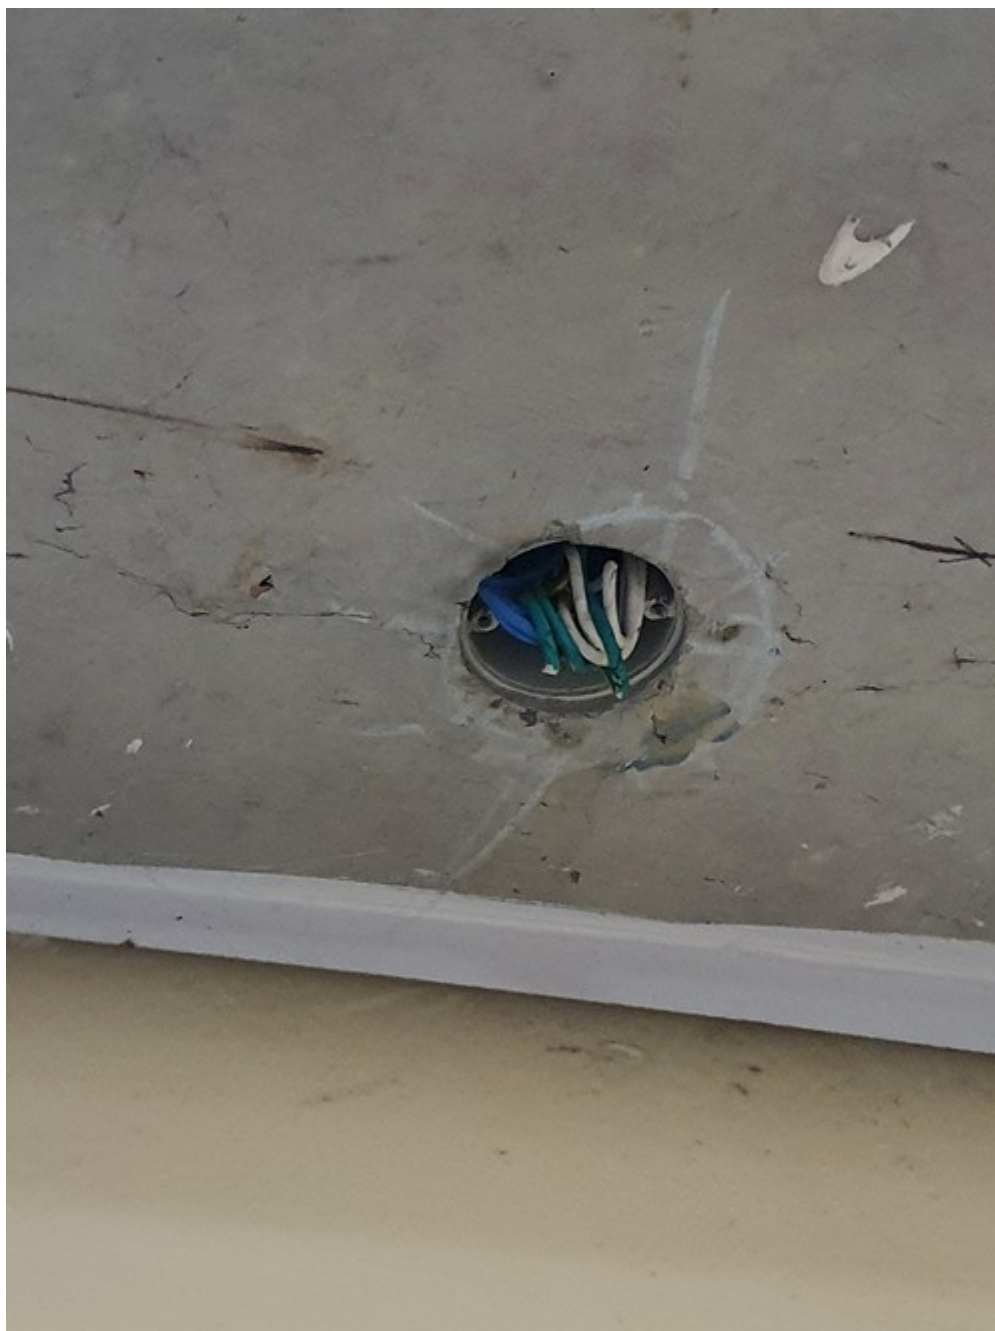
19 Electrical wires on ceiling in basement of Block A foyer for more than two years

Photo taken on 11th of July 2021:

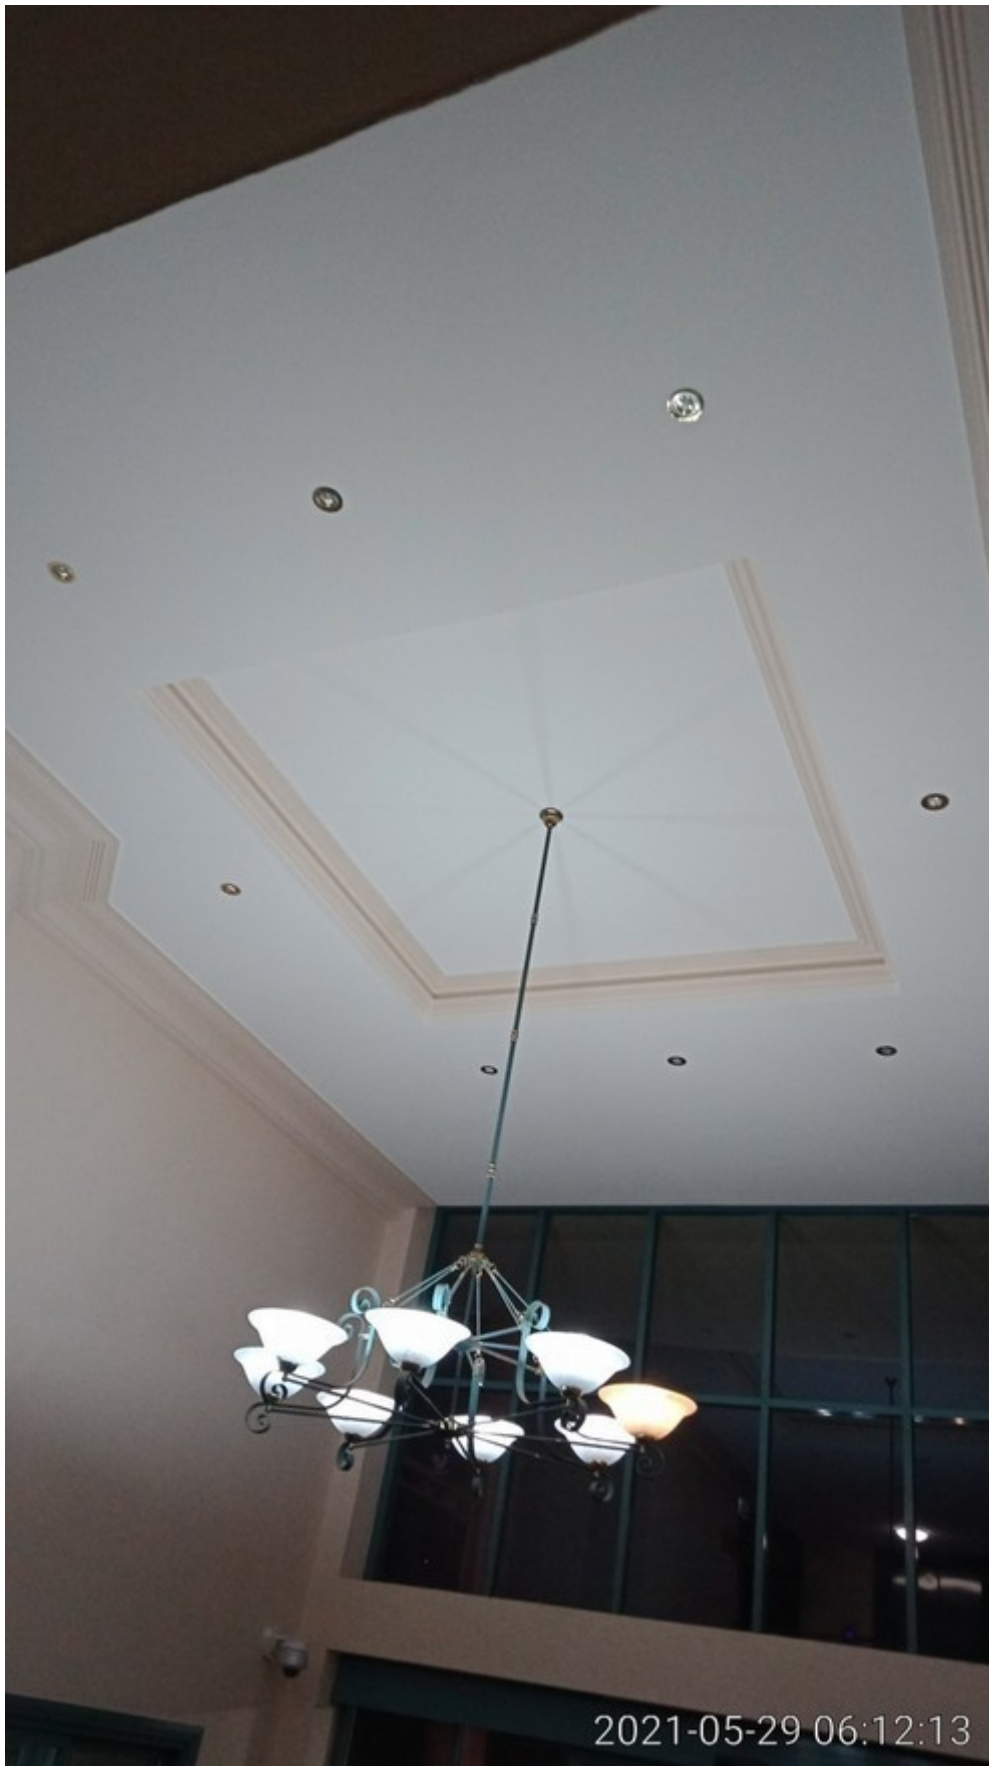
20 Down-lights not-operational in foyers of all four buildings for at least one year

a) Block A, none of eight down-lights operational

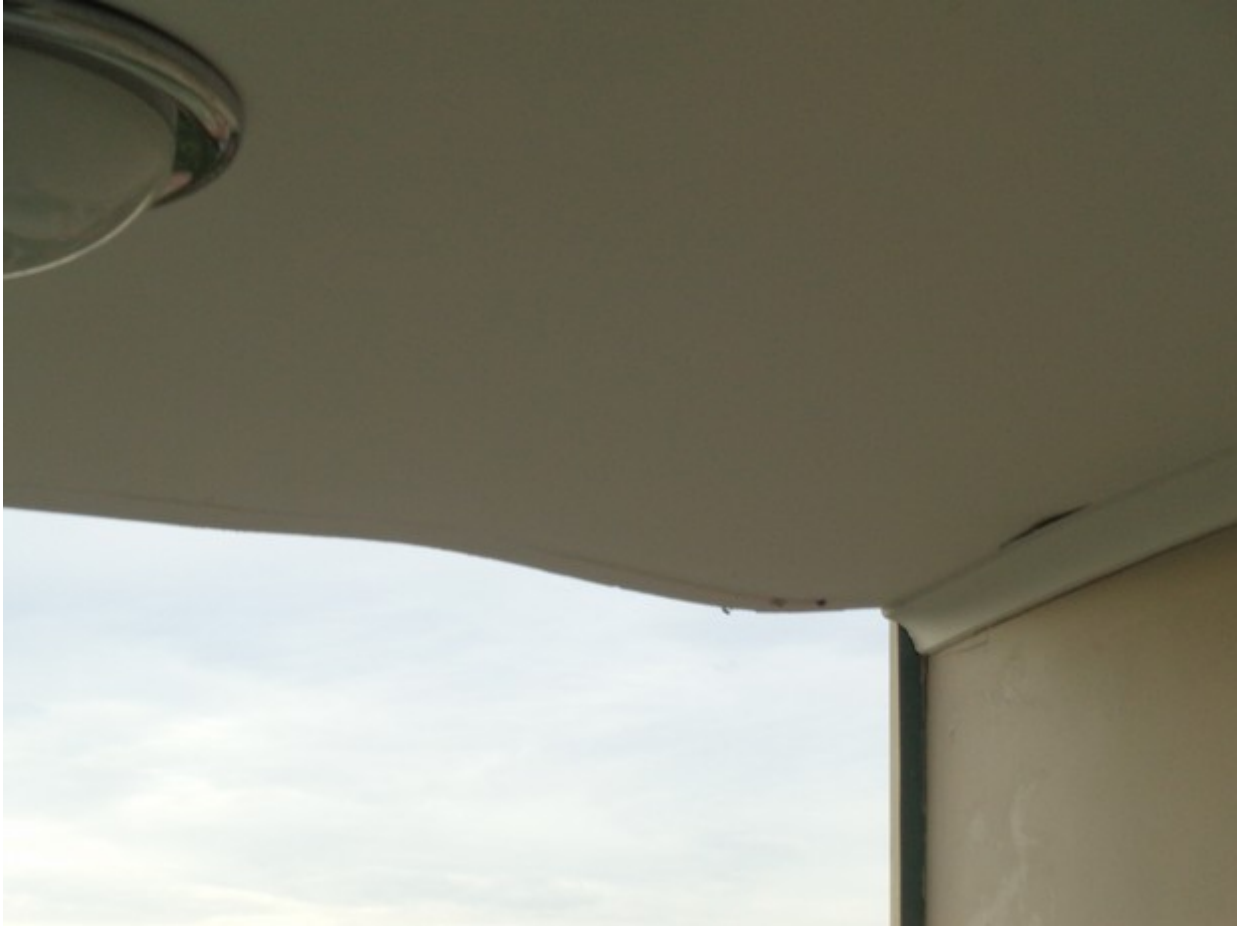
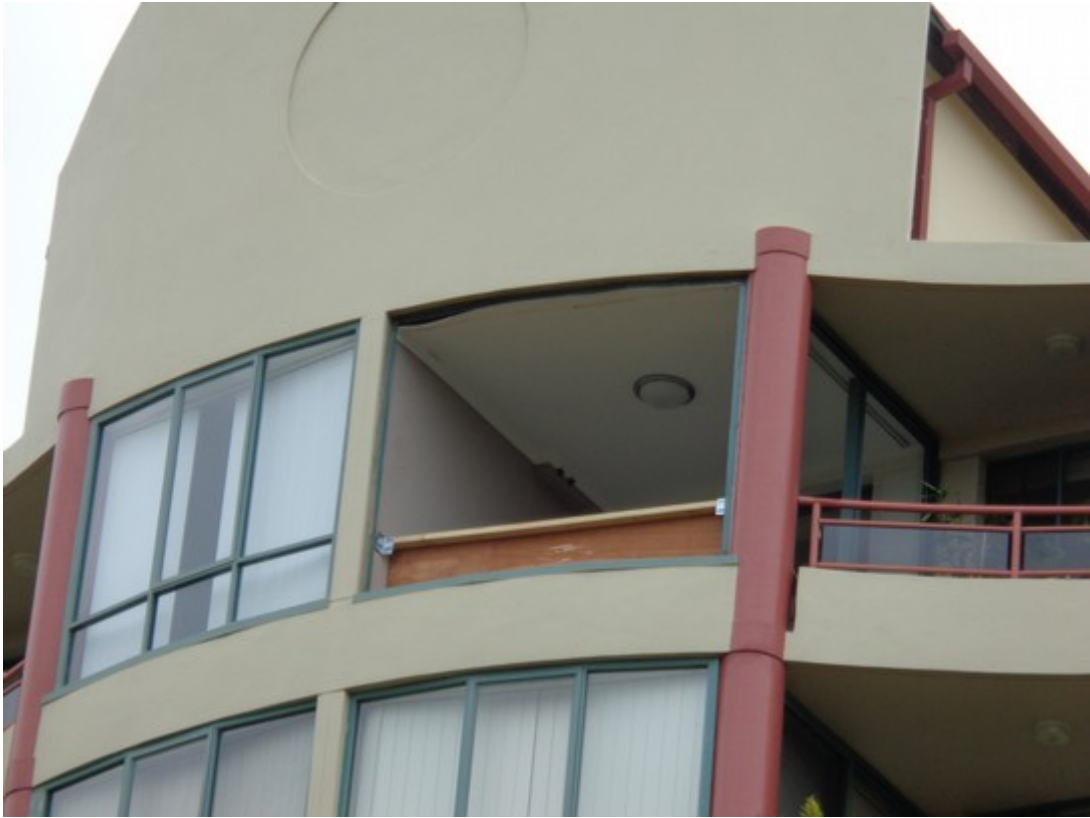
- Third time it happened on 29th of November 2020 for Lot 190.

SP52948 has been extremely lucky that female tenant of Lot 190 let go off sunroom frame before it was blown in front of the building. She tried to hold onto it but was too weak to prevent the disaster. Otherwise, we would have had major or even fatal incident.

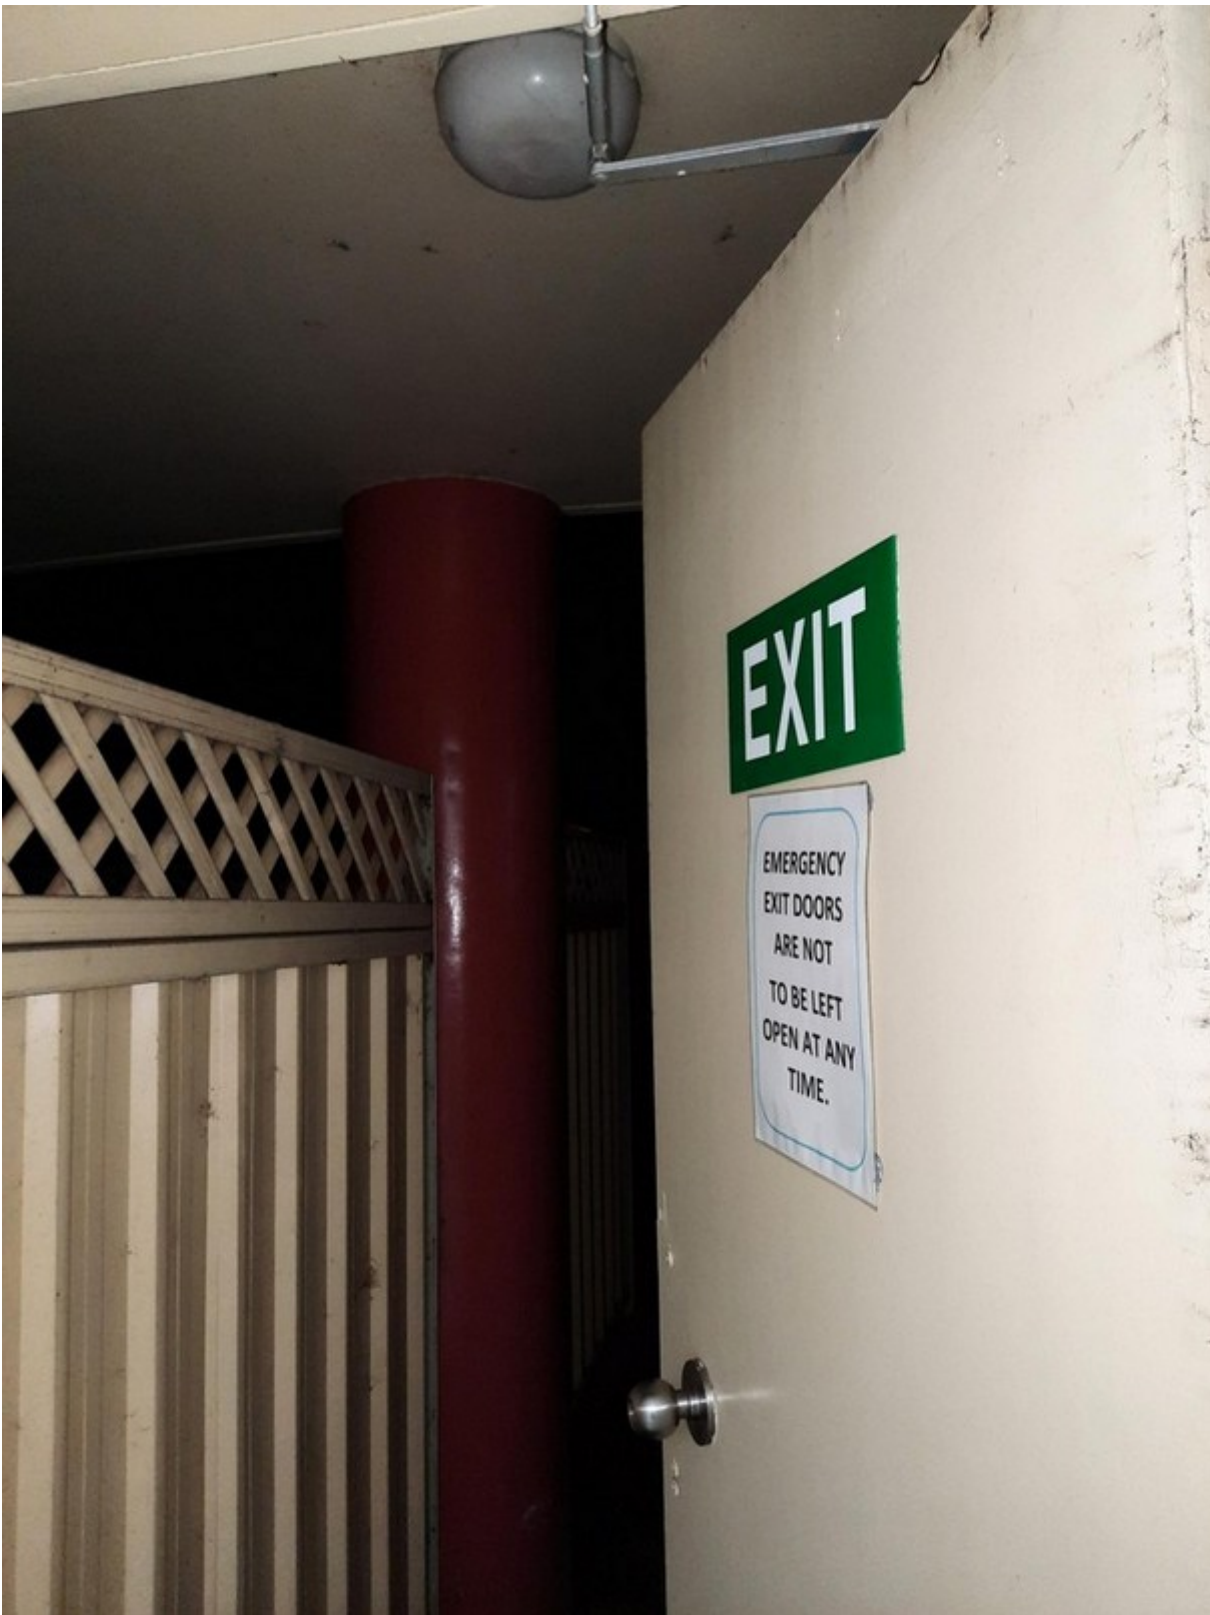
30 Example of fire exit lights out of order for almost two months in late July 2021

Fire exit, ground floor behind Block C, light out of order since 31 May 2021. Photo taken on 22 June 2021:

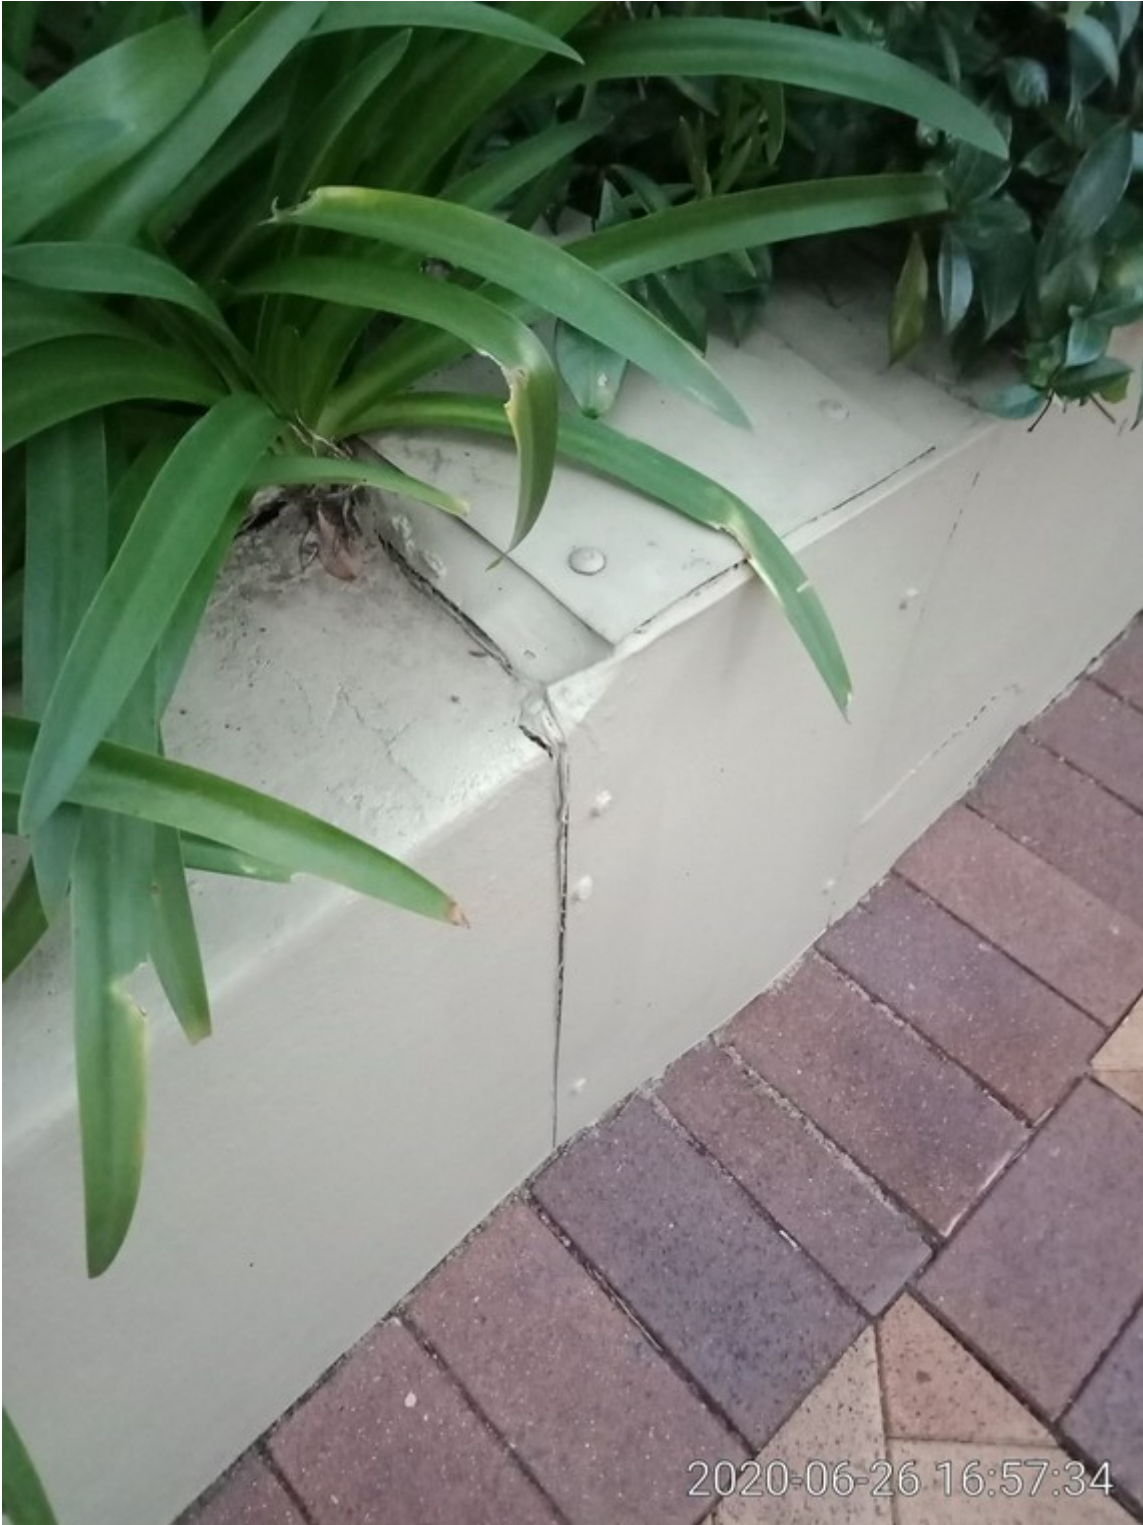
Metal plates, which not only hide status of the concrete behind them but also create safety risks due to sharp edges in areas where children play every day:

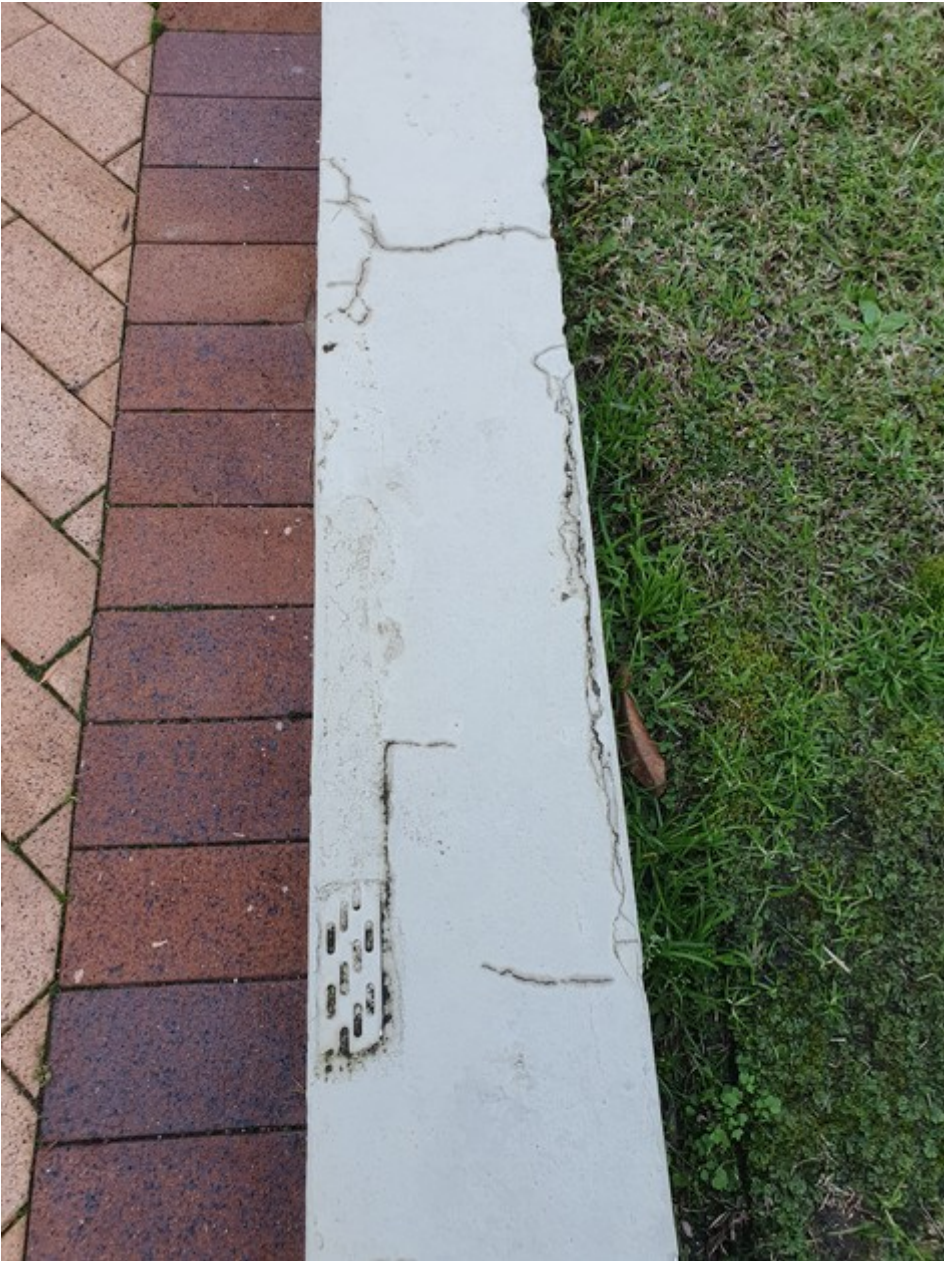
35 Injury hazard with garden bed walls and sharp edges with protruding plastic and metal pieces in areas where children play every day
