Major upgrades on 26 townhouses in amount of \$92,950.00 in 2017 without evidence of work done

This document lists just some of the problems in the complex that can cause injury, health problems, or even death in dire circumstances.

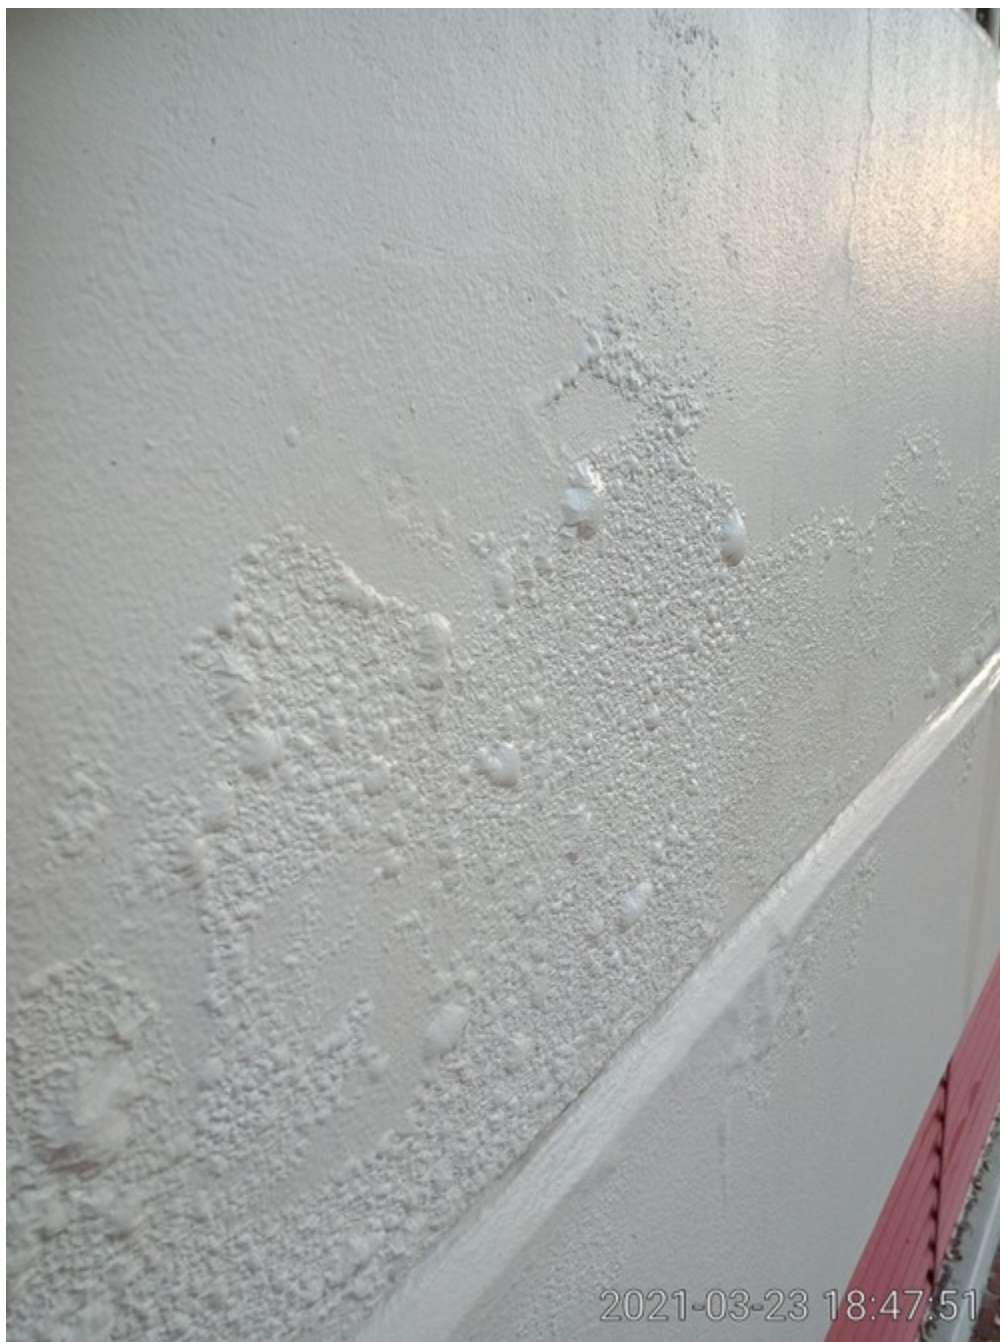
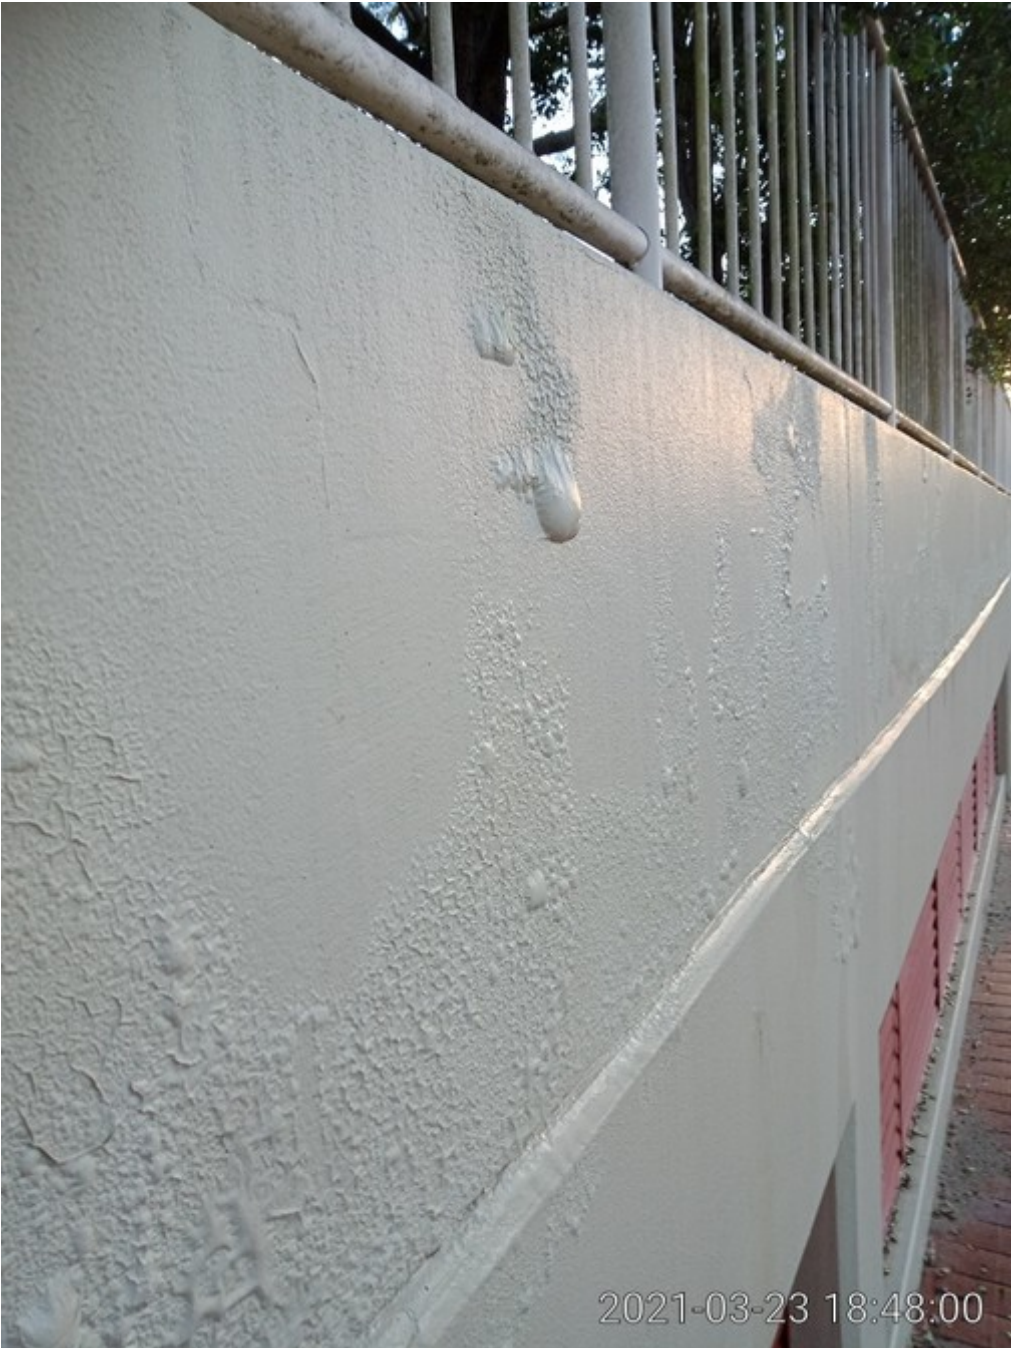
36 Appearance of garden bed walls near tennis courts after rain

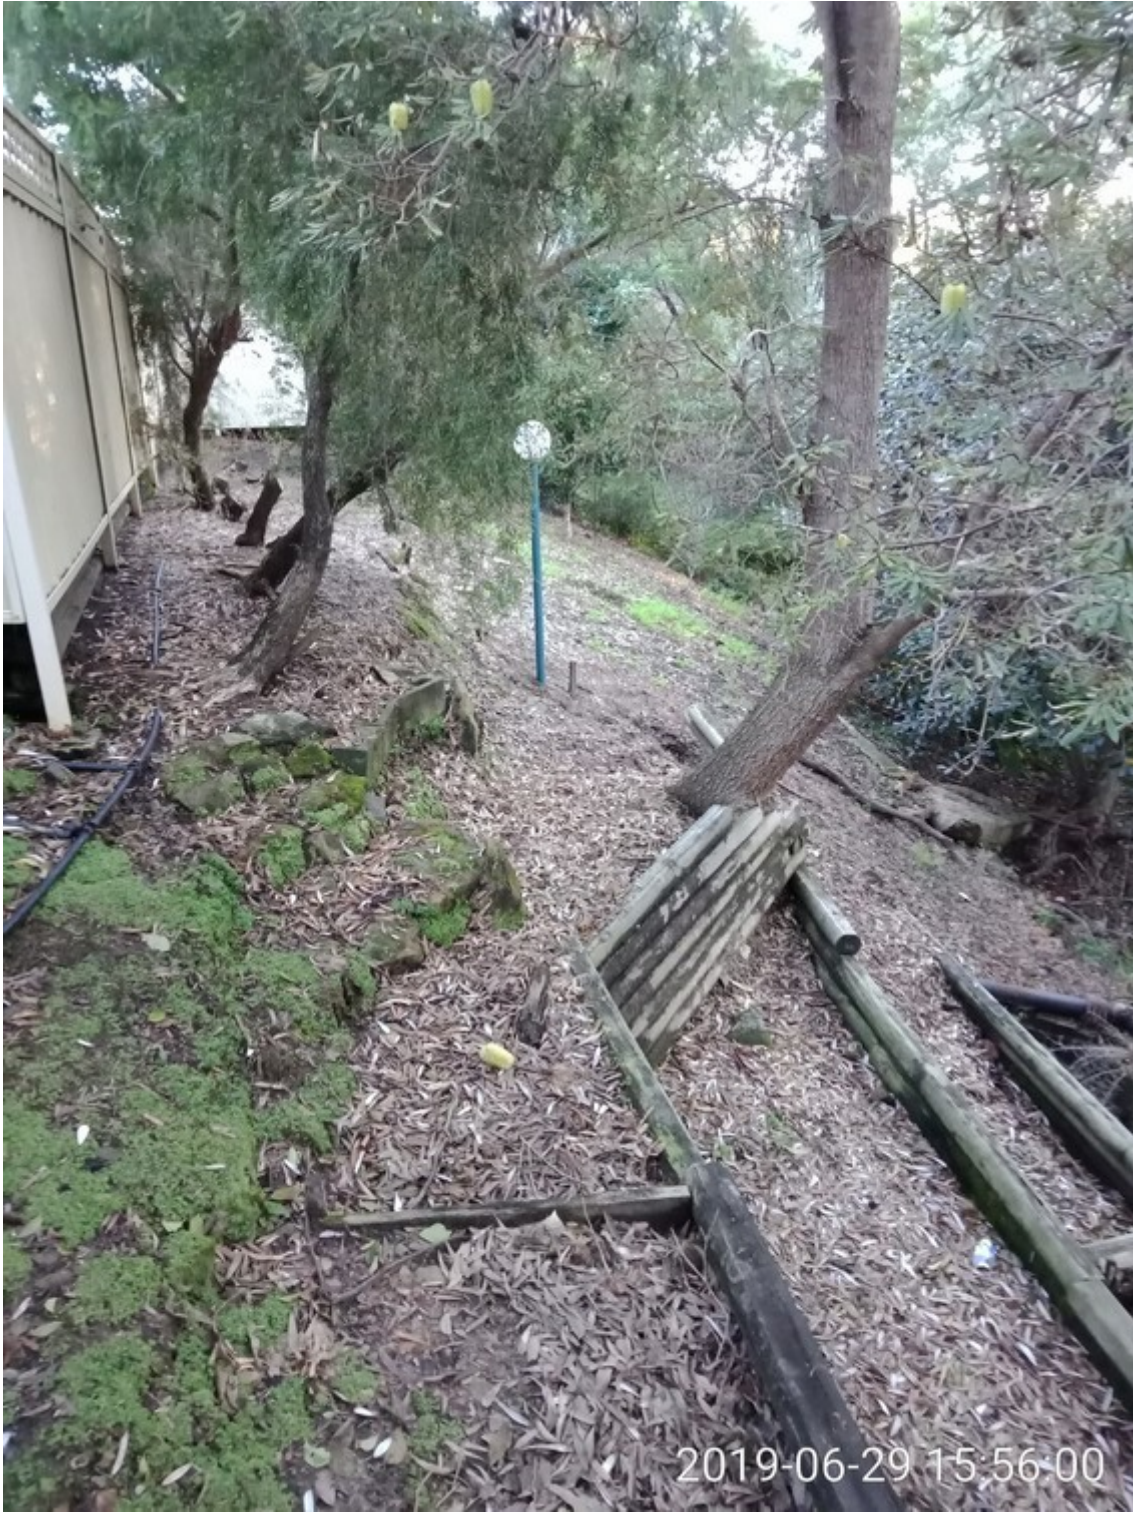
38 Wooden railings disappeared behind townhouses due to rot and not repaired since 2014

Most of railings started collapsing since 2015. Attempts to reason with strata managers to repair common property failed.

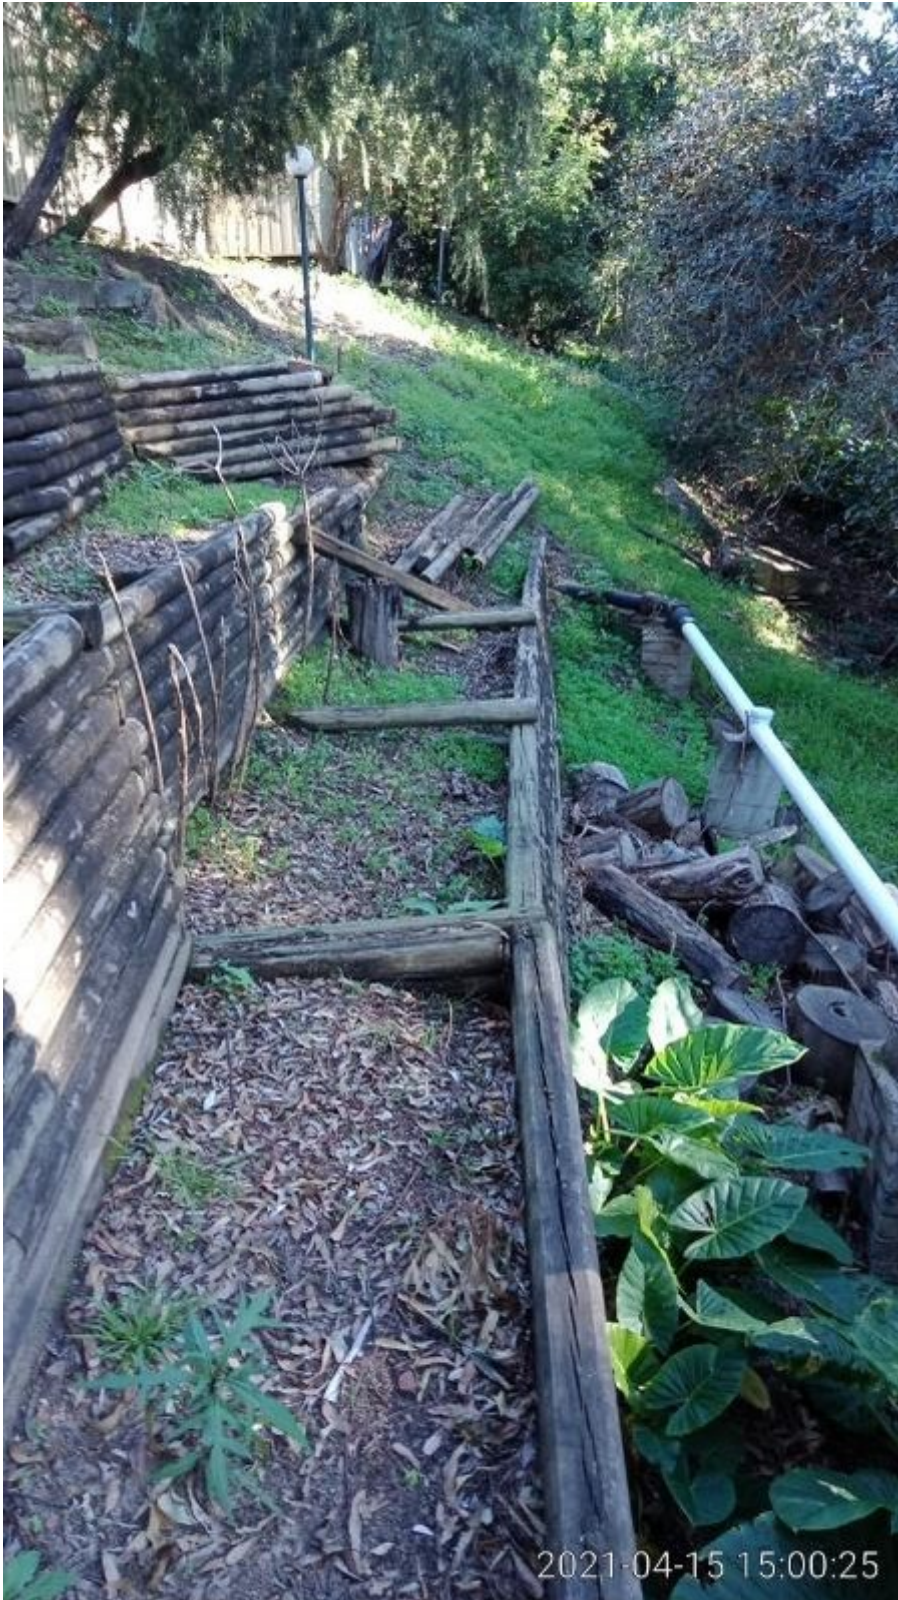
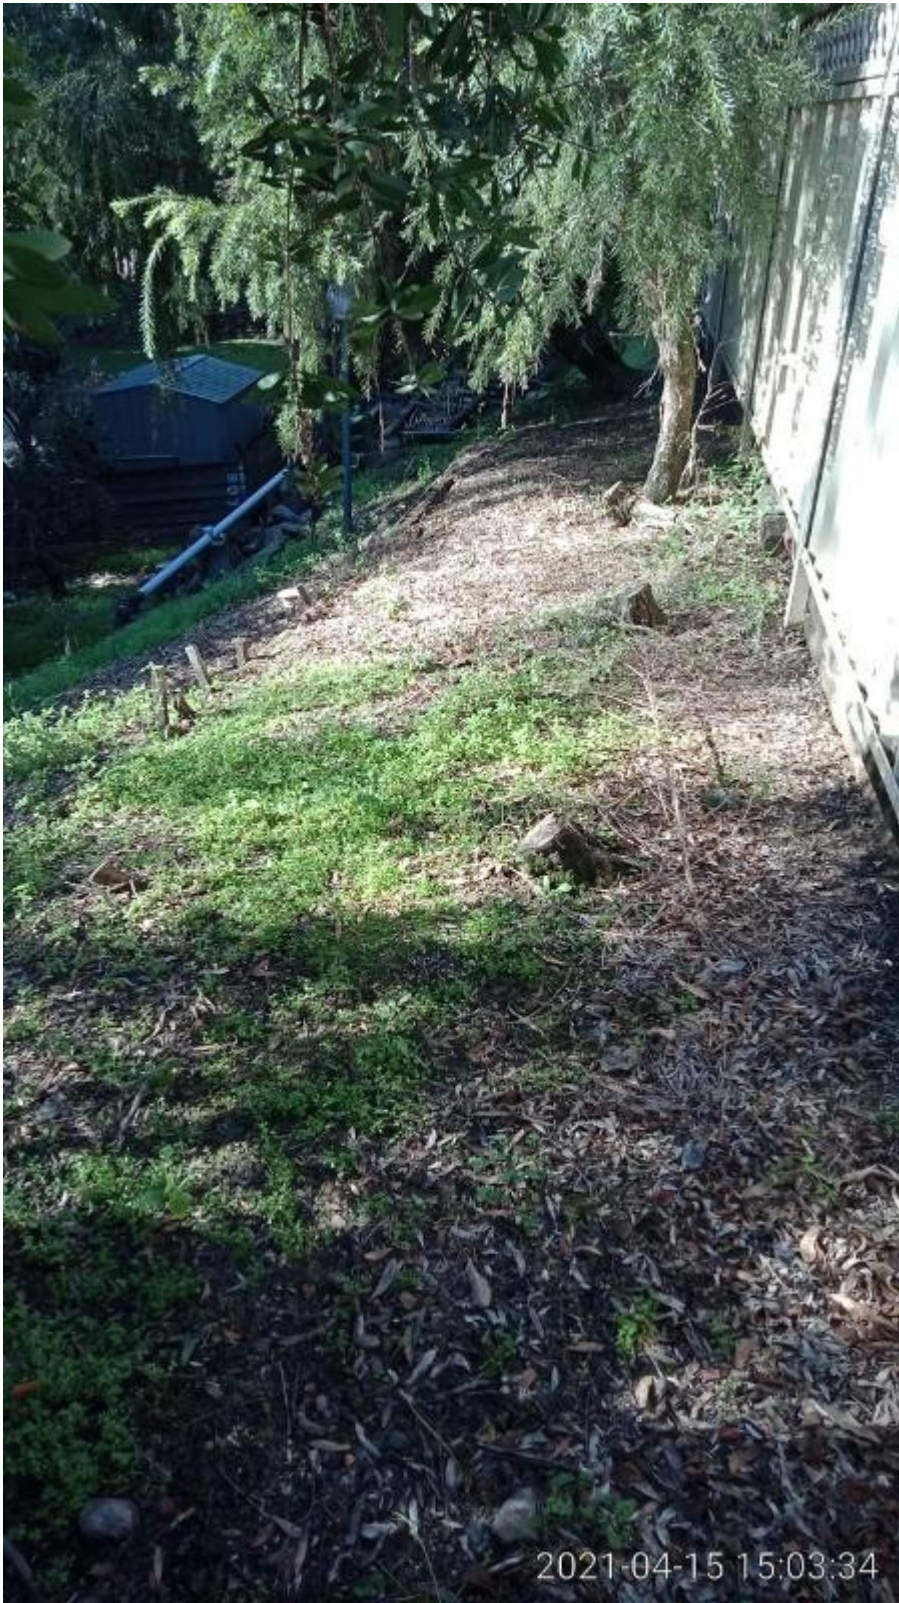
In 2021, walking in sloping site behind townhouses is quote risky, especially work workers.

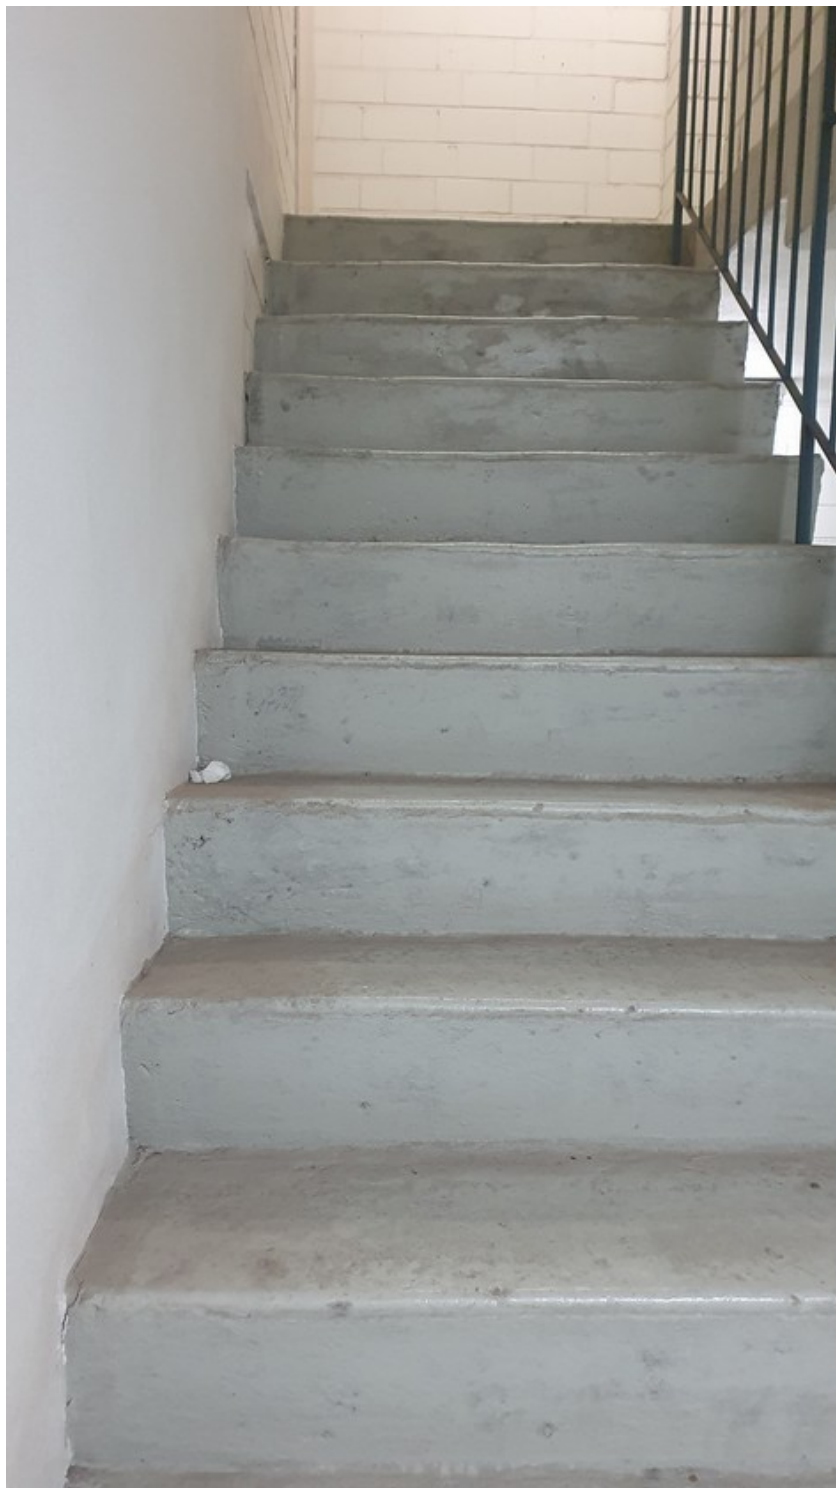
44 Used paper napkin not cleaned from fire stairs in Block A for 10 months (since 24 September 2020)

Photo last taken on 26 July 2021:

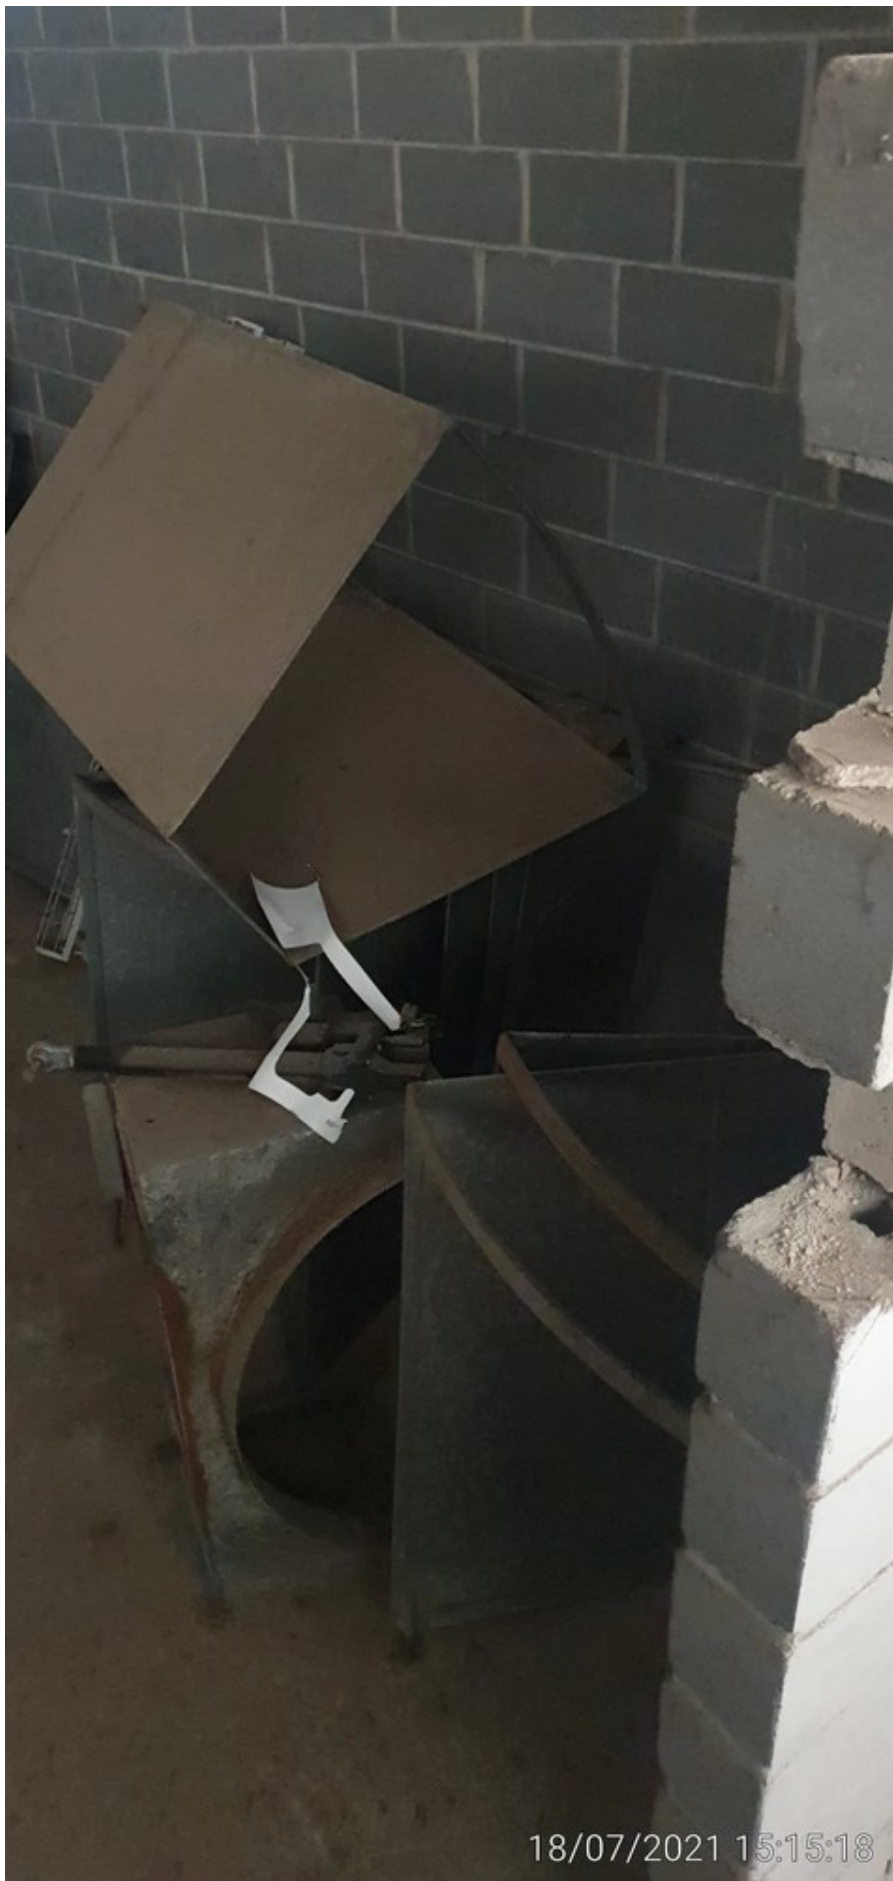
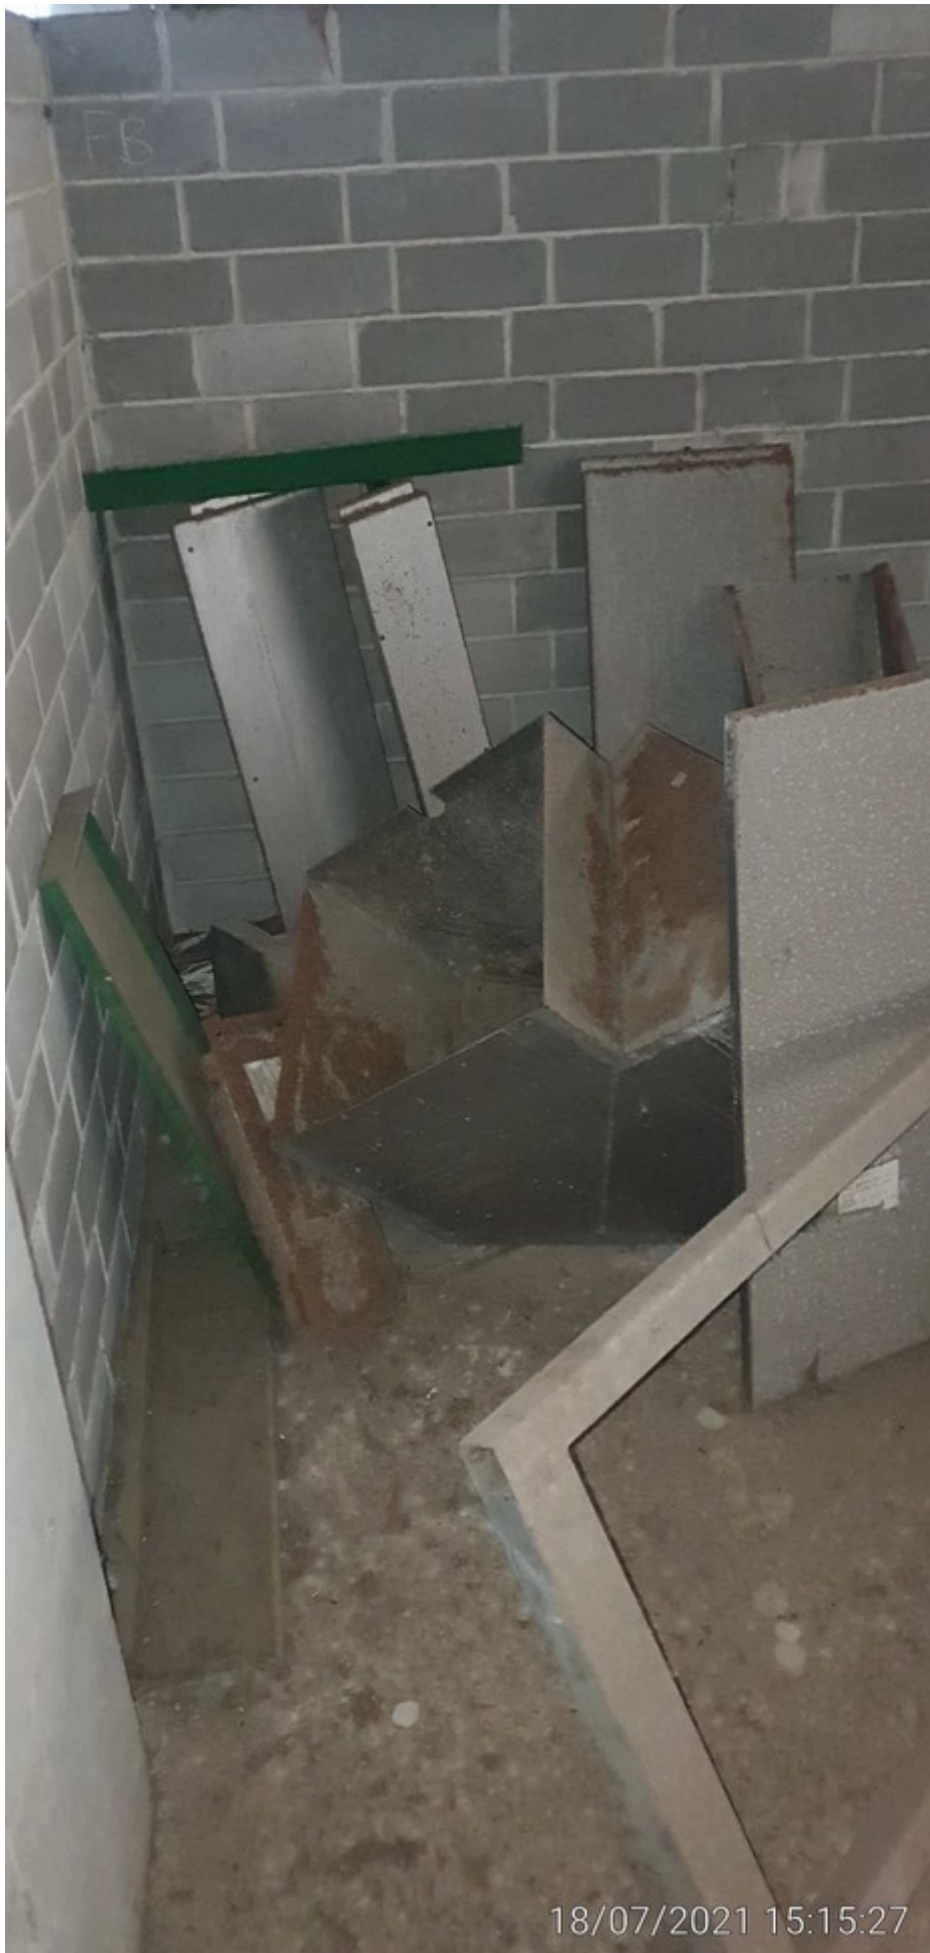
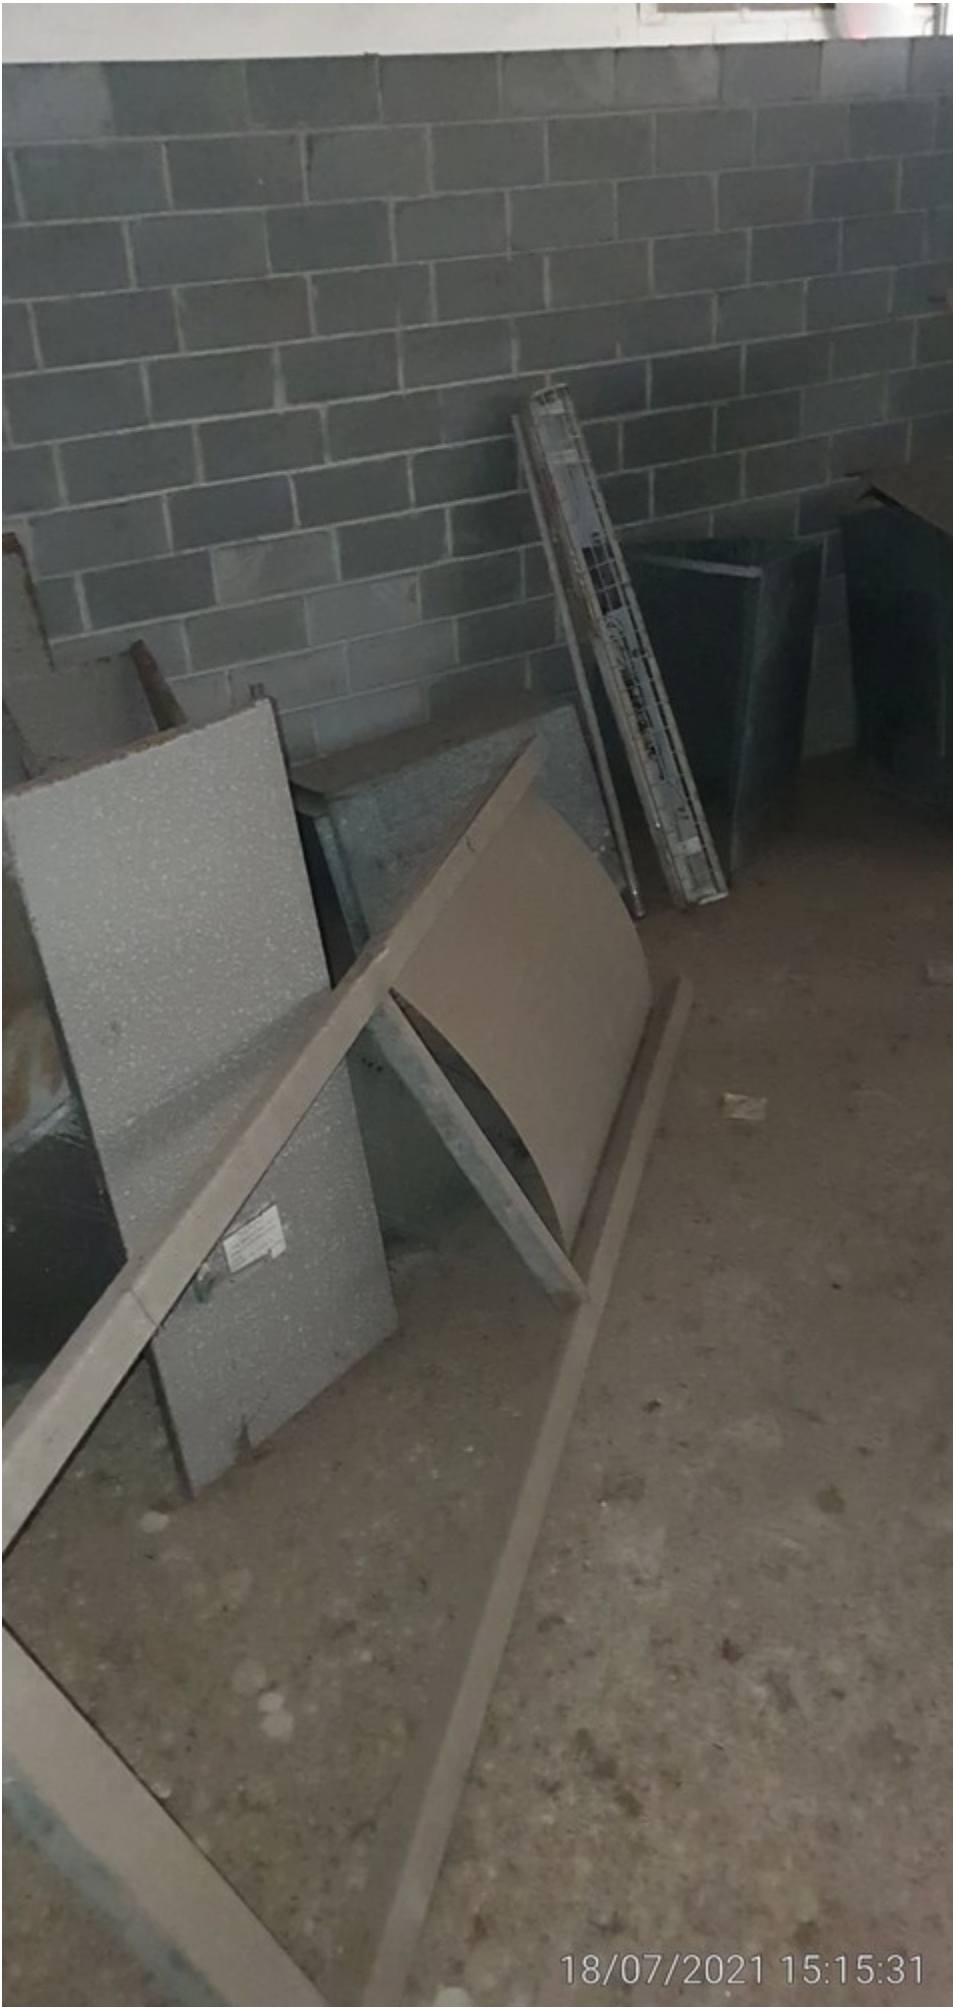
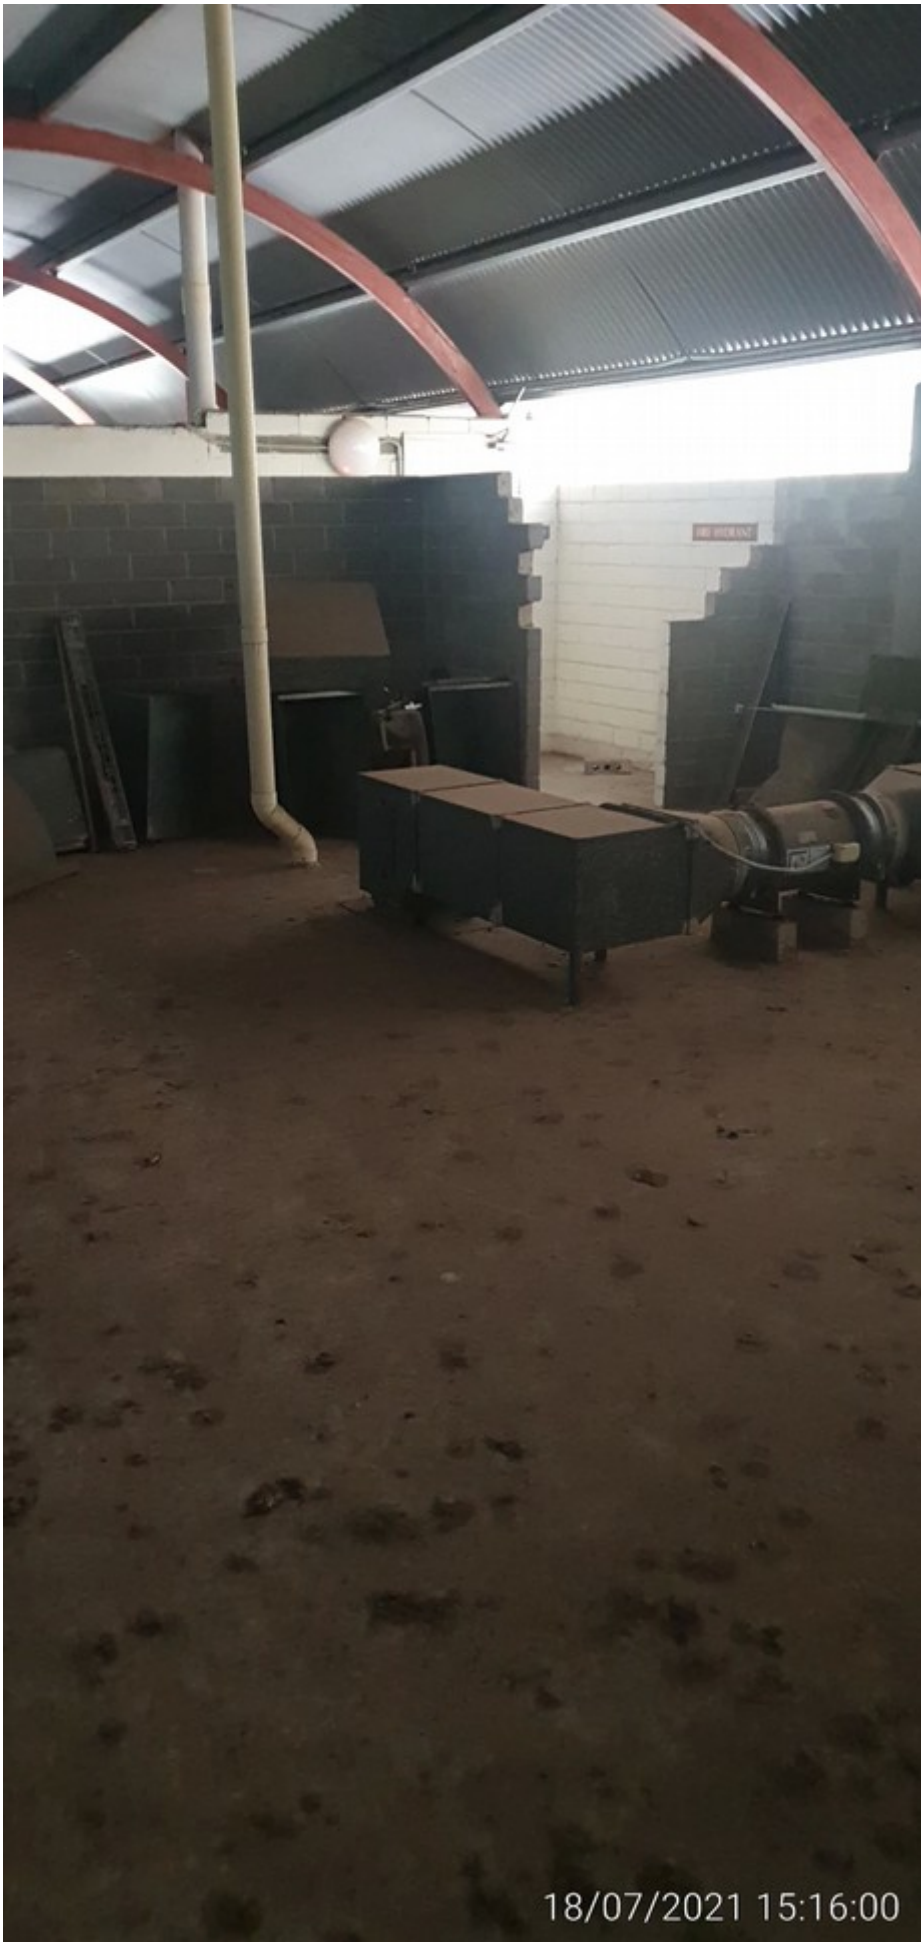
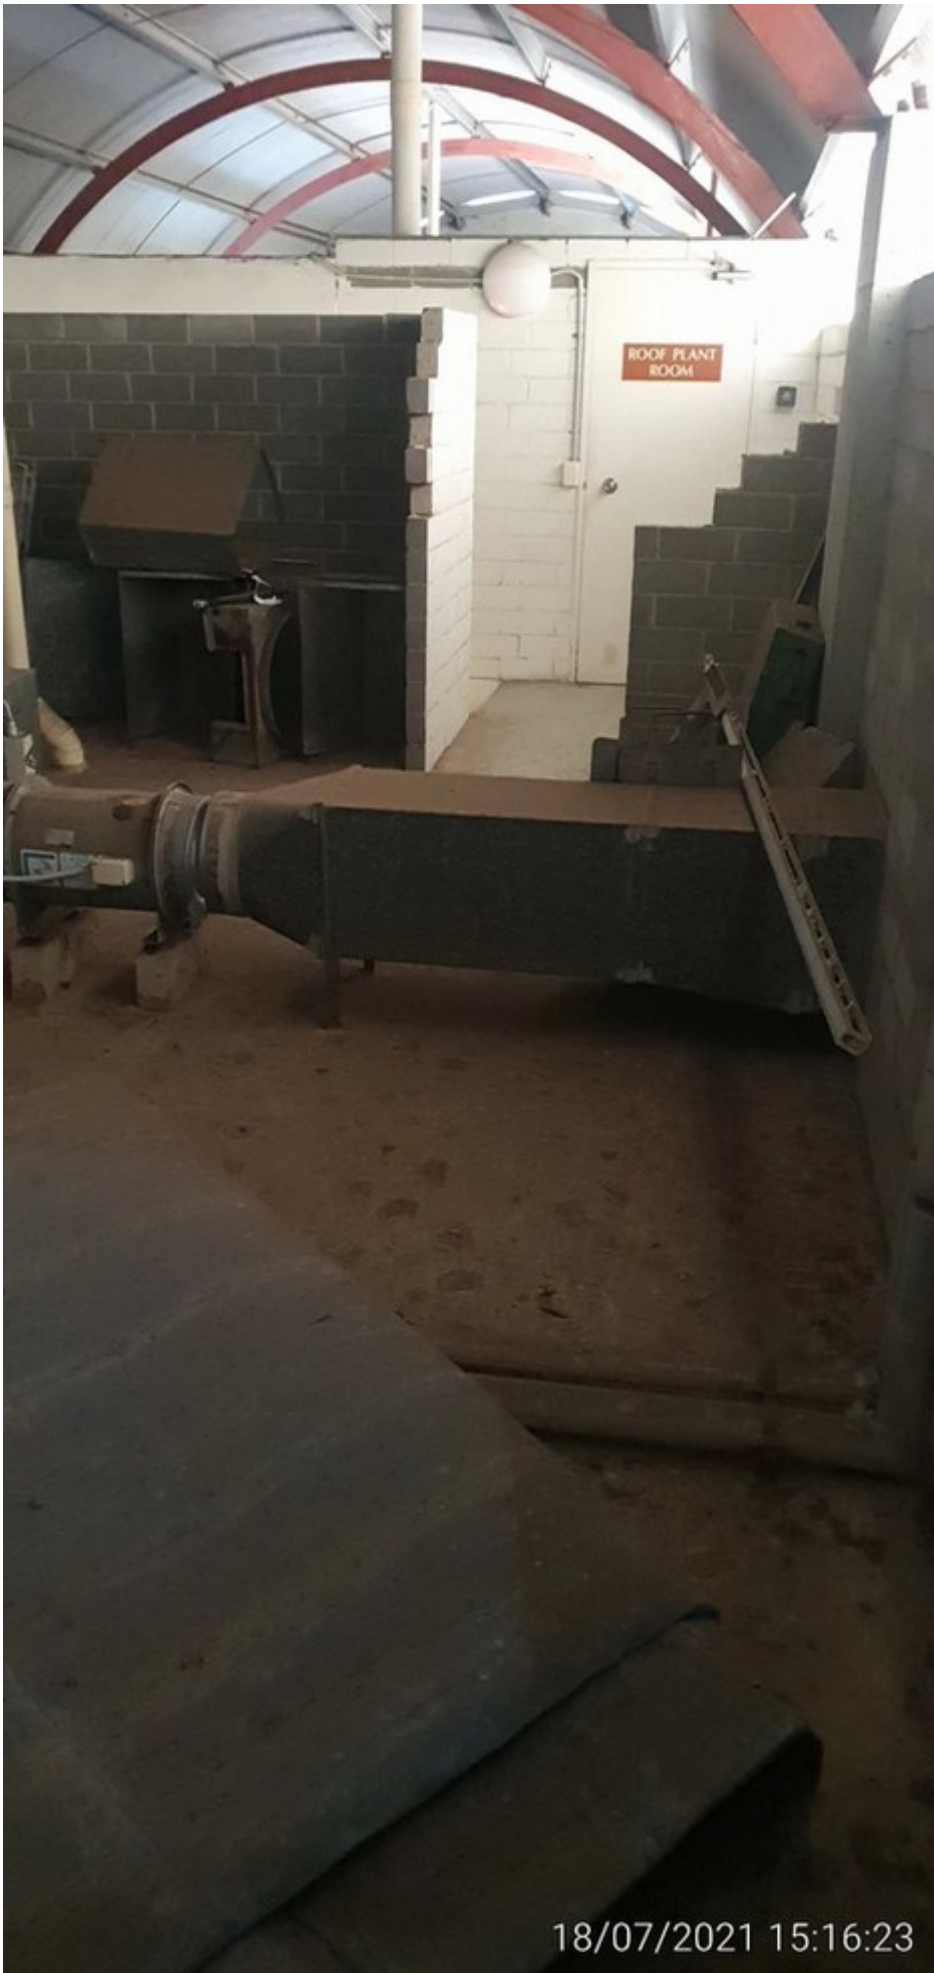
45 Under-roof area of Block C not cleaned for eight years, reported as OH&S risk in Napier & Blakely's professional report in July 2012

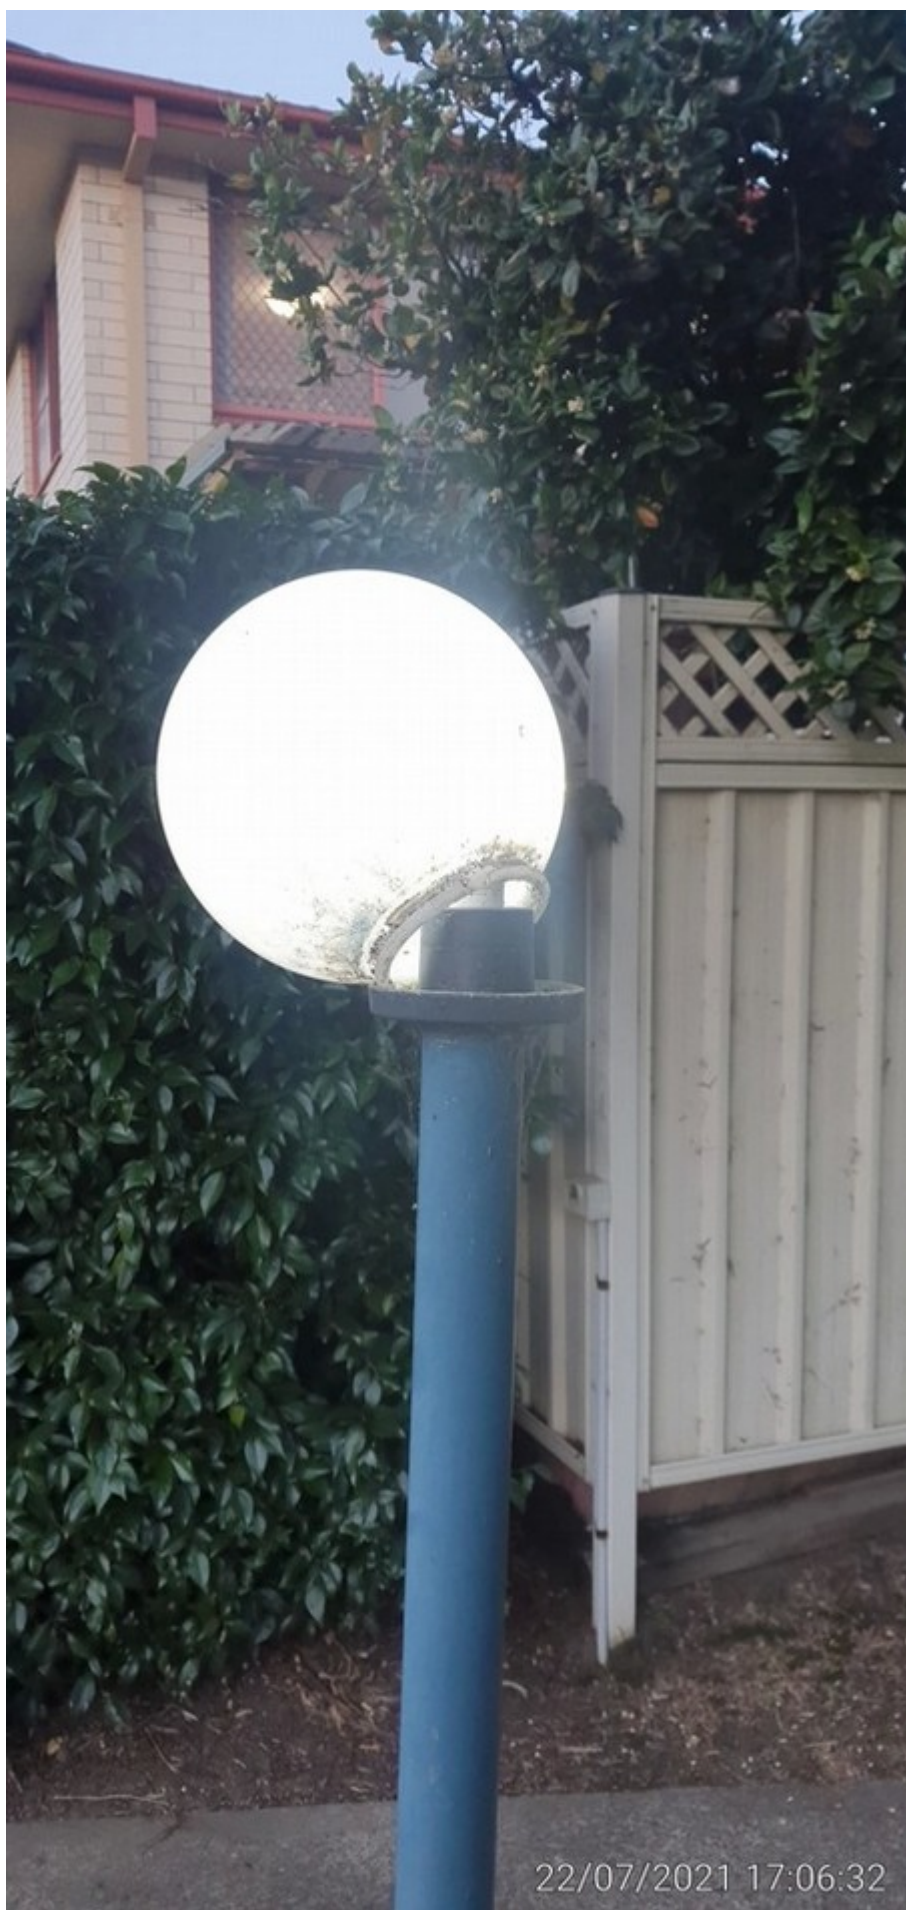
Photo taken on 22 July 2021:

49 Unsafe light post behind townhouse near car wash area

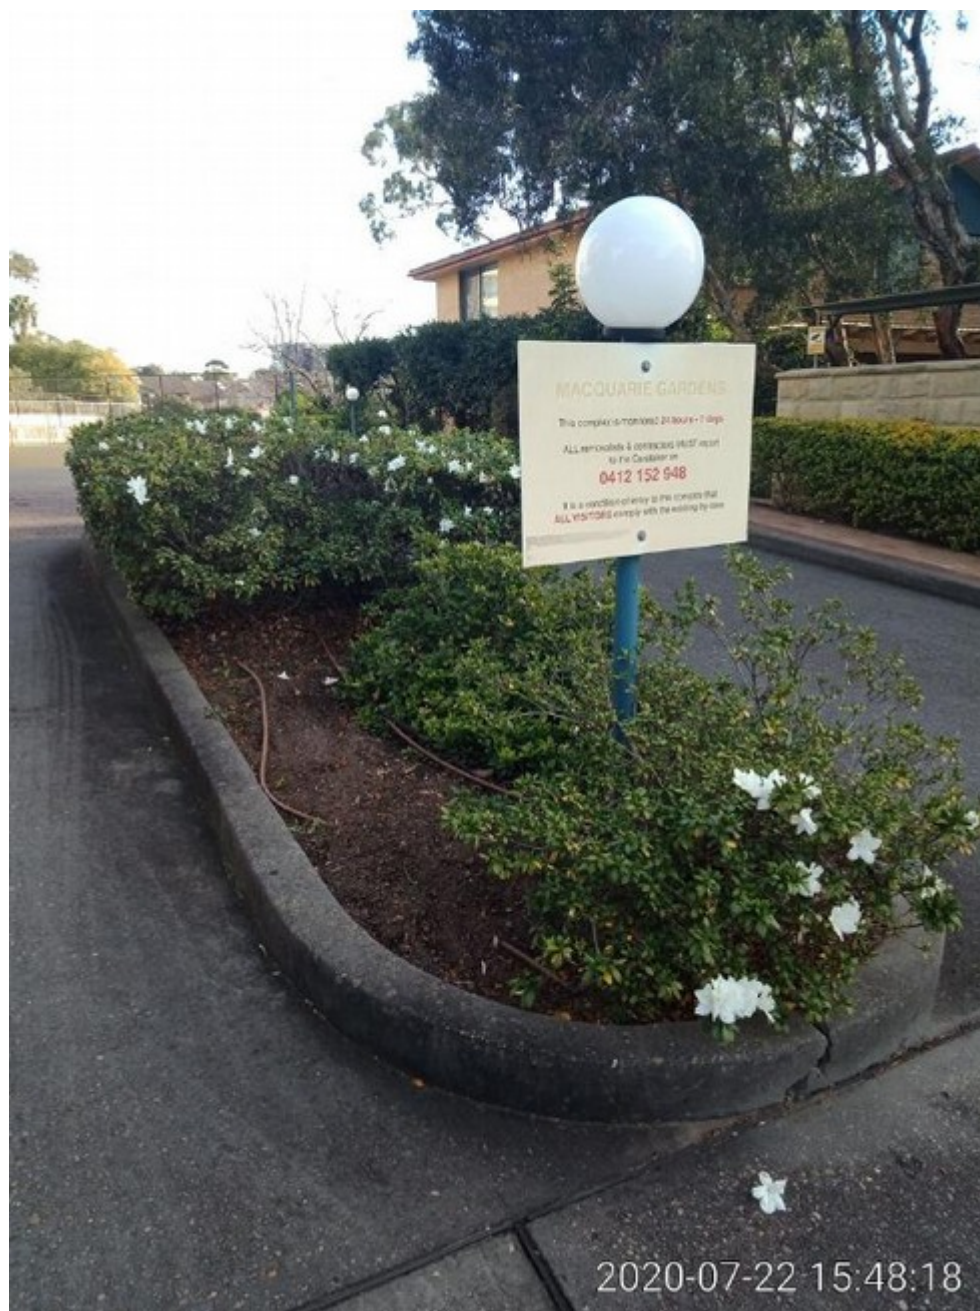
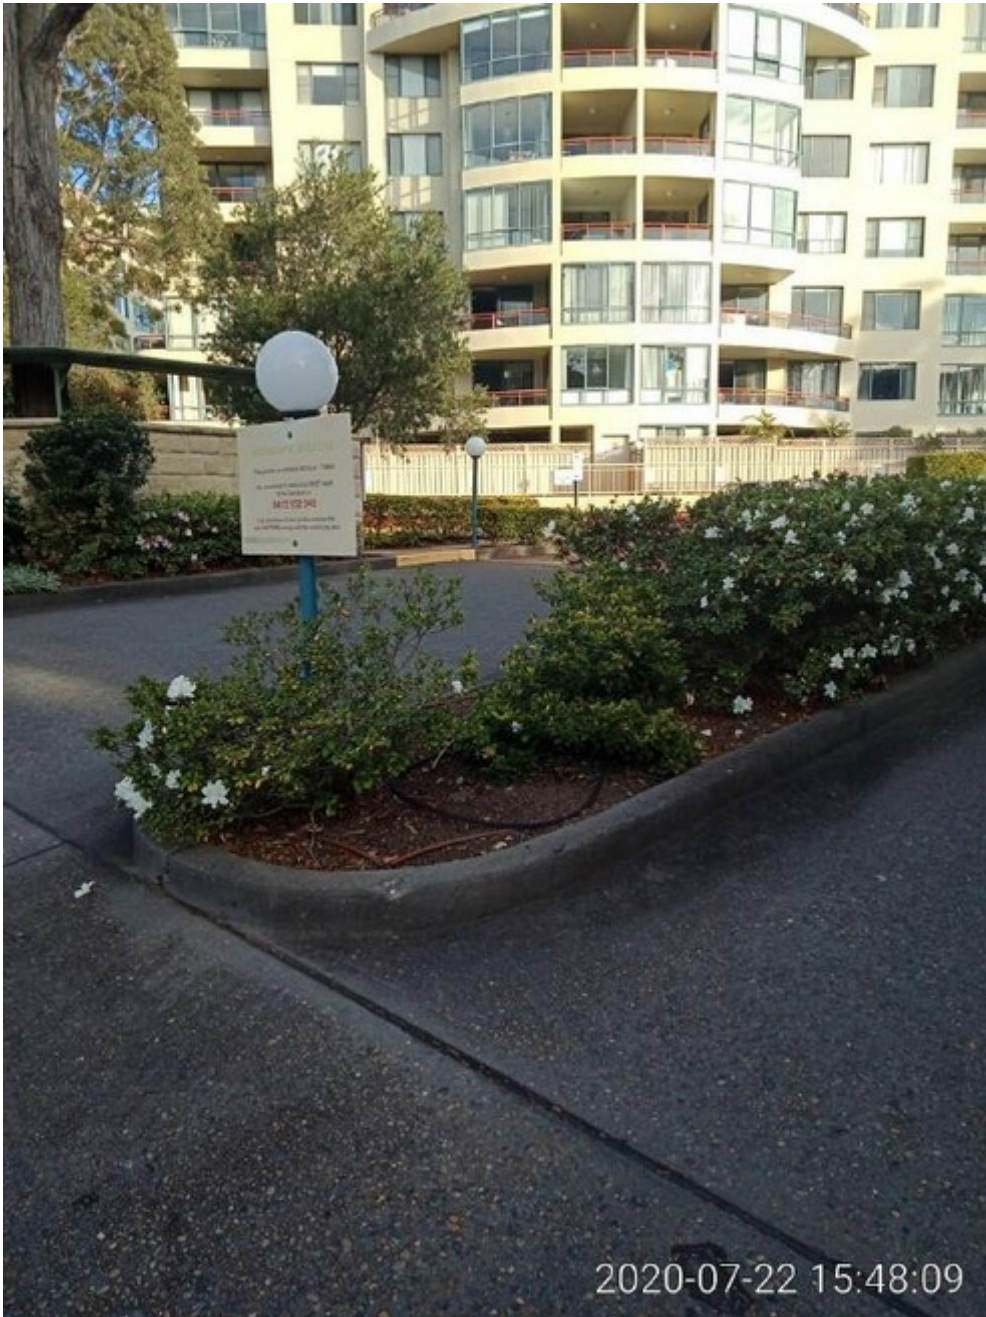
52 Unsightly entrance to the complex

On 29 July 2020, complaint was sent to Waratah Strata Management about appearance of the gardens at the entrance to the complex.
