Major upgrades on 26 townhouses in amount of \$92,950.00 in 2017 without evidence of work done

1 SP52948 – Solicitor Adrian Mueller, on behalf of owners corporation, confirming that maintenance of common property is compulsory and that some strata files are missing on 14th of November 2019

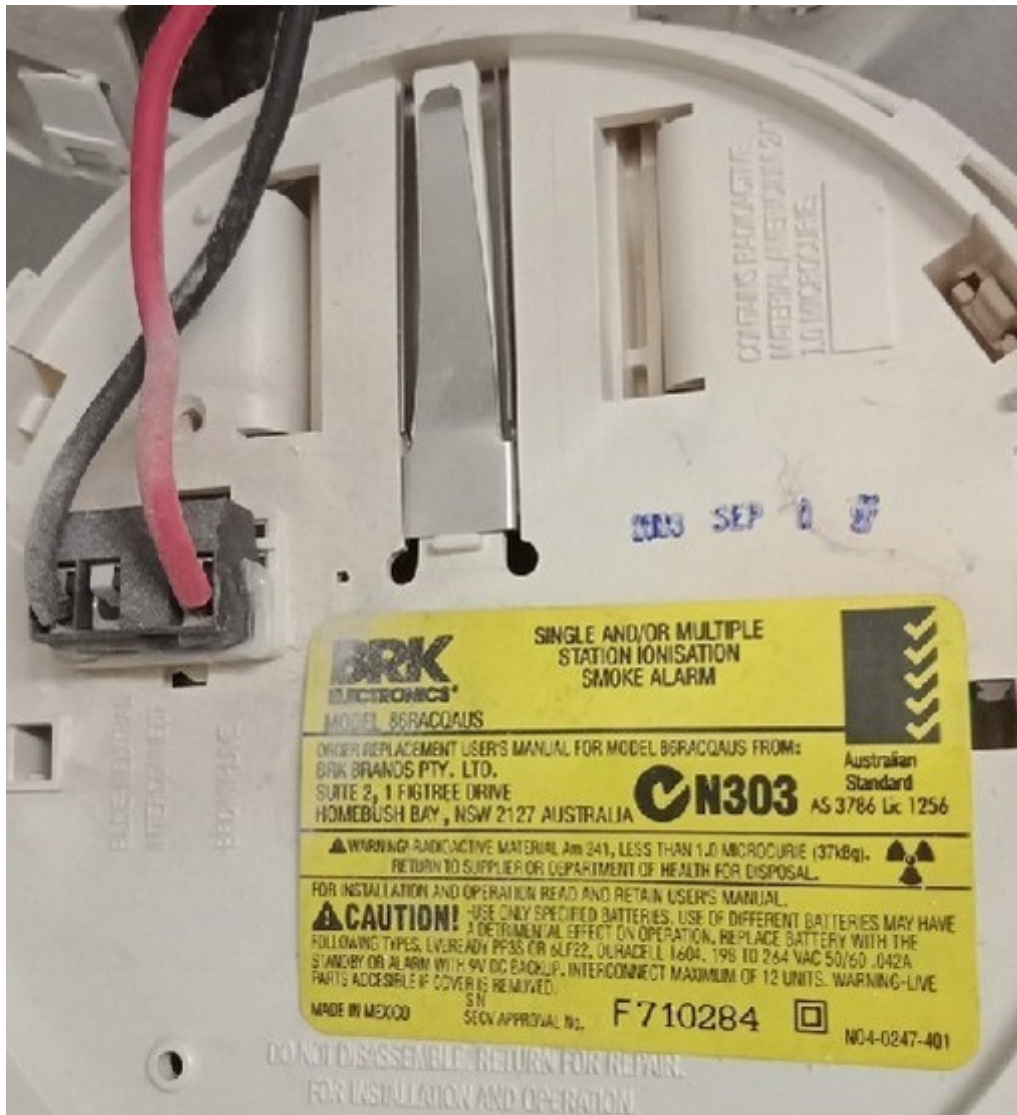
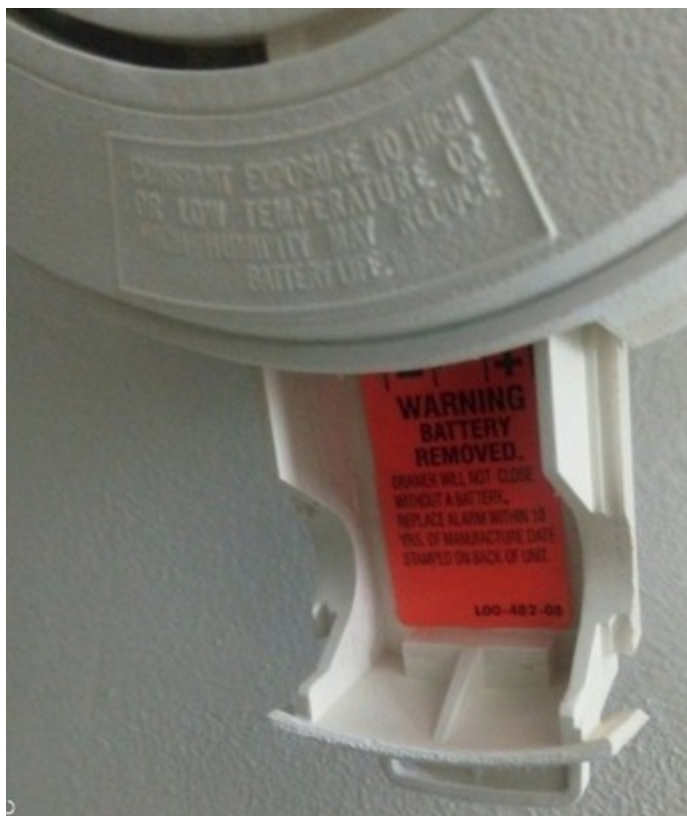
Foyer near main bathroom and kitchen (manufacture date 2008, expired in 2019)

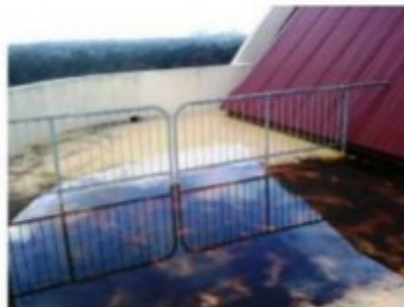
Standing water to flat roof deck, Block B

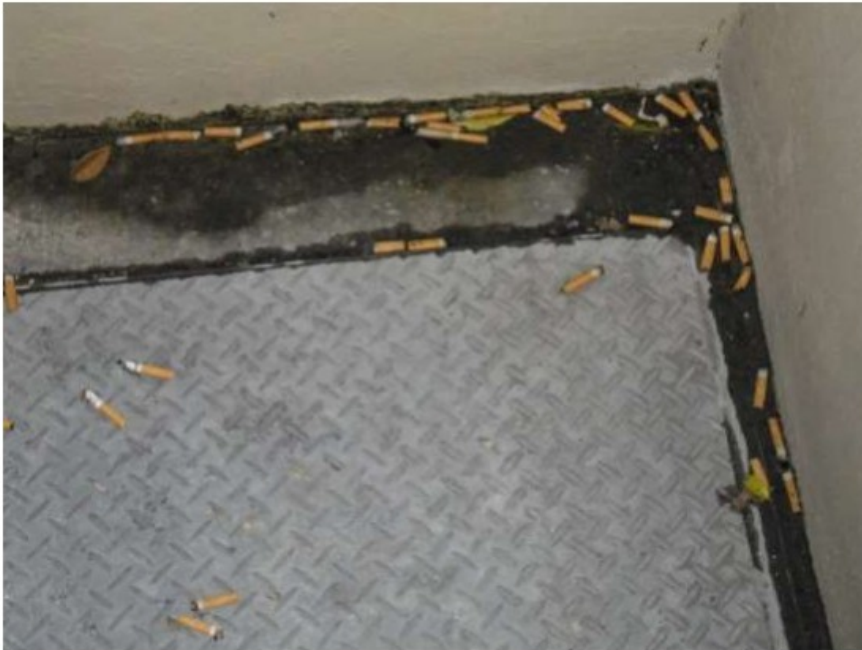
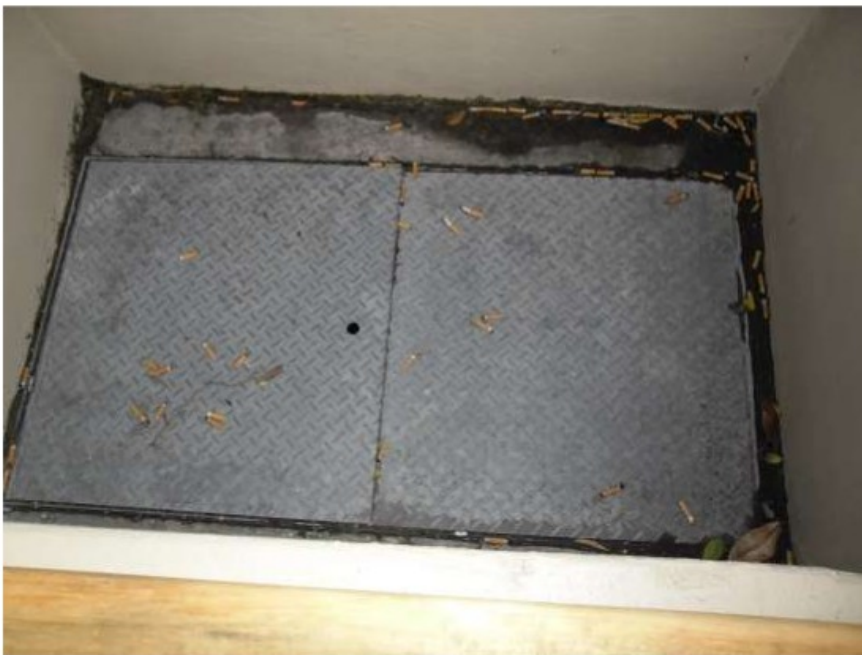
Example of cigarette butt litter on 24th of November 2014:

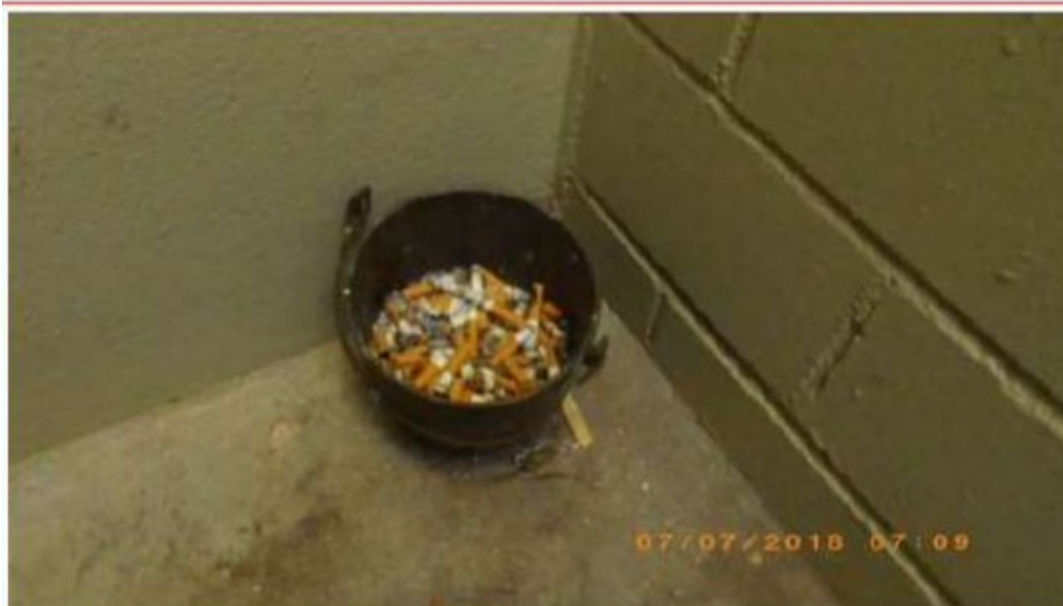
Examples of smoking near fire door 2 below Block A in June and July 2018:

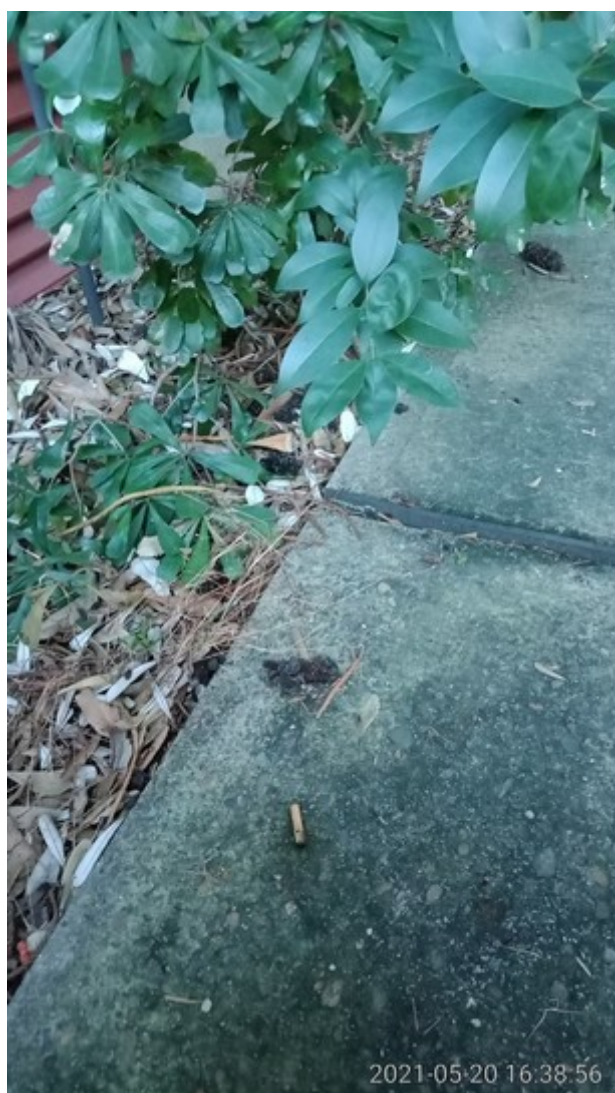
17 Smoking in the complex continue to be a serious fire safety risk – Block D garden pathway where lot of dry barks and leaves cover the grounds

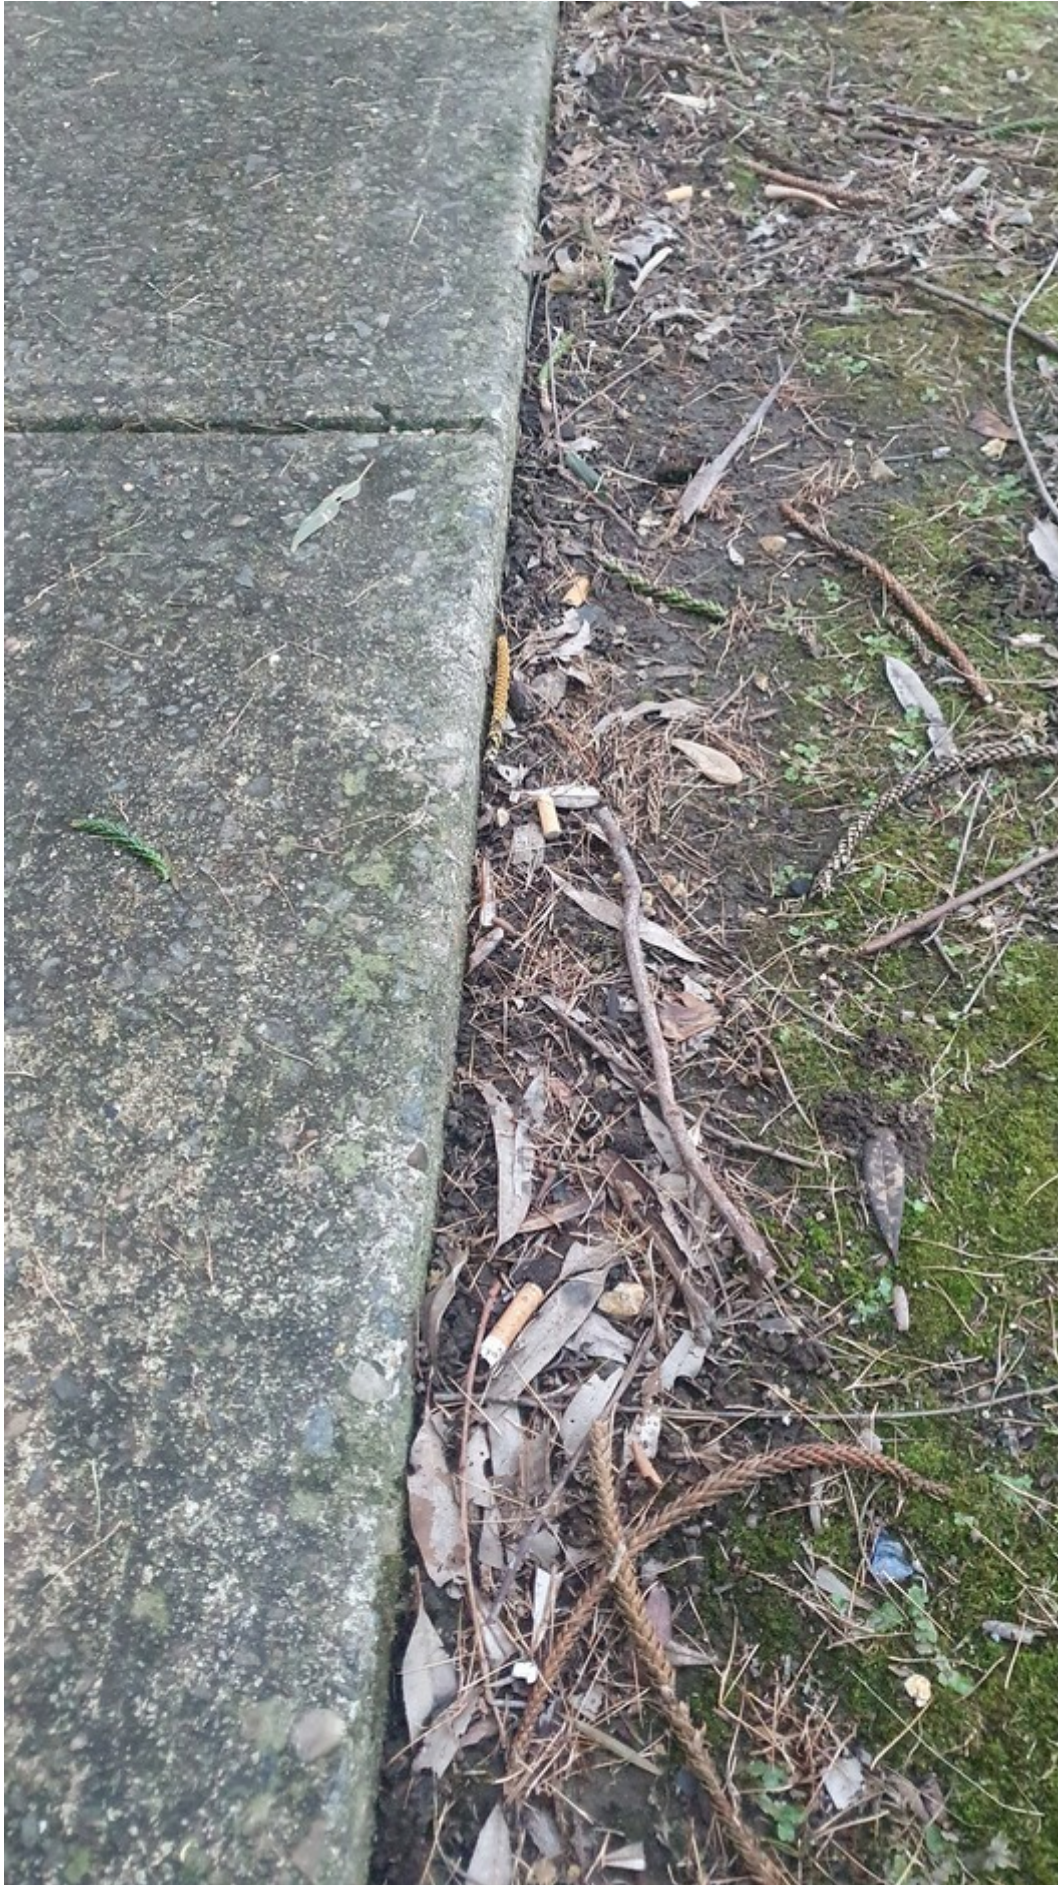
Photo taken on 16th of July 2021 prove the same problem is still in existence:

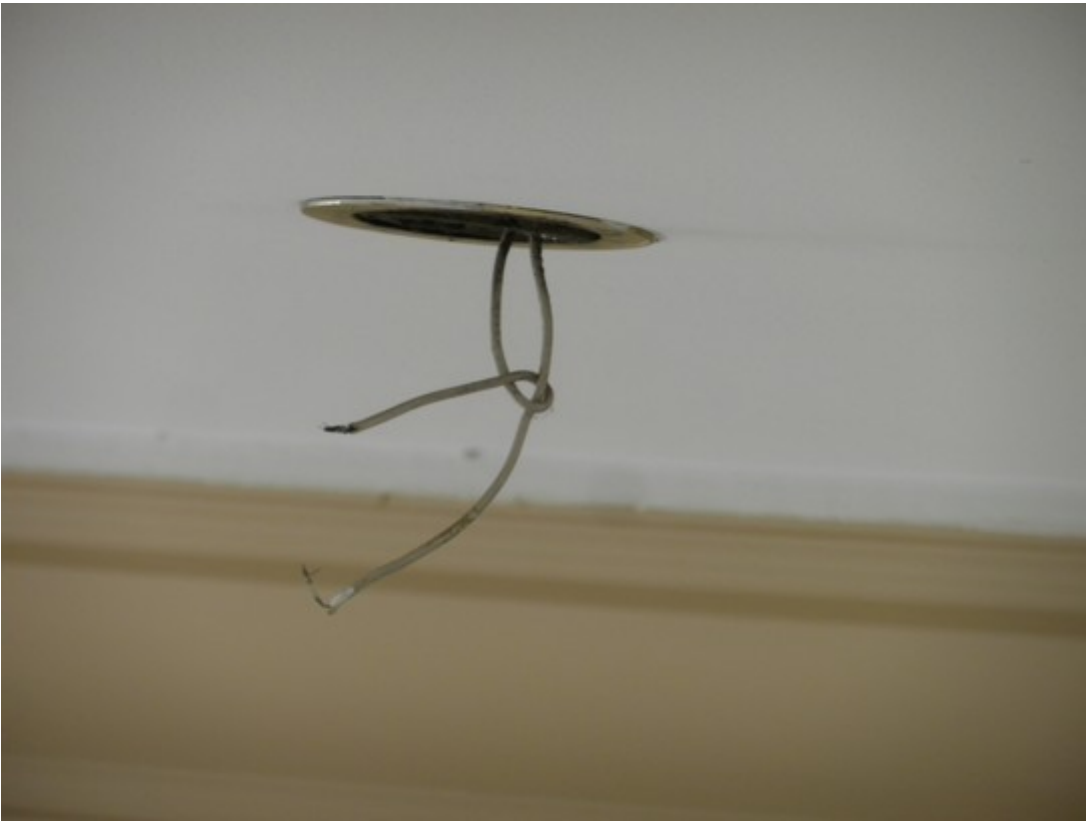
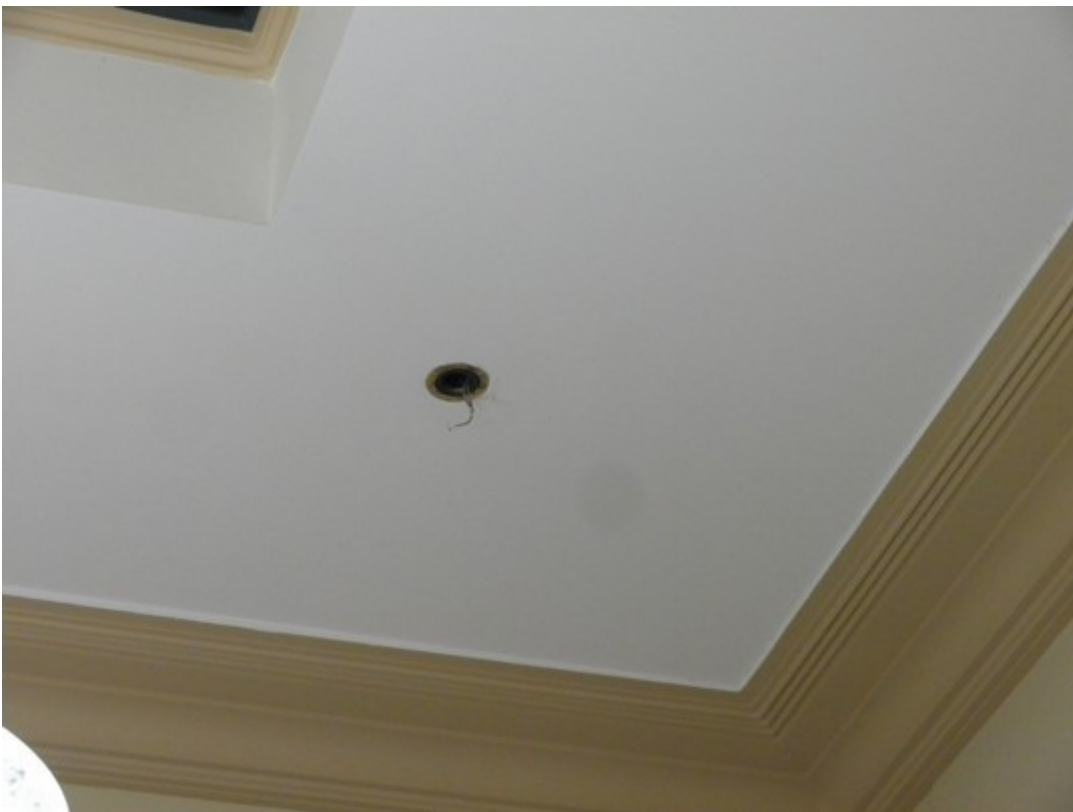
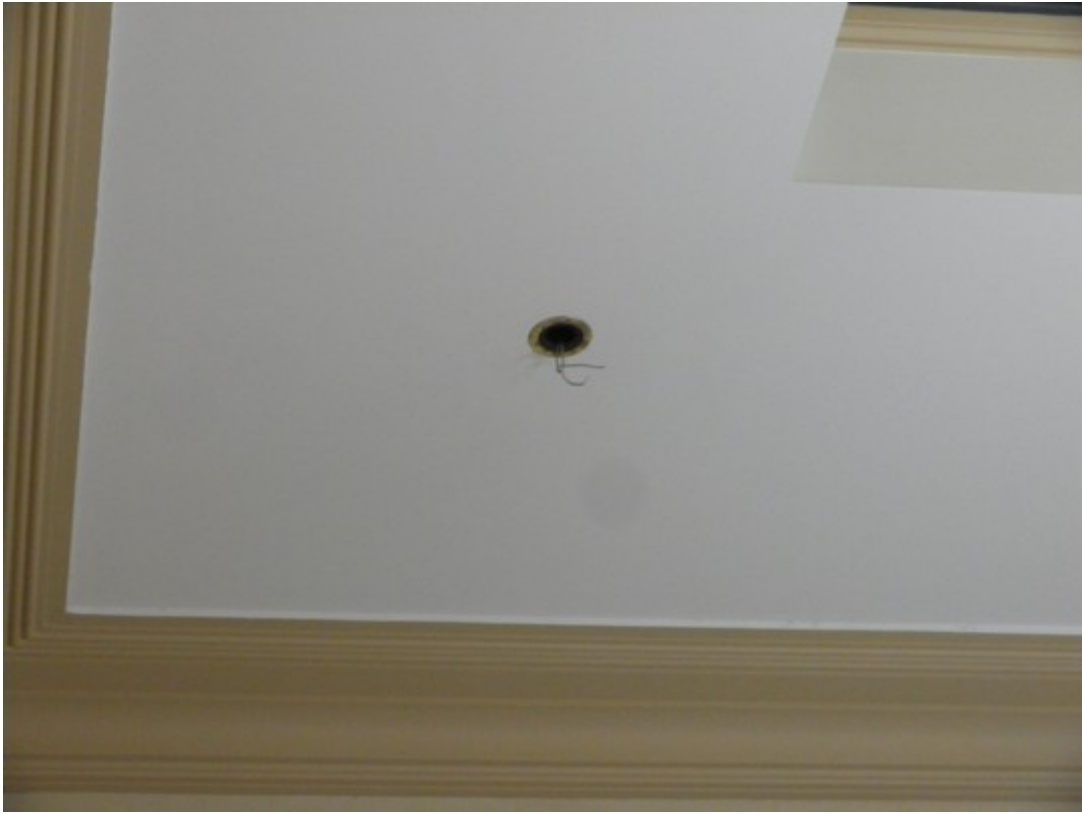
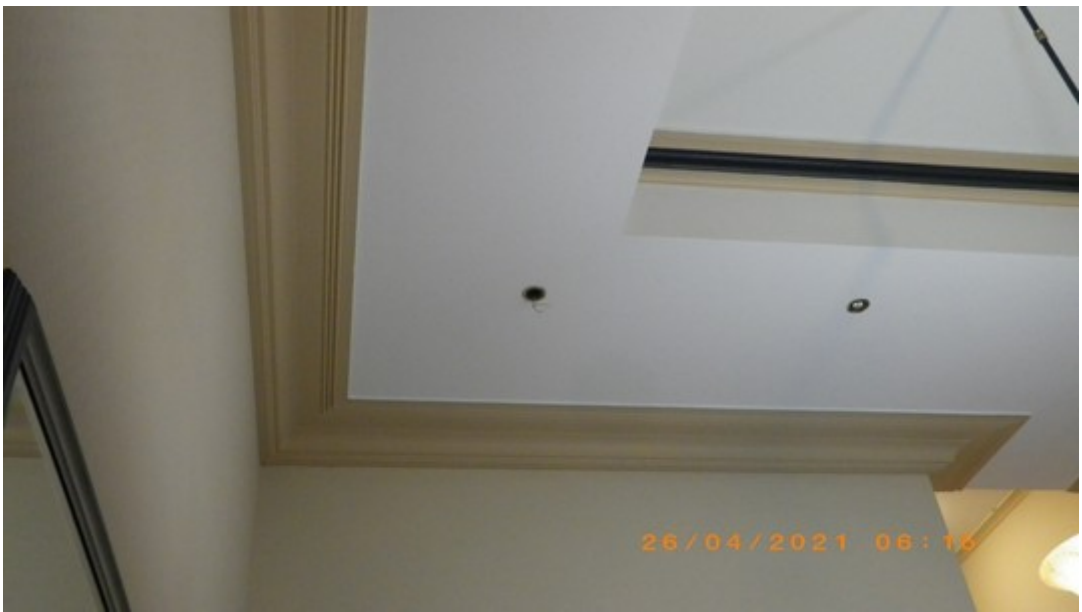
19 Electrical wires on ceiling for one down-light in Block D foyer for more than one year

Reported to strata managers repeatedly, Still an unresolved issue.

Not only down-light is not operational but potentially live wires are protruding from the ceiling.

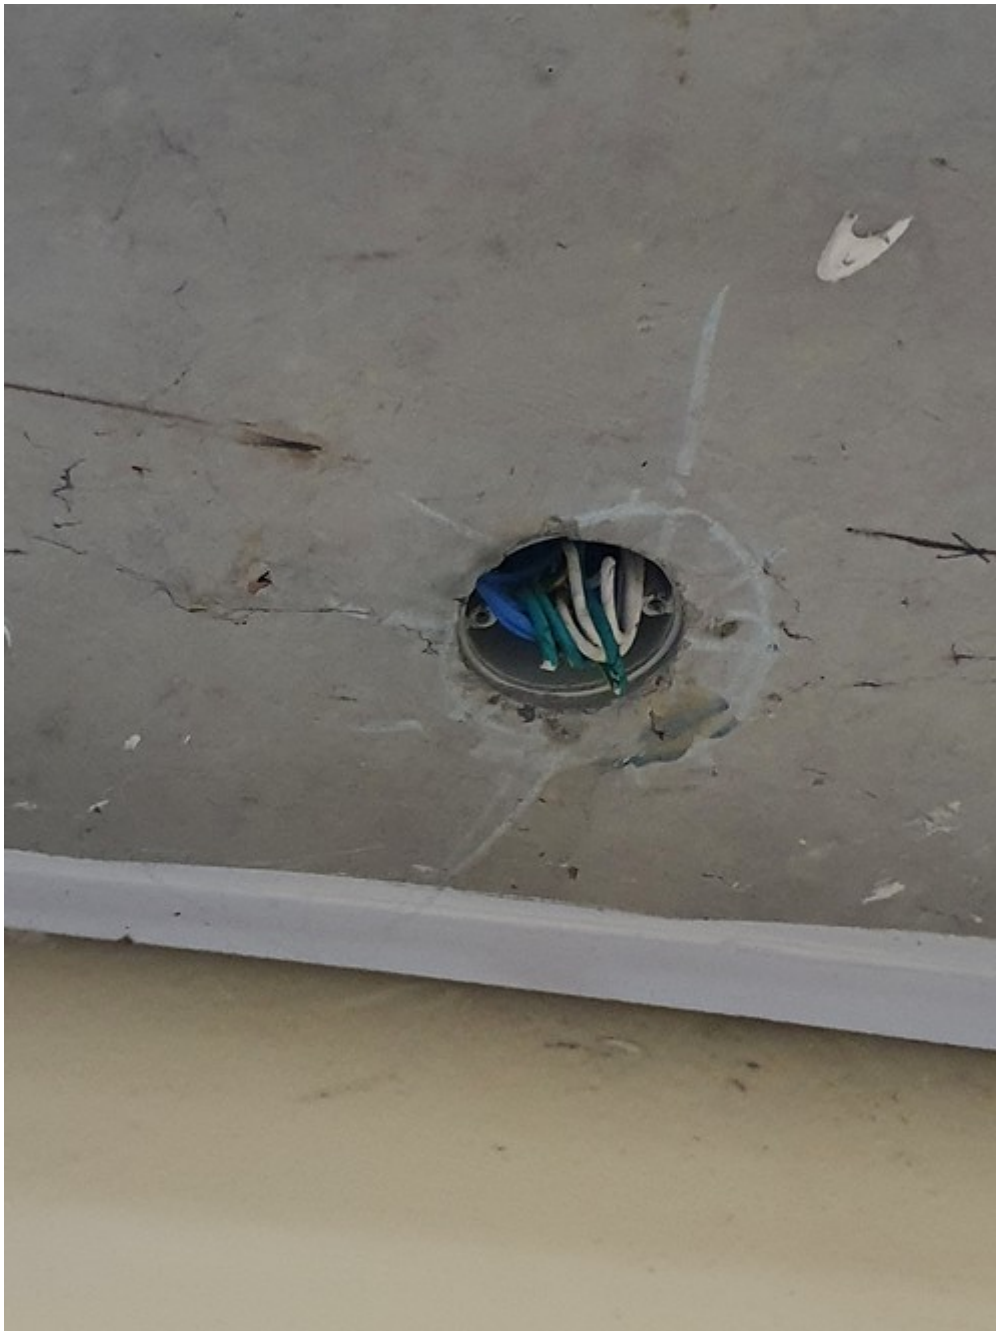
20 Electrical wires on ceiling in basement of Block A foyer for more than two years

Photo taken on 11th of July 2021:

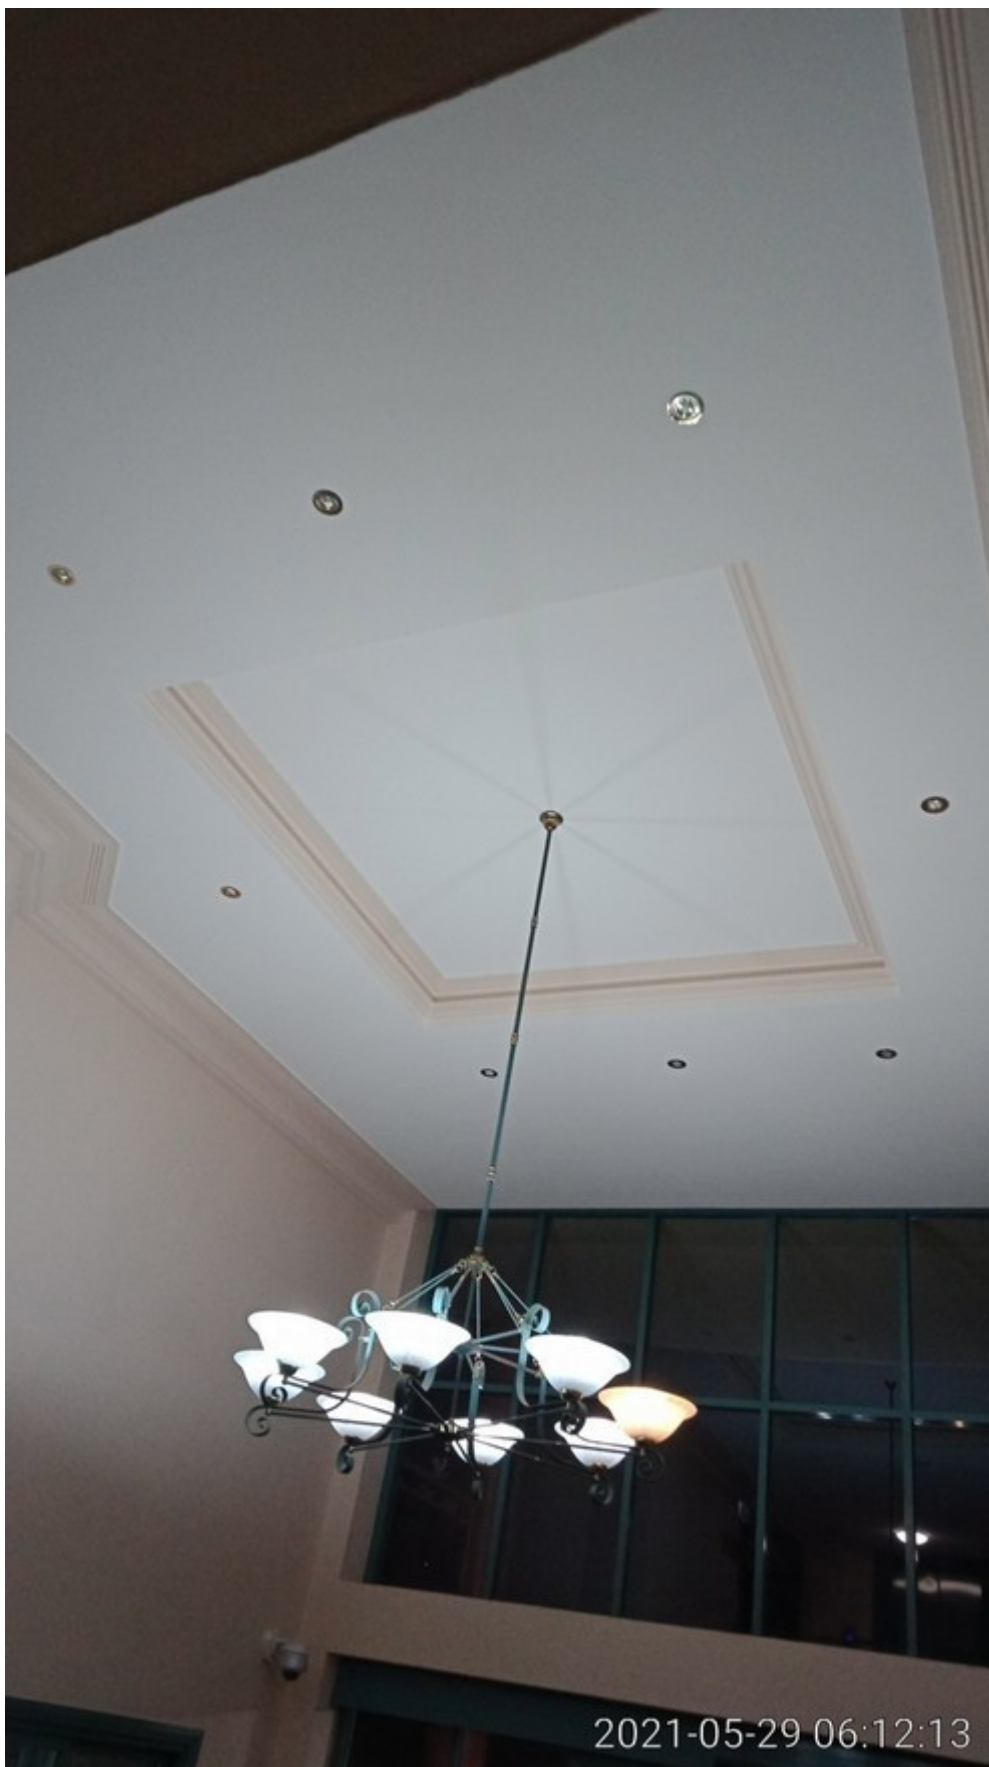
a) Block A, none of eight down-lights operational

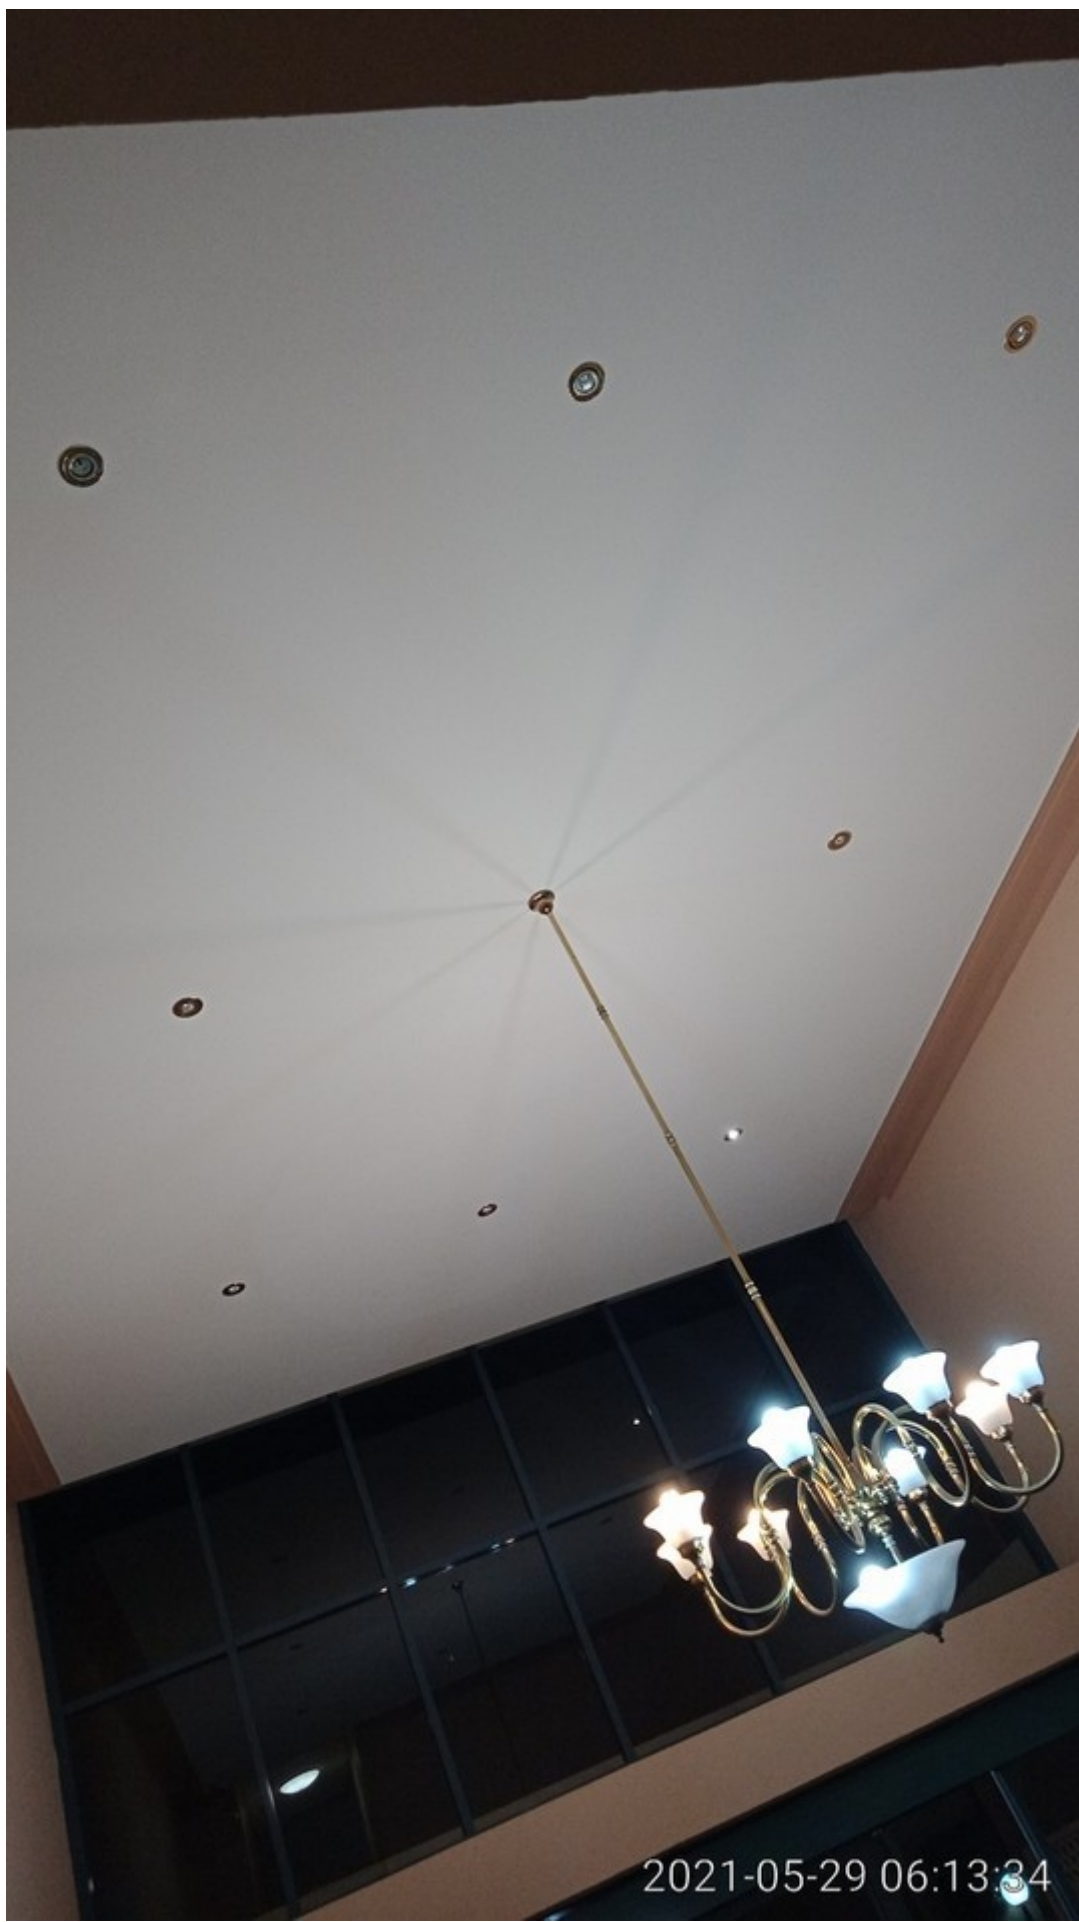
b) Block B, none of eight down-lights operational

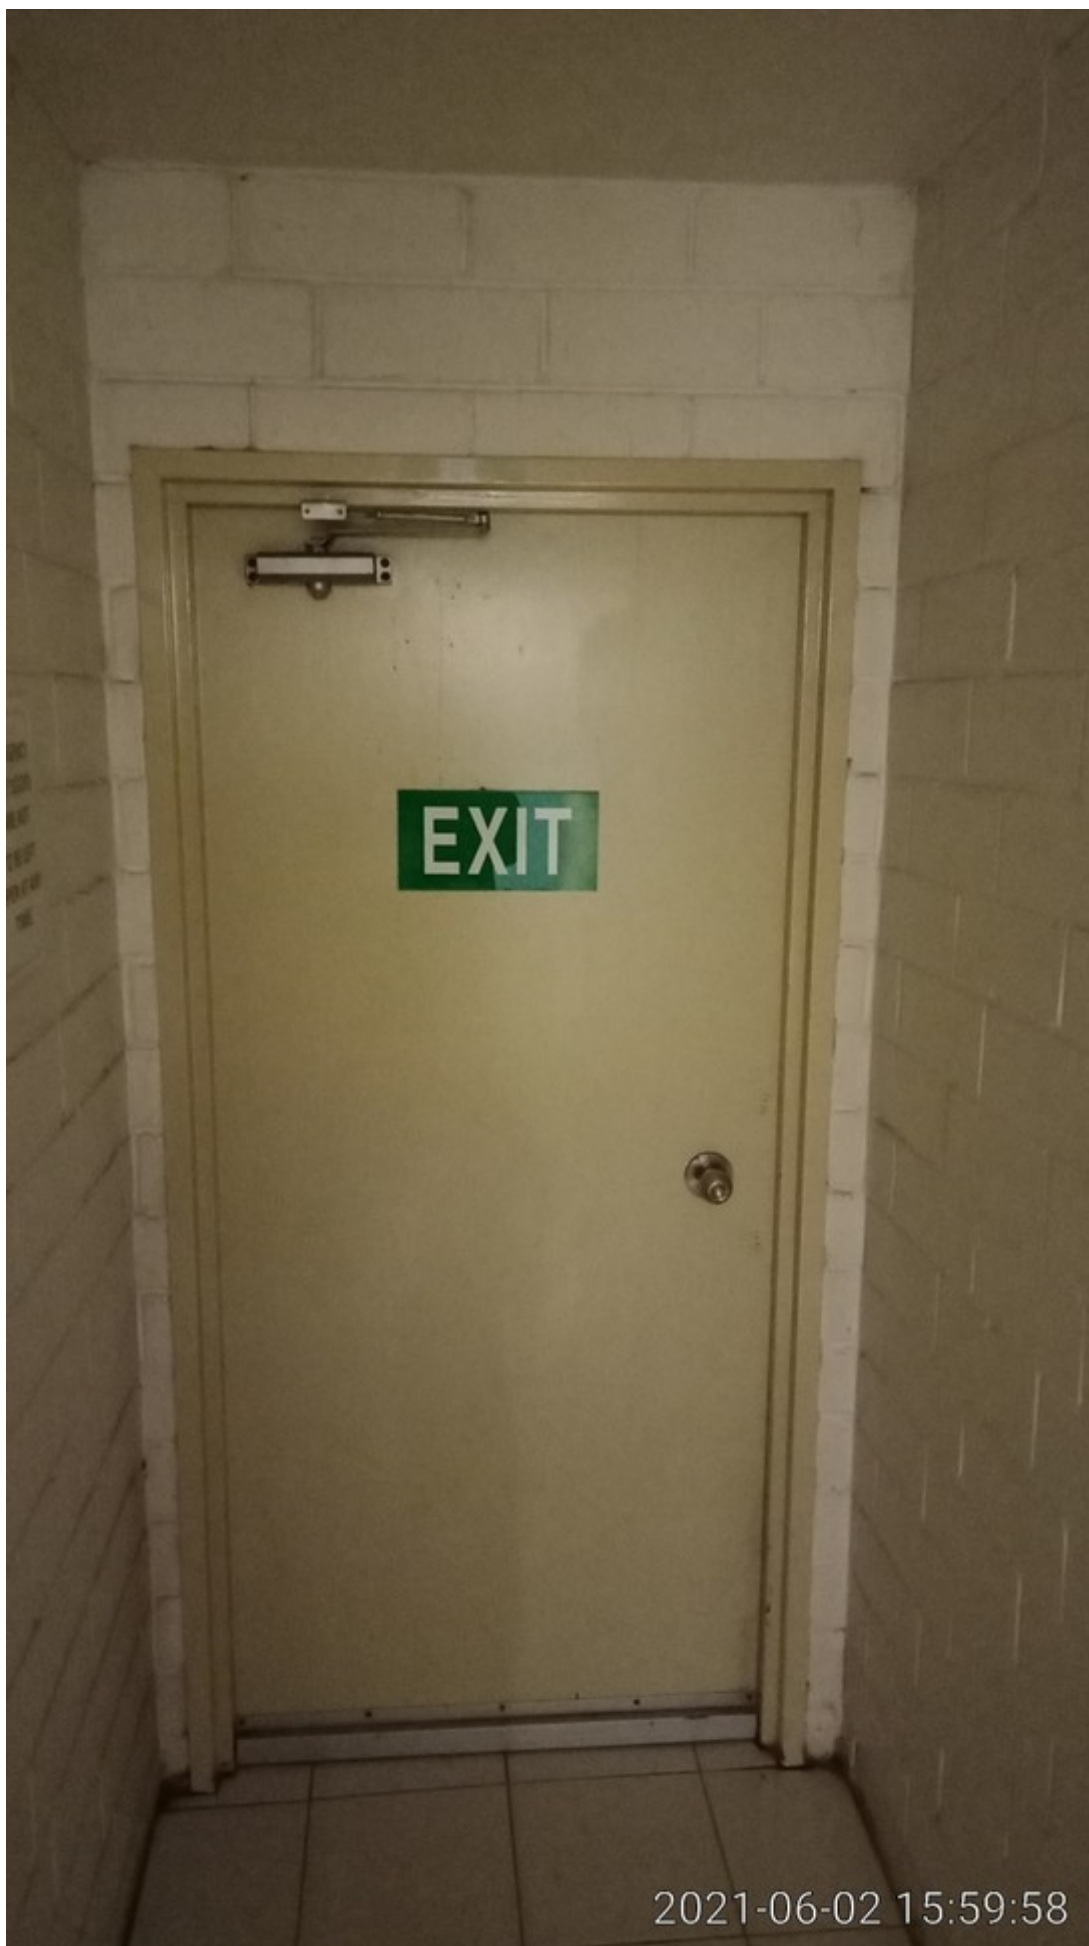
c) Block C, without notice for thoroughfare
