Major upgrades on 26 townhouses in amount of \$92,950.00 in 2017 without evidence of work done

1 SP52948 – Solicitor Adrian Mueller, on behalf of owners corporation, confirming that maintenance of common property is compulsory and that some strata files are missing on 14th of November 2019

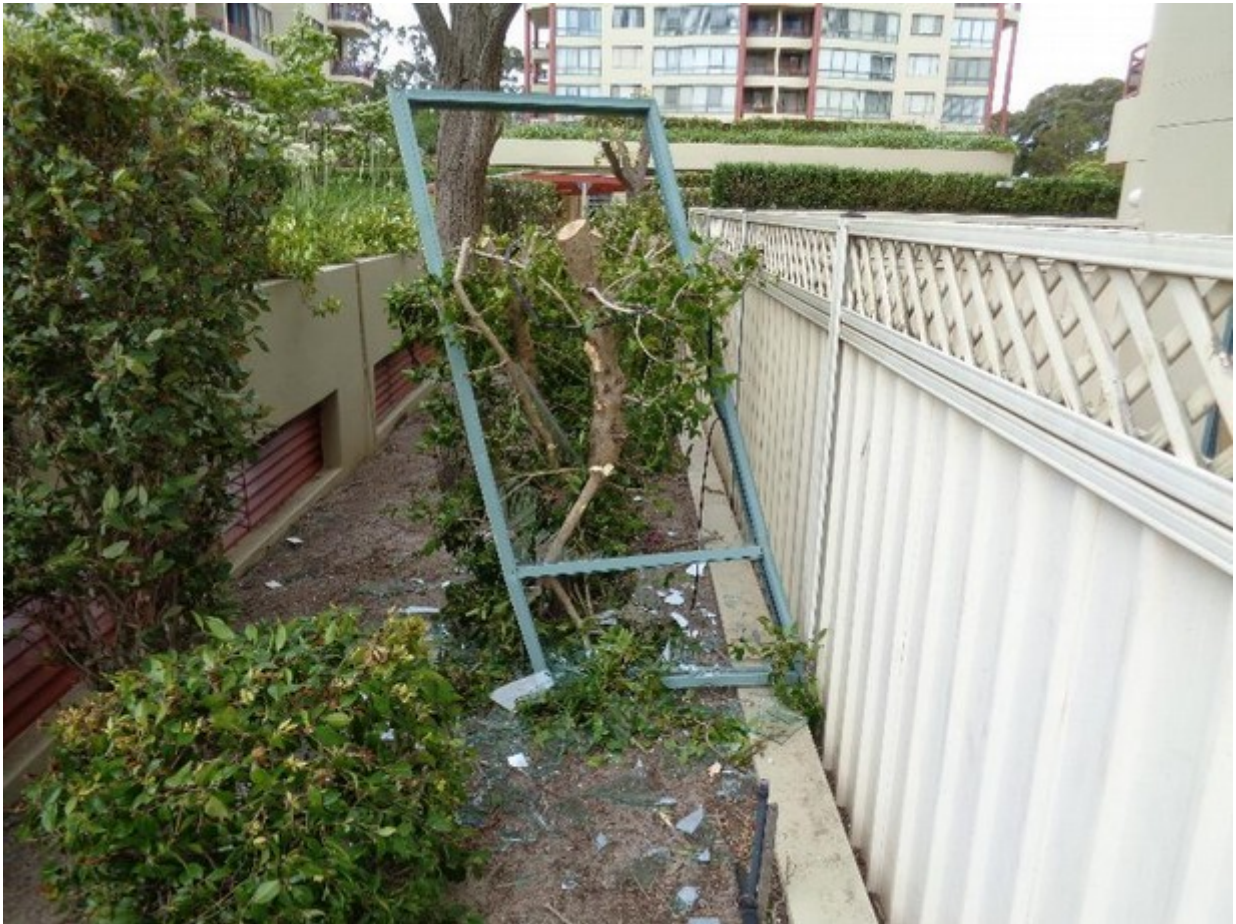
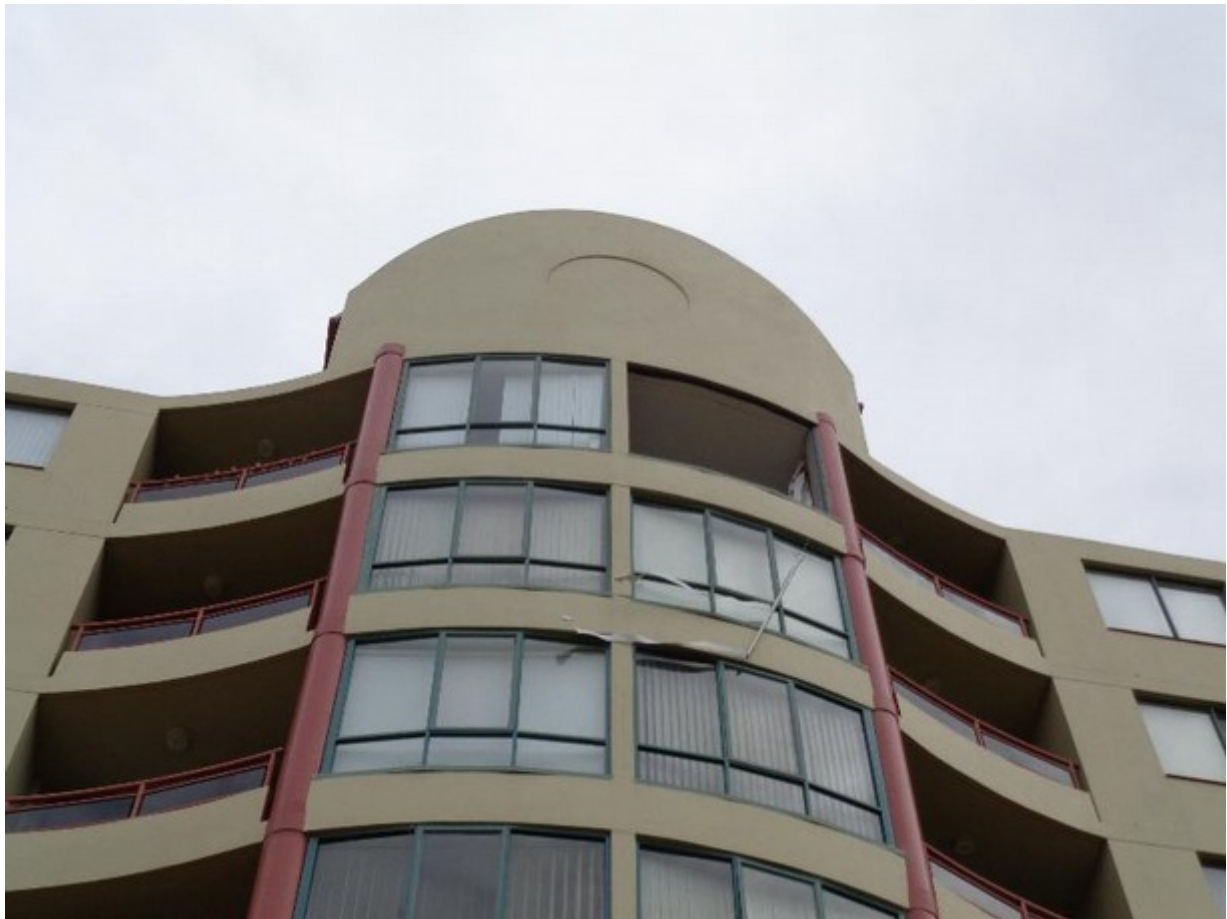
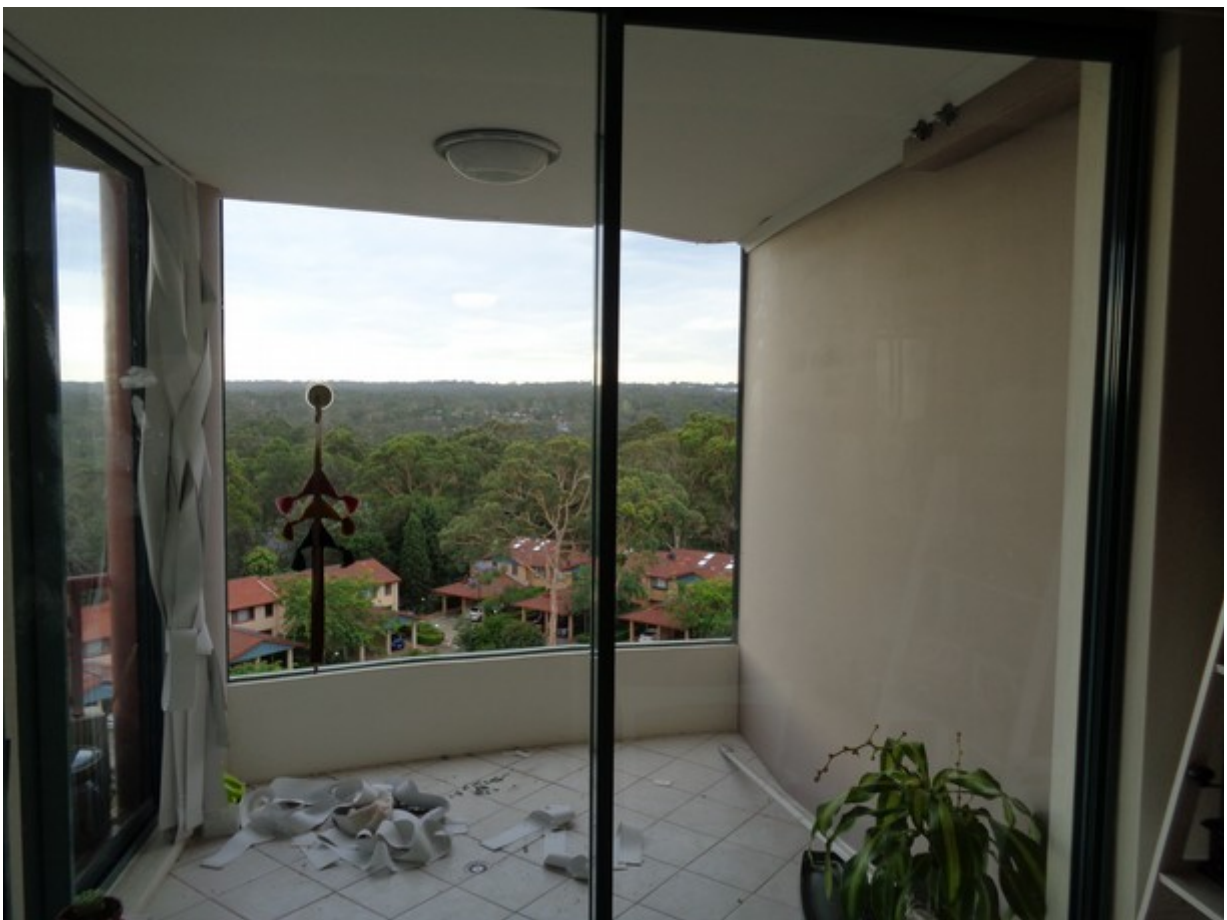
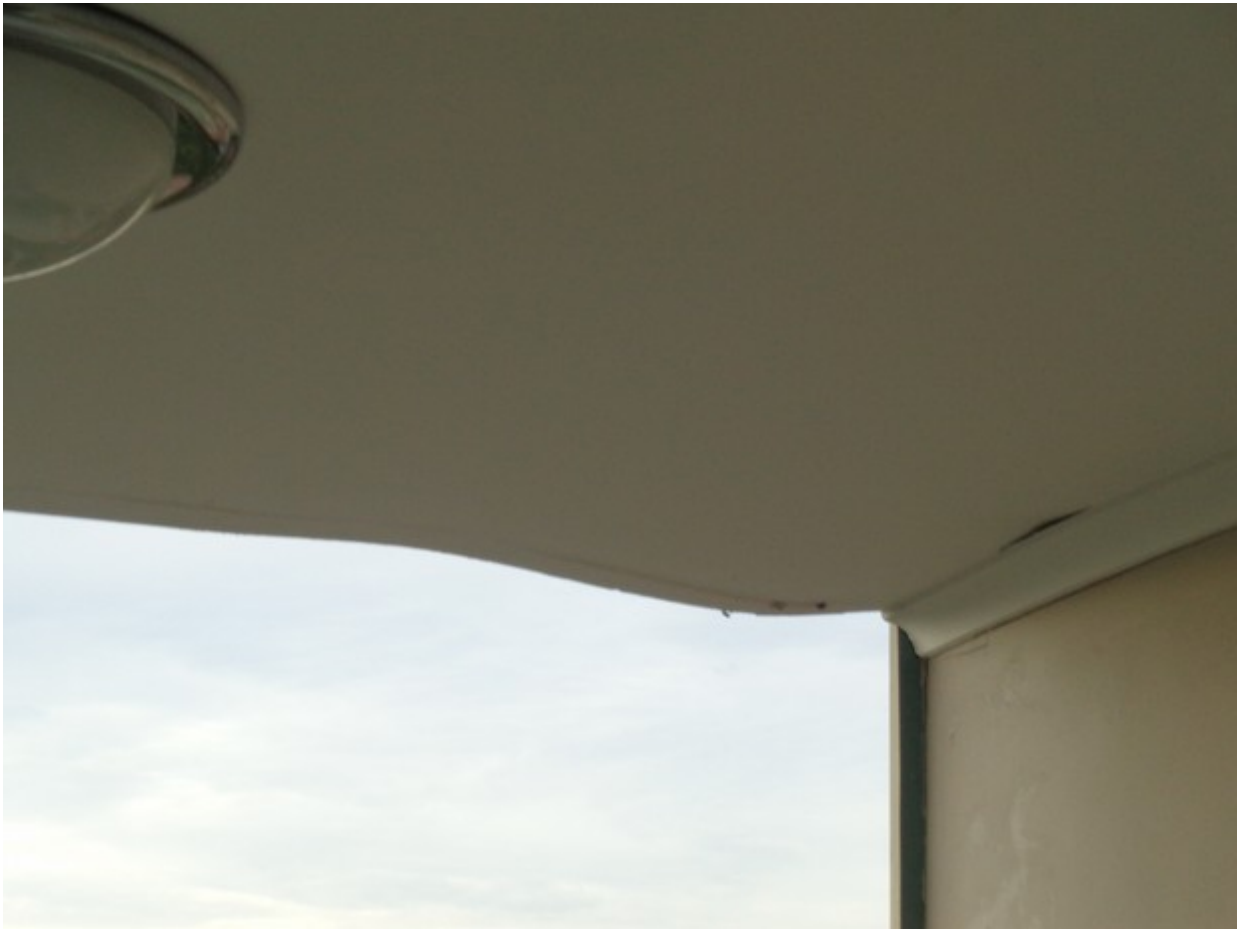
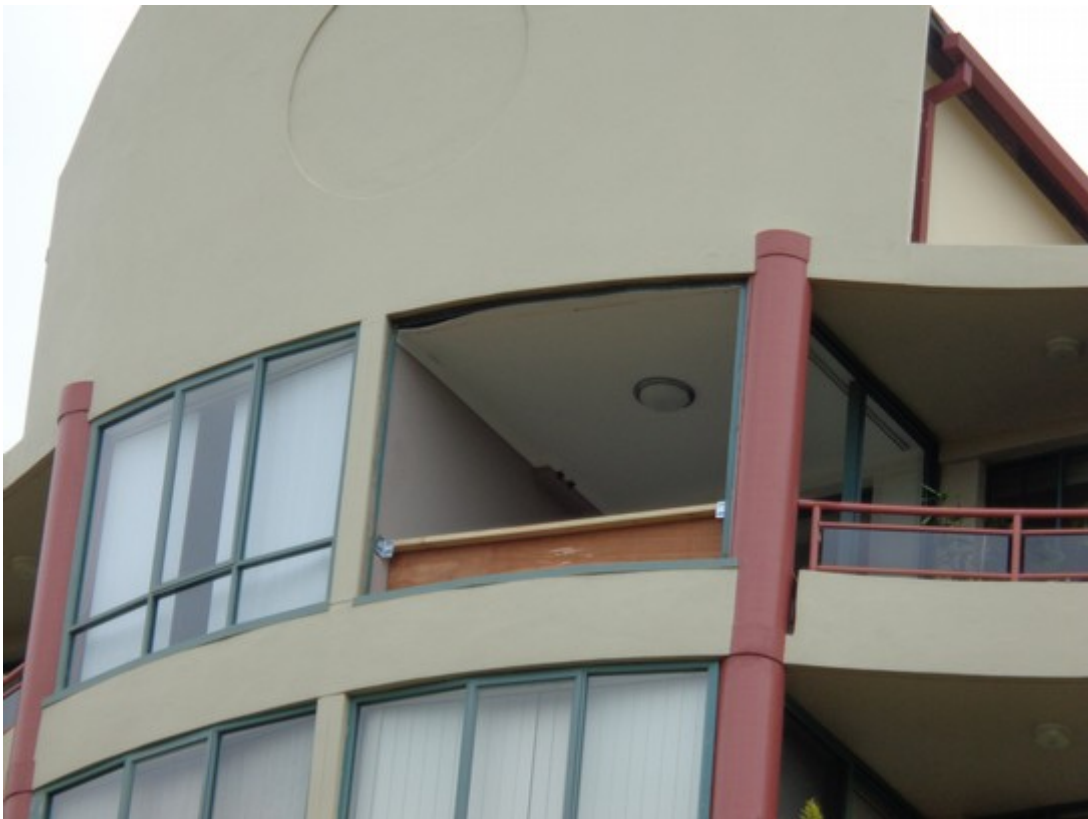
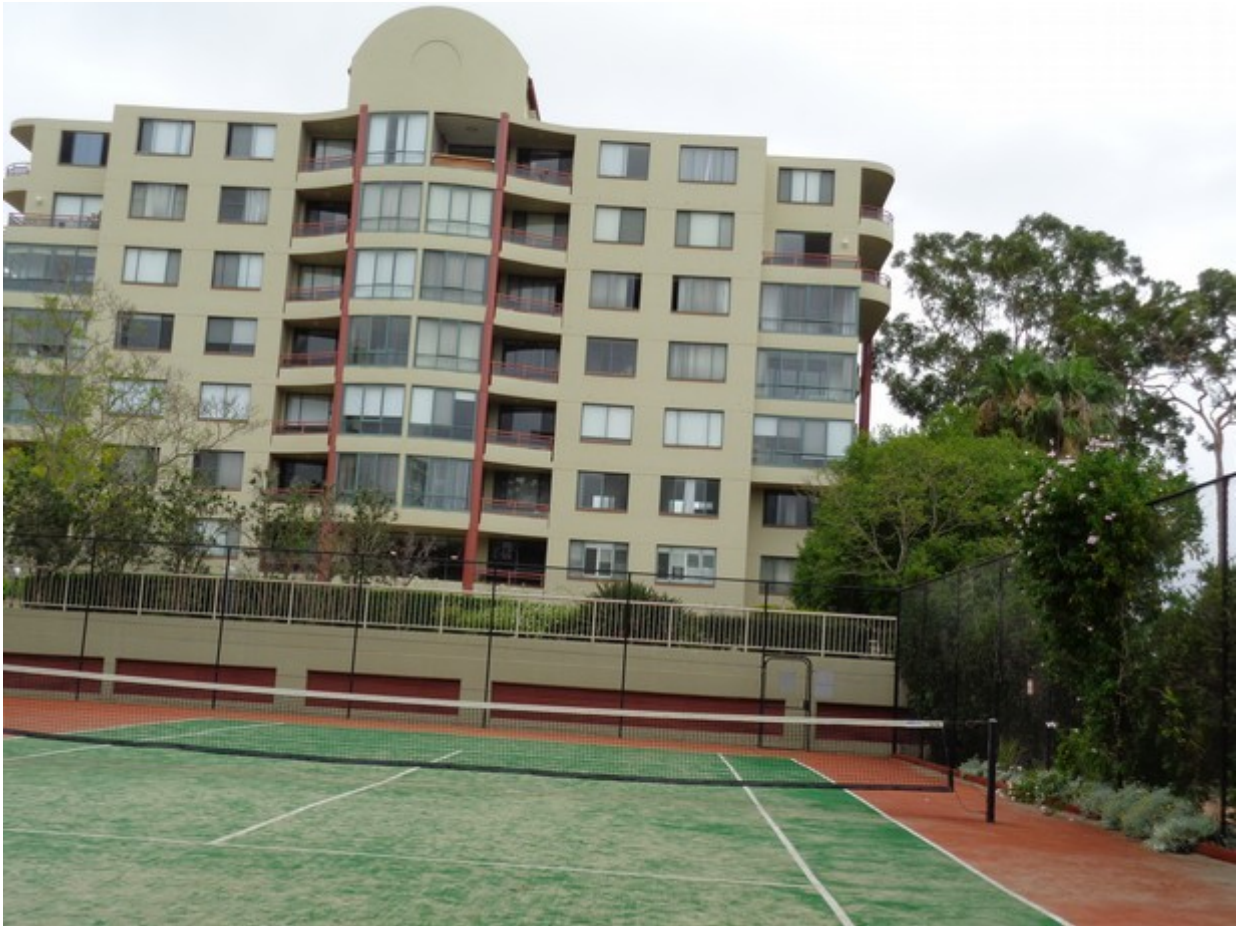
- Third time it happened on 29th of November 2020 for Lot 190.

SP52948 has been extremely lucky that female tenant of Lot 190 let go off sunroom frame before it was blown in front of the building. She tried to hold onto it but was too weak to prevent the disaster. Otherwise, we would have had major or even fatal incident.

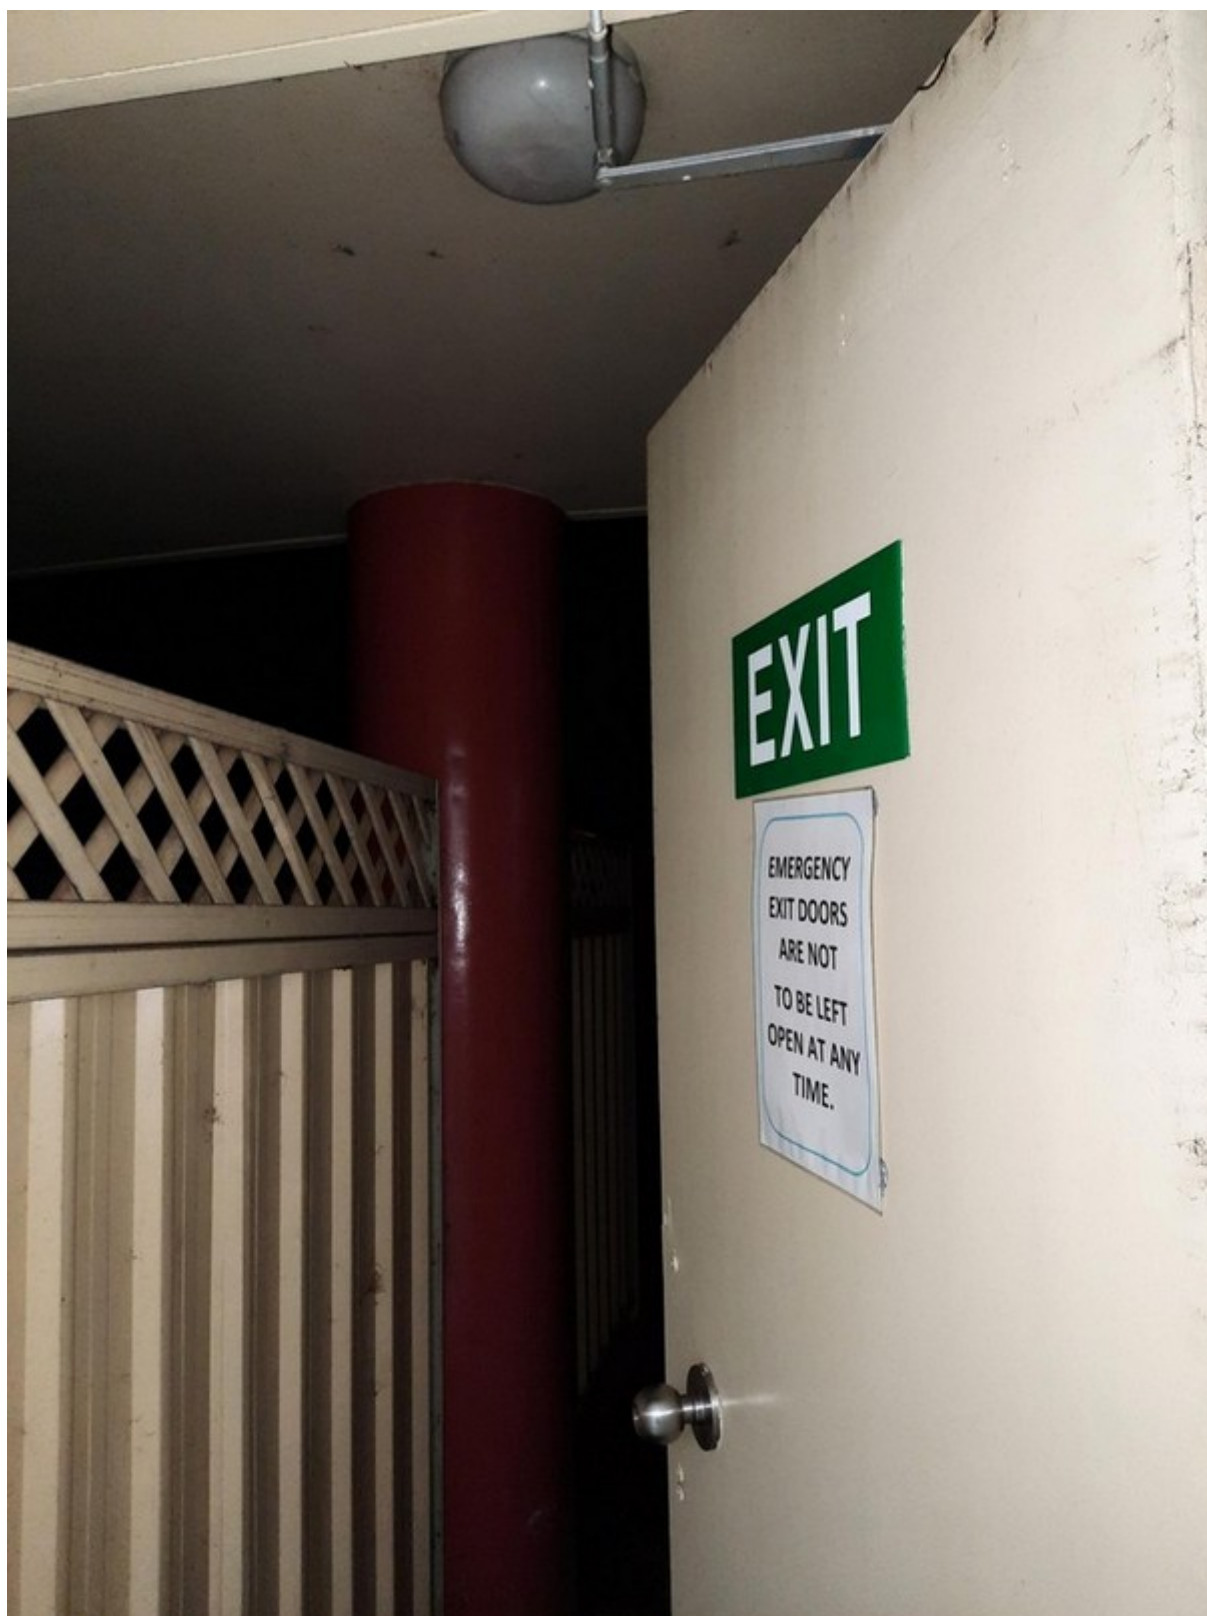
31 Example of fire exit lights out of order for almost five months as of 1st of October 2021

Fire exit, ground floor behind Block C, light out of order since 31 May 2021. Photo taken on 22 June 2021:

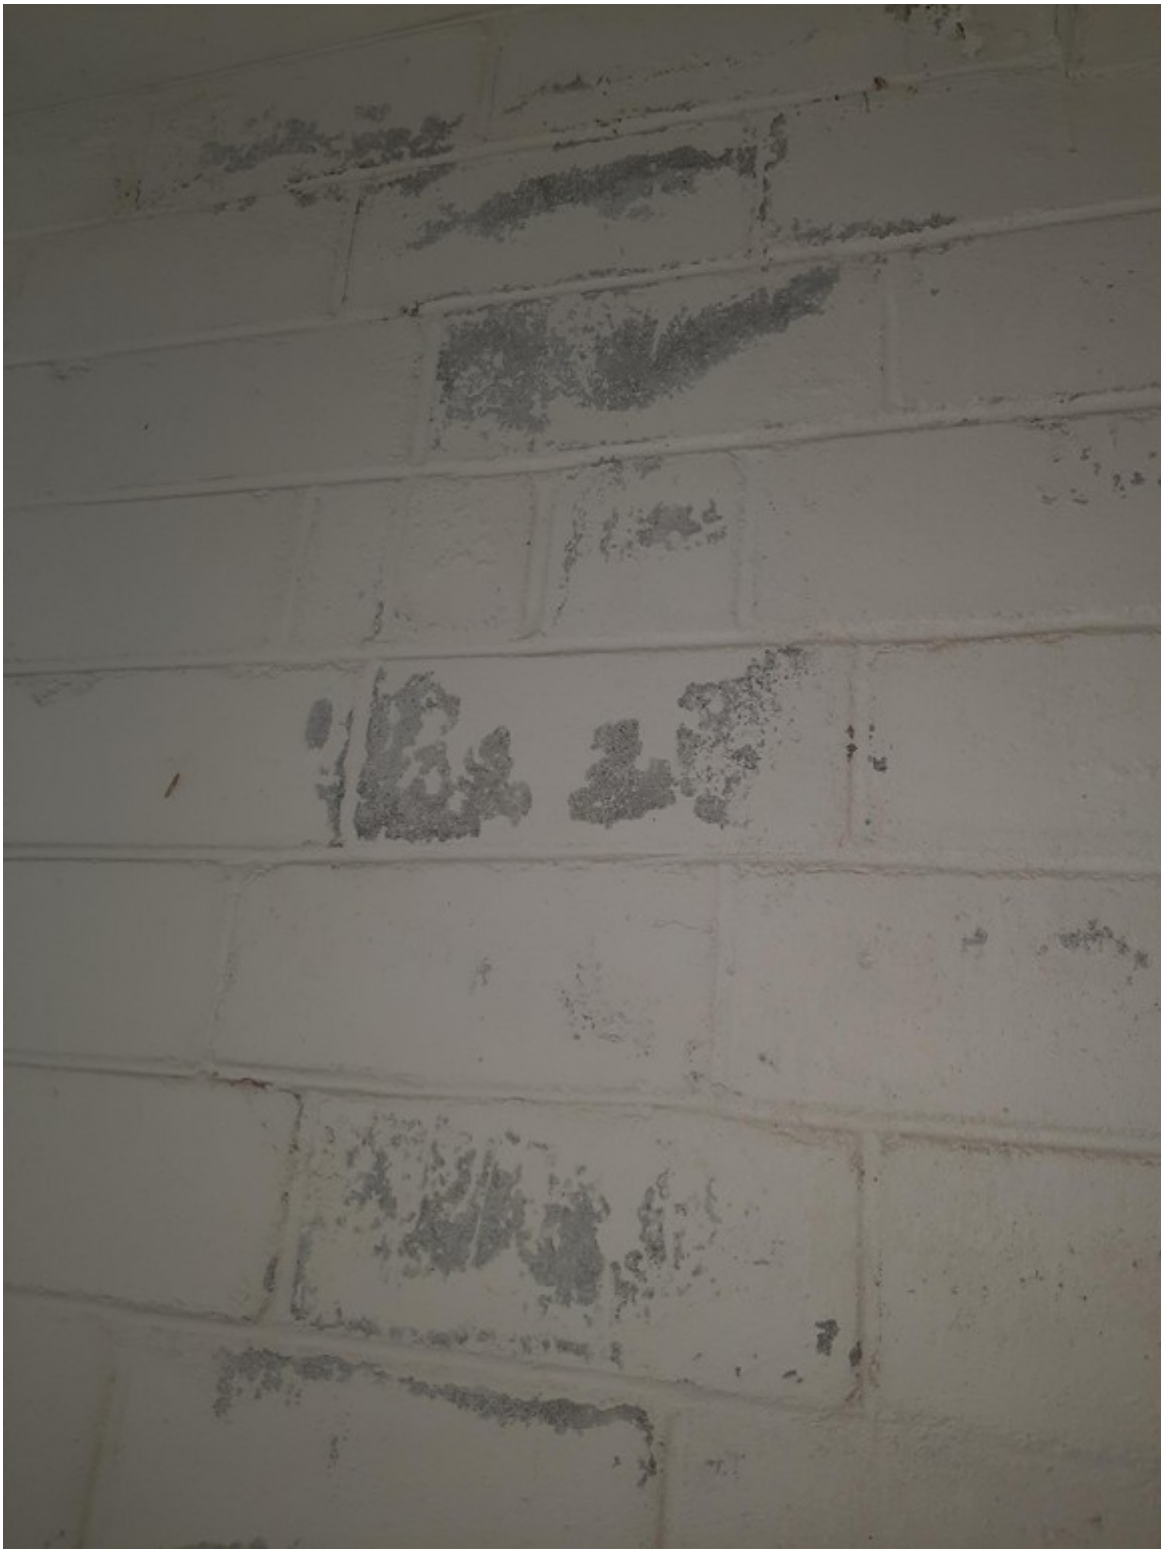
33 Example of water leak damages near fire door exit in Block C ground floor in June 2021

Wall was repainted in July 2021, but the metal plate stayed as is on 1st of October 2021.

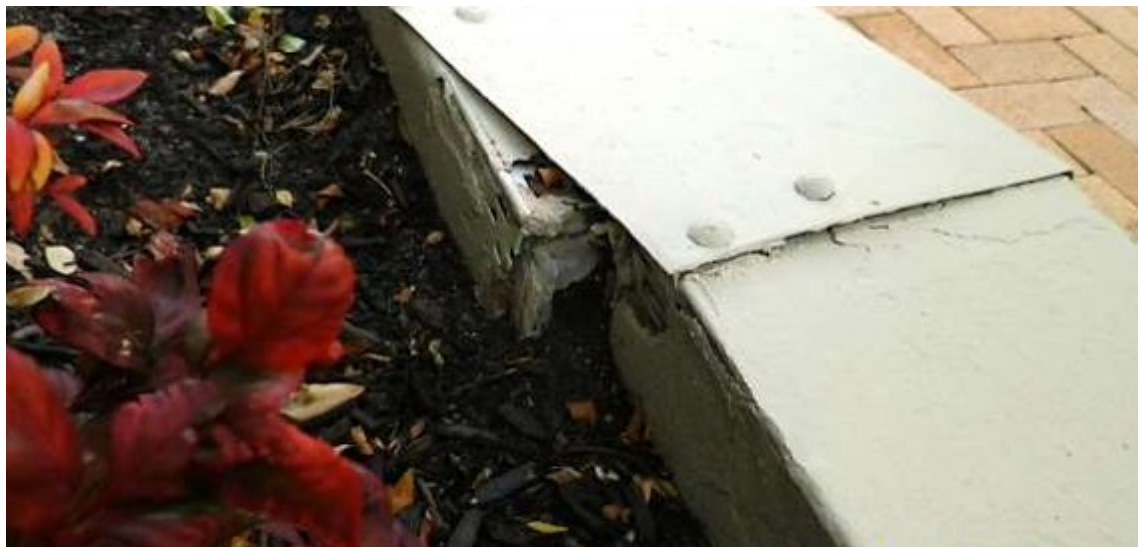
34 Example of garden bed collapse risk near Block D in July 2021

Problem exists since 2013:

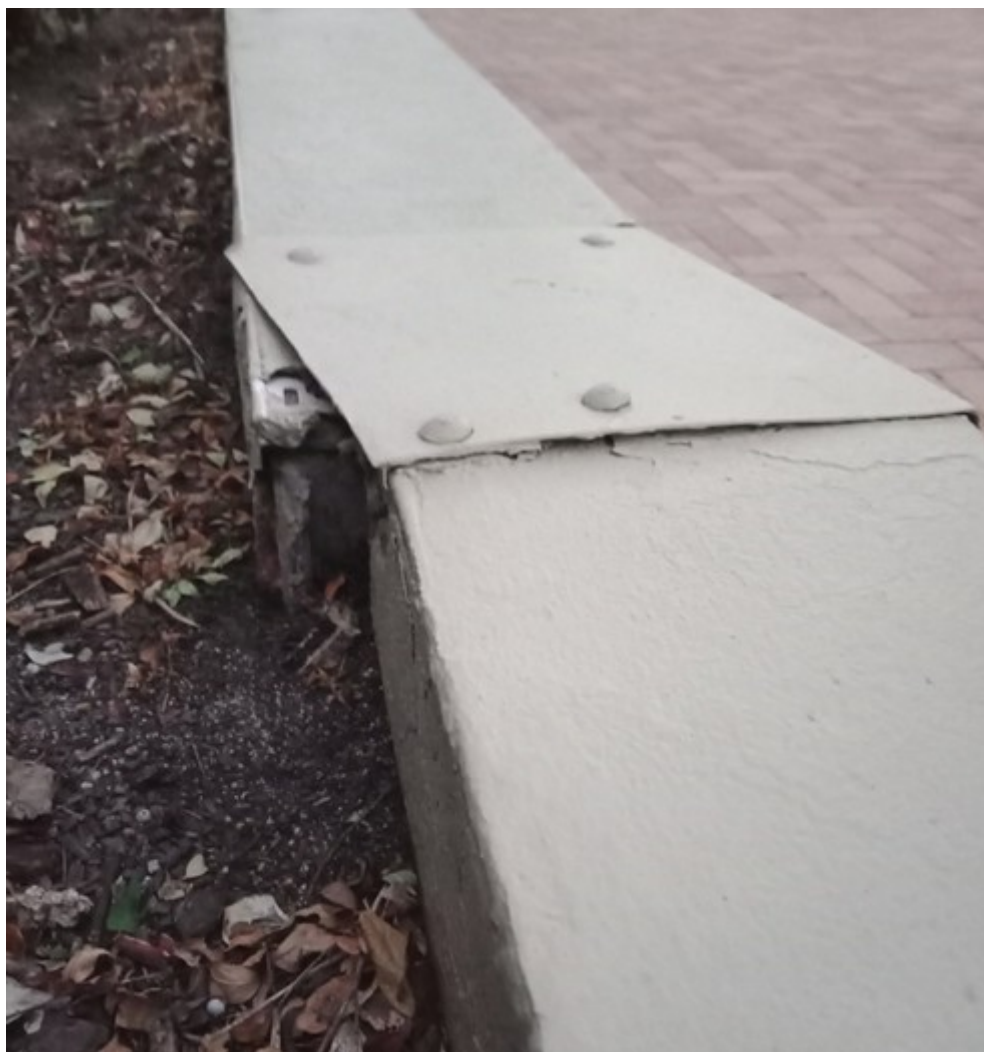
In October 2021, still a problem:

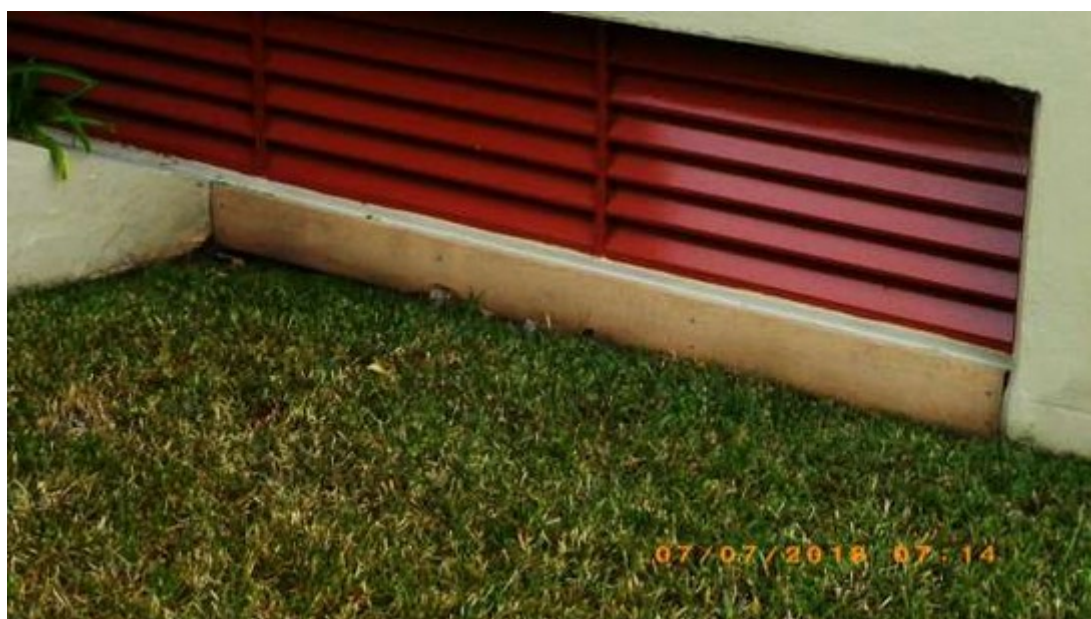
35 Examples of garden bed problems covered with wooden planks or metal plates, instead of being repaired

Instead of repairing the concrete cancer and cracks, simply cover it by piece of wood:

After installation of wooden plank:
