Major upgrades on 26 townhouses in amount of \$92,950.00 in 2017 without evidence of work done

1 SP52948 – Solicitor Adrian Mueller, on behalf of owners corporation, confirming that maintenance of common property is compulsory and that some strata files are missing on 14th of November 2019

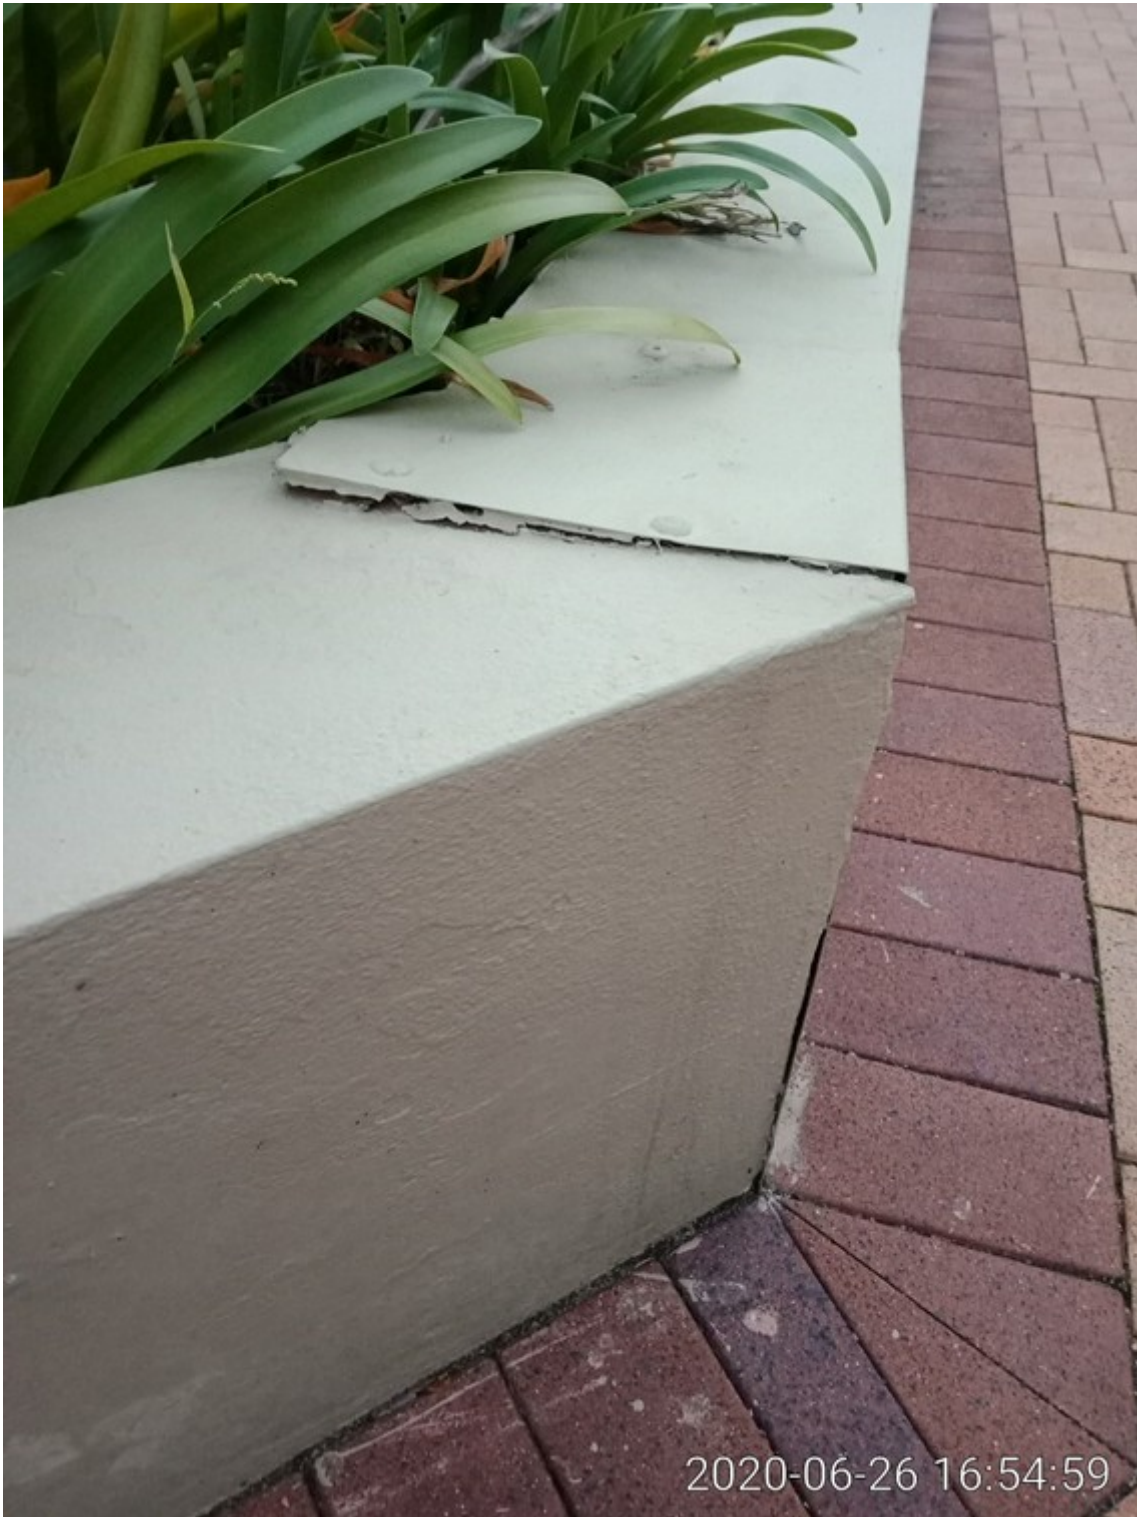
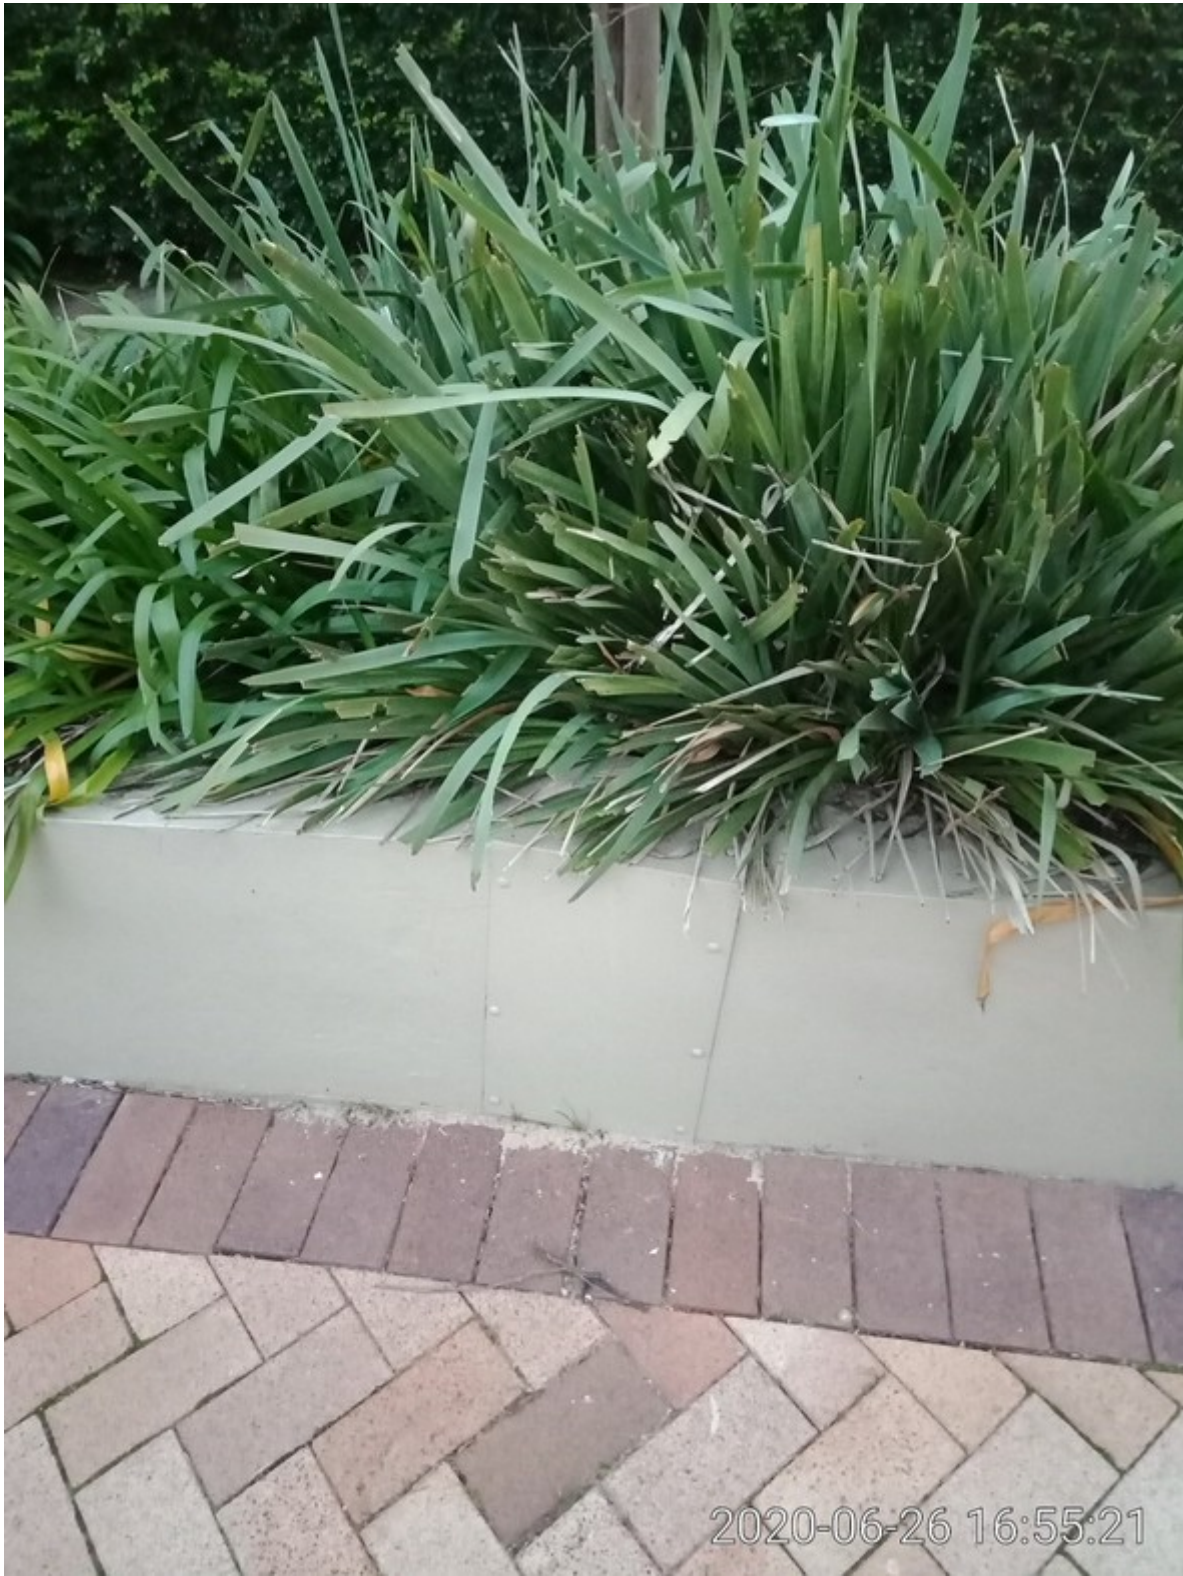
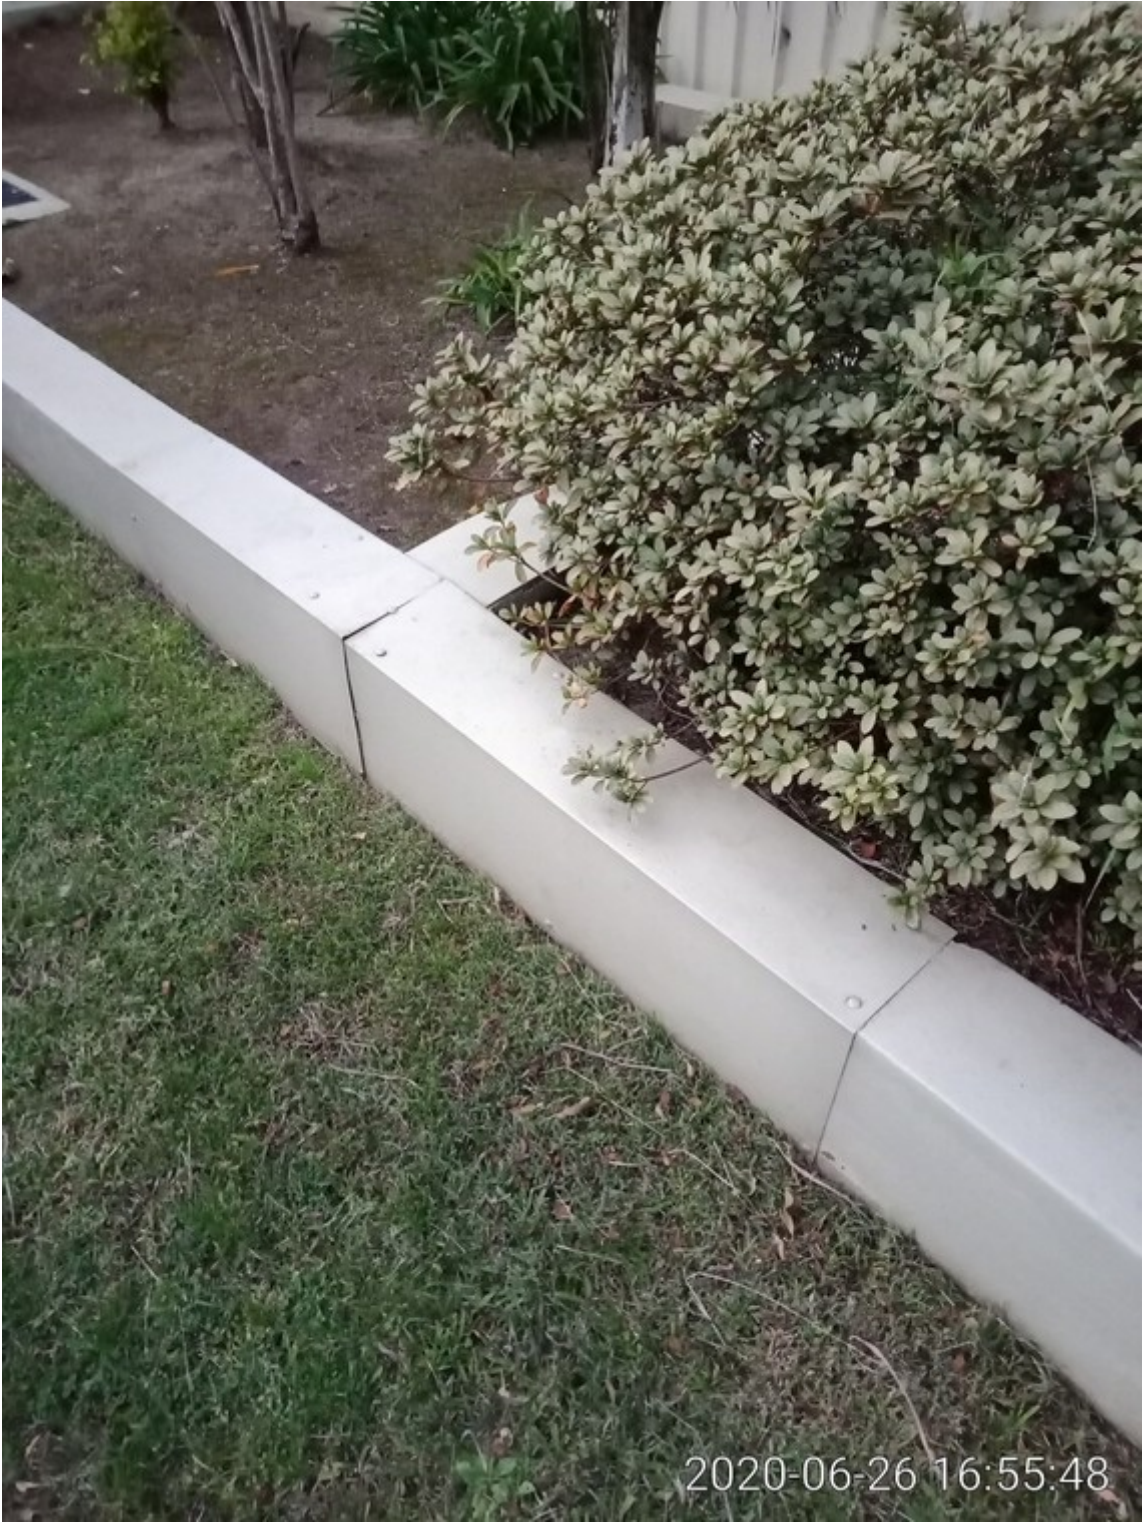
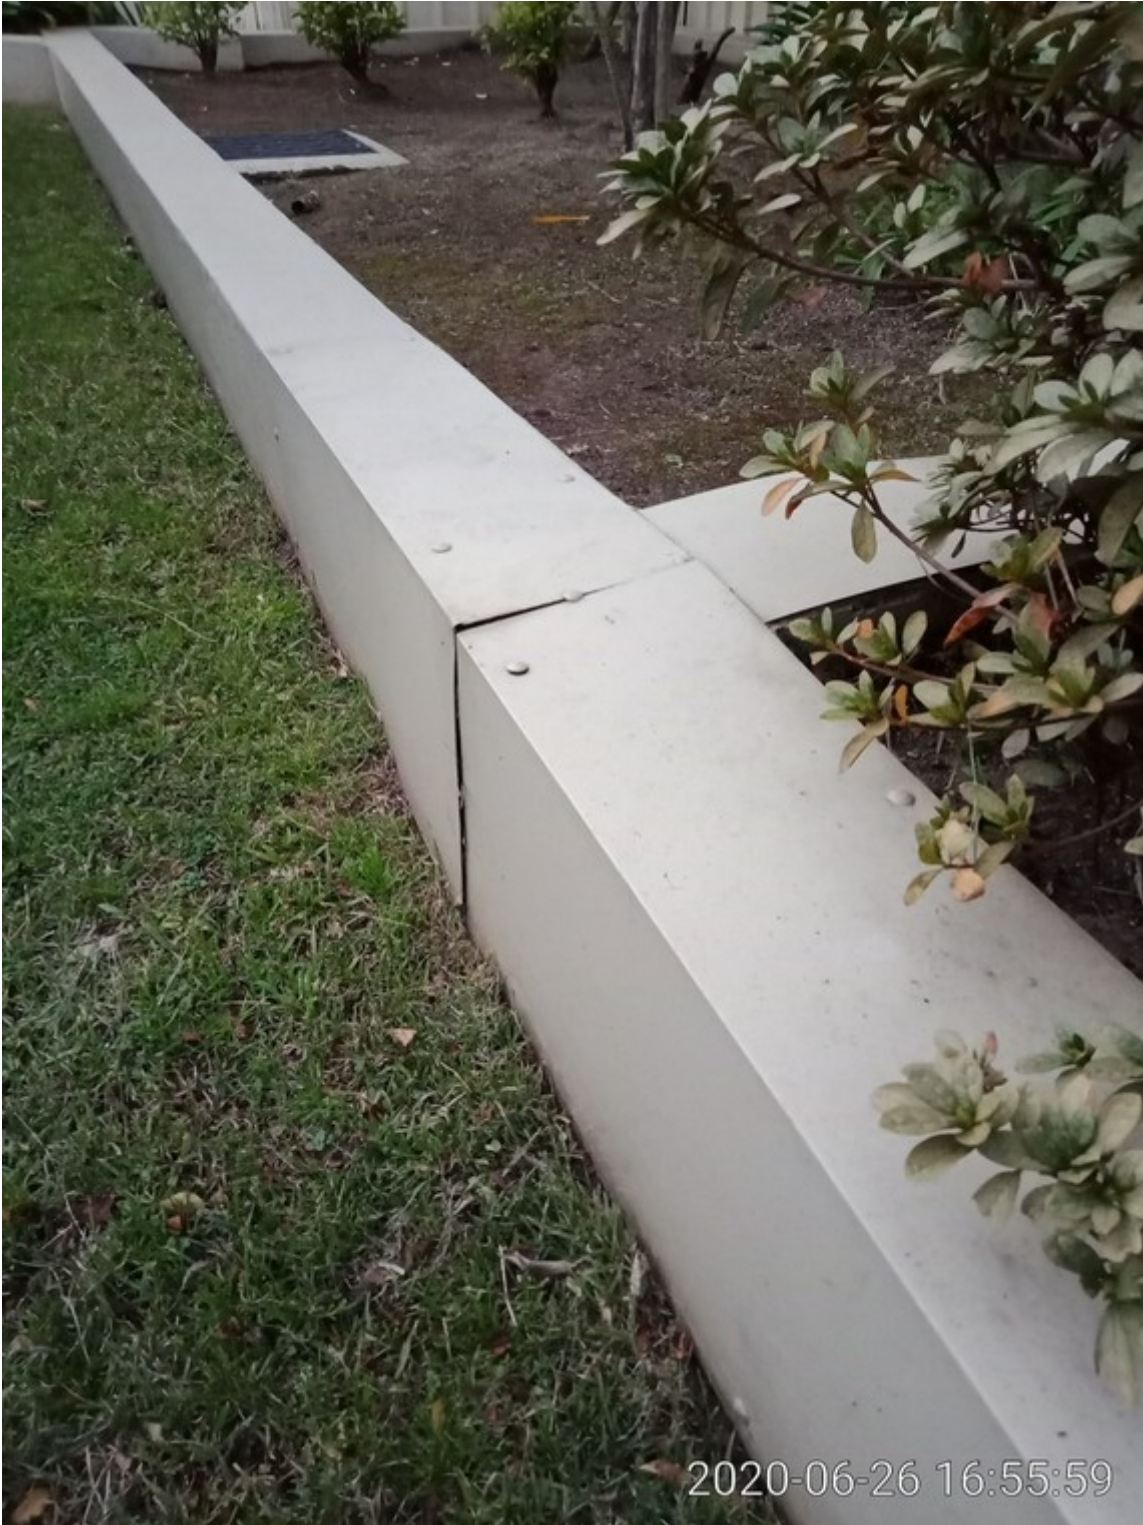
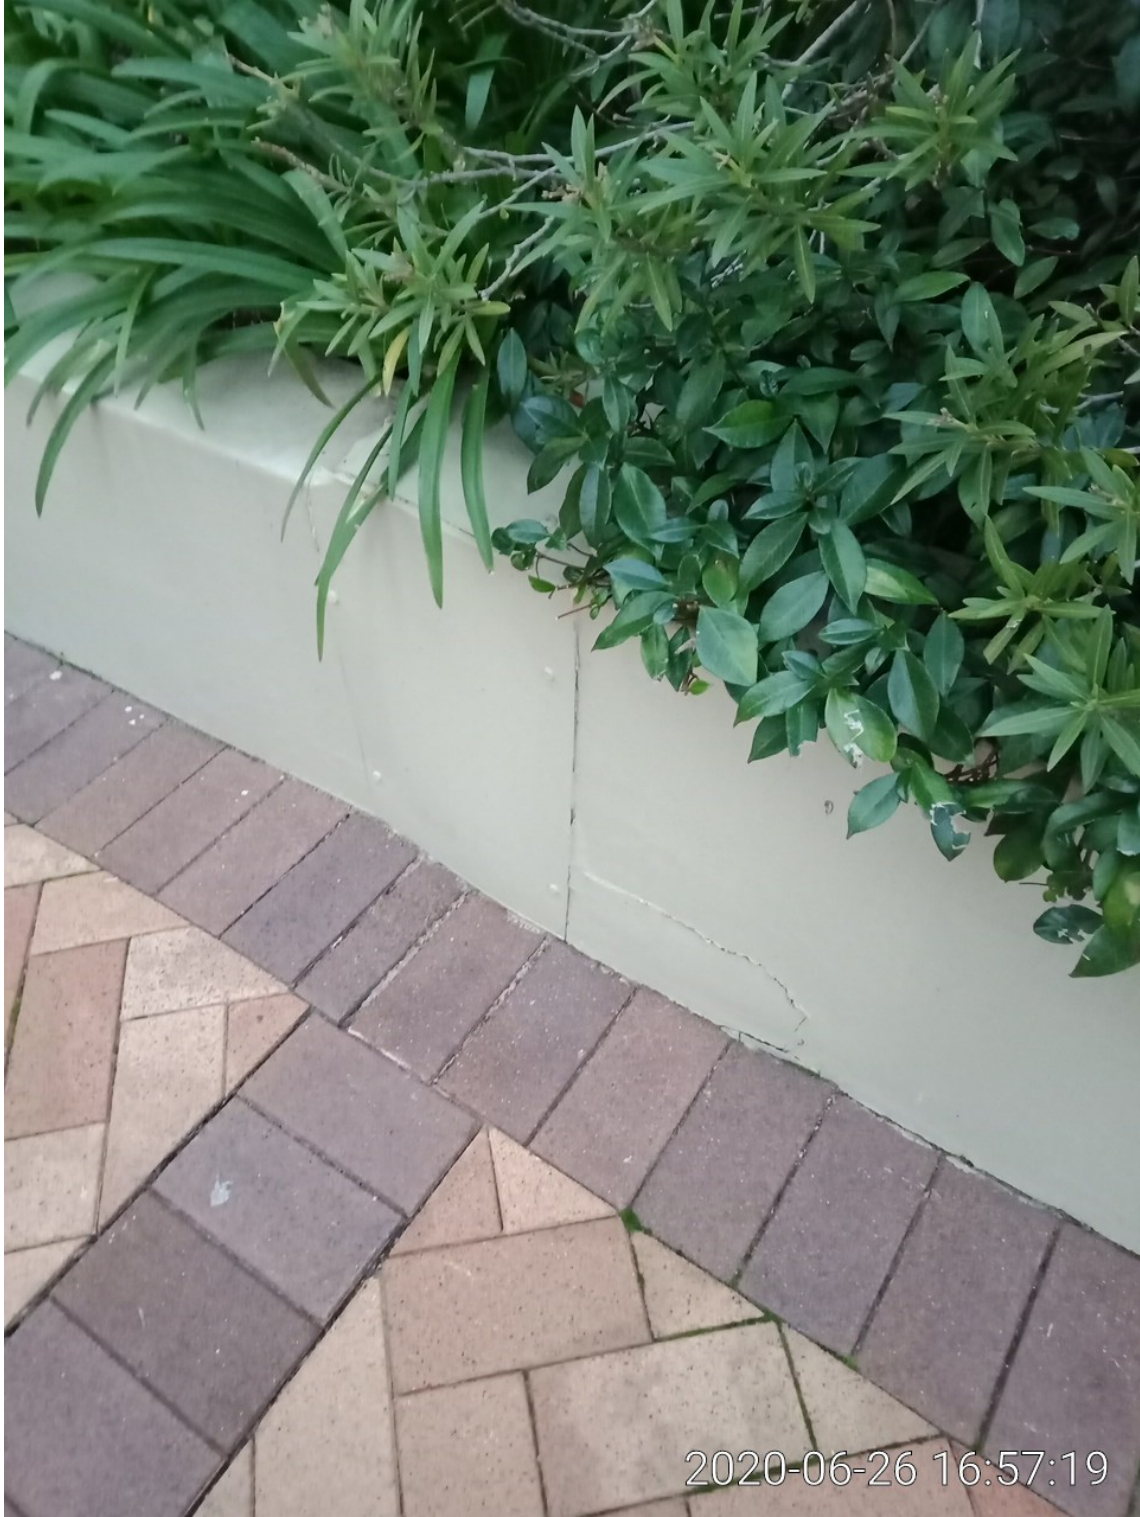
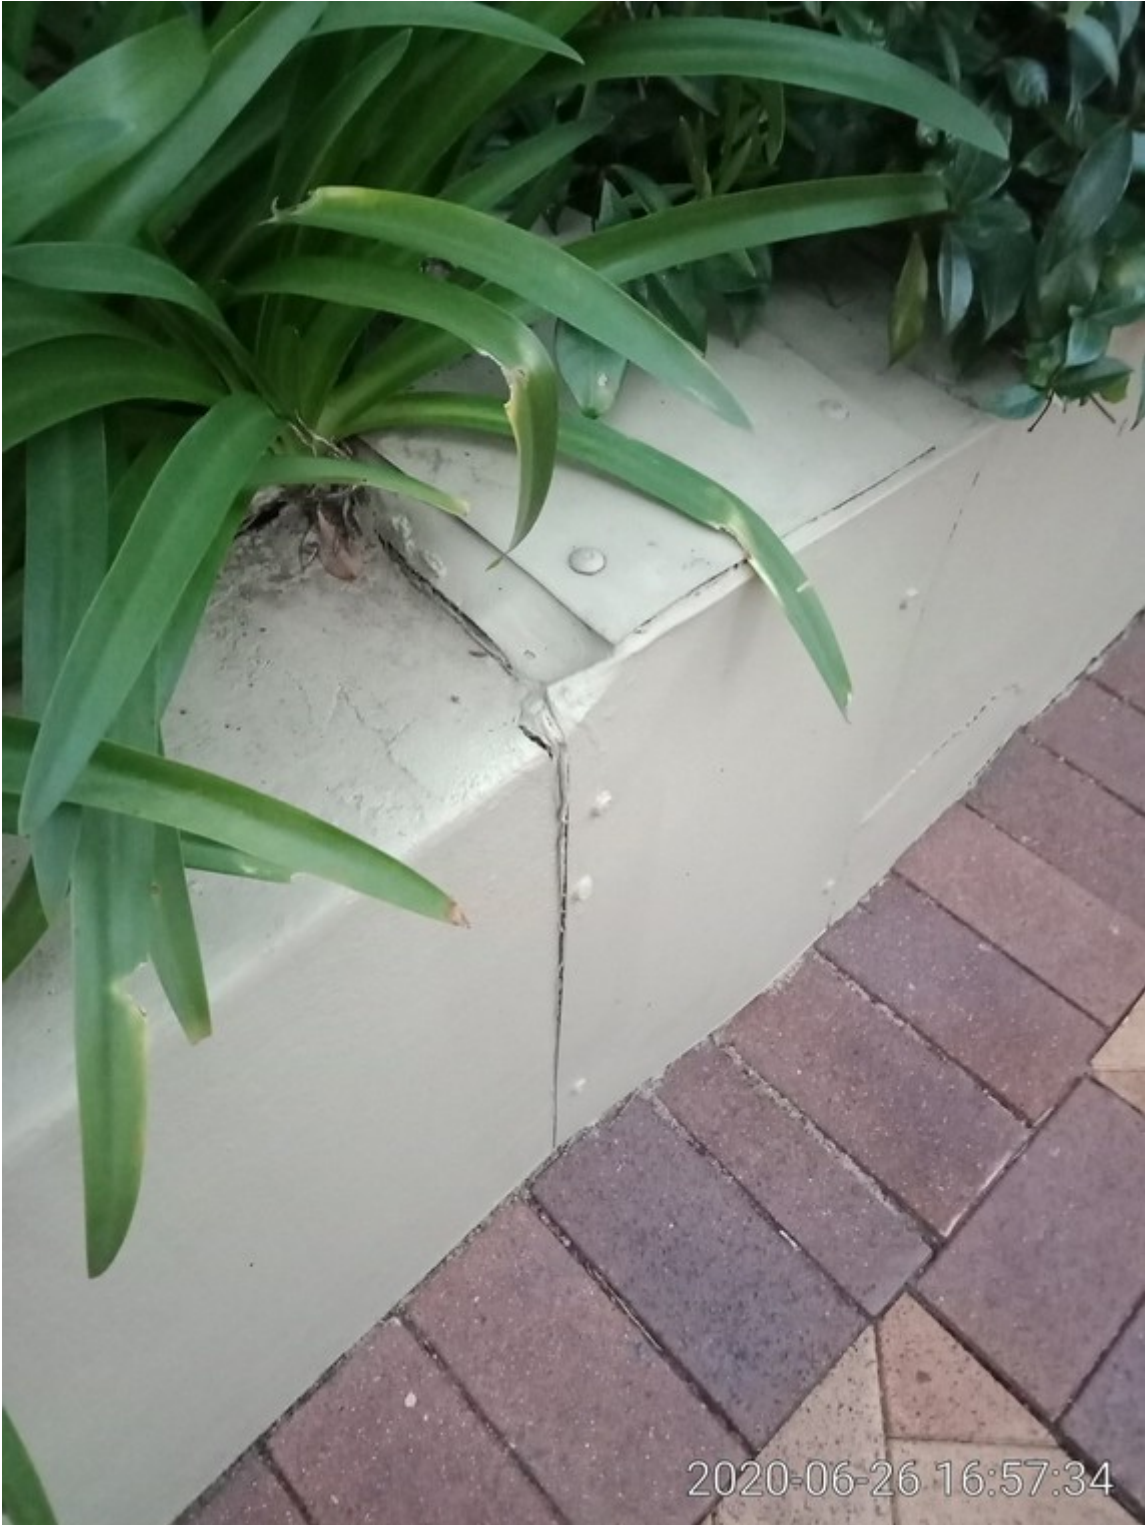
Metal plates, which not only hide status of the concrete behind them but also create safety risks due to sharp edges in areas where children play every day:

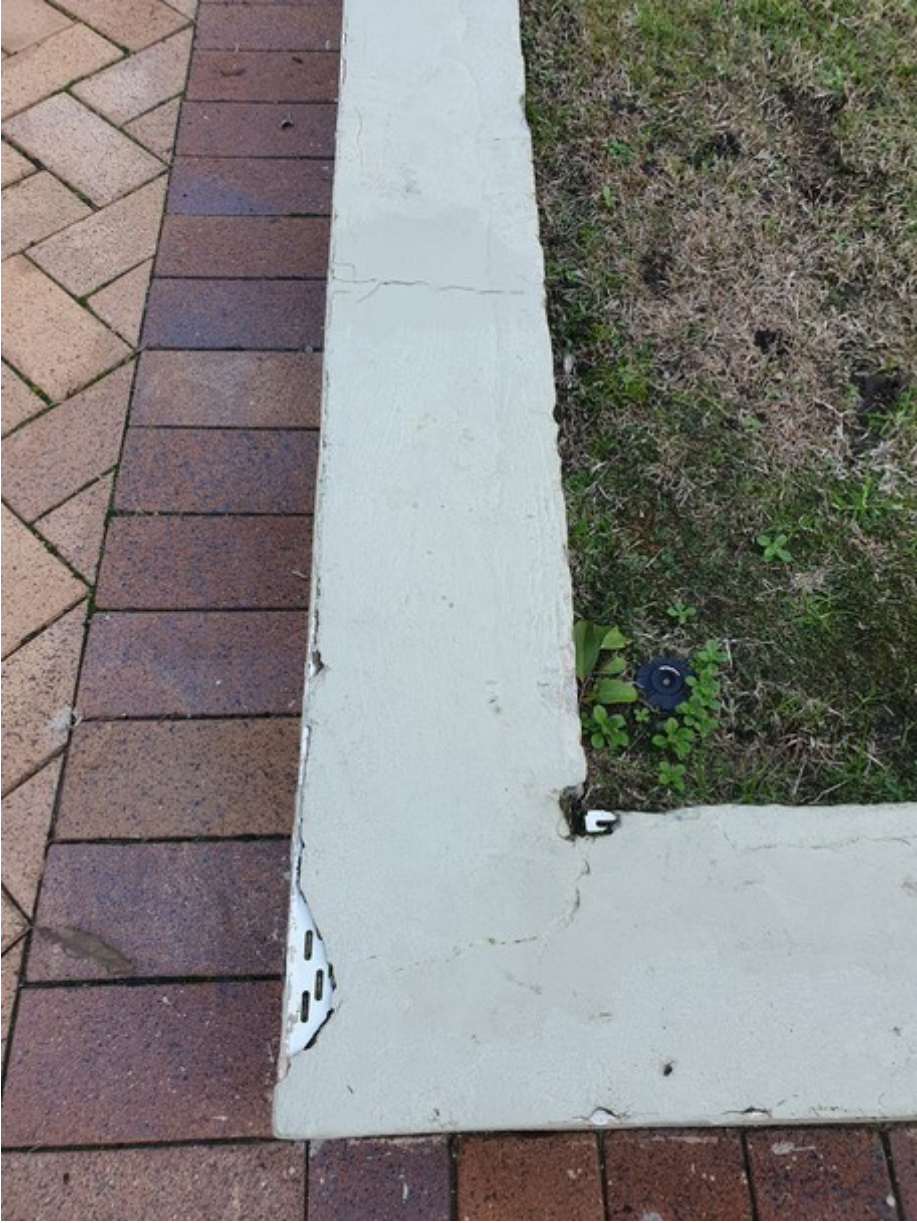
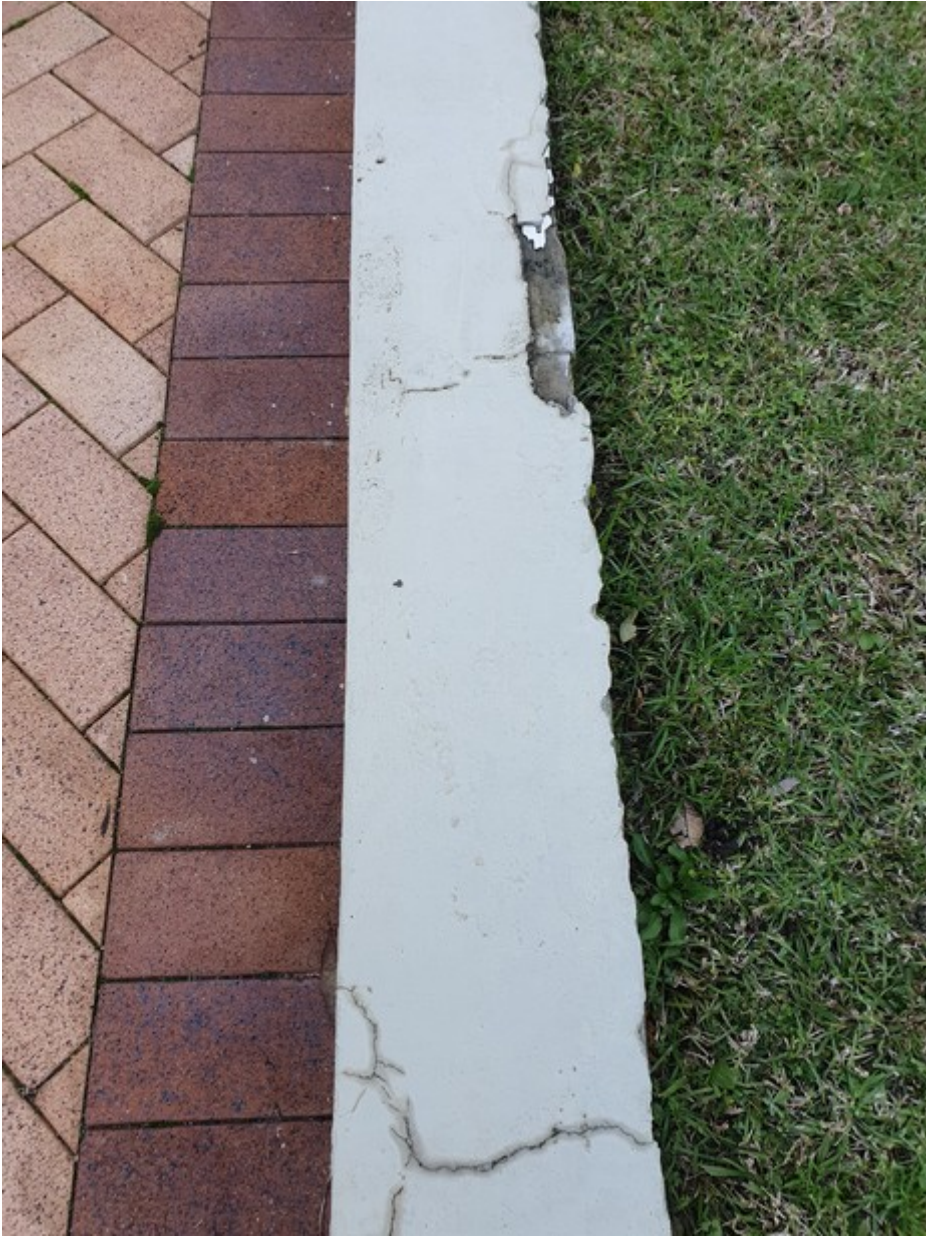
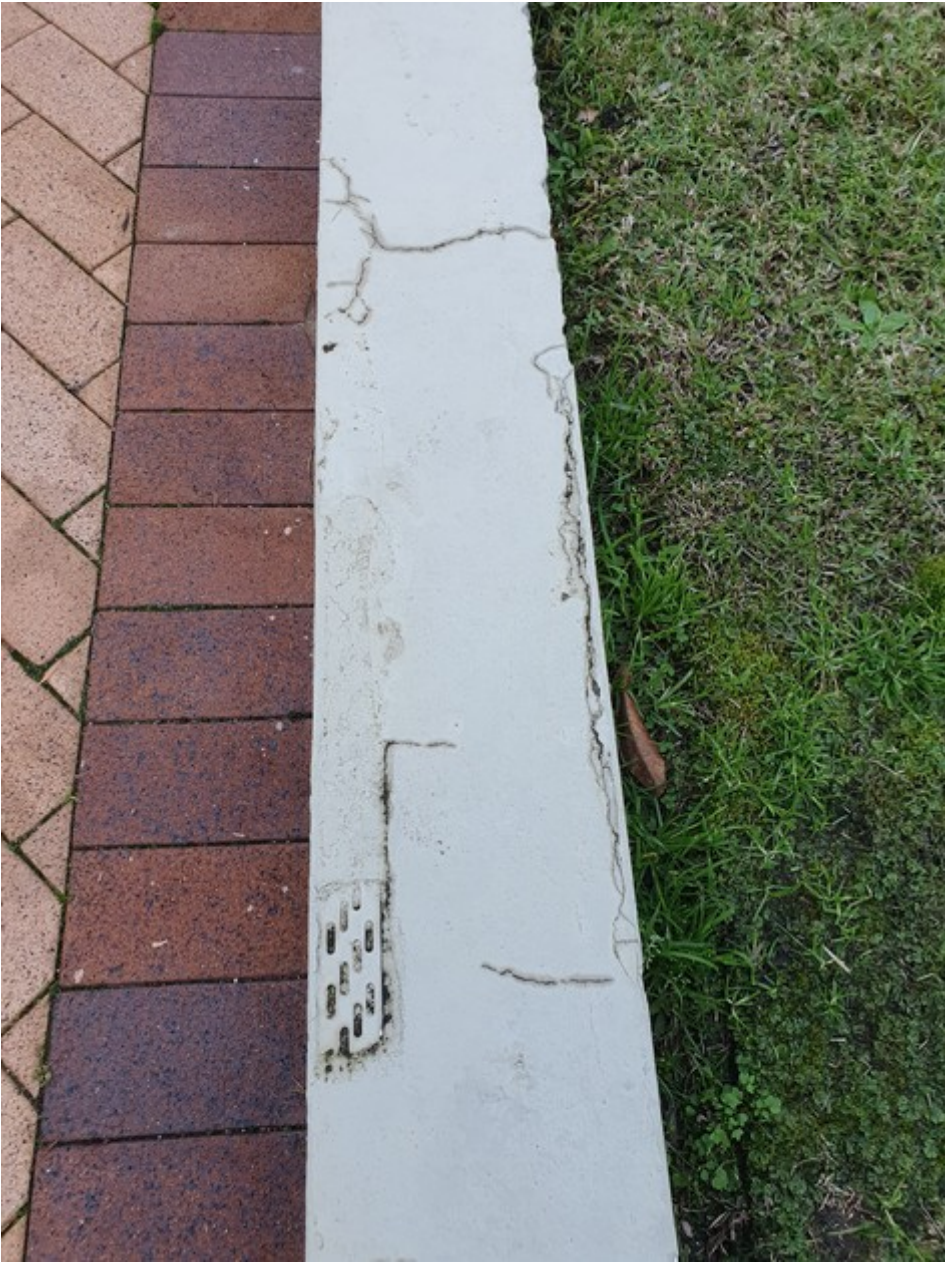
36 Injury hazard with garden bed walls and sharp edges with protruding plastic and metal pieces in areas where children play every day

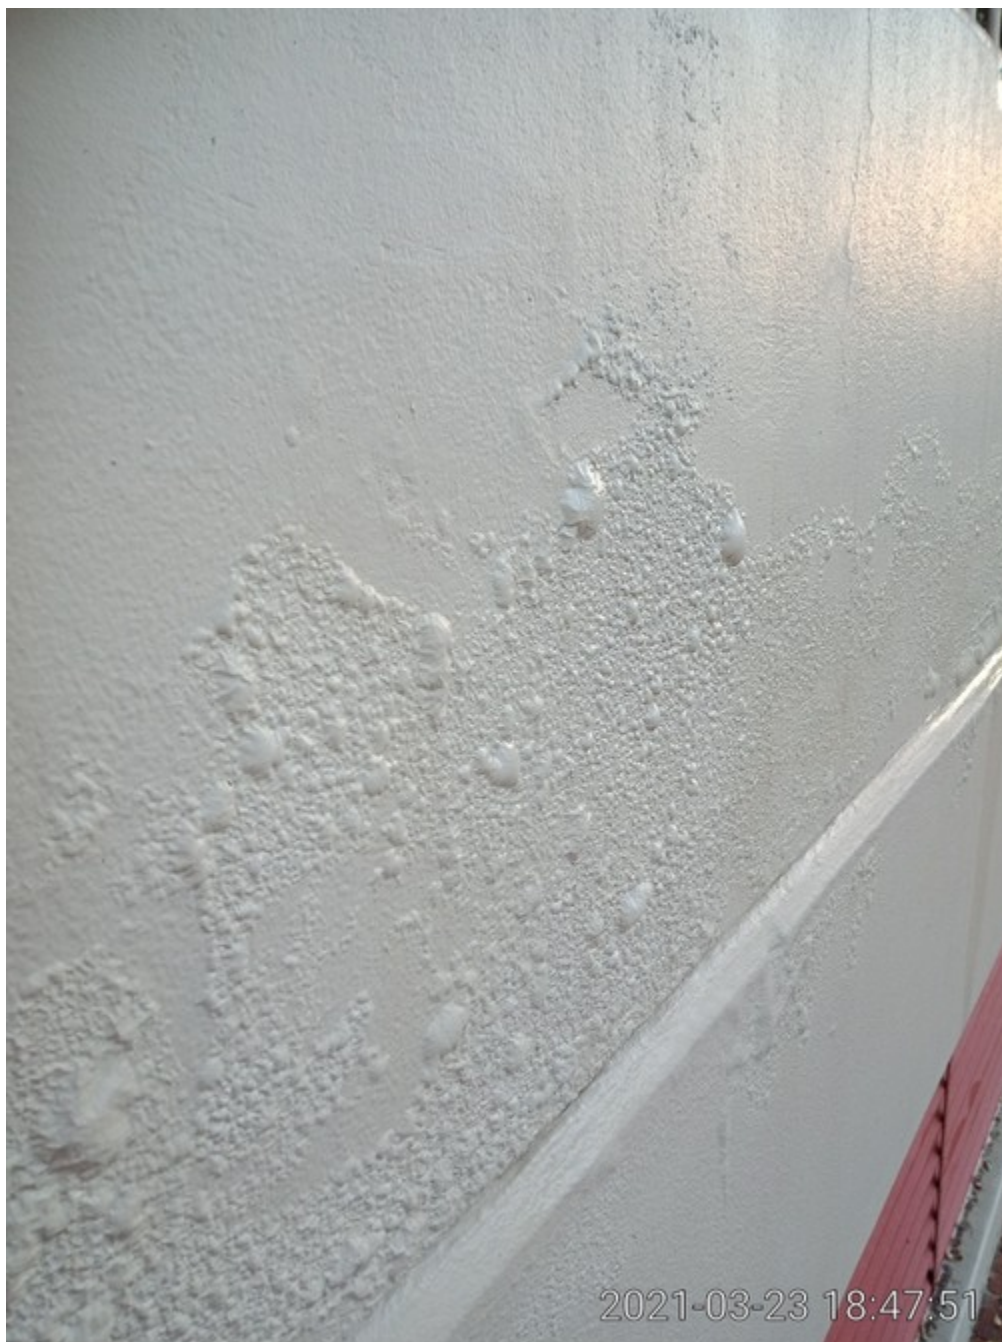
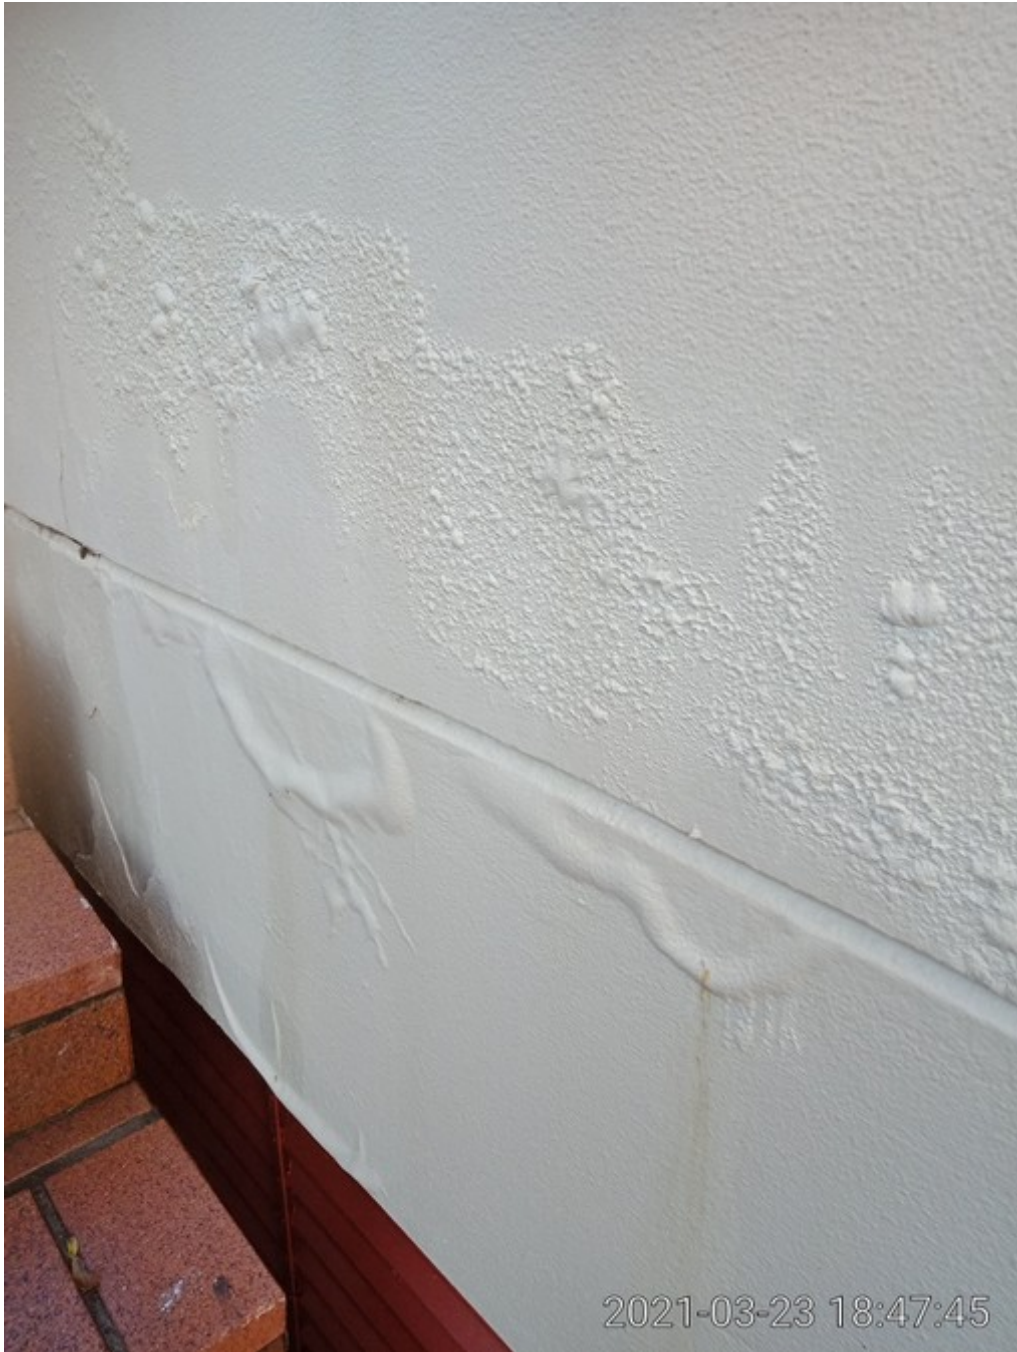
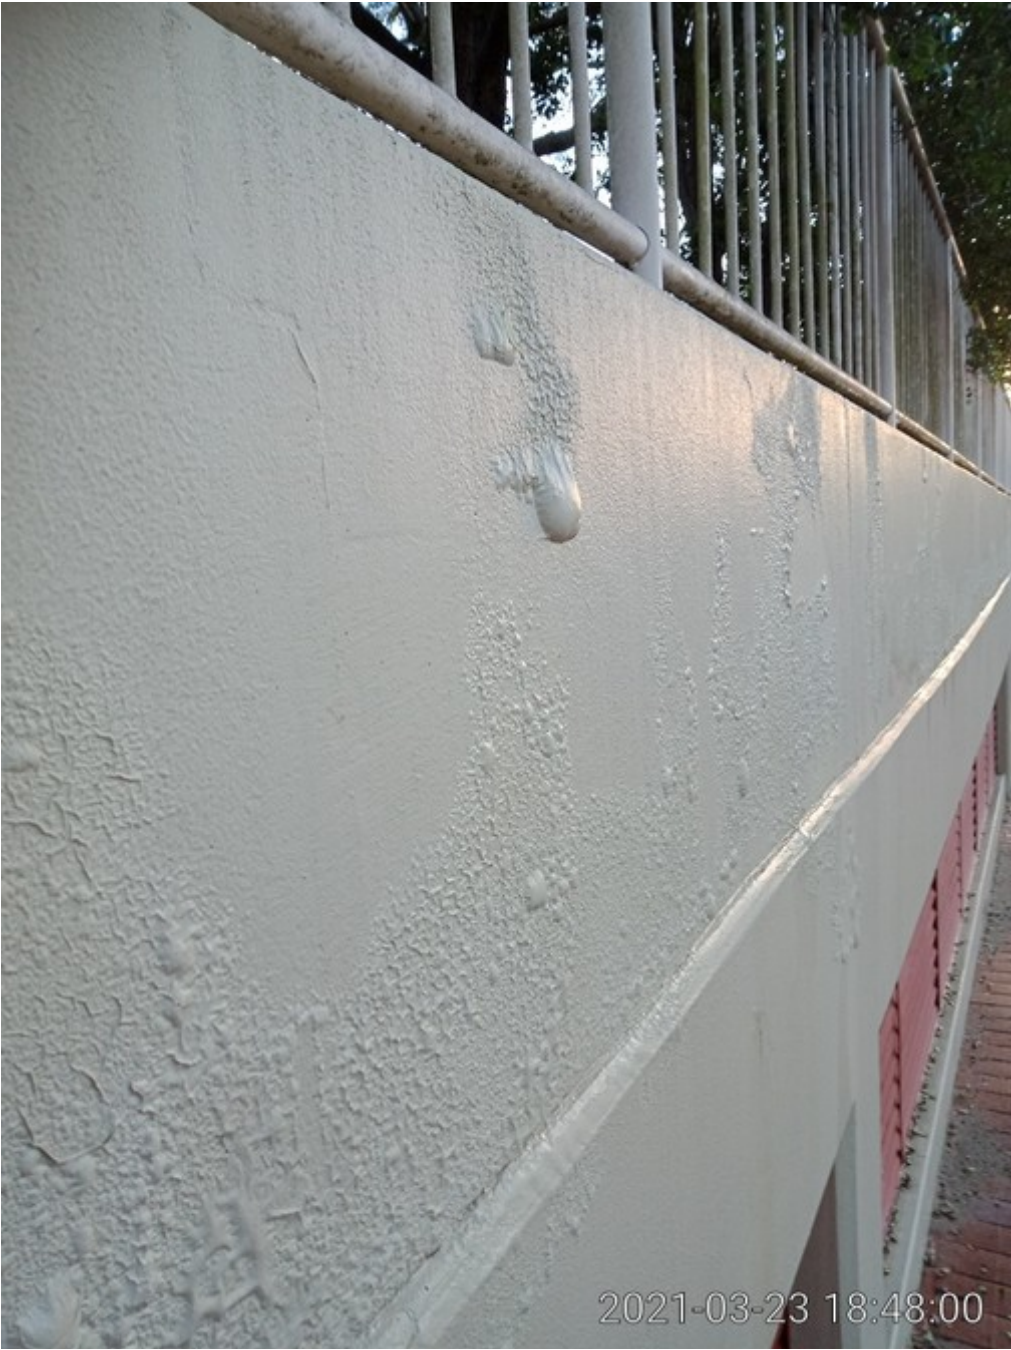
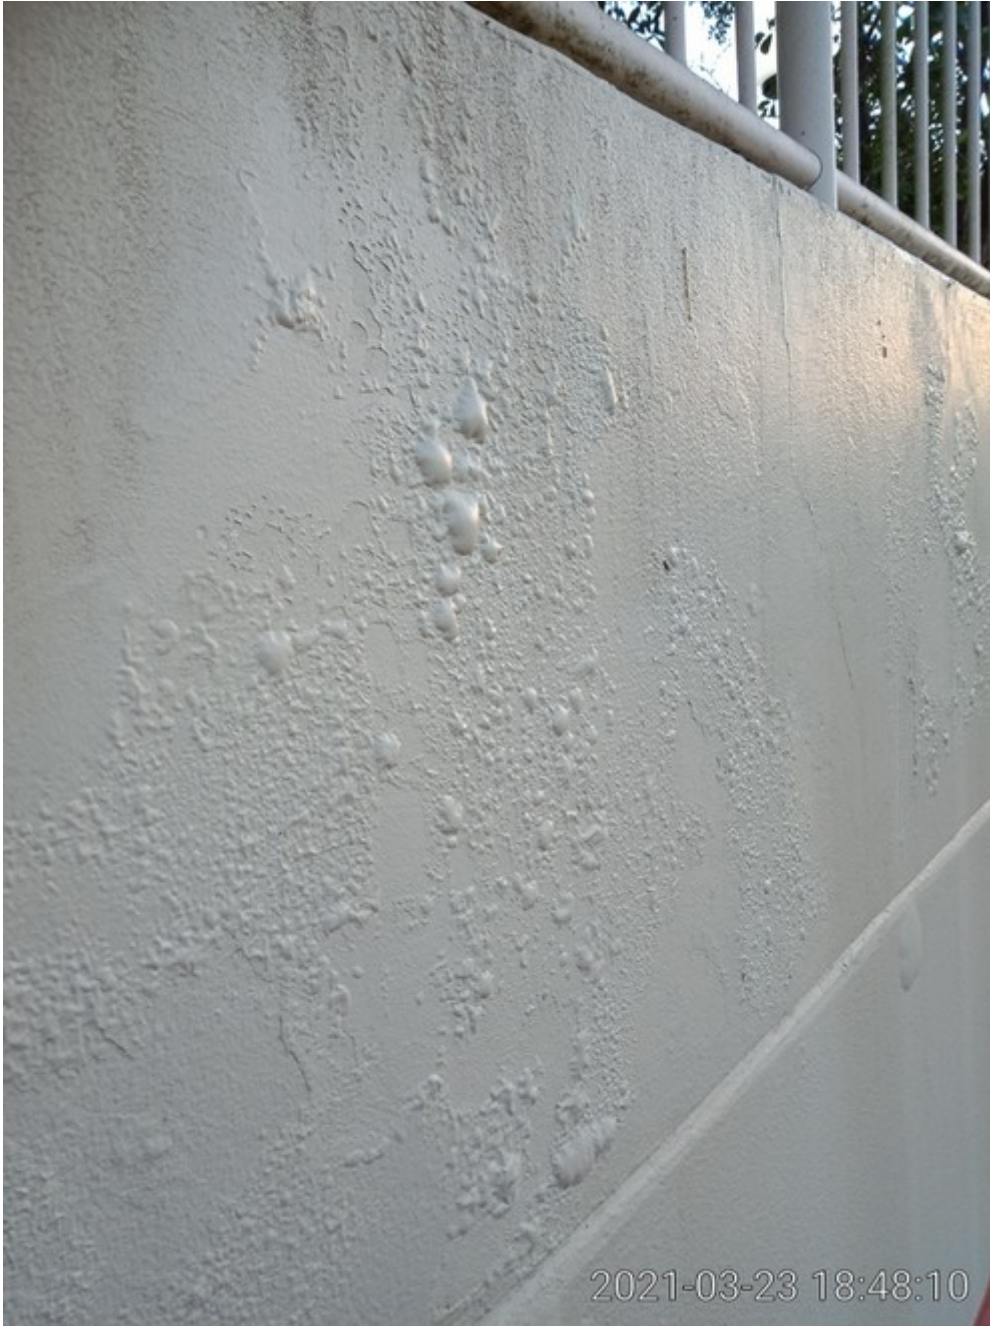
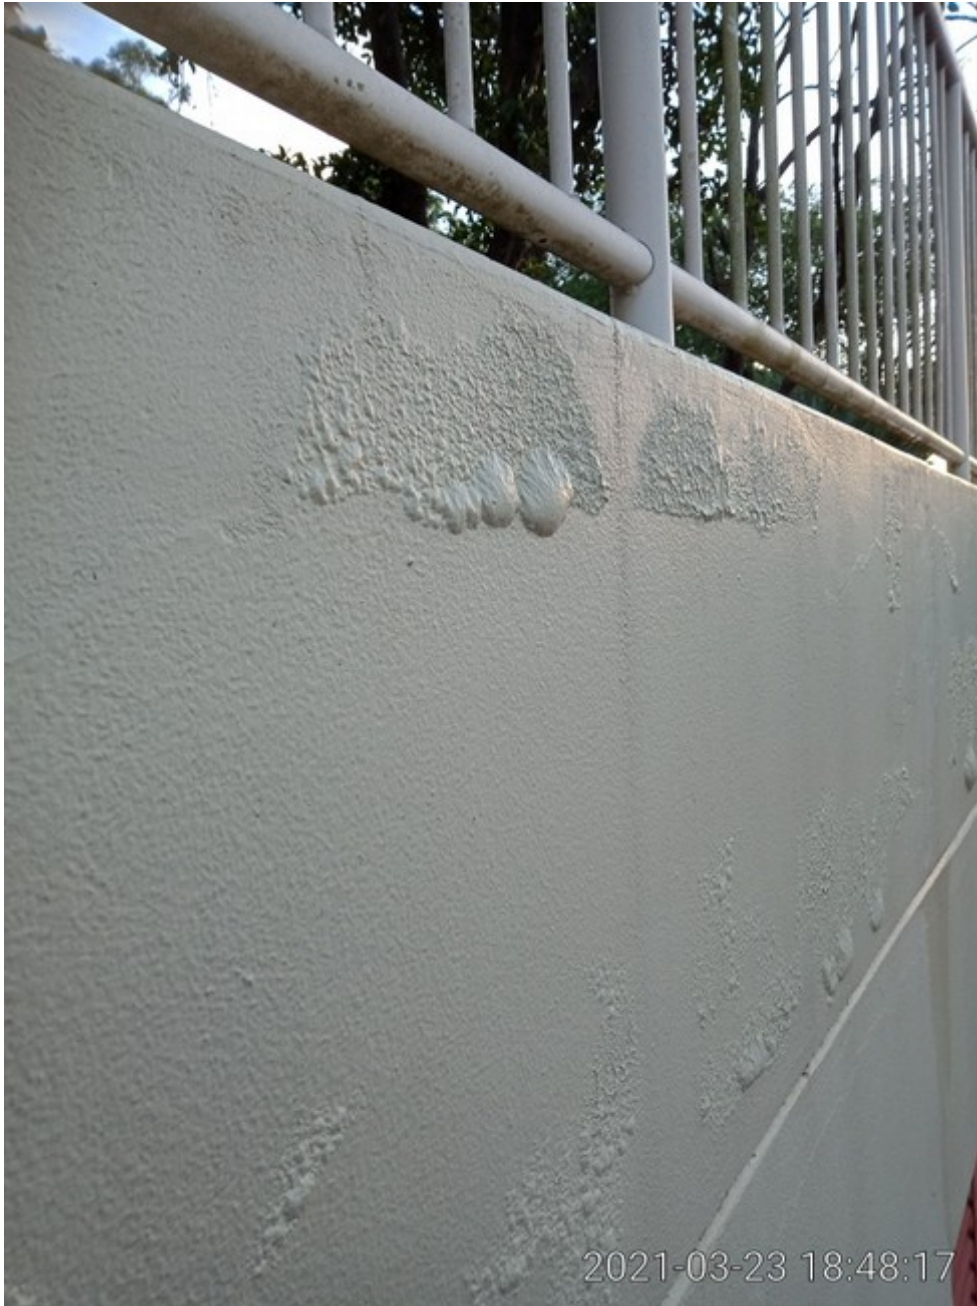
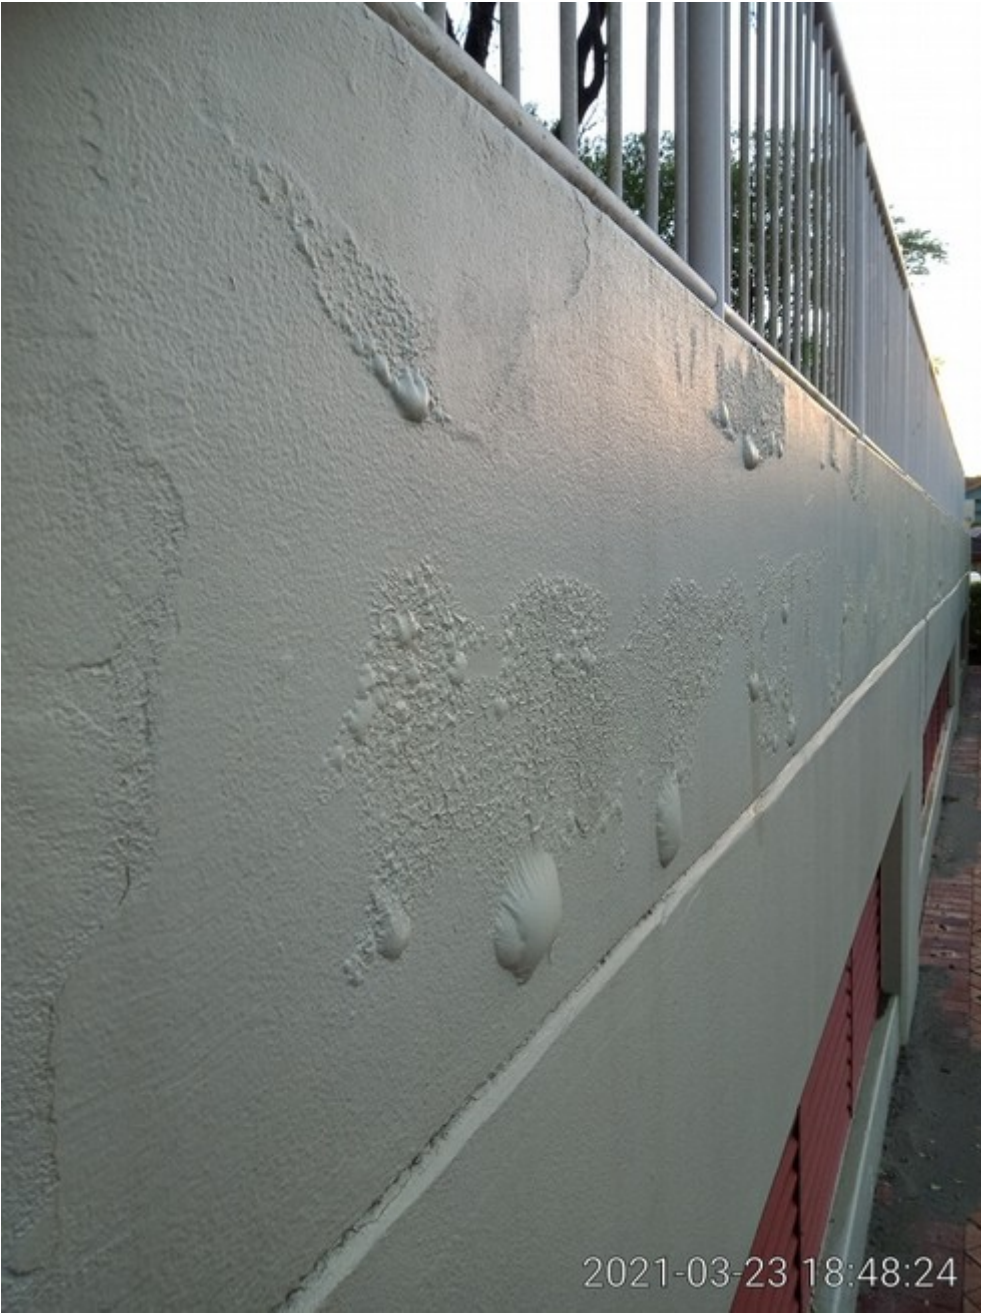
37 Appearance of garden bed walls near tennis courts after rain
