Major upgrades on 26 townhouses in amount of \$92,950.00 in 2017 without evidence of work done

1 SP52948 – Solicitor Adrian Mueller, on behalf of owners corporation, confirming that maintenance of common property is compulsory and that some strata files are missing on 14th of November 2019

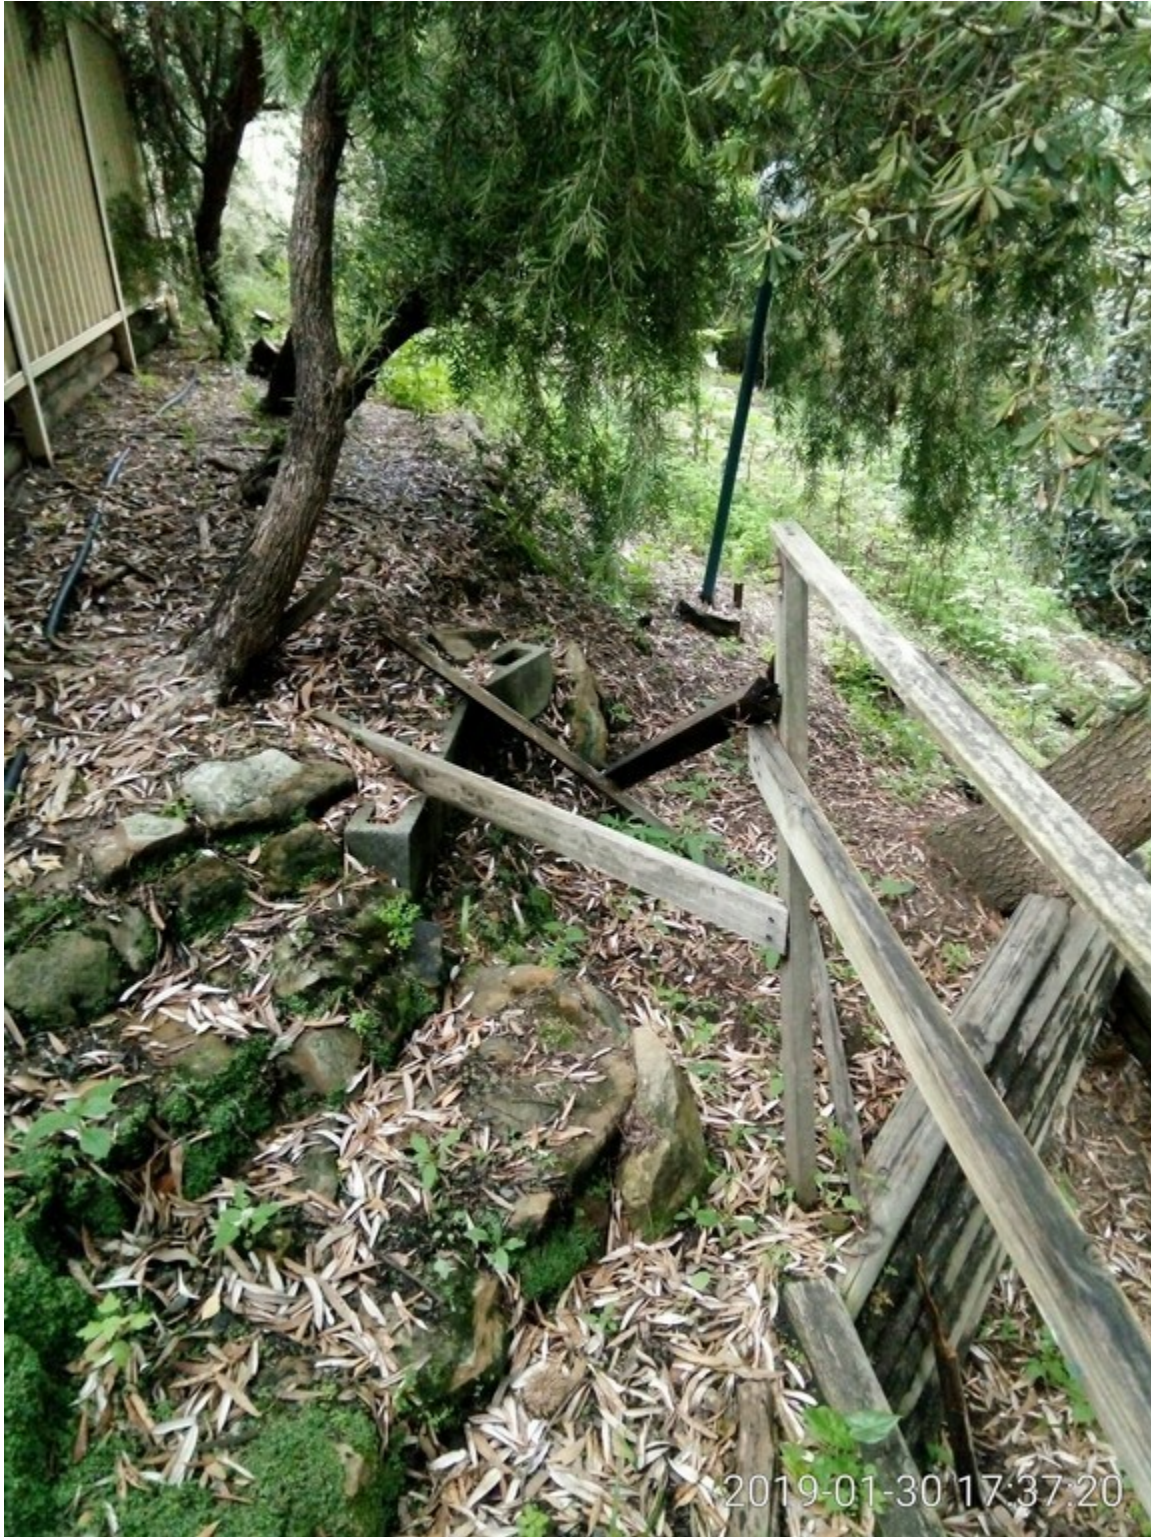
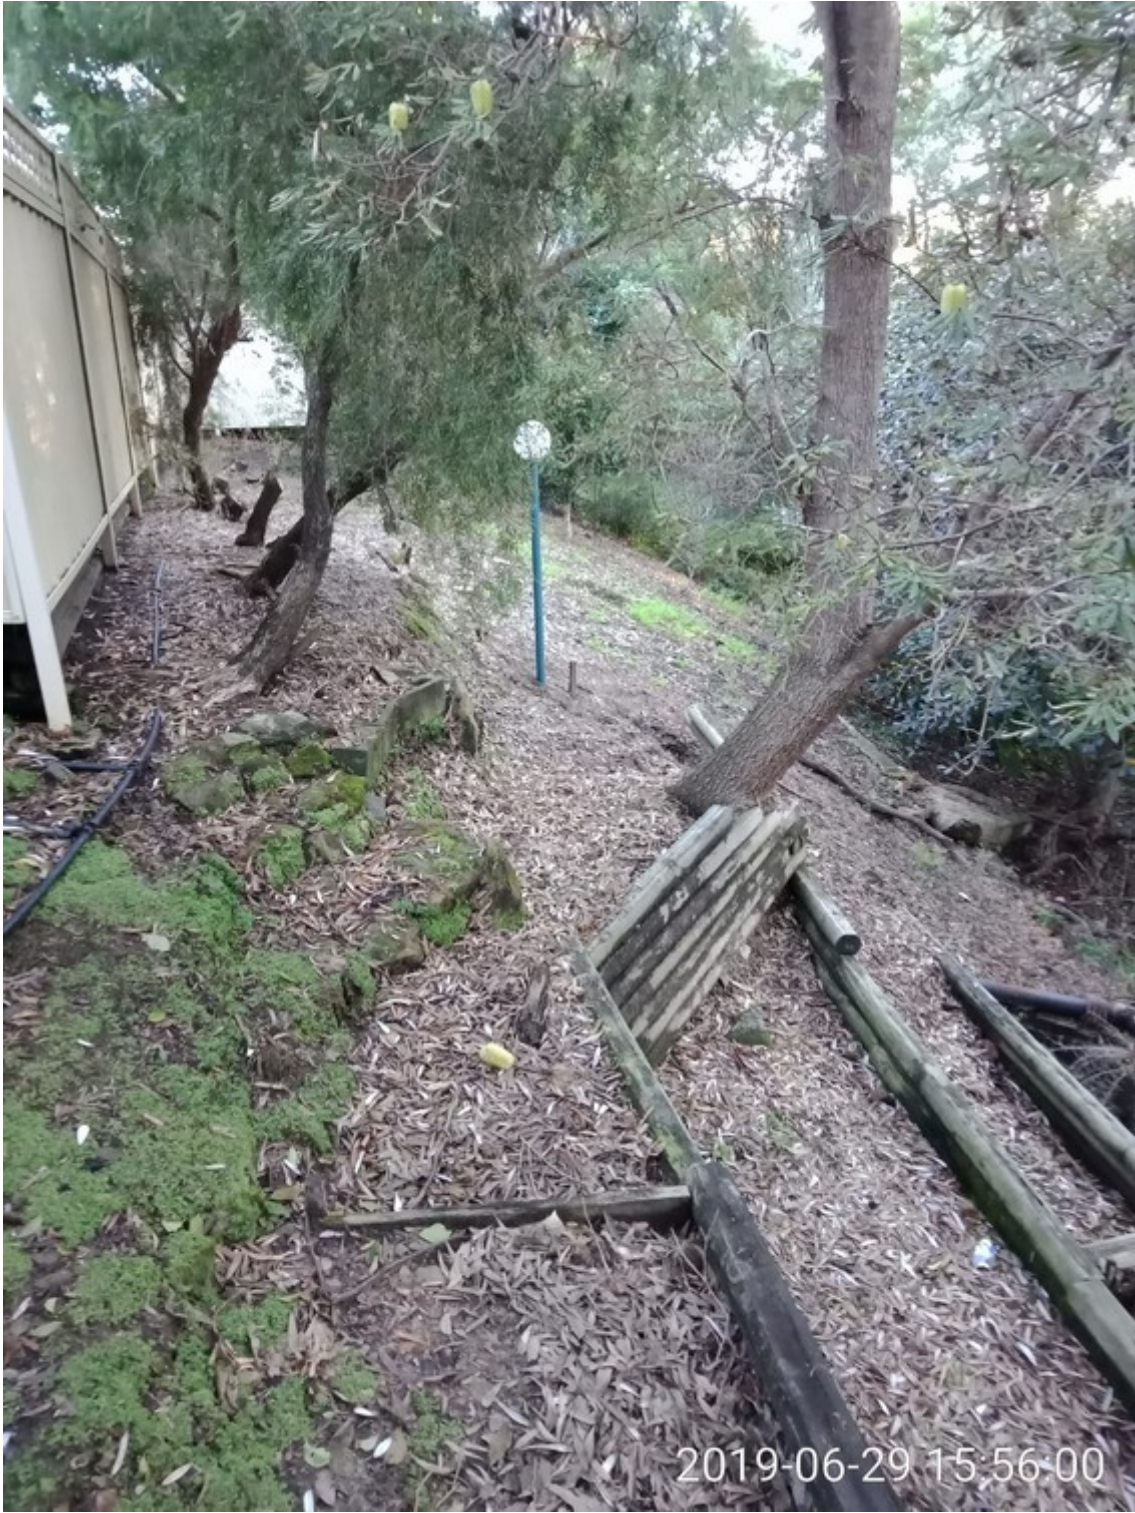
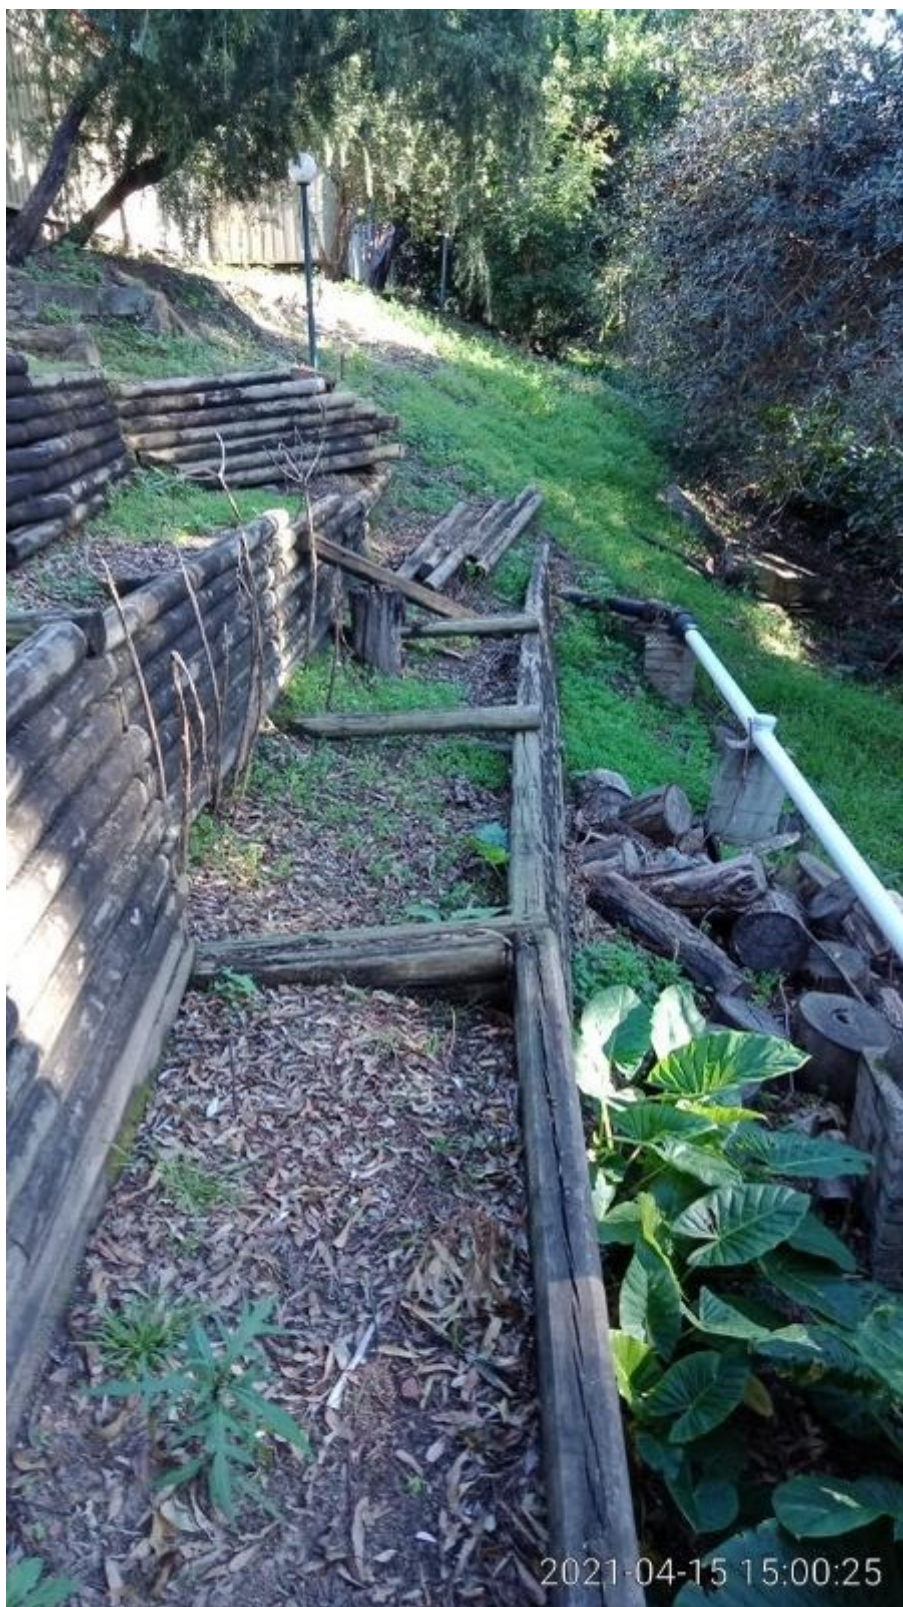
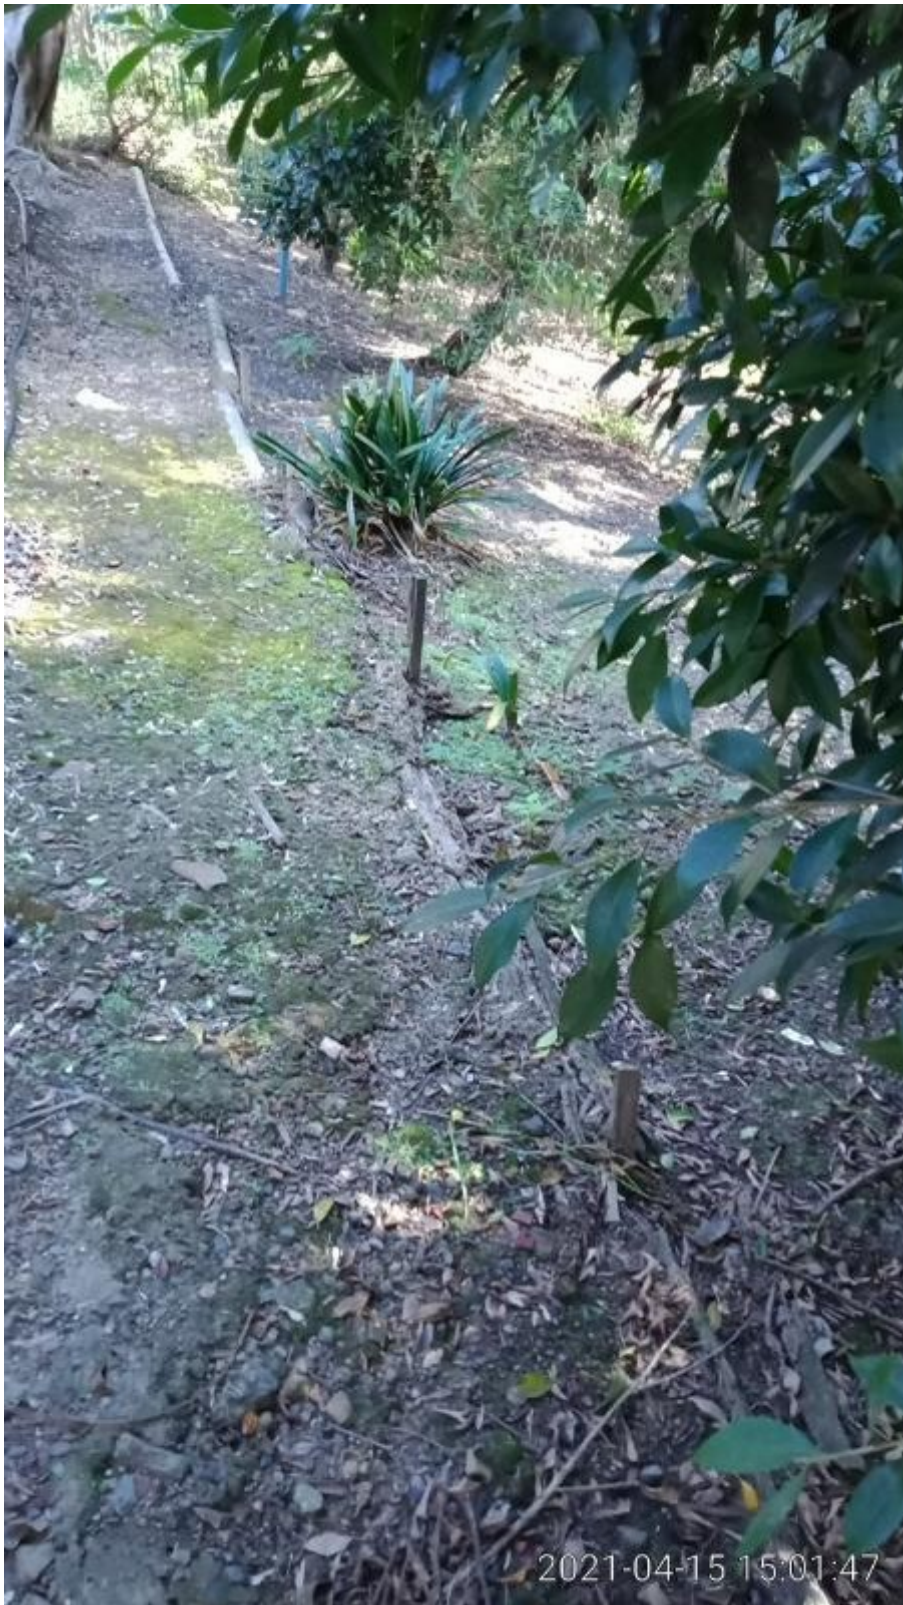
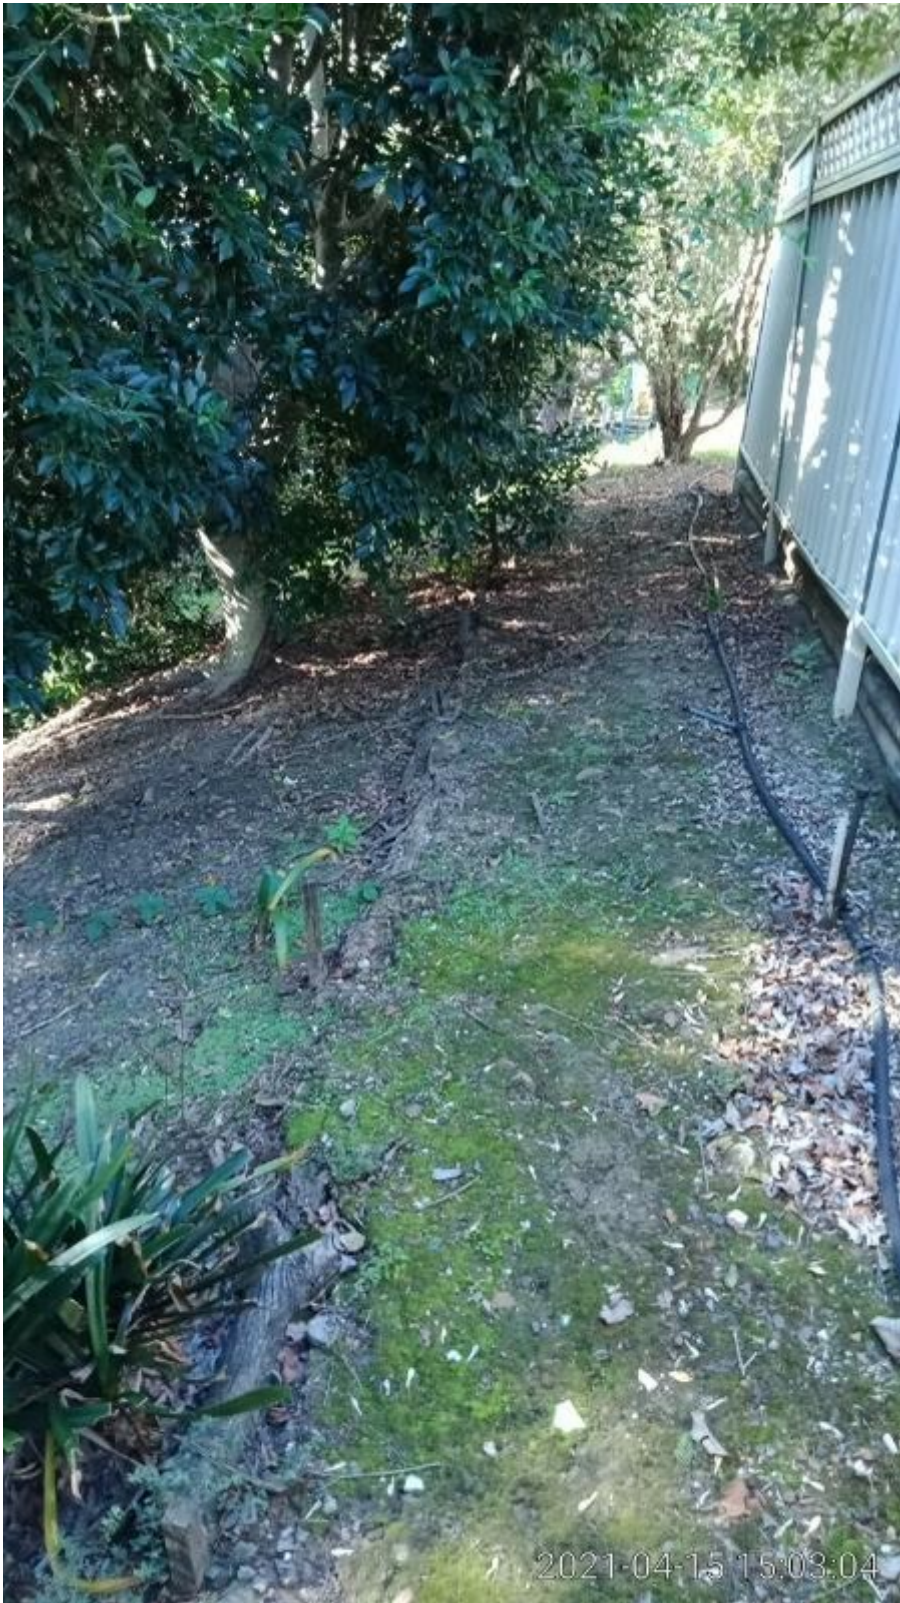
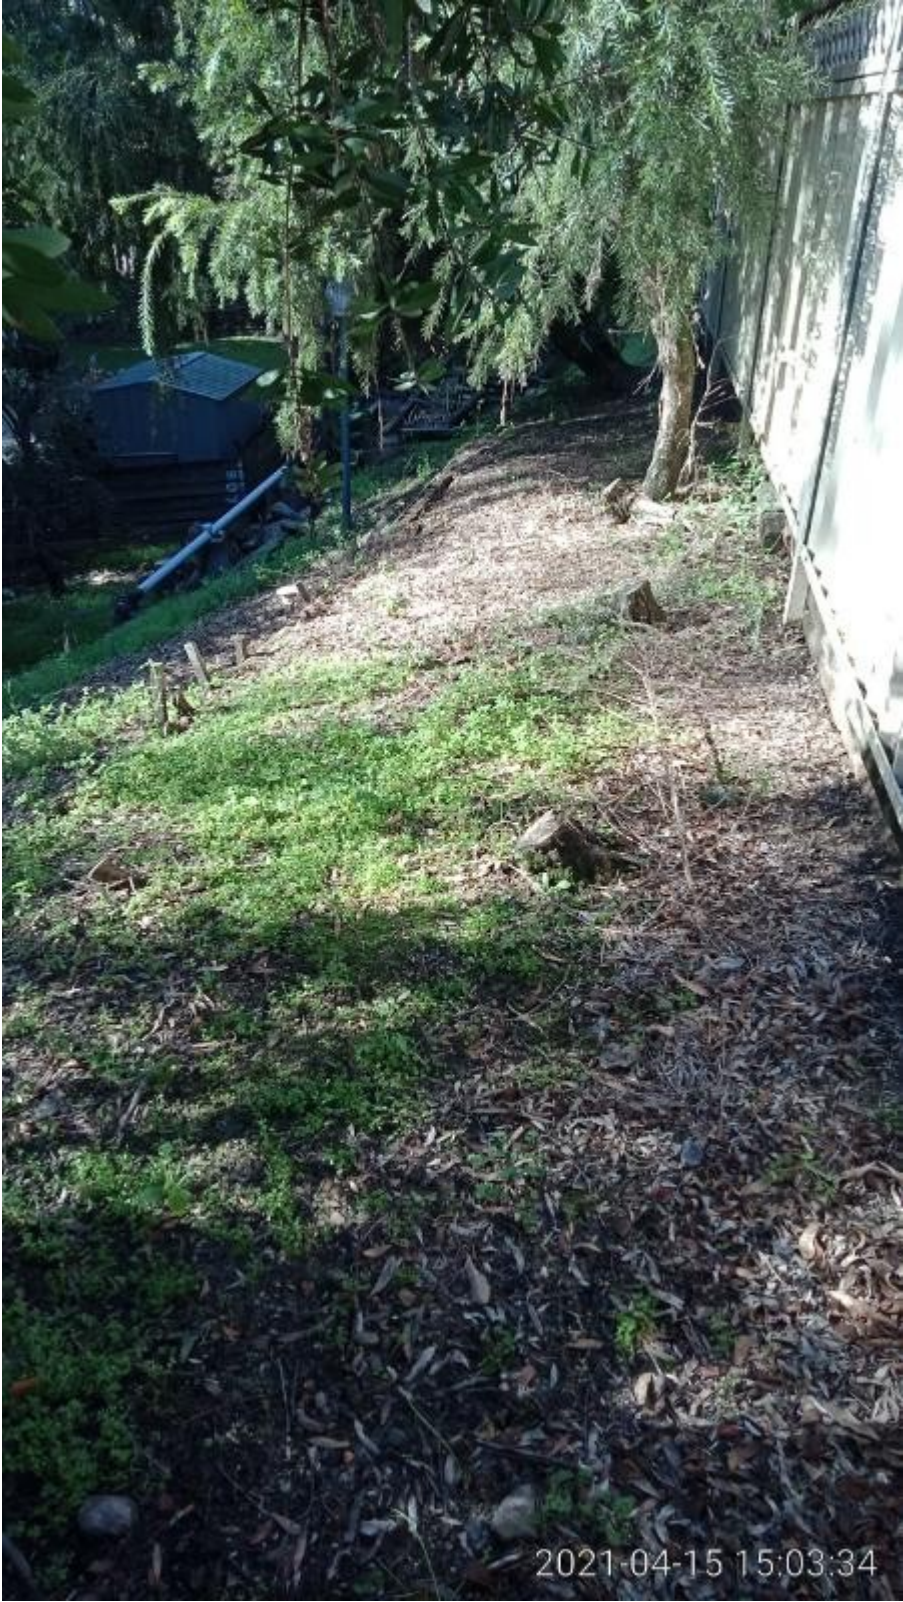
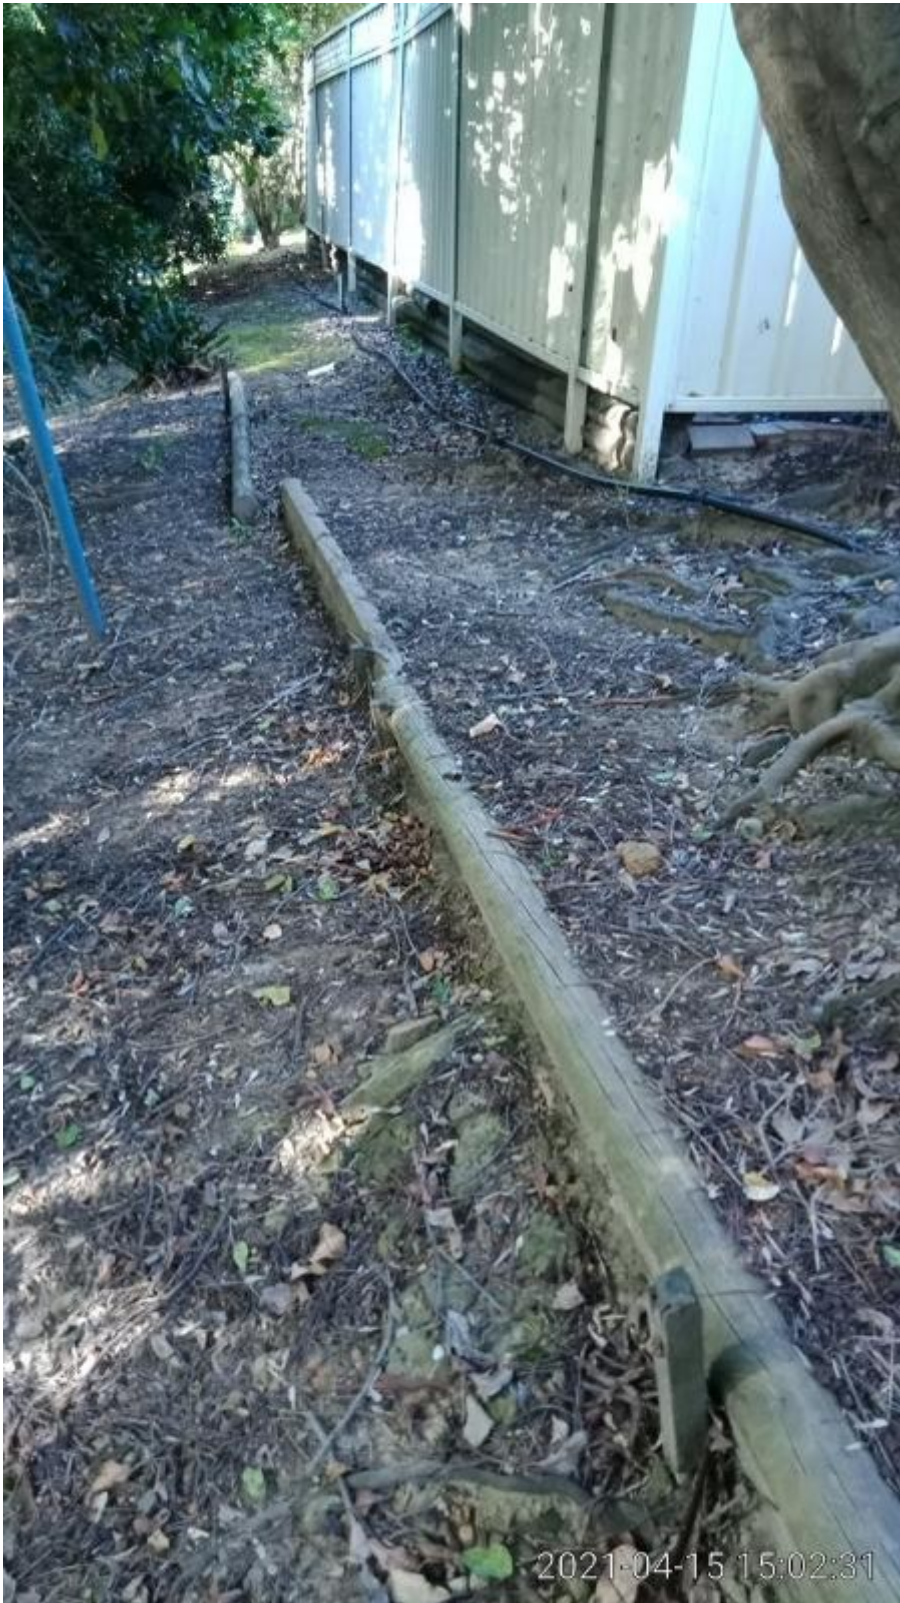
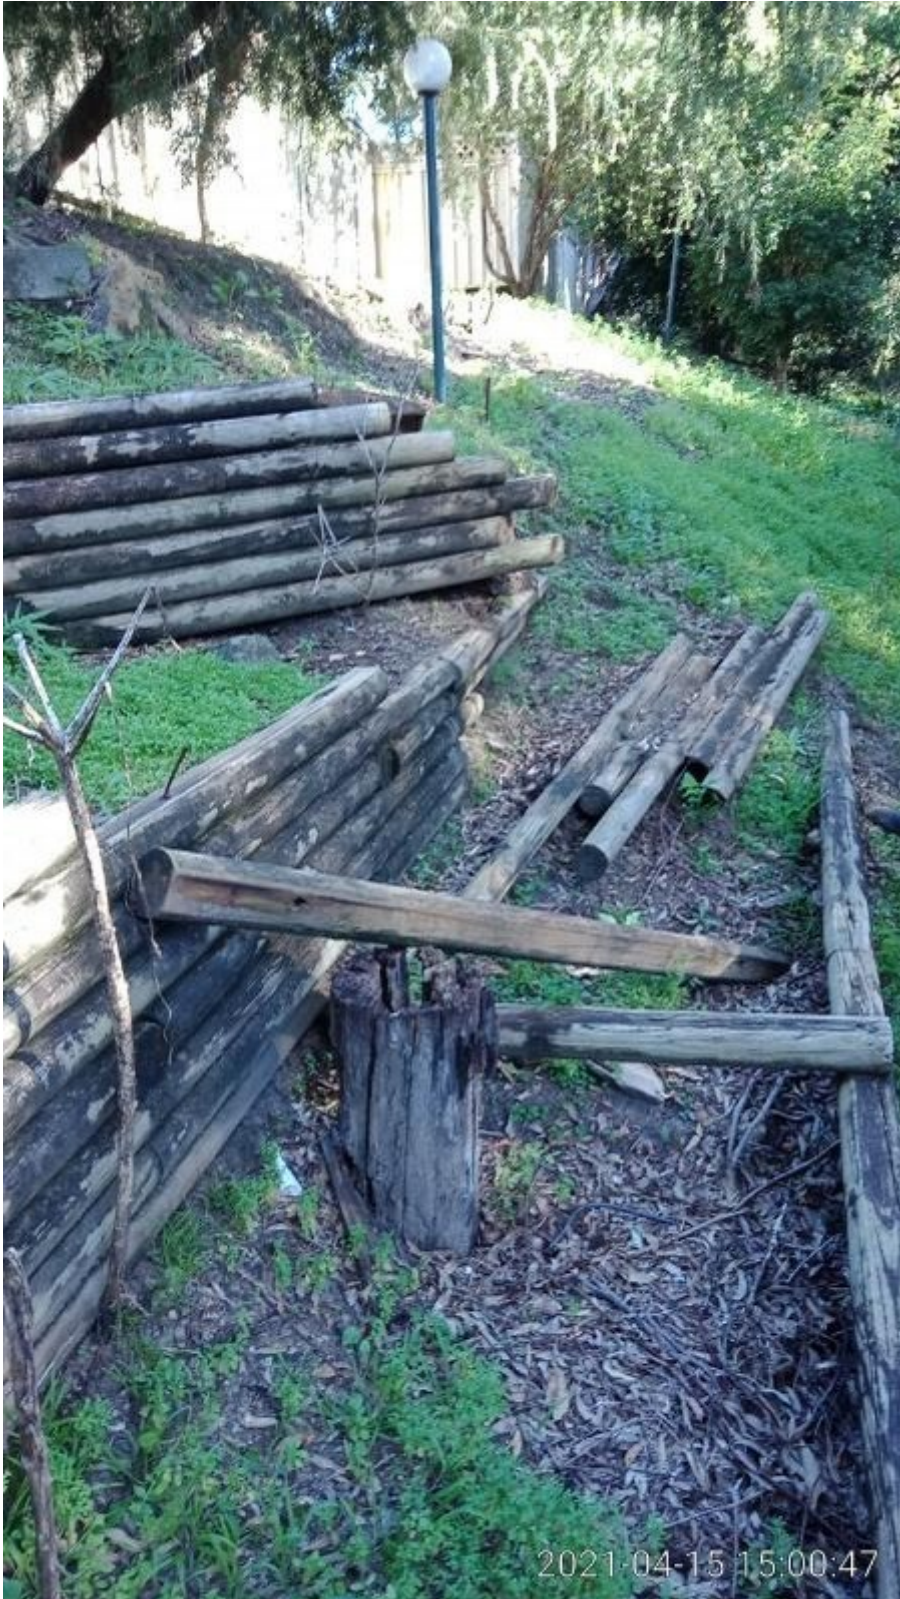
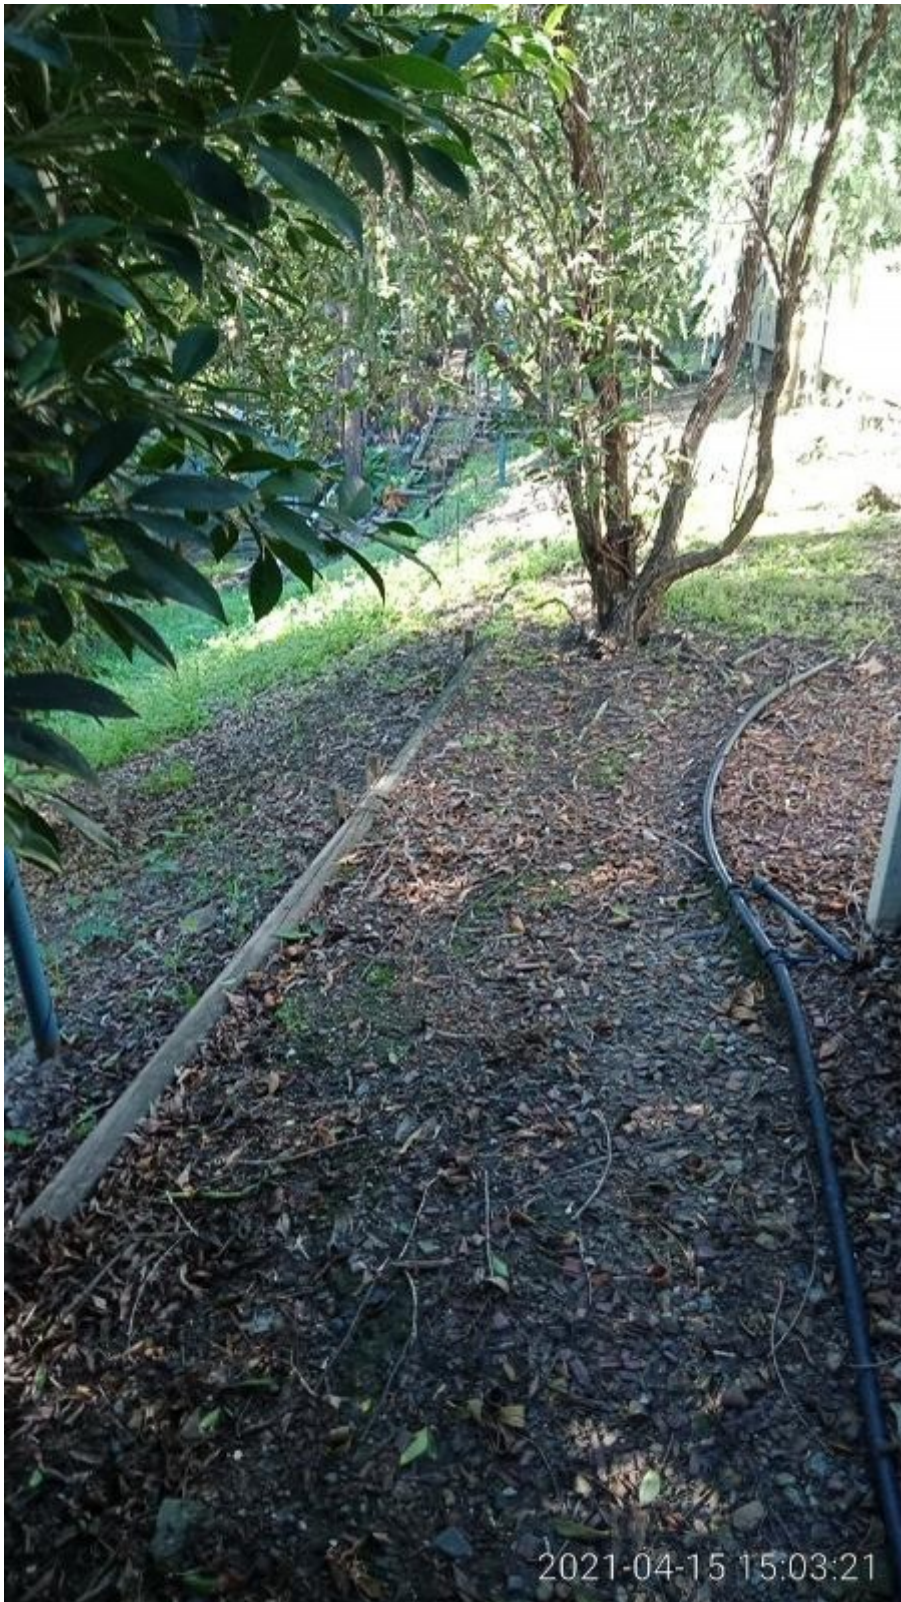
39 Wooden railings disappeared behind townhouses due to rot and not repaired since 2014

Most of railings started collapsing since 2015. Attempts to reason with strata managers to repair common property failed.

As of October 2021, walking in sloping site behind townhouses is quite risky, especially for workers.

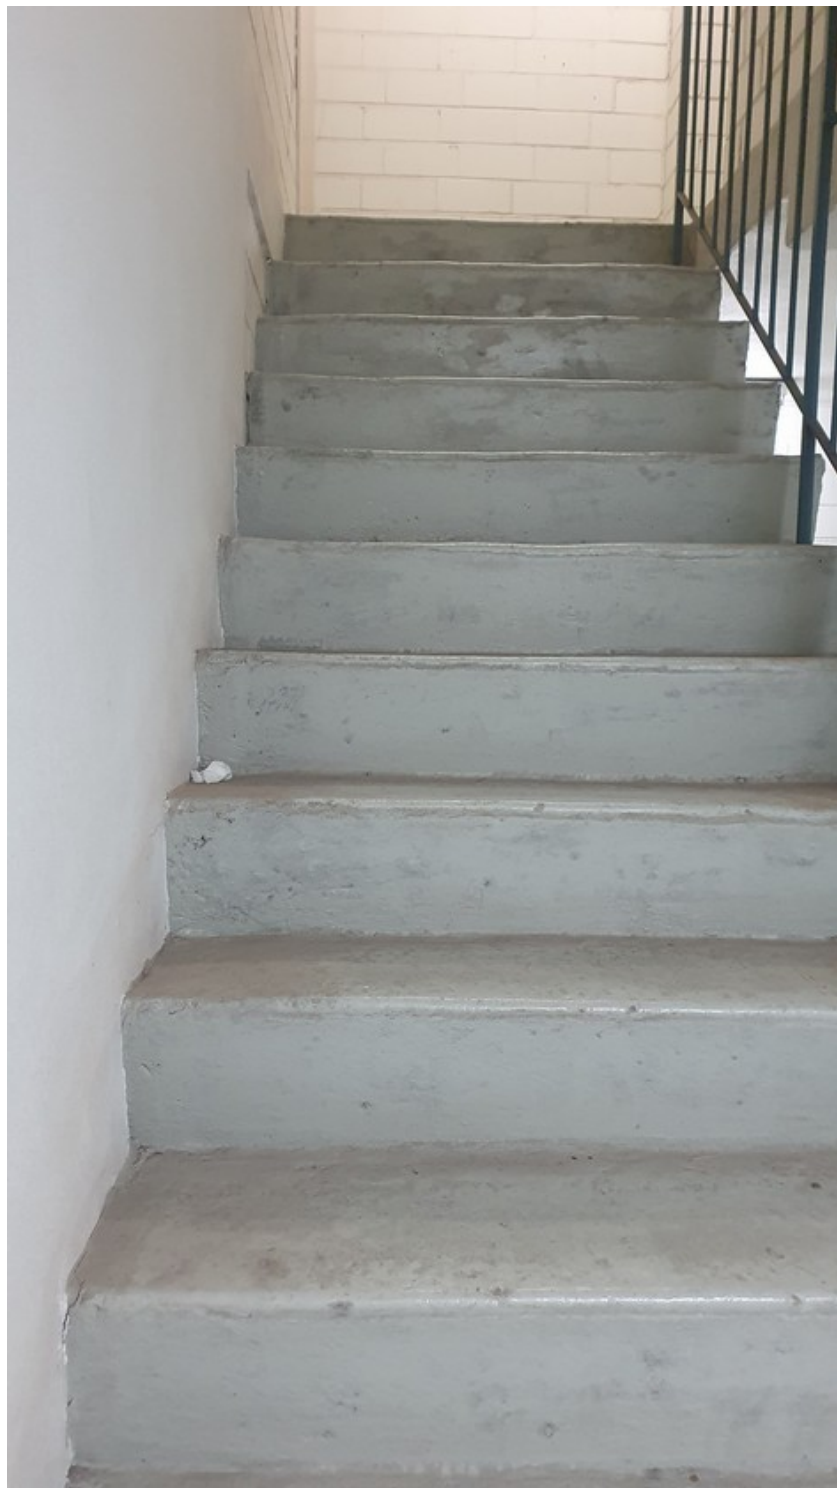
45 Used paper napkin not cleaned from fire stairs in Block A for 12 months (since 24 September 2020) and finally removed in August 2021

Photo last taken on 26 July 2021:

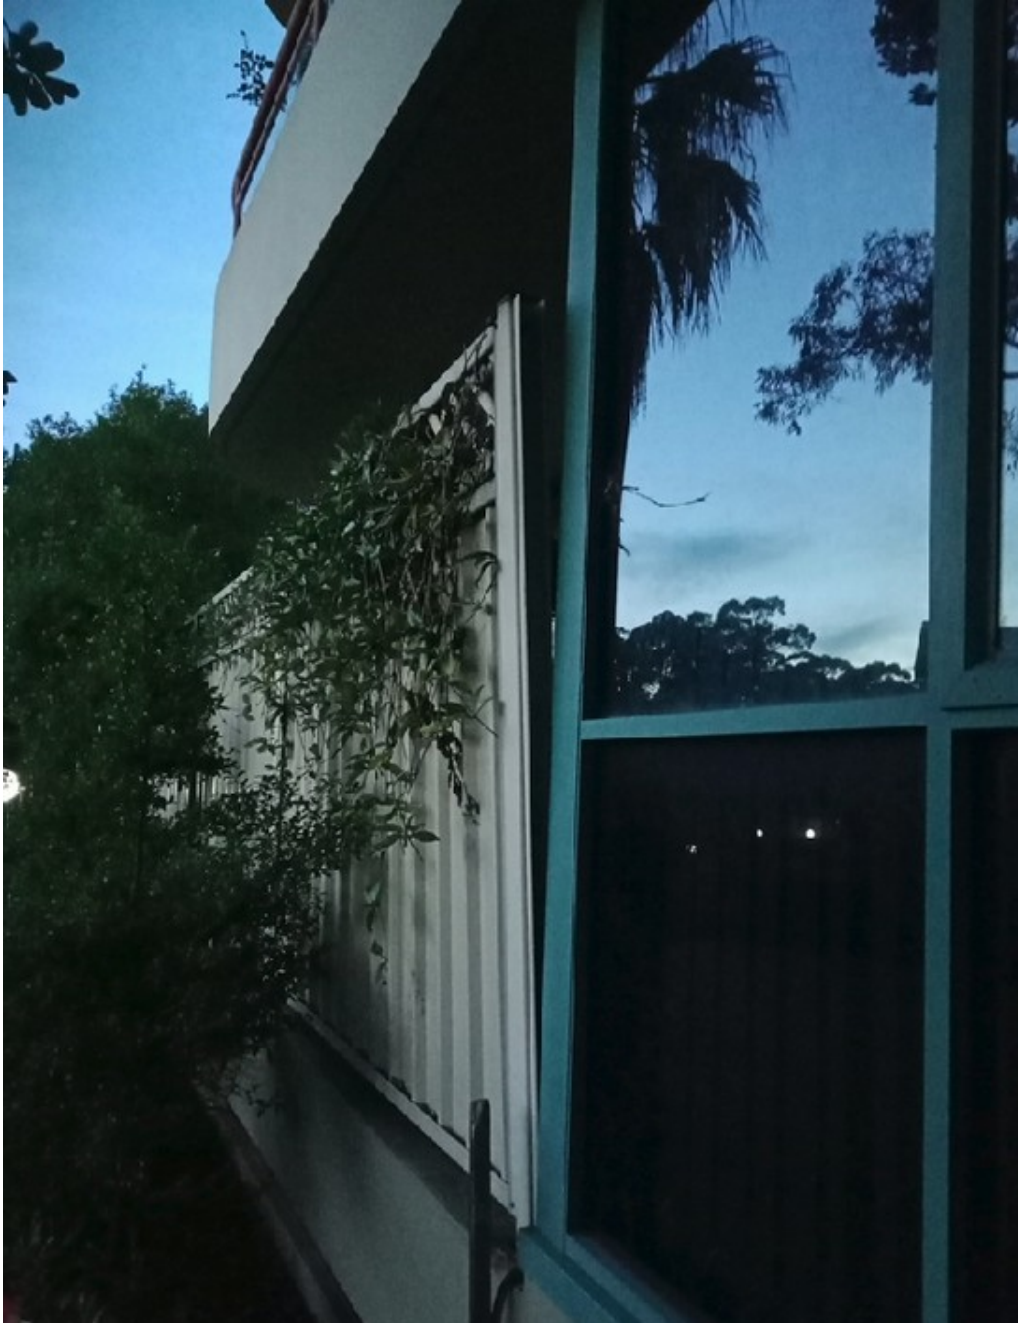
48 Leaning colorbond fence in courtyard of Lot 147 not repaired for seven months

As of late July 2021, it looks as this:

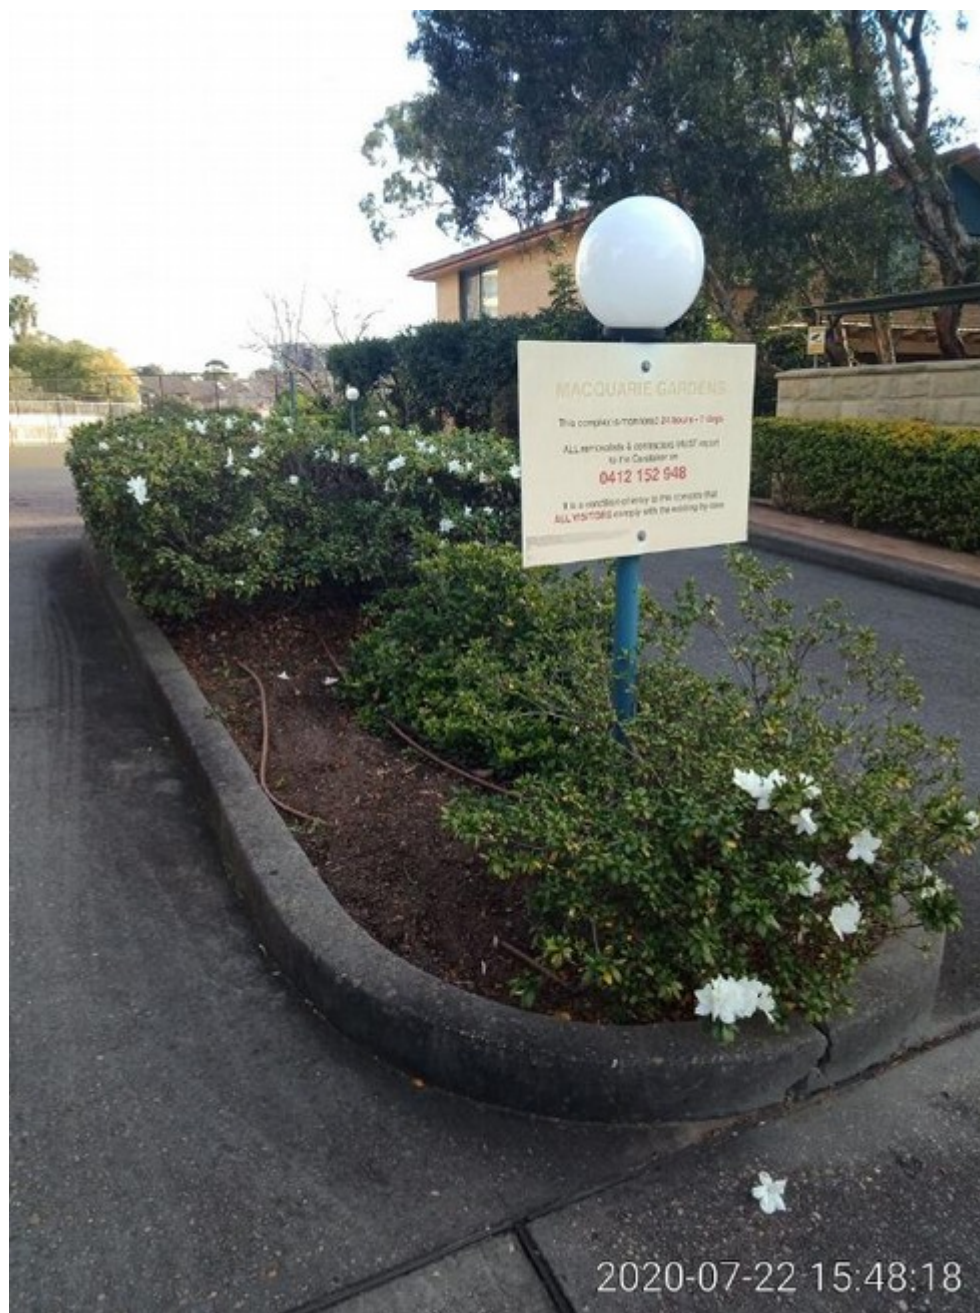
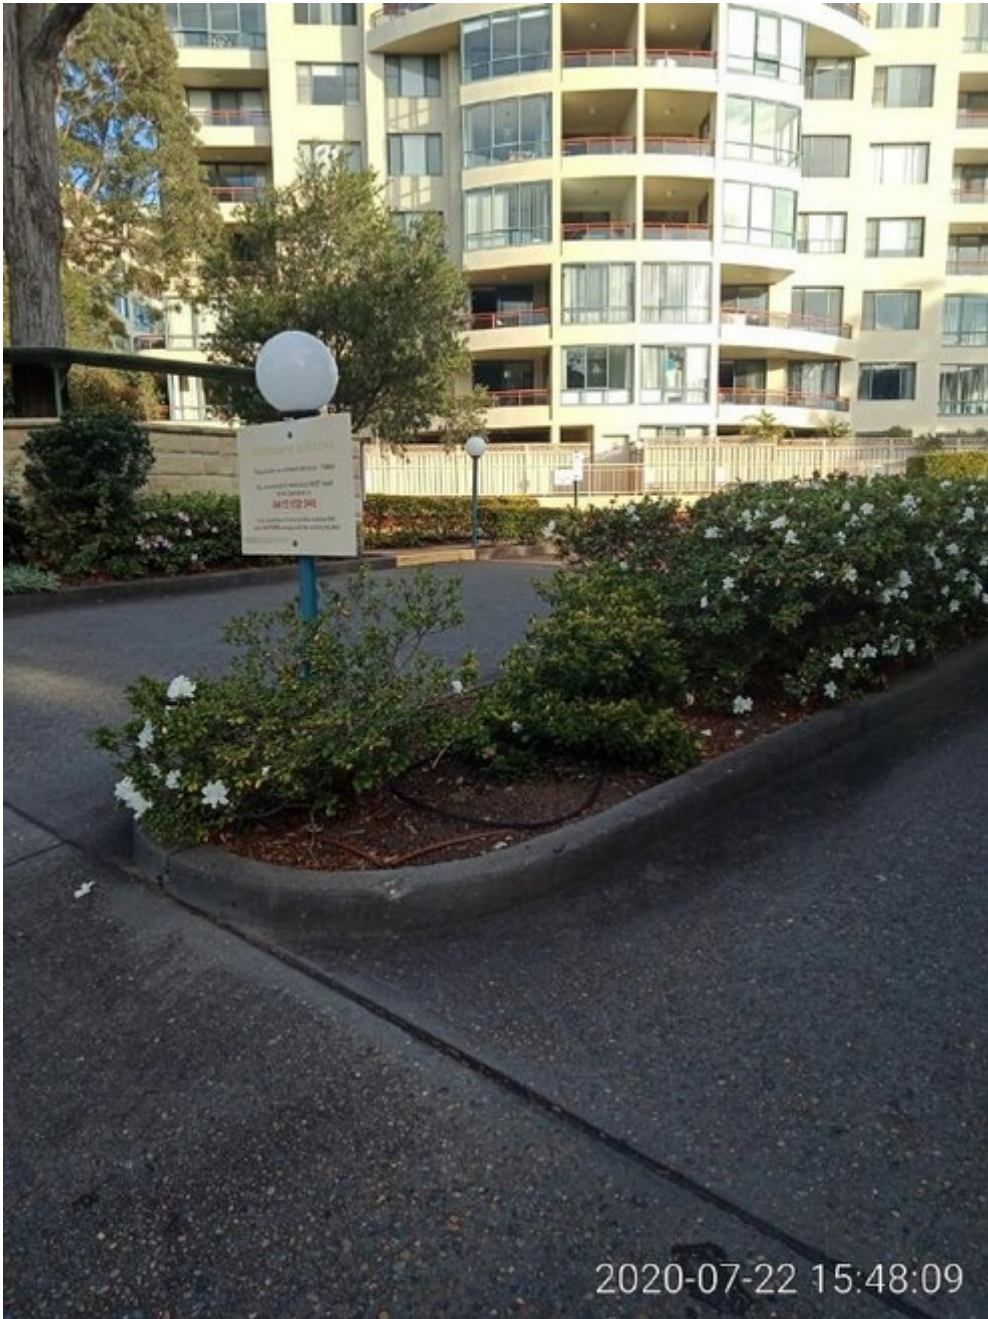
52 Unsightly entrance to the complex

On 29 July 2020, complaint was sent to Waratah Strata Management about appearance of the gardens at the entrance to the complex.

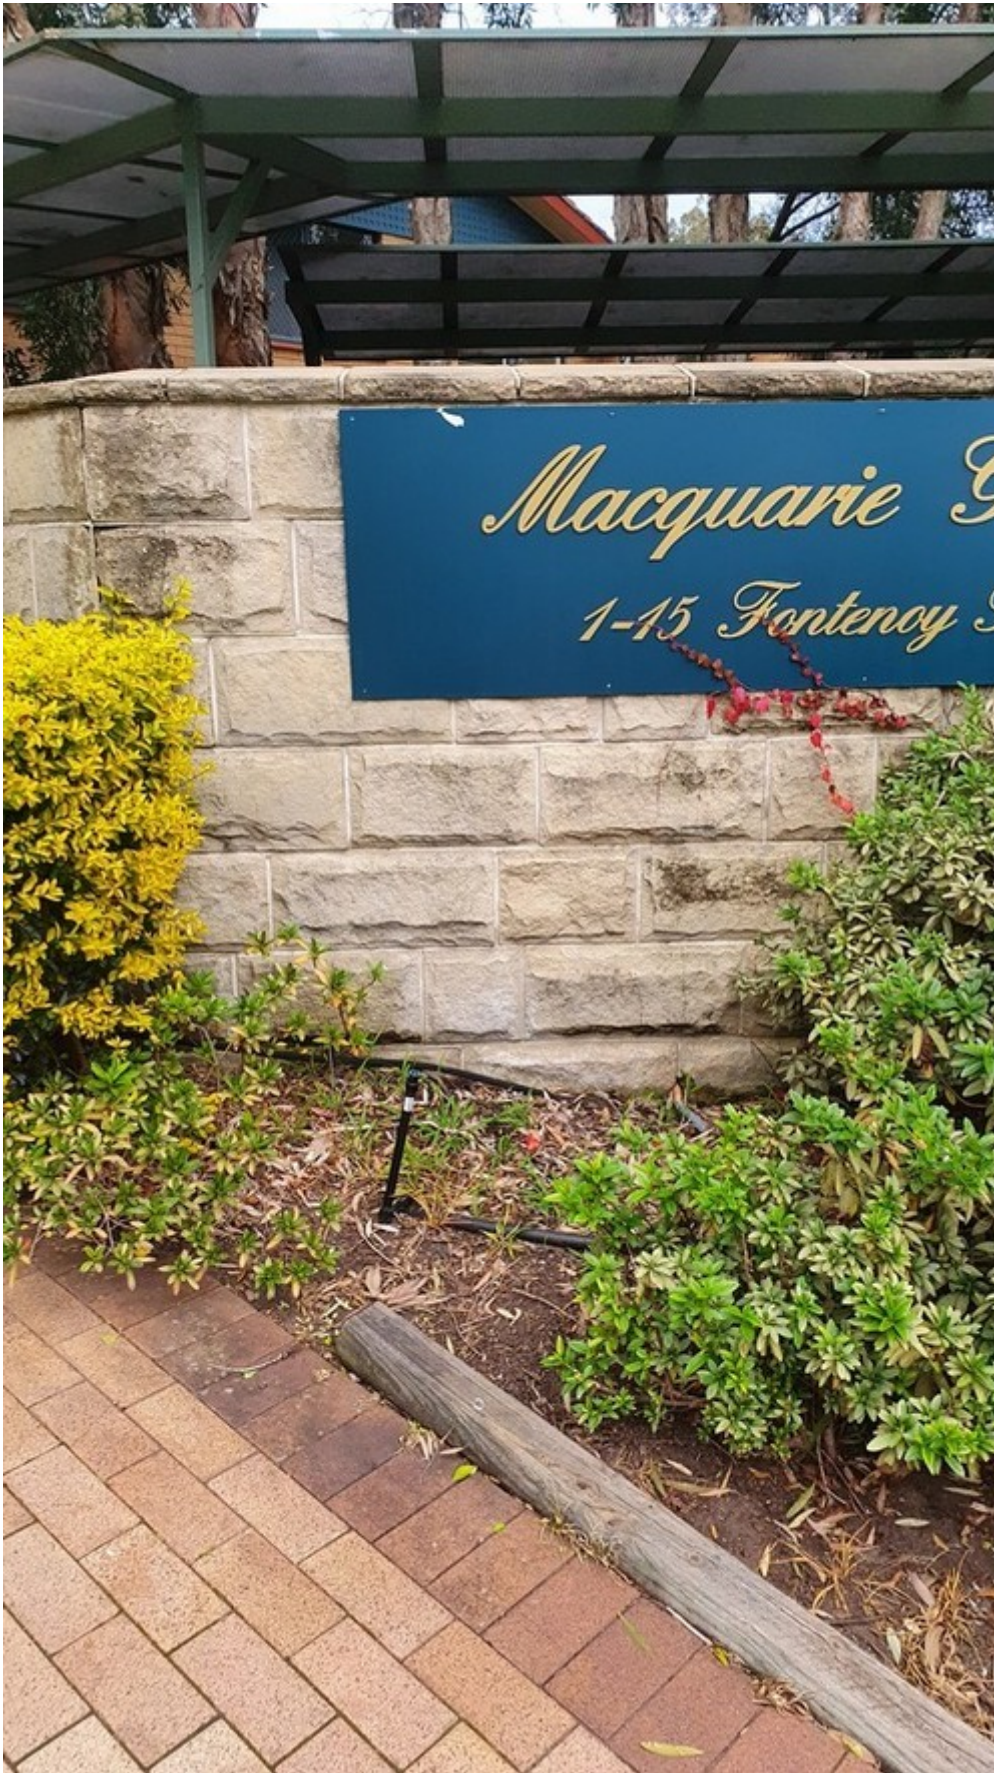
These shrubs are missing/dying for several years.

Photo taken on 28 July 2021:

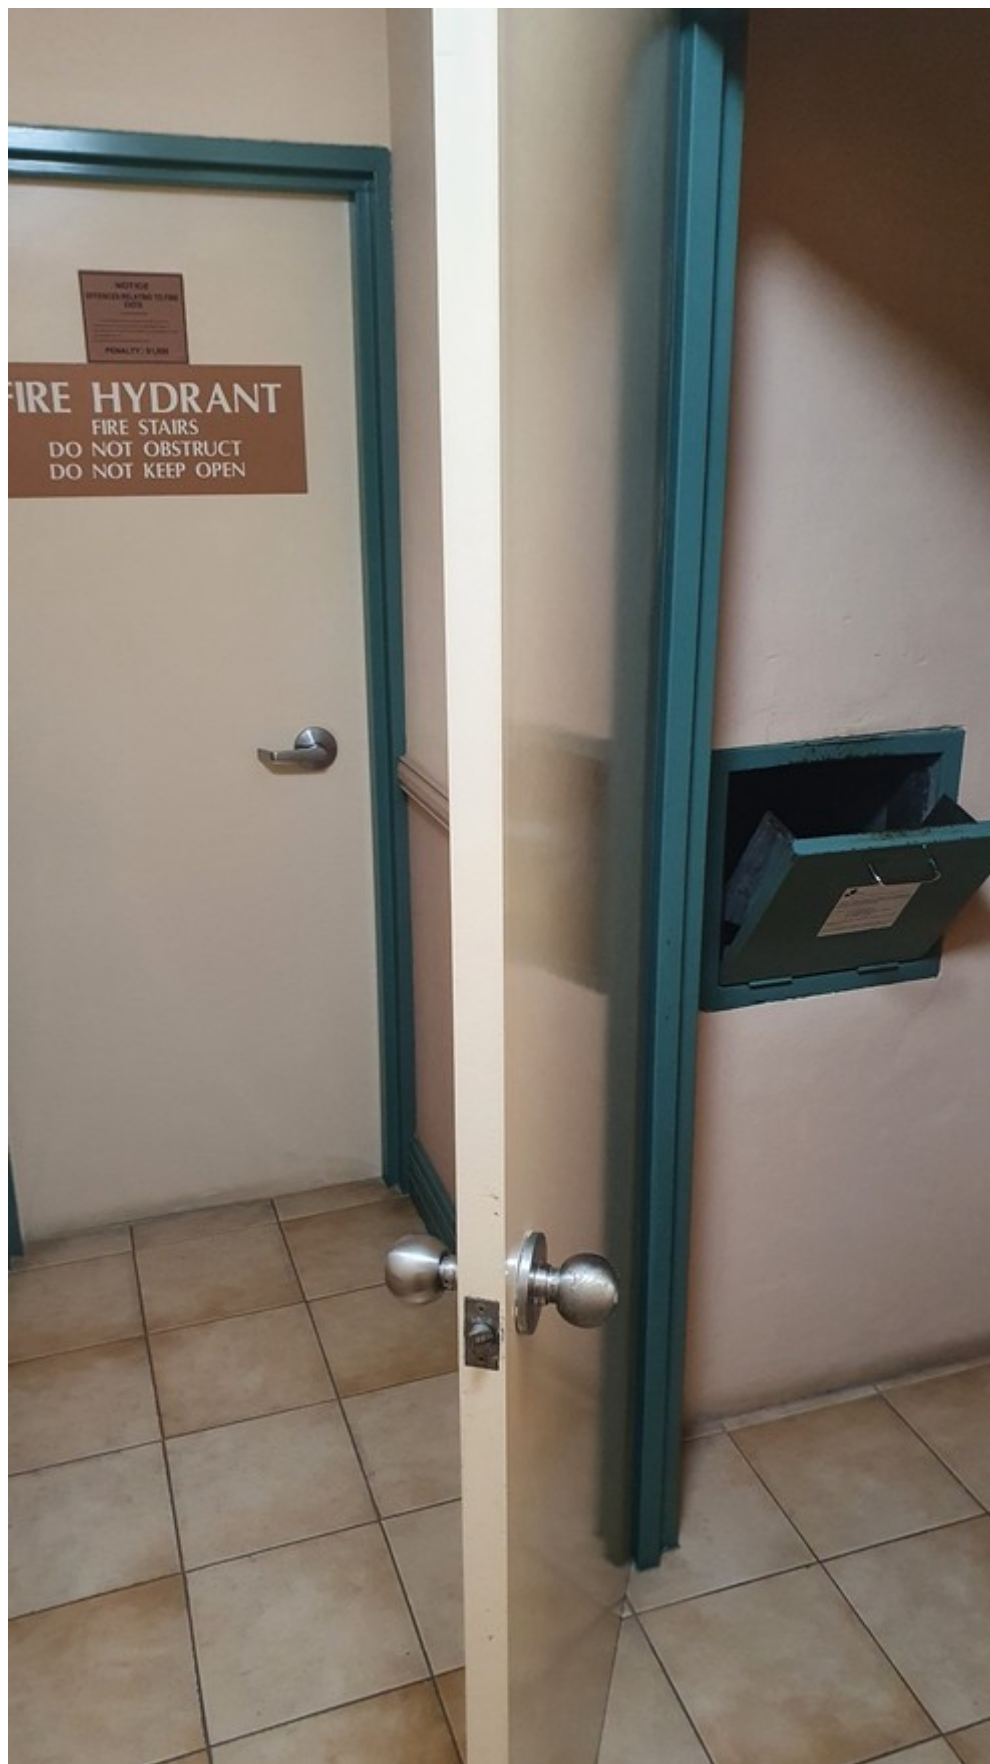
53 Long-term problem with some garbage system refuse compactors in four buildings not closing

Examples from Block A, seventh floor:
